NATIONAL TRANSPORTATION SAFETY BOARD

Flight Data Recorder

Group Chairman's Factual Report by Dennis R. Grossi

Aircraft: Southwest Airlines, Flight 1248, B737-700, N471WN

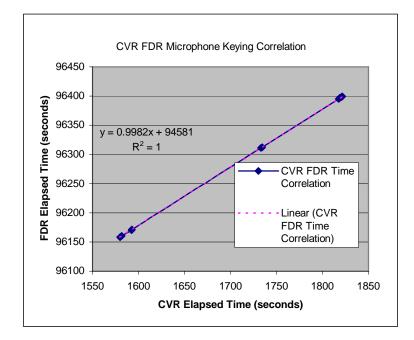
Figure 1

The last five microphone keying events recorded by the FDR and the radio transmission recorded by the CVR were used to establish a common time base for the two recordings. A regression analysis of the time interval between the start and stop of each radio transmission as recorded by the FDR and CVR indicated a linear relationship with a coefficient of determination (R²) of 1, where 1 represents the best possible fit (see Figure 1). The Aircraft Performance Group established the following local time correlation (see Group Chairman's Factual Report for details):

CVR Trans.	FDR Mic Key
1580.005	96157.816
1581.604	96159.816
1592.554	96169.816
1592.932	96170.816
1732.953	96310.816
1734.396	96311.816
1817.746	96394.816
1818.916	96396.816
1820.61	96397.816
1821.501	96398.816

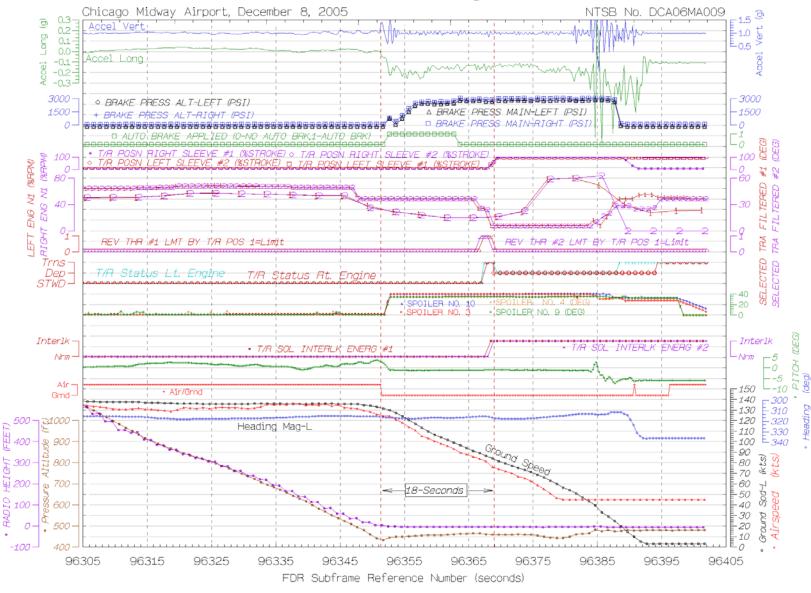
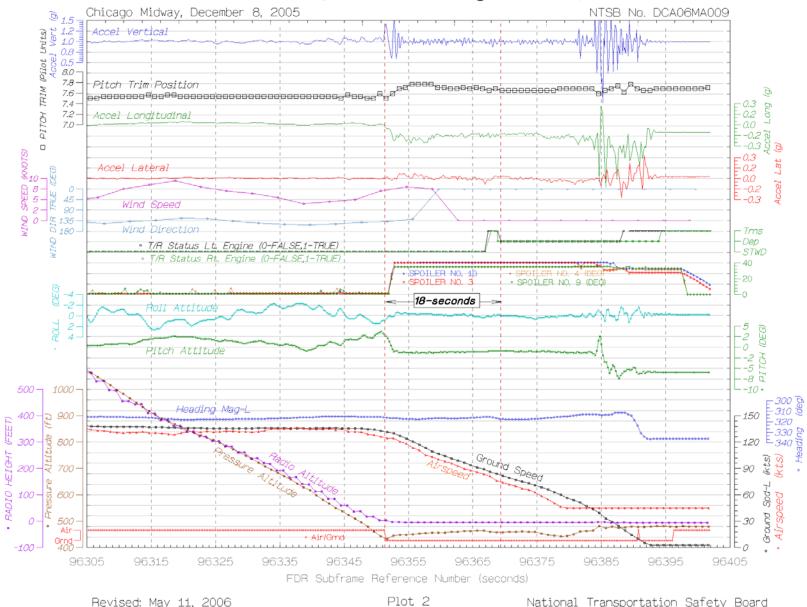
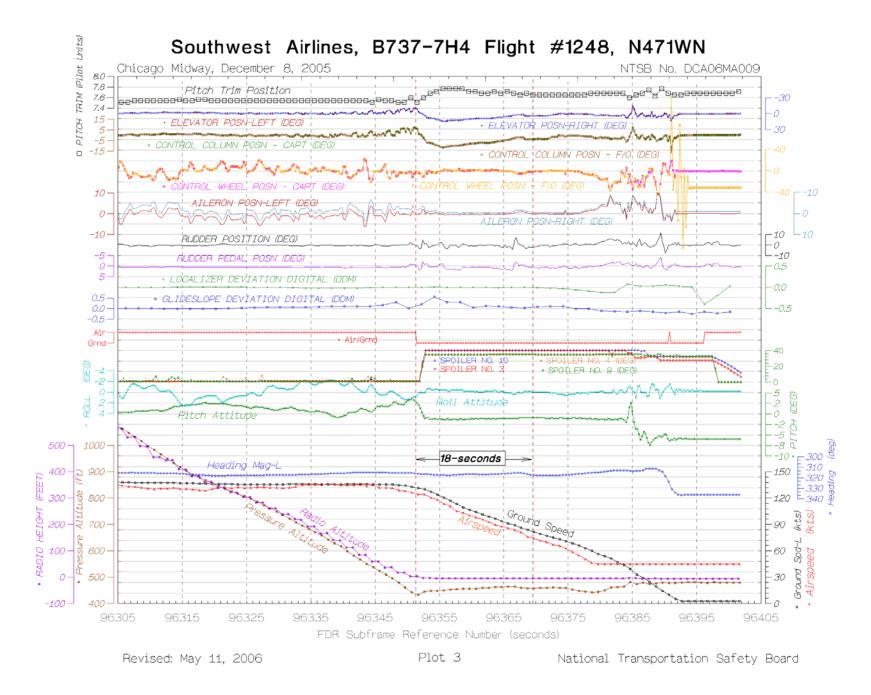
Southwest Airlines, B737-7H4 Flight #1248, N471WN

Plots of selected parameters for the accident flight and the prior flights listed above are attached. The plots cover the period from short final through the landing roll and runway departure. For comparison, the longitudinal acceleration and ground speed traces from the accident flight are overlaid on the corresponding traces of the prior flights. The time correlation between the accident flight and prior flights was established at main gear touchdown as determined by main gear air/ground parameter.

- Until approximately 13 seconds prior to touchdown, the glide slope and localizer data indicate a less than ½ DOT¹ deviation from the instrument landing system (ILS) glide path. At this point in the approach the radio altitude had decreased to 141 feet and the glide slop deviation value reached approximately 1DOT (high or Fly Down), where it remained until just prior to touchdown. The localizer values did not deviate more than 1/2 DOT;

- When the main gear air ground parameter indicted the transition from air to ground or main gear touchdown the airspeed was 124 knots, the ground speed was 131 knots, heading 316° and the vertical acceleration reached 1.413 g's. The wind speed and direction at touchdown were 5.5 knots and 147.7°, respectively.

- The ground spoilers fully deployed and auto brakes were applied within 1.25 seconds after main gear touchdown as vertical acceleration registered a peak value of 1.74 g's. Once the auto brakes were activated the brake pressure rose steadily over the next 5-seconds to 2400psi (left. brake) and 2600psi (right. brake).

- The longitudinal acceleration values reached a peak deceleration of –0.26342 g's approximately 6-seconds after main gear touchdown as the brake pressure reached the peak brake pressure commanded by the auto brakes. The ground speed decreased to 113 knots at the point of peak longitudinal deceleration.

- Approximately 10-seconds after touchdown engine fan speed (N1) decreased from 32% at touchdown to approximately 20% where it remained for approximately 8 seconds.

- The auto brakes were selected off approximately 12-seconds after touchdown and the brake pressure increased to 3000psi.
- The first indication of thrust reverse activity occurred 15-seconds after main gear touchdown. The thrust reversers were fully deployed 18-seconds after touchdown, and N1 reached 80% 9-seconds later or 27-seconds after touchdown as ground speed decreased to 62 knots.

- The data are consistent with the nose gear departing the paved surface of the overrun and overriding the blast fence 33.8 seconds after main gear touchdown.
 This was evident in the sharply increased activity of the acceleration parameters and pitch attitude, which spiked from -1.9° to 2.6° in less than a second. At this point in
