# Hydraulic and Geomorphic Monitoring of Experimental Bridge Scour Mitigation at Selected Bridges in Utah, 2003-05

Prepared in cooperation with the  
UTAH DEPARTMENT OF TRANSPORTATION

## Scientific Investigations Report 2006-5033

U.S. Department of the Interior  
U.S. Geological Survey

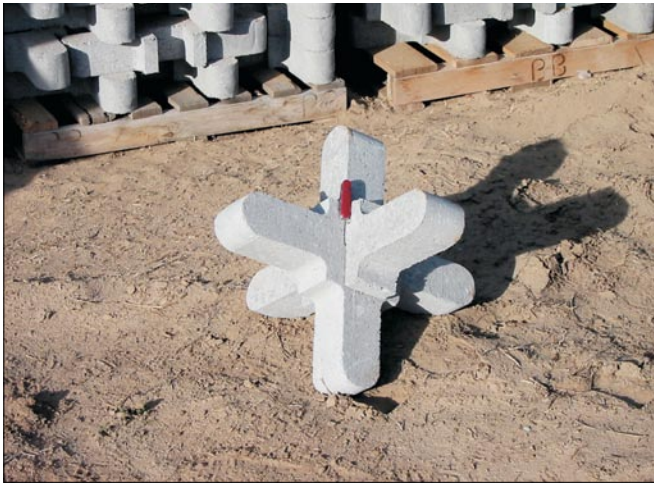
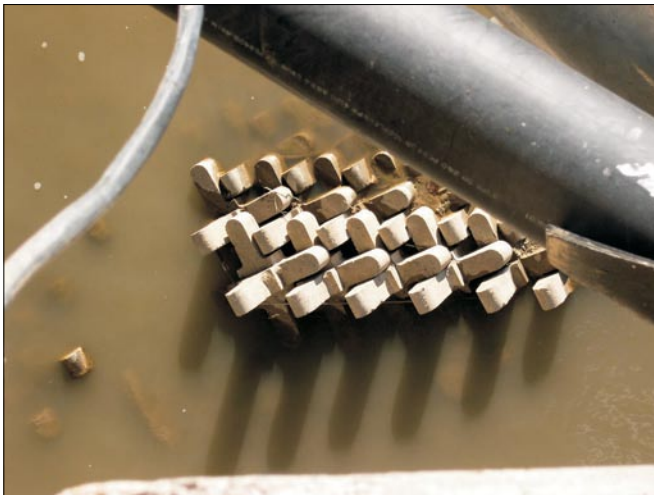
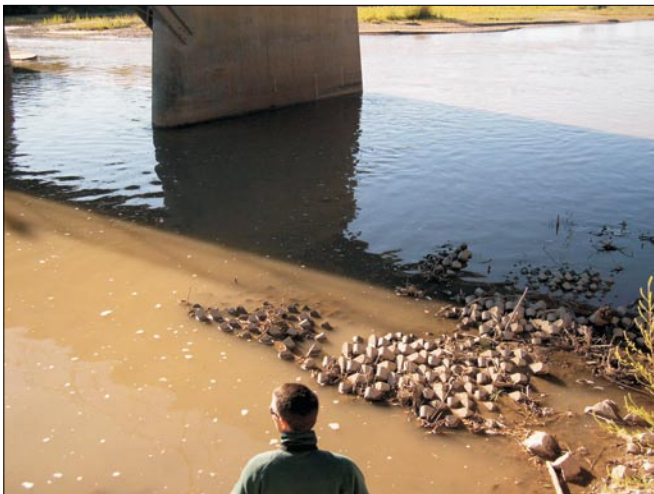
**Figure 2.** (A) Single A-Jack (Photograph by T.A. Kenney), (B) A-Jacks module installed at Green River Bridge at State Road 19 (Photograph by T.L. Ularich), and (C) a portion of the A-Jacks matrix at Green River Bridge at State Road 19 during low flow conditions, October 2003 (Photograph by T.L. Ularich).

UDOT engineers designed plans using concrete A-Jacks scour countermeasures for the scour-susceptible areas of the two bridges. In the UDOT design, 36 single A-Jacks structures are banded together to form modules that are placed in a matrix on the streambed (fig. 2). The design of these modules has three benefits: they armor the streambed, they dissipate

energy near the substrate around the piers, and they promote sediment deposition onto and between the A-Jacks modules. Conceptually, this design is self-propagating because it inhibits scour while increasing its armoring capabilities (Michael Fazio and Denis Stuhff, Utah Department of Transportation, oral commun., 2003).

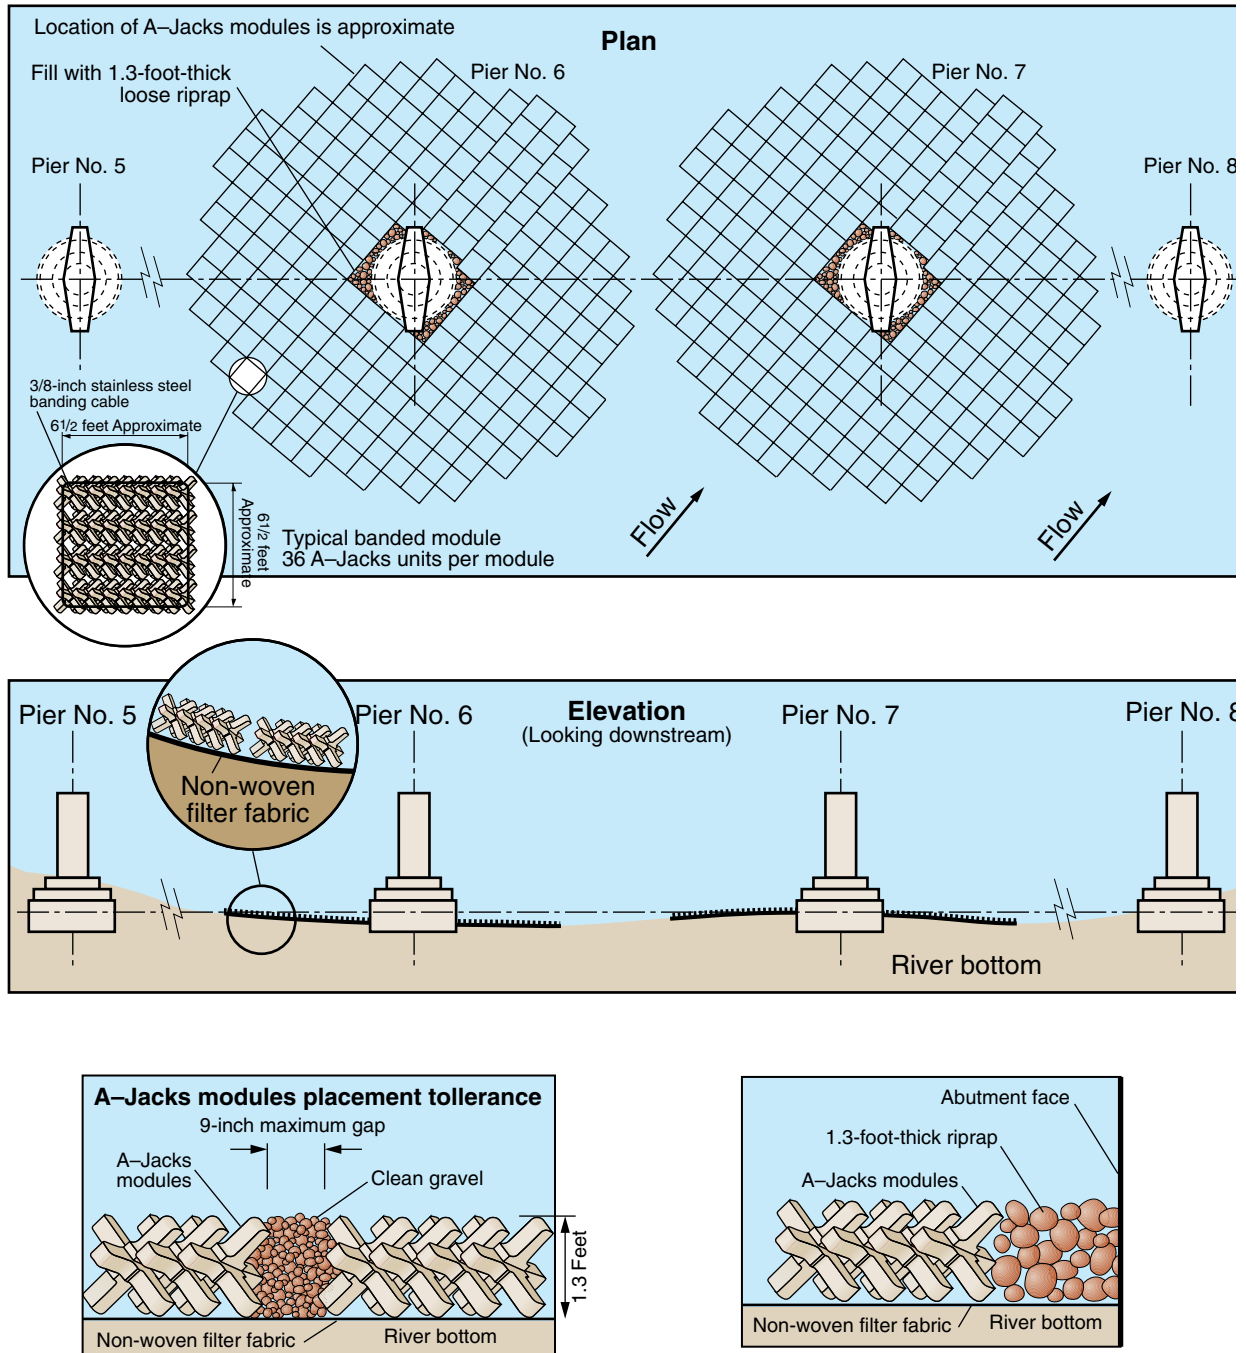
Figure 3. Schematic design for A-Jacks scour countermeasures for the Colorado River Bridge at State Road 191.

The UDOT designs are unique and experimental for several reasons. At the Colorado River Bridge, two different matrices were installed concentrically around two piers (fig. 3). Deployment of the modules at the Green River Bridge at State Road 19 is such that a single matrix occupies the entire area from the right abutment past the right-most bridge pier (fig. 4). At this site, no geo-tech fabric is installed underneath the modules. Installations at both sites were made with only minor channel-bed modifications. Installation of the A-Jacks scour countermeasures was completed in February 2003 at the Green River Bridge, and March 2004 at the Colorado River Bridge. Case studies on these types of deployments in steep, mobile gravel-bed river environments have not been done before this study. The U.S. Geological Survey (USGS), in cooperation with UDOT, monitored streambed elevations and water velocities associated with the A-Jacks deployments at the Colorado River Bridge at State Road 191, and the Green River Bridge at State Road 19, from 2003 through 2005.

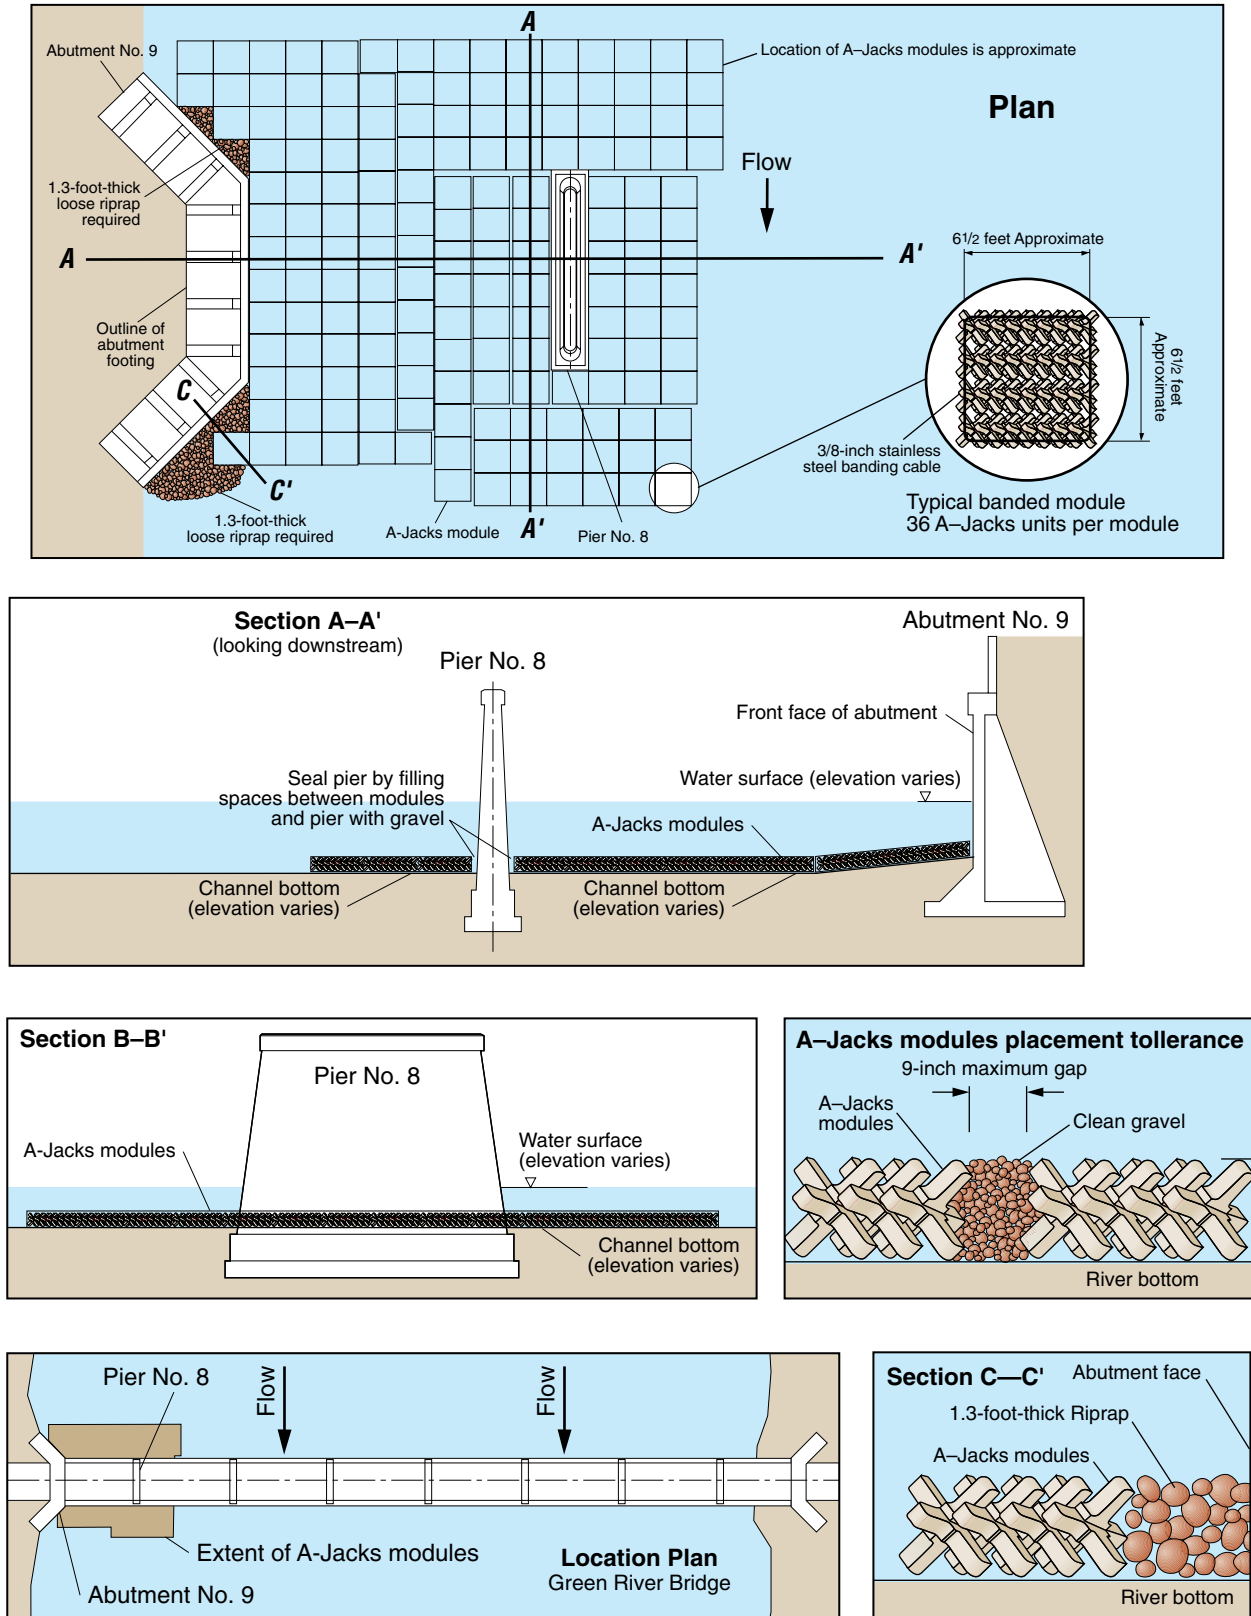
Figure 4. Schematic design for A-Jacks scour countermeasures for the Green River Bridge at State Road 19.

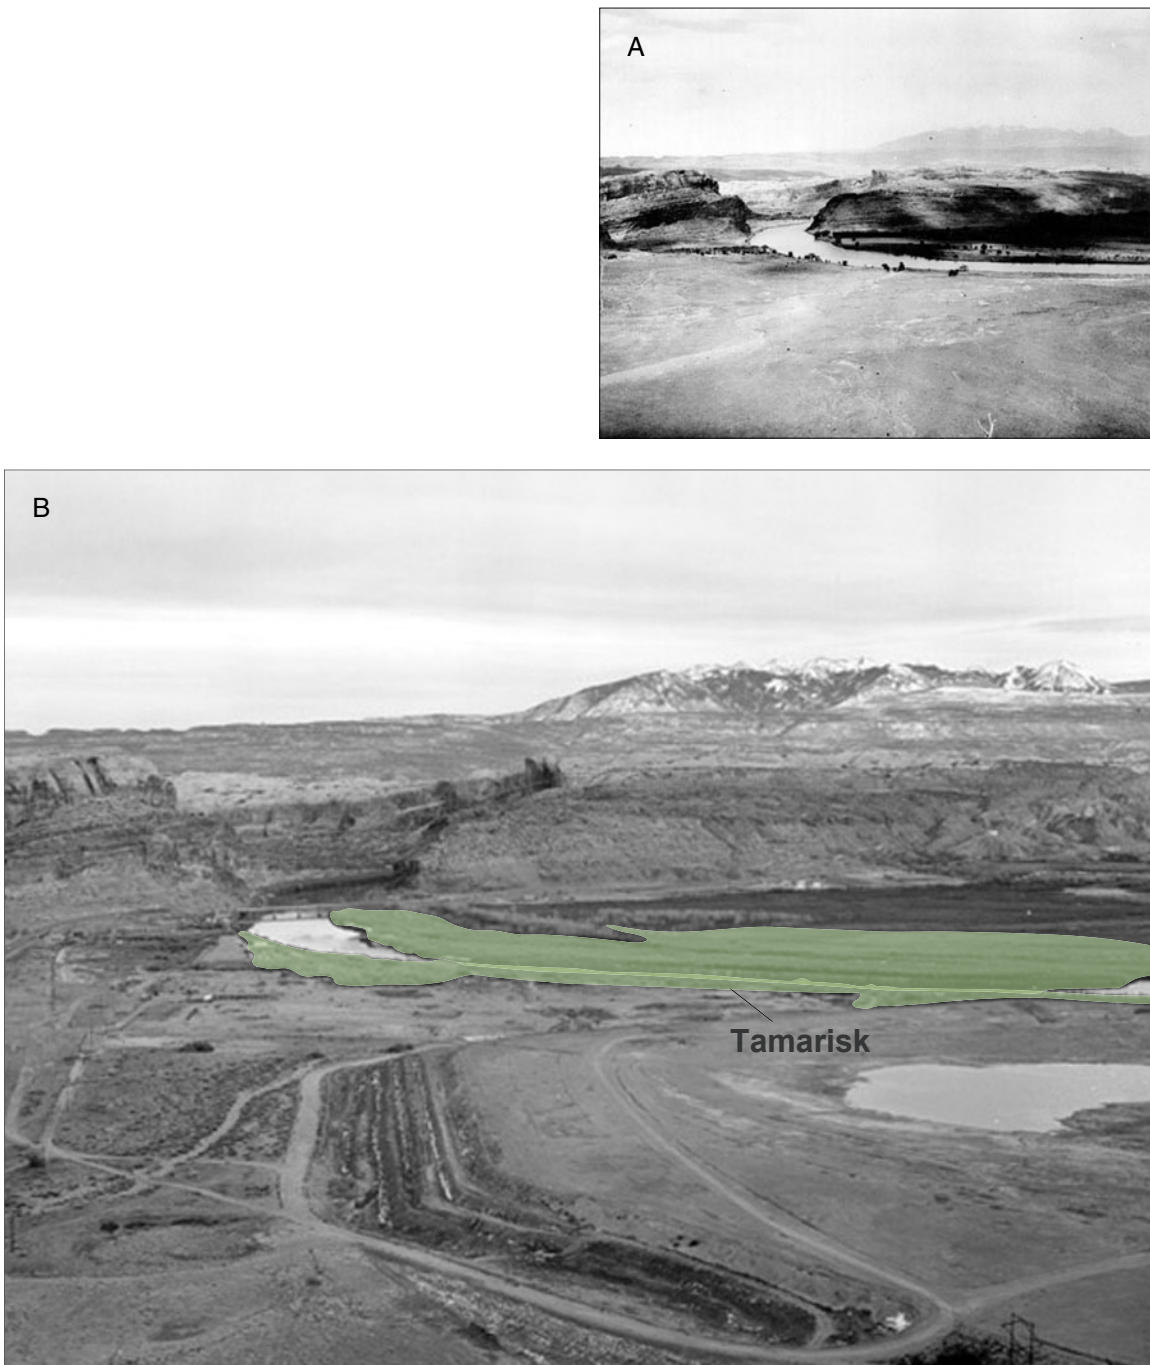
**Figure 5.** (A) Colorado River inlet to Moab Valley, Utah, 1905. Note lack of tamarisk presence (Photograph by C.C. Whitman); (B) Colorado River inlet to Moab Valley, Utah, 1998. Photo modified to show Tamarisk presence along river banks (Modified from Kenney, 2005).

throughout the upper Colorado and Green River drainage basins. Although first introduced to the region in the 1800s, around 1940 the invasive riparian shrub, tamarisk, appeared along the Colorado River near Moab, Utah, and the Green River near Green River, Utah. The spread of tamarisk throughout the Colorado Plateau has led to the most dramatic change in the fluvial landscape during the past century (Graf, 1978). By densely colonizing much of the riverbanks and many channel islands, tamarisk has stabilized channel margins by anchoring the soil and dissipating water-velocity energy. This stabilization together with flow regulation has caused historically wide, shallow rivers to narrow and become incised. This change is apparent in repeat photography of Moab Valley taken in 1905 and 1998 (fig. 5). Evidence of this type of channel evolution, which is associated with some of the scour problems being mitigated, can be seen at both bridges.

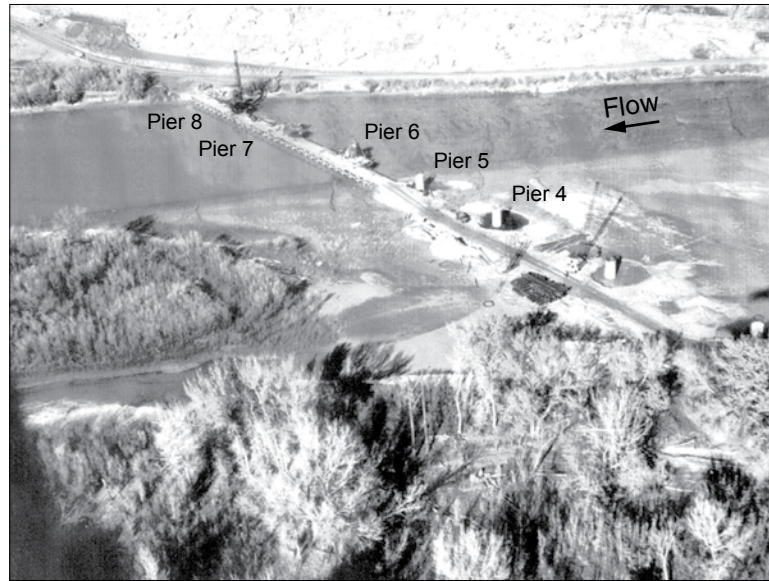
**Figure 6.** Construction of the Colorado River Bridge at State Road 191, mid 1950s.  
(Photograph by D.E. Byrd, courtesy of Moab Times-Independent)

Nearly all discharges at the Colorado River Bridge at State Road 191 are currently conveyed through only four of the eight spans of the bridge, which has in part led to the scour identified by UDOT at pier numbers 6 and 7. An historical photograph taken at low flow conditions during the construction of the Colorado River Bridge at State Road 191 shows evidence that recent streamflow, likely the spring runoff, occupied the left side of the river channel at pier numbers 3, 4, and 5 (fig. 6). Note the lack of tamarisk on the left bank of the river near the bridge. Tamarisk can be seen in this same area in a photo taken in 2005 (fig. 7).

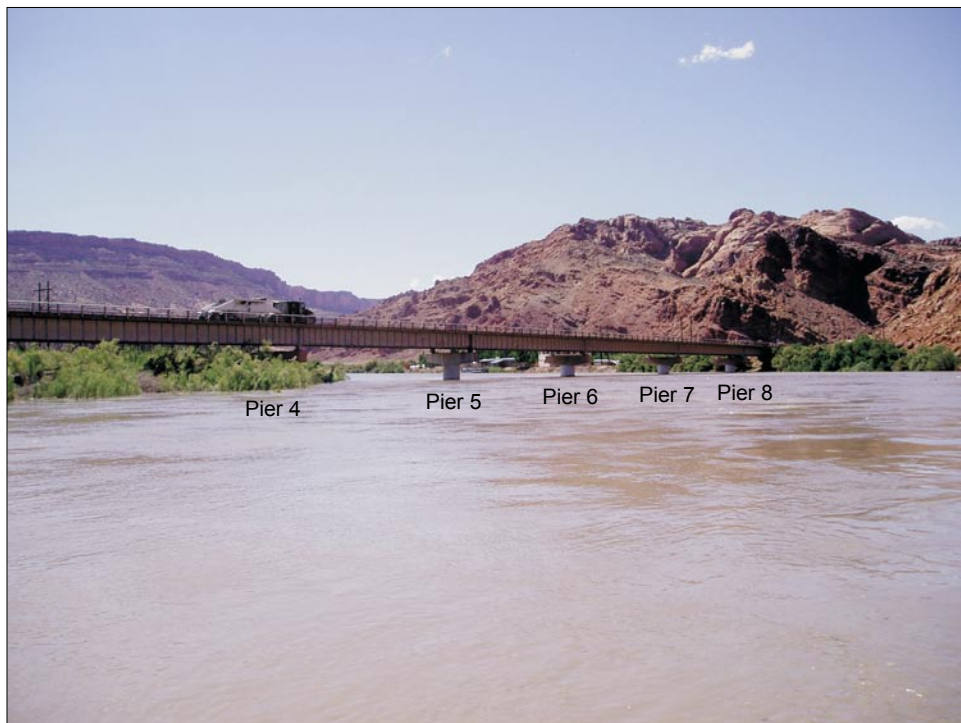
**Figure 7.** Downstream view of the Colorado River Bridge at State Road 191, 2005.  
(Photograph by T.A. Kenney)

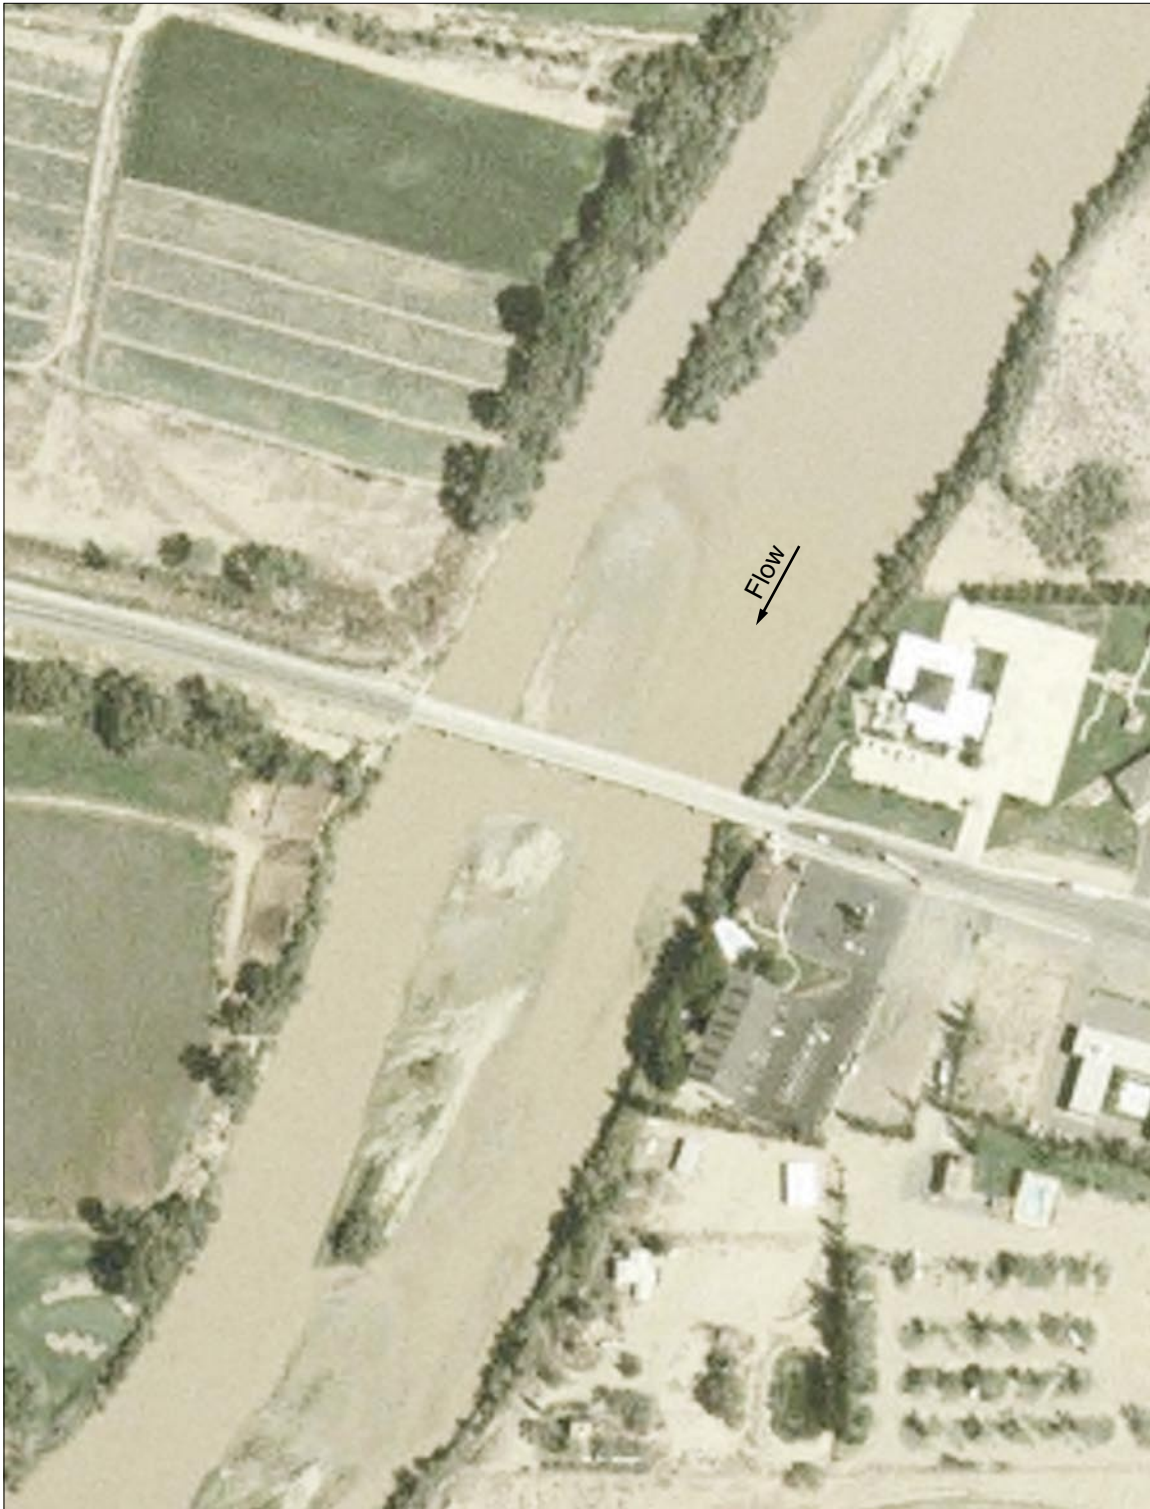
**Figure 8.** Aerial photograph of Green River Bridge at State Road 19, 2004.

Sediment deposition on the downstream end of channel bar extending through the bridge can be seen.

The stabilization by tamarisk of a prominent mid-channel island upstream of the Green River Bridge at State Road 19 has led to an uneven distribution of streamflow through the seven bridge spans. Sediment deposition on the downstream side of the island has propagated through the reach containing the bridge (fig. 8). Flow has become incised and concentrated on the right edge of the river through the two bridge spans separated by pier number 8.

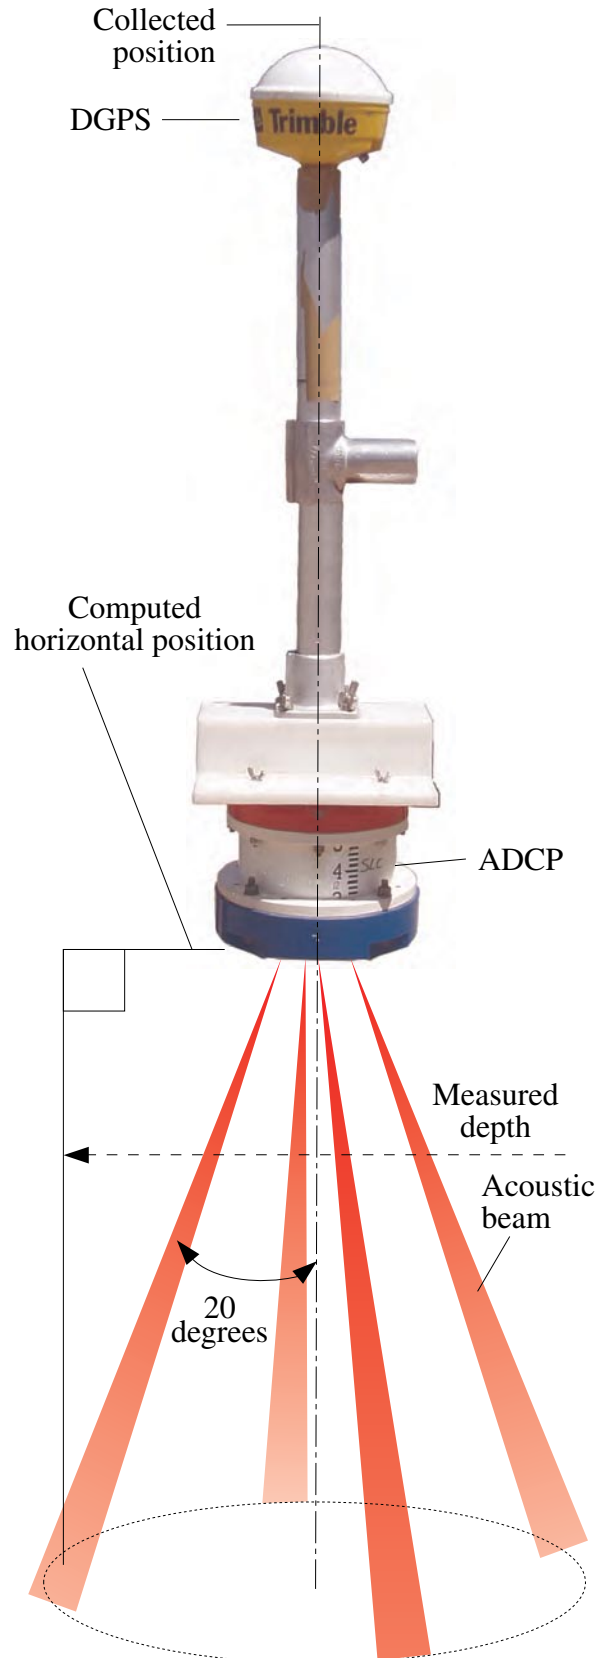
**Figure 9.** Schematic of how a unique location is assigned to discrete depths measured by each acoustic Doppler current profiler beam.

The macros separate the discrete depths measured by each of the ADCP's four beams. DopplerMacros computes the horizontal offset from the logged ADCP position by solving the trigonometric relation associated with the 20-degree-from-center beam and the measured depth. This offset is then added to the logged horizontal position, in proper relation to the internal compass reading of the ADCP, and a unique location of each measured depth is assigned (fig. 9). The computer programs subtract the measured depths from user input water-surface elevations, changing the dataset from depths below water surface to streambed elevations. A single water-surface elevation, measured at each bridge structure, was input for each of the surveys conducted. Water-surface elevations at the Green River Bridge at State Road 19 were referenced to an arbitrary vertical datum of 100 feet assigned to the top of the bridge deck barrier, and water-surface elevations at the Colorado River Bridge at State Road 191 were referenced to a surveyed bridge deck elevation of 3,984.37 feet. The processed streambed elevation datasets are contained in appendix A; however, the river slope is not represented in this dataset.

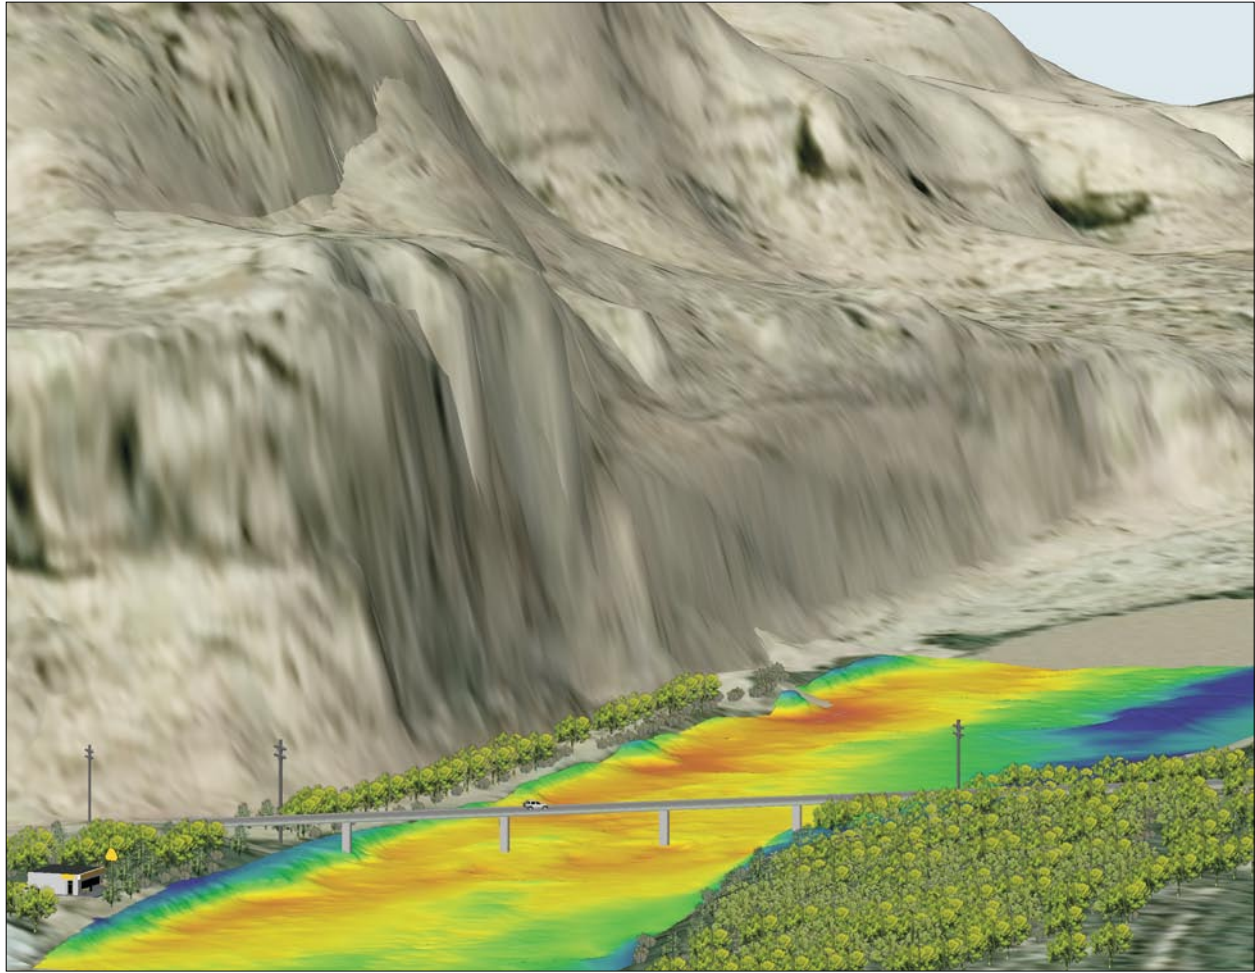
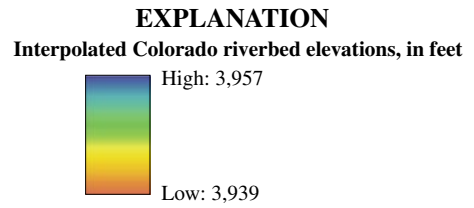
Vertical exaggeration is 1.5

**Figure 10.** Three-dimensional simulated view of Colorado River Bridge at State Road 191 developed from interpolated elevation dataset of 2005 combined with a digital elevation model.

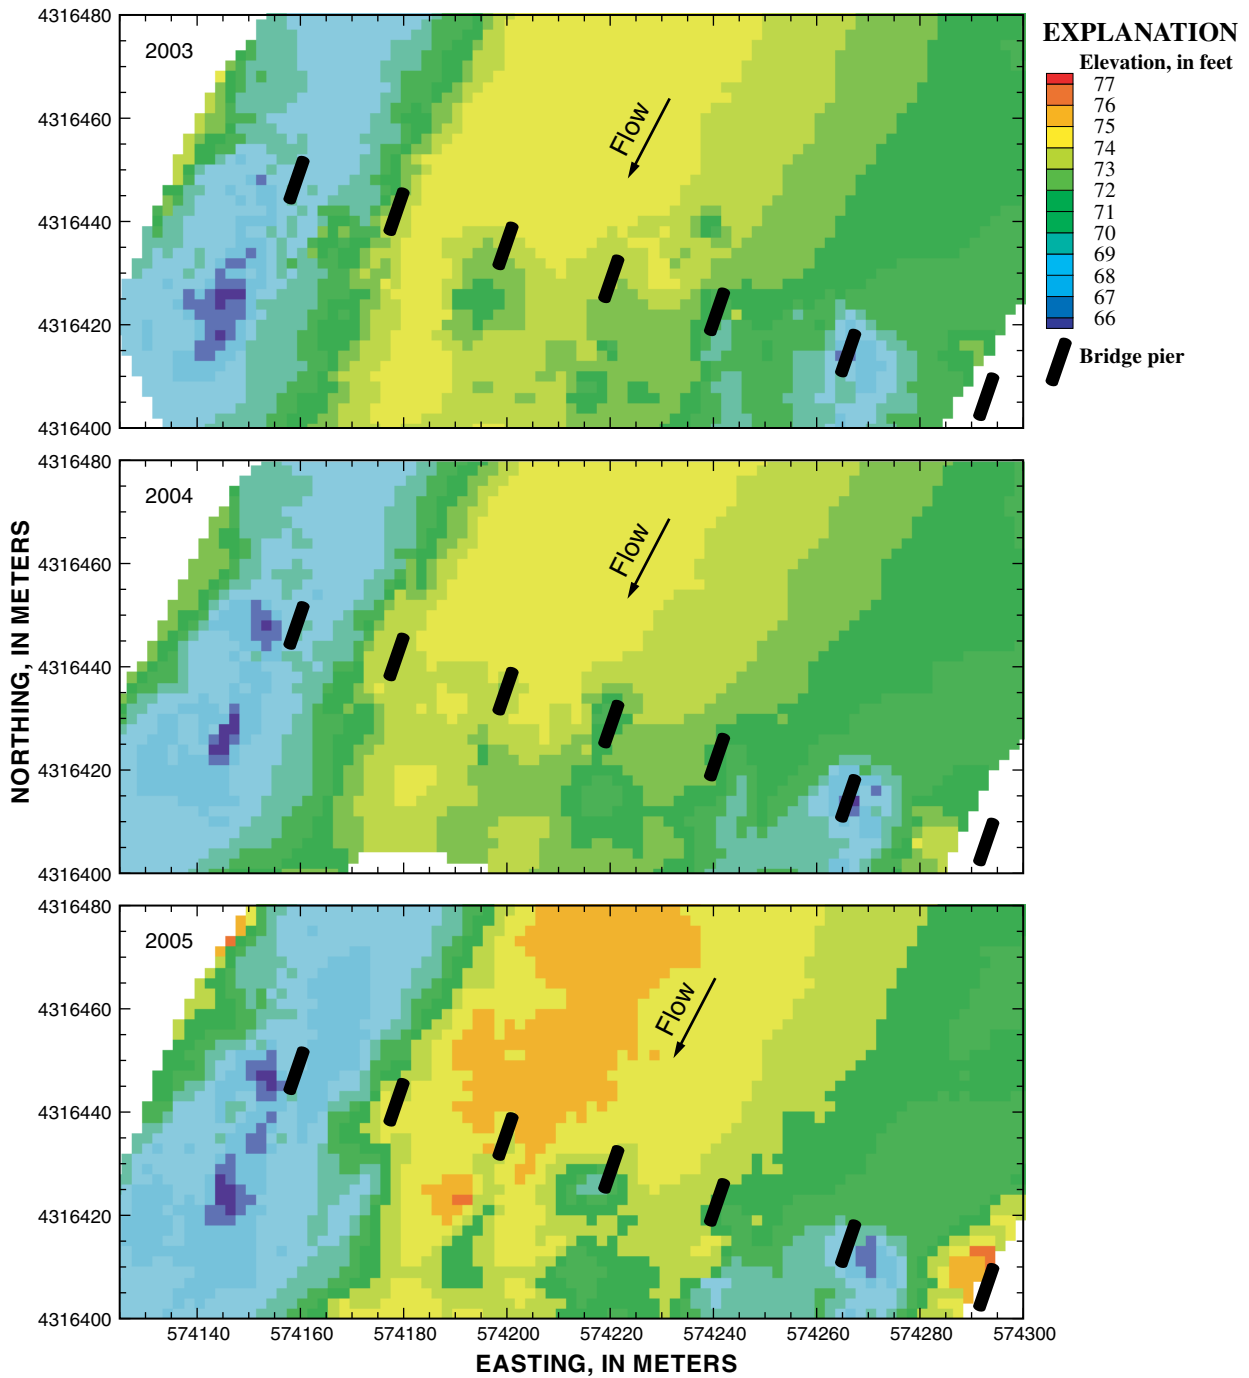
**Figure 12.** Zoomed in plan views of interpolated elevation datasets for Green River Bridge at State Road 19, 2003-05. Bridge pier number 8 is the left-most pier in the figure.

Monitoring at the Green River Bridge at State Road 19 began following the deployment of the A-Jacks. From the three datasets acquired, the topography near the Green River Bridge (fig. 12) has changed little from 2003 to 2005. More specifically, the area near pier number 8, the location of the A-Jacks, appears to be at the same elevation in all three datasets.
