Copper Pitting Corrosion and Pinhole Leaks: A Case Study

Darren A. Lytle
U.S. Environmental Protection Agency
ORD, NRMRL, WSWRD, TTEB,
Cincinnati, Ohio 45268

Case Study

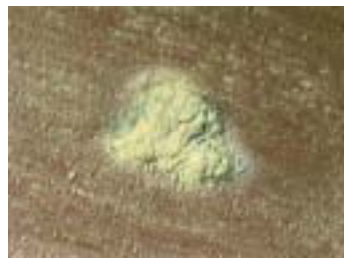
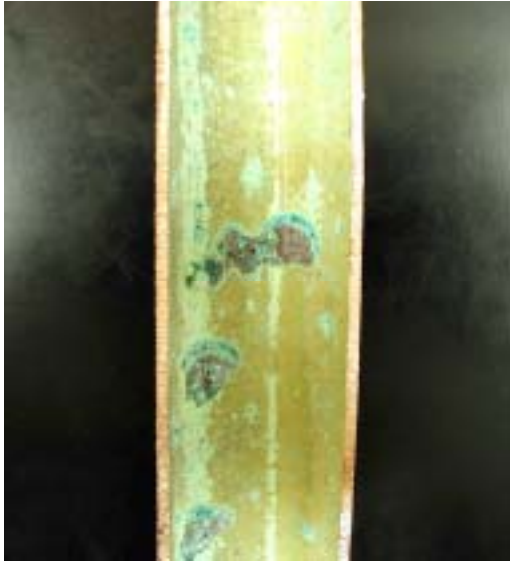
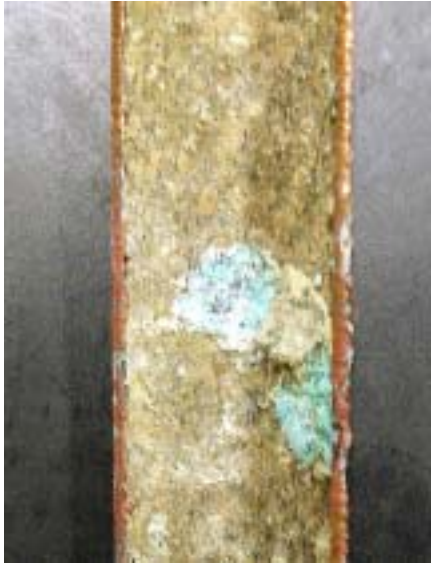
Pitting Comparison

Ohio site #1

Wisconsin

Ohio site #2

All micrographs taken at 10x

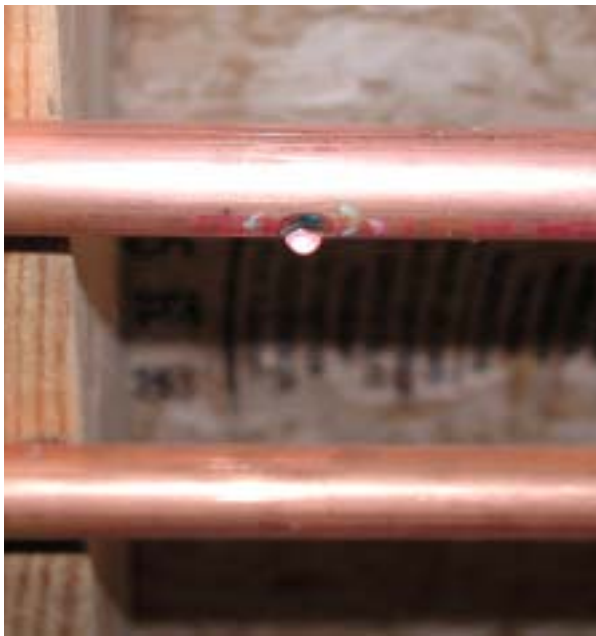
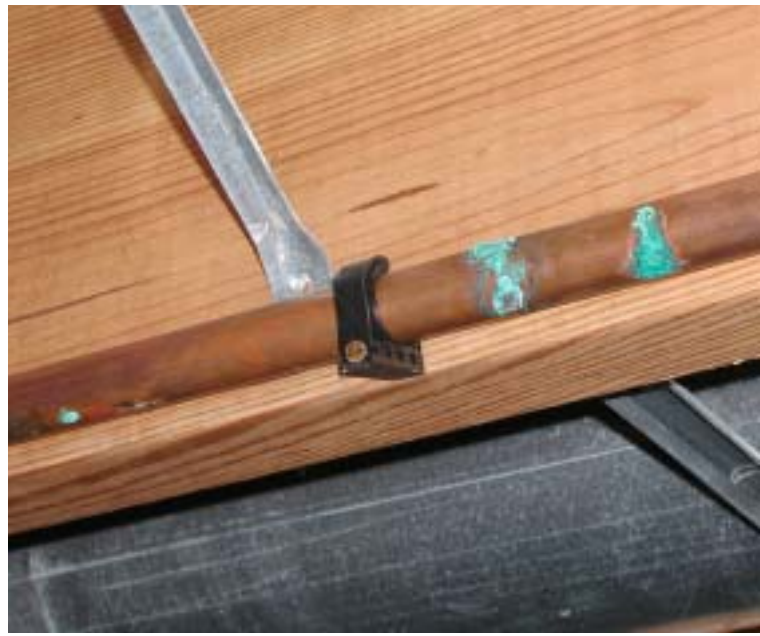
Pinhole Leaks

Pinhole leaks resulting from copper pitting

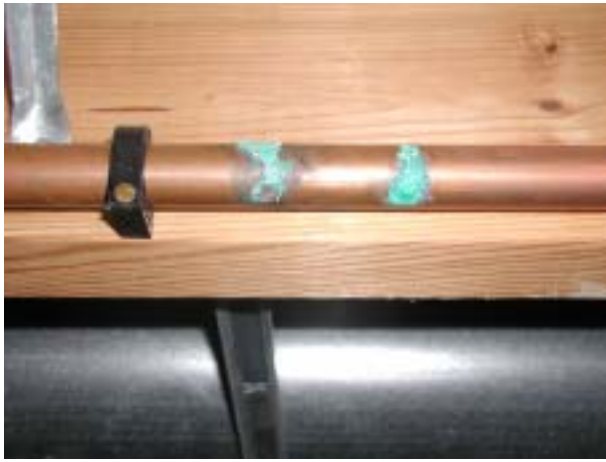
3/4" pipe

- Cold water
- Horizontal runs of pipe
- $\frac{3}{4}$ and $1\frac{1}{2}$ " pipe
- Homes are about 7 years old
- Leaks occur near elbows and joints as well as in long runs
- No preference for the top or bottom of a pipe

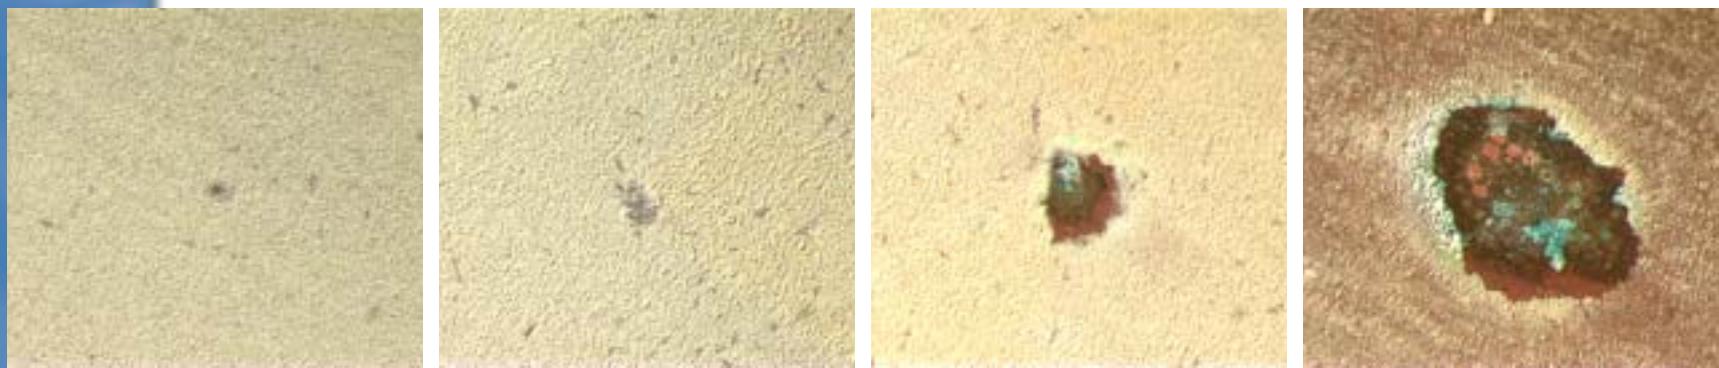
Particle deposition, particle growth, and corrosion cell formation

All pictures taken at same magnification
