# ANALYSIS OF NHTSA'S ROLLOVER PLAN

**Martha W. Bidez, Ph.D.**

Submitted to Docket No. NHTSA-2005-22143  
November 21, 2005

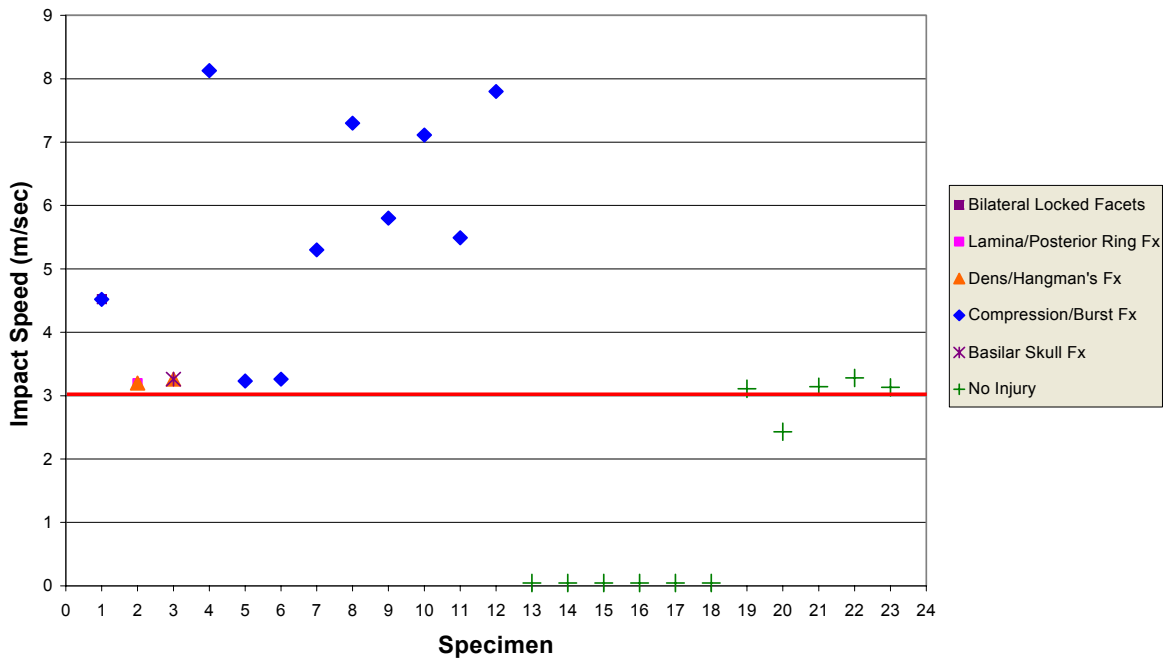
**FIGURE 1**  
**AIS ≥ 3 Spinal Injuries**  
 (Unconstrained - Head/Cervical Spine Component Tests)

The scientific literature<sup>1-9</sup> is replete with cadaver studies, which conclusively demonstrate the rate dependence of serious (MAIS  $\geq 3$ ) injury of the head and cervical spine (Figures 1-2, Tables 1-2). When the head is not trapped by roof crush (i.e. unconstrained end condition), a threshold for catastrophic injury appears to be 3-4 m/s (7-9 mph).

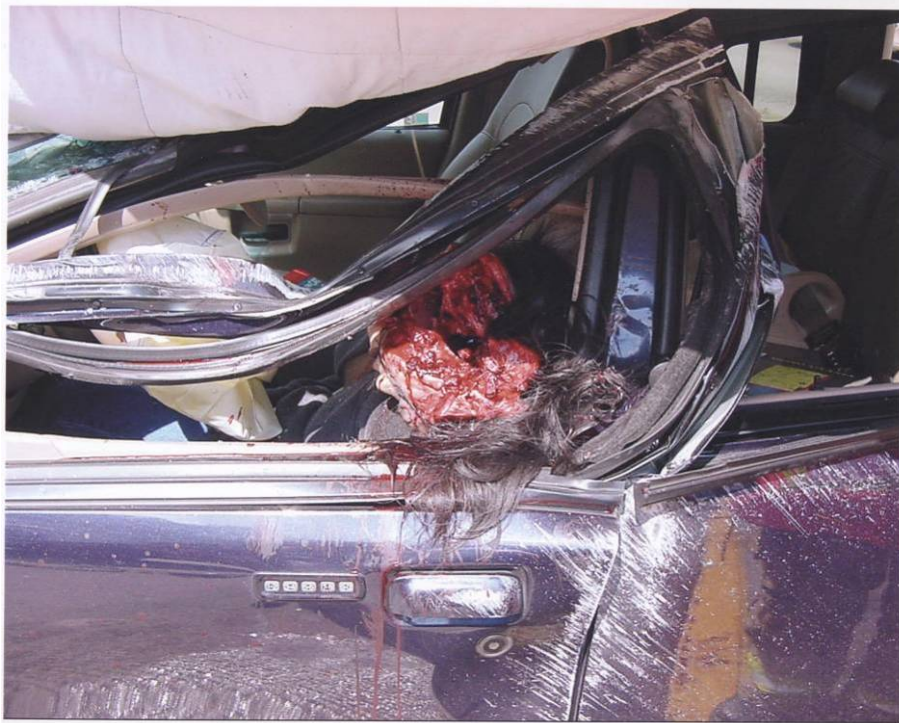
**FIGURE 5**  
Blood and tissue noted at scene on interior and exterior of intruding window frame/roof rail

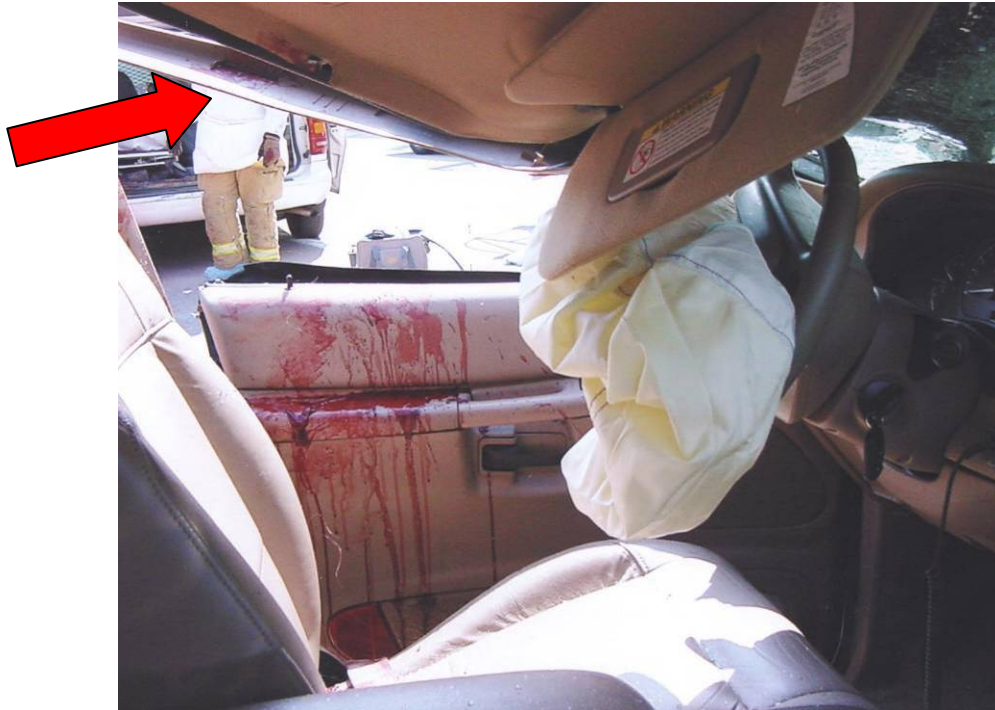
**FIGURE 6**  
**Regular borders of skin wounds consistent with cleavage by “sharp” metal of window frame/roof rail.**

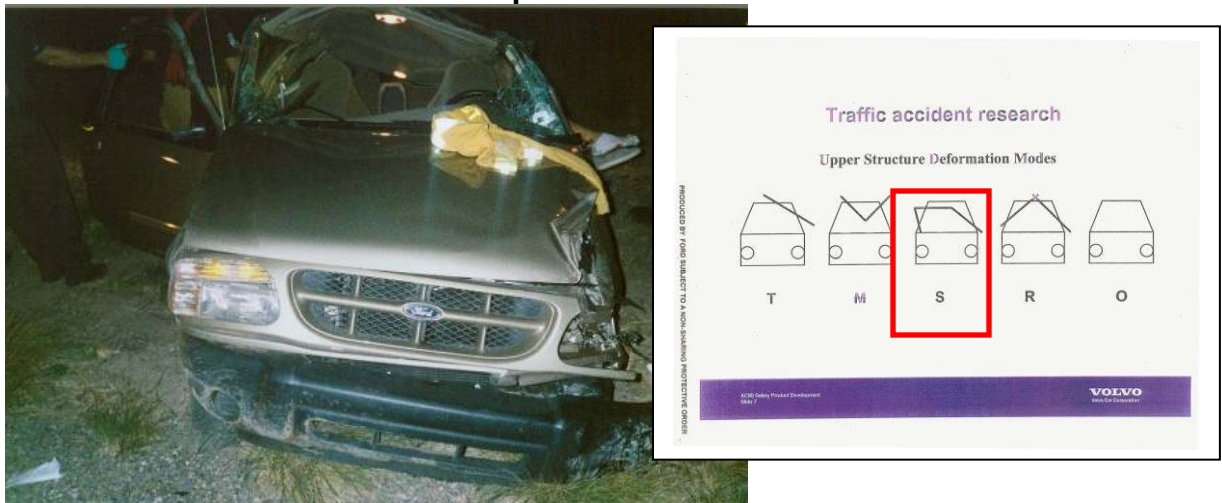
A restrained female driver (21 yrs, 66 inches, 136 lb) of a 2000 Ford Explorer rolled under highway conditions, passenger-side leading a total of four complete rolls. During the rollover, her head was partially ejected out the driver’s side window and was positioned below the driver’s side roof rail when the structure crushed downward and inboard. The impact, which was just left of the mid-sagittal plane resulted in a degloving, scalp laceration, linear skull fracture and underlying fatal brain injury. During the collision, a minimum of 7 inches of slack was introduced dynamically into the driver’s belt restraint system, due to B-pillar collapse and retractor unlocking during the rollover. This slack, in turn, passed into the driver’s lap belt with concomitant loss of effective restraint. She was found dead at the scene.

**FIGURE 7**  
**2000 Ford Explorer at Final Rest**

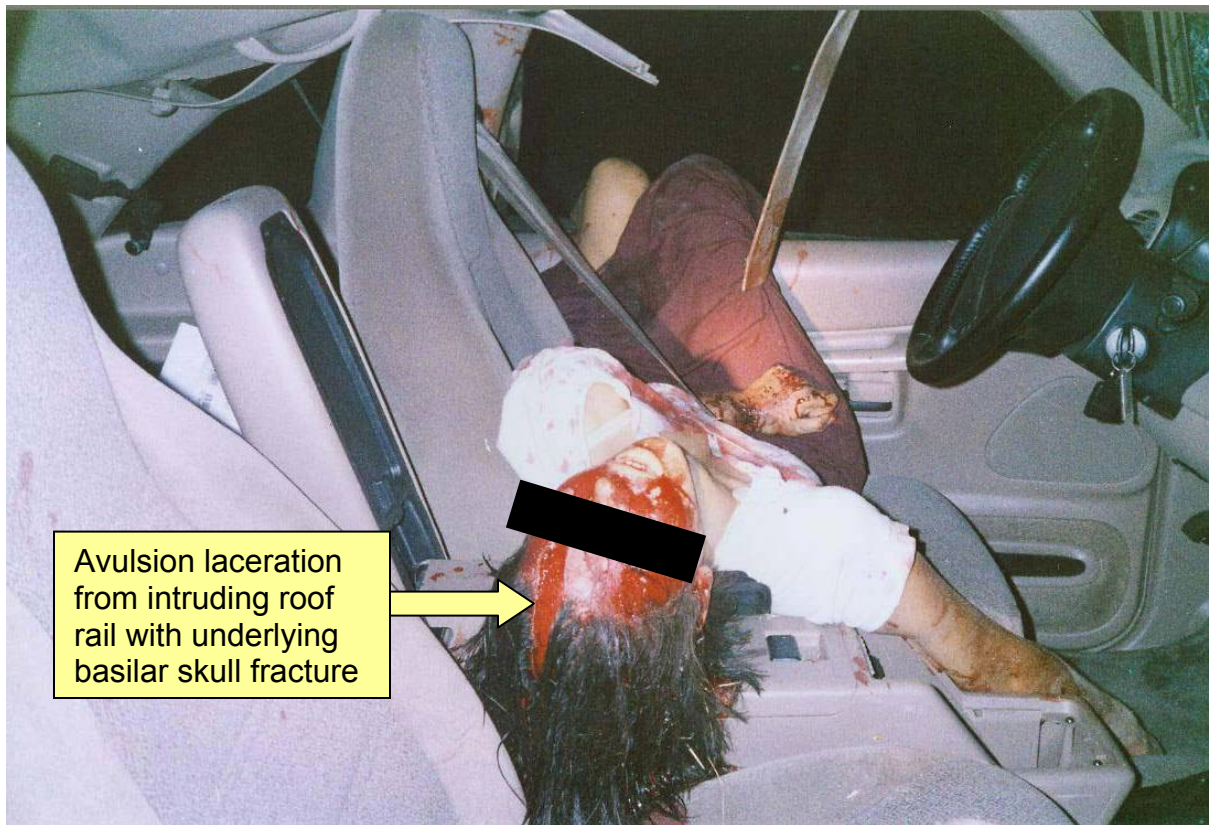
**FIGURE 8**  
**Deceased college (honors) student in post-crash, final rest position**  
**(Note adequacy of post-crash headroom, as defined by NPRM.)**

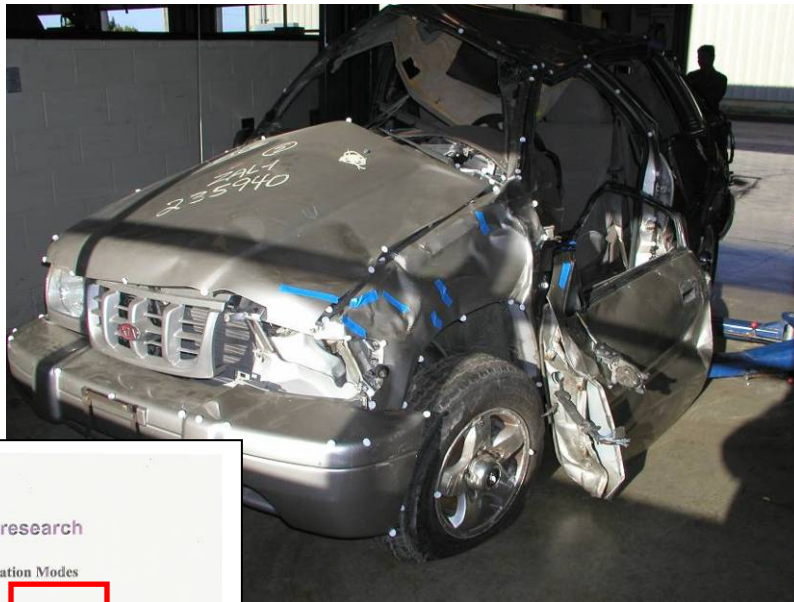
A restrained female driver (40 yrs, 64 inches, 200 lb) of a 1998 Kia Sportage lost control of her vehicle under icy road conditions and rolled two times. During the rollover, the driver's side of the vehicle sustained roof damage and the driver's head was trapped underneath the deforming window frame. (Figure 9) She sustained multiple spinal fractures, including C7-T1 bilateral locked facets with anterior wedging, resulting in permanent quadriplegia.

**FIGURE 9**  
**1998 Kia Sportage**

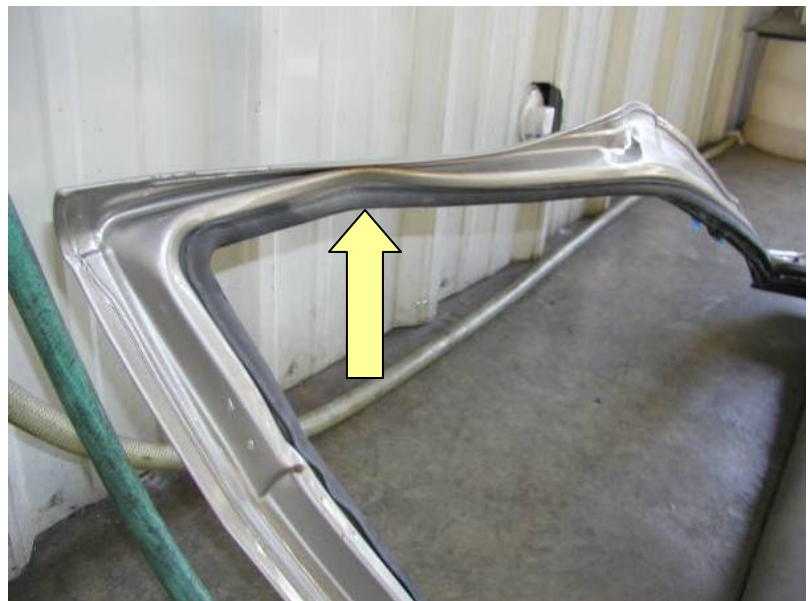
The restrained driver's head was trapped in the deforming window frame as evidenced by the concavity in the upper frame from occupant loading.

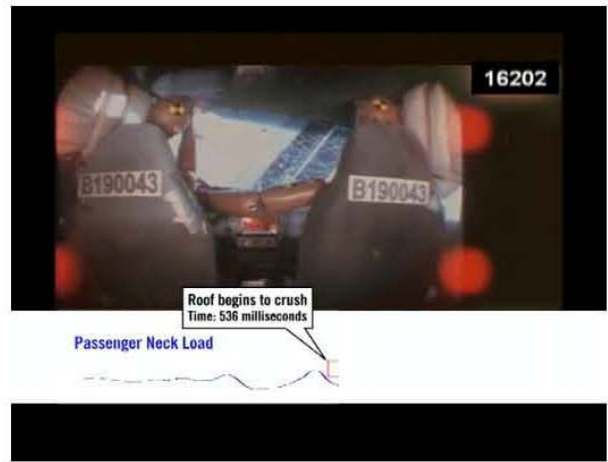
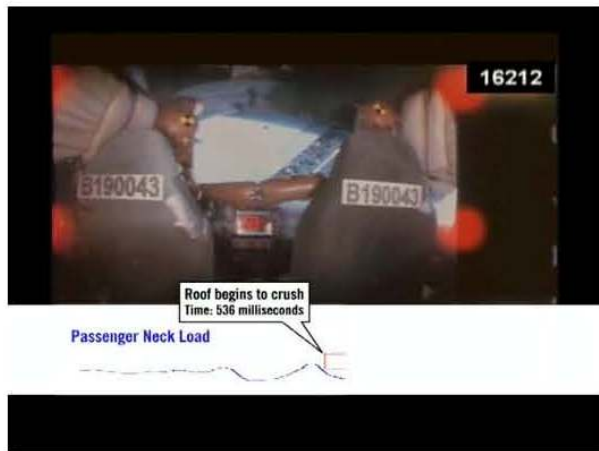
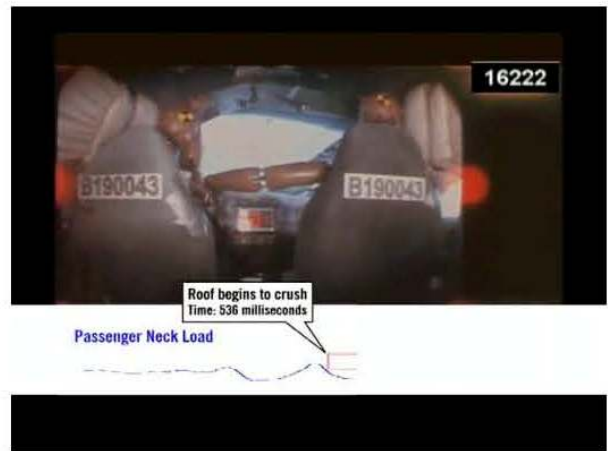
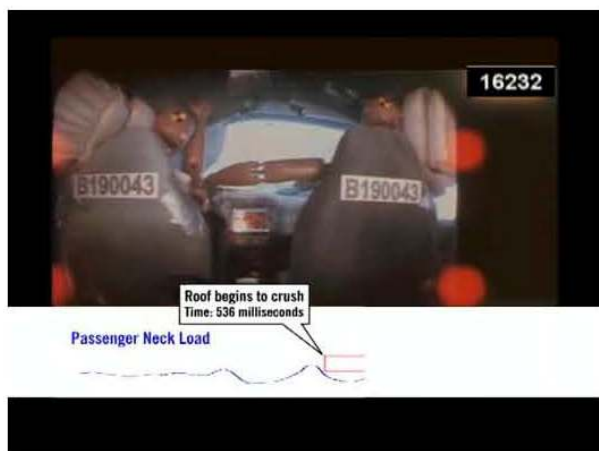
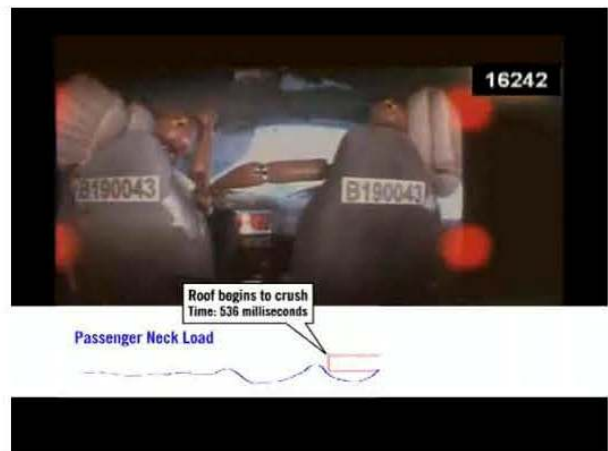
- A continuous deformation wave progressing from the first ground strike (driver's roof rail), across the roof, and onto the passenger's side roof rail (indicated by the red box in the data graph).

- During the first ground strike, the driver's side roof rail strikes the driver dummy's head; however, the dummy head is unconstrained and no injurious neck loads were recorded.

- In contrast, the passenger dummy head is "trapped" between the deformation wave progressing toward the passenger side, as well as, the collapse of the A-pillar on the passenger side. Based on the dummy sensor data, a catastrophic neck injury was predicted at 764 ms (Table 3).

- At all times during the first 1000 ms, the dummies' heads were in contact with the roof. Restated, the dummies exhibited ZERO HEADROOM beginning with the roof-to-ground contact; however, injurious neck loads were not recorded until significant roof crush occurred.

**FIGURE 10**  
**Observable Roof Crush and Passenger Neck Load**

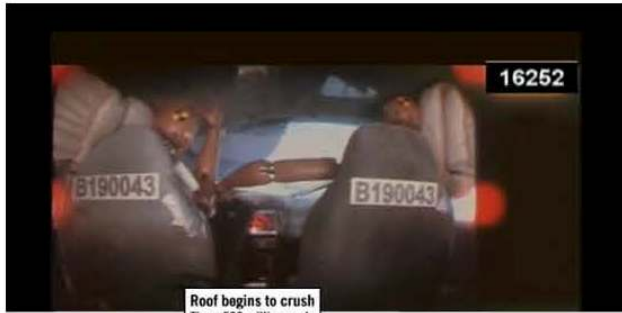
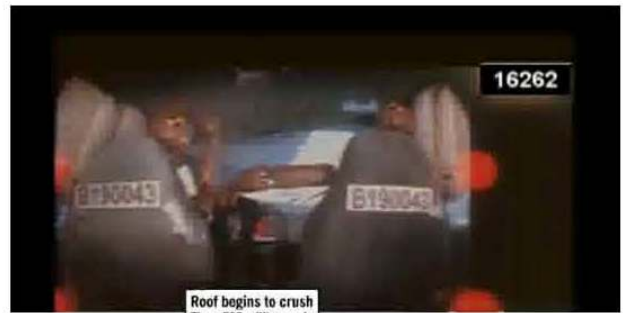
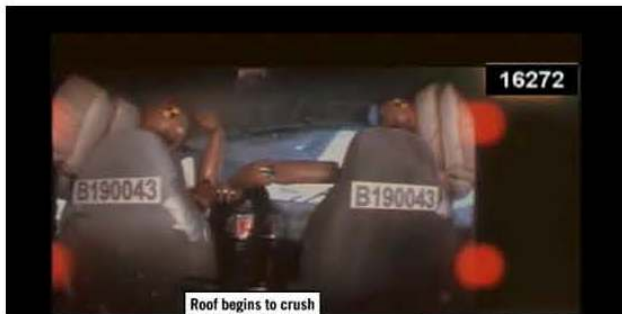
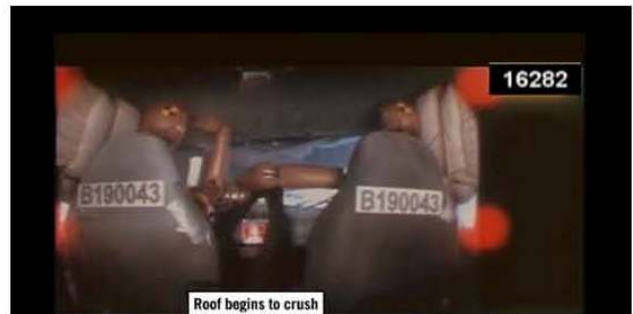
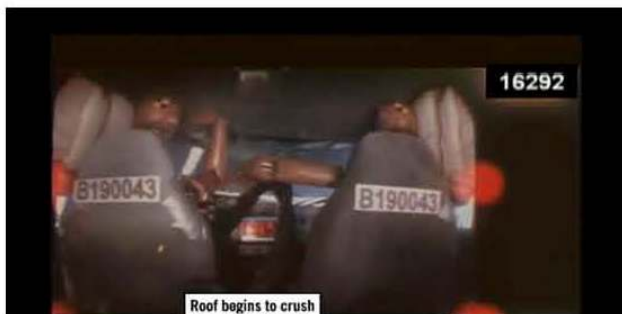
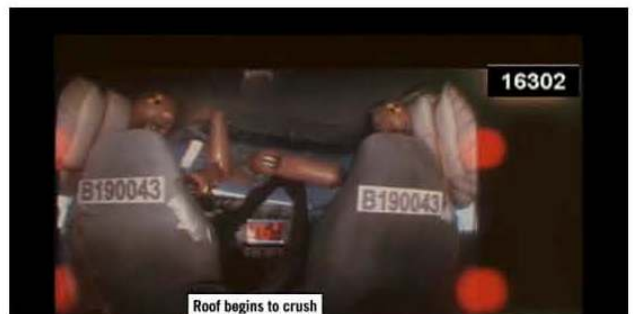
The entrapment of an occupant's head, resulting in a catastrophic cervical spine injury was predicted in the dynamic rollover tests of the 1998-1999 Ford Explorers, which was described in a previous submission to the roof crush docket. (Docket No. NHTSA-1999-5572-120) Referring to Figure 10, the video clips of the first 1000 milliseconds from test B190043 demonstrate:

- Dynamic roof crush (not simple head contact) was the direct cause of the injurious neck load recorded in the passenger dummy.
- The far side occupant dummy repeatedly demonstrated injurious neck loads in all three Autoliv tests, whereas the near-side occupant escaped likely injury during the first ground strike event.

The far side occupant dummy consistently predicted injurious neck loads in the Autoliv tests, which occurred simultaneous to observed roof crush.

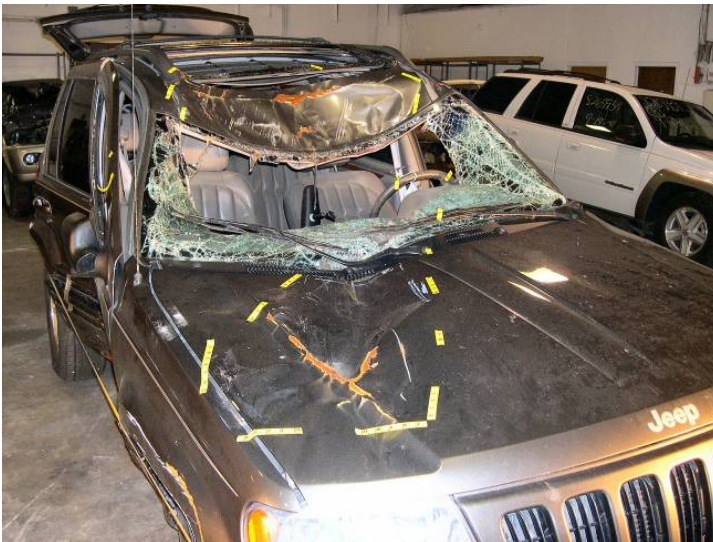
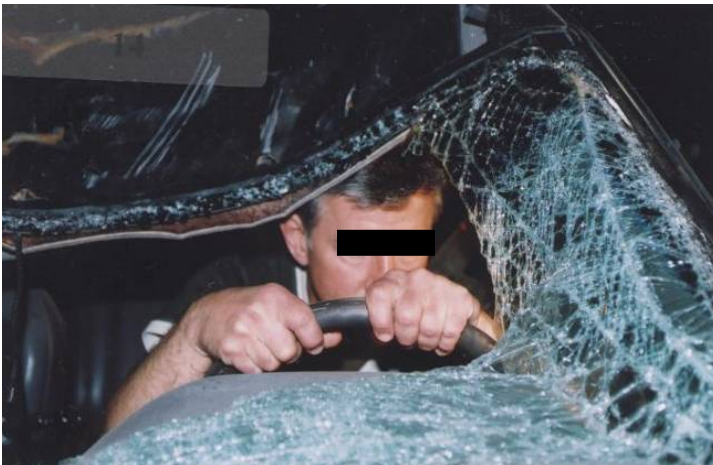
A 1999 Jeep Cherokee rolled onto its driver's side after being struck in the passenger side by a Ford Taurus which was driven through a red traffic light in an intersection. The Jeep then slid on the road (on its driver's side). The restrained, male driver (49 yrs, 68 inches, 168 lbs) did not lose consciousness during this initial ground impact. Instead, he reportedly used his left arm as a brace to keep his head from being partially ejected and sliding on the road. While in this "braced" position, the roof of the Jeep impacted a parked minivan, causing the roof to intrude into the driver's occupant survival space. The deforming roof contacted the right side of the driver's head, causing it to rotate counterclockwise (i.e. toward his left shoulder) beyond its physiologic limits. (Figure 11) The resulting injury was a right, unilateral locked facet at the level of C4-C5 with concomitant spinal cord injury and quadriplegia.

**FIGURE 11**  
**1999 Jeep Cherokee SUV**

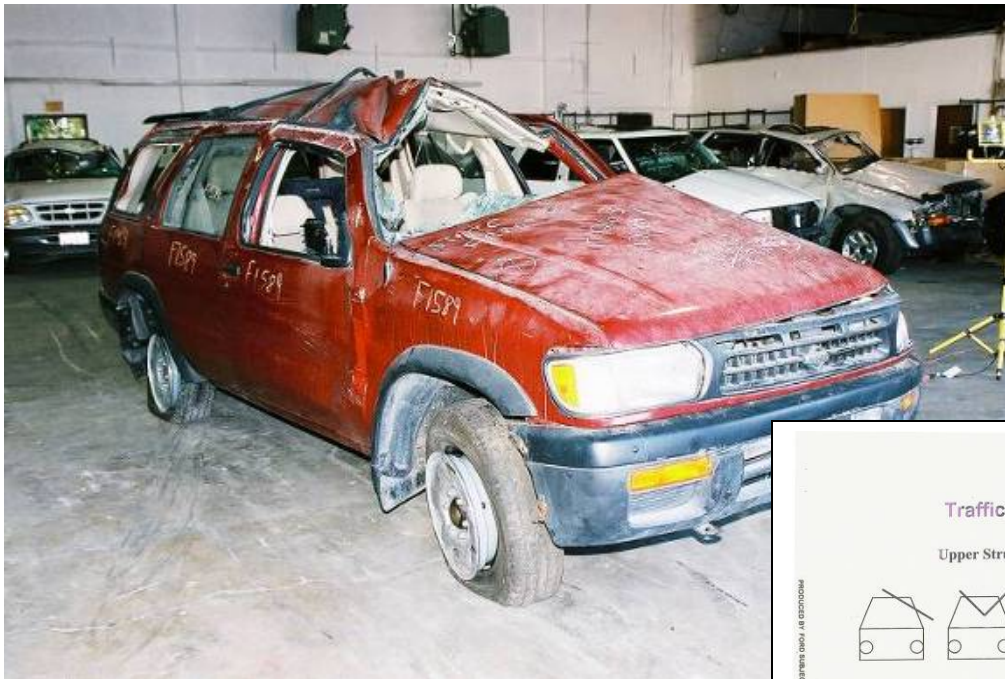
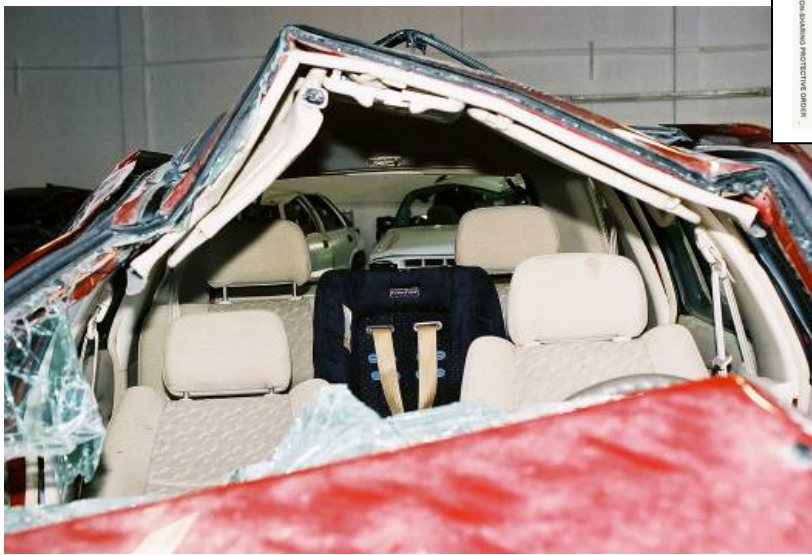
A restrained female driver (37 yrs, 66 inches, 135 lb) was driving a 1997 Nissan Pathfinder 4-door SUV when it drifted off the pavement to the left. The driver steered back to the right to bring the vehicle back onto the roadway. The vehicle began to yaw and subsequently rolled over (Figure 12). She sustained bilateral fractured facets and a large right frontal parieto-temporal epidural hematoma with underlying depressed skull fracture.

**FIGURE 12**  
**1997 Nissan Pathfinder**

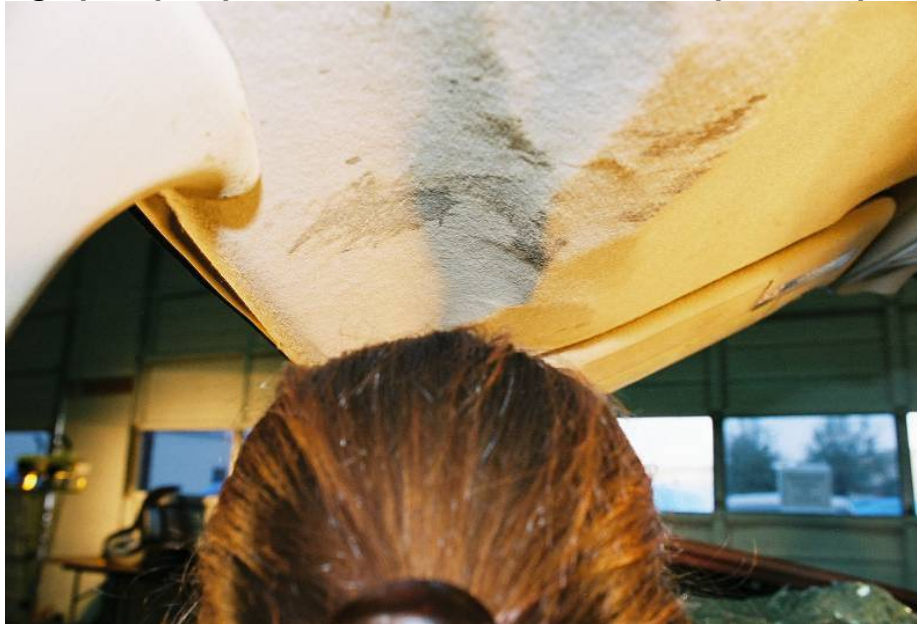
**FIGURE 13**  
**Concave Impression in the Driver's Side Roof Liner with Blood Stain**  
**(Photographic perspective taken from the rear occupant compartment)**

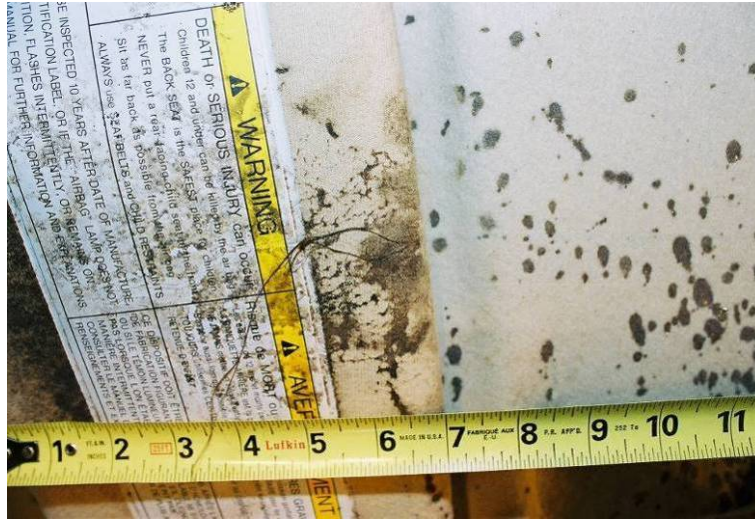
**b. Blood and hair located on passenger side sun visor from driver head contact**

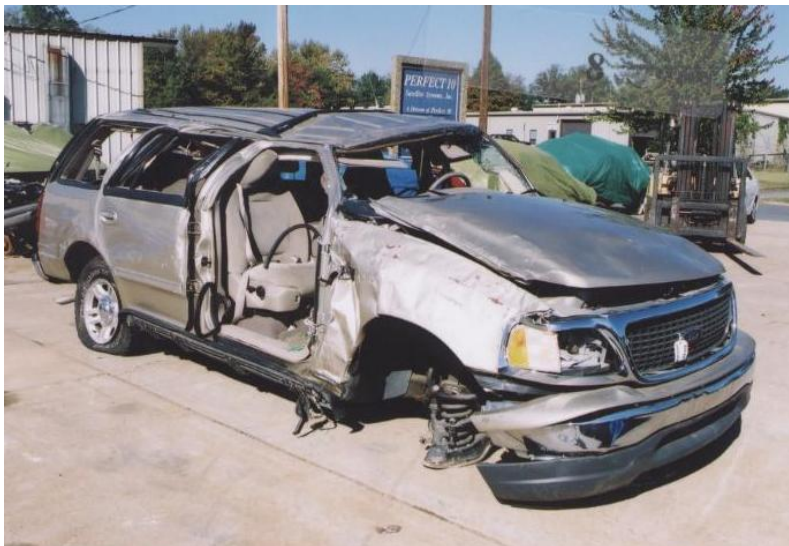
FIGURE 20

The NPRM appears to arbitrarily choose to only consider vertical intrusion as a measure of occupant safety, which is a significant omission. Lateral roof intrusion, as observed in Case Study No. 6, can expose an otherwise properly restrained occupant to partial ejection with catastrophic injury or death.

A restrained adult male was driving a 2000 Ford Expedition on a two-lane highway, accompanied by his wife and 2 children (seated in back). All occupants were wearing the available safety belt systems. The rear of the vehicle was loaded with luggage. The weather was clear and the road surface was dry. As they traveled down the highway, the Expedition was involved in a loss of control event that resulted in a single vehicle, on-road rollover. The Expedition rolled and came to rest wheels down. The right front passenger was found dead at the scene, still restrained in her lap and shoulder belt. (Figure 20-21) Lateral roof crush opened an ejection portal above her head and she died from head-to-ground contact. (Figure 22)

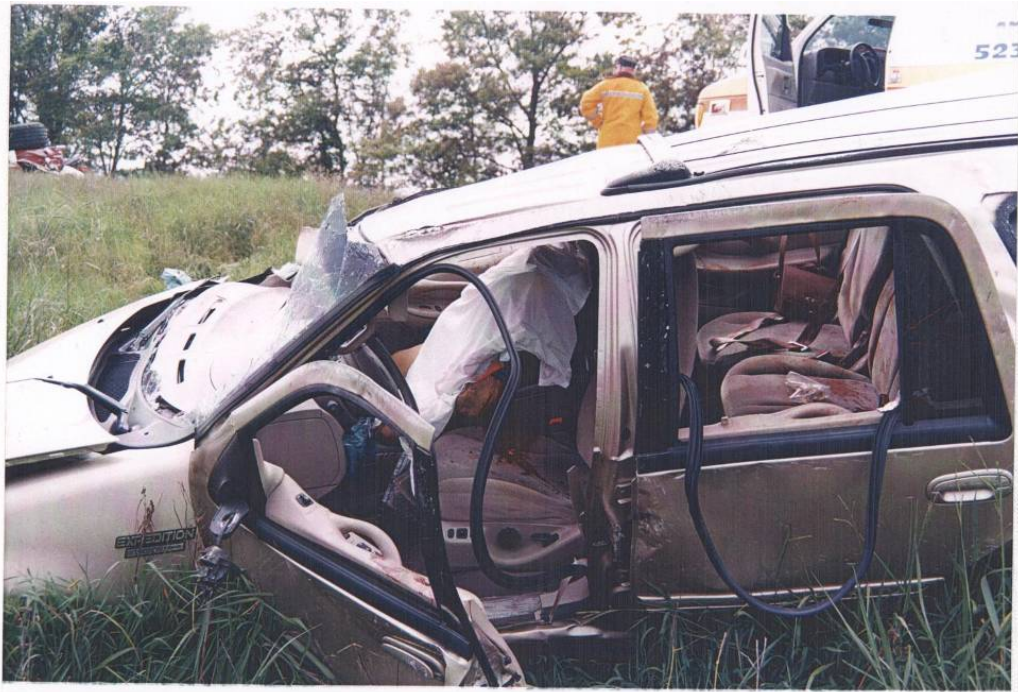
**FIGURE 21**  
**Restrained RF Passenger Dead at the Scene**

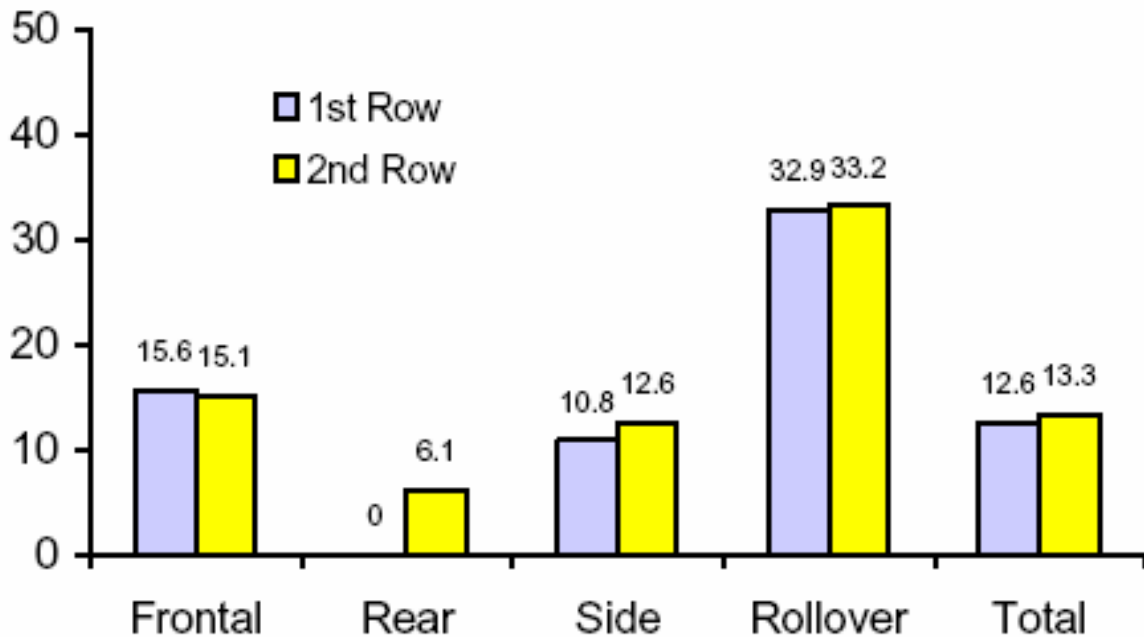
**FIGURE 24**

Rollover crashes result in the highest rate for MAIS 3+ injury to children aged 4-12 years old in car crashes (Figure 24), yet absolutely no provision has been made to protect these most vulnerable passengers in the current NPRM. Many adult women, including those presented in case studies in this report, are in the same stature range as 11-12 year old youth. (Table 5). No dynamic rear seat occupant protection criteria is provided for this population in any part of the NPRM or the entire FMVSS. NHTSA, however, as well as the auto industry and every child advocacy group in the U.S., continue to advise parents and caregivers to restrain all children aged 12 years and under in the back seat.

Rate (#/1000) of seriously injured MAIS 3+ children aged 4-12 years involved in crashes for front and second row seating.  
(Parenteau and Viano, 2003)

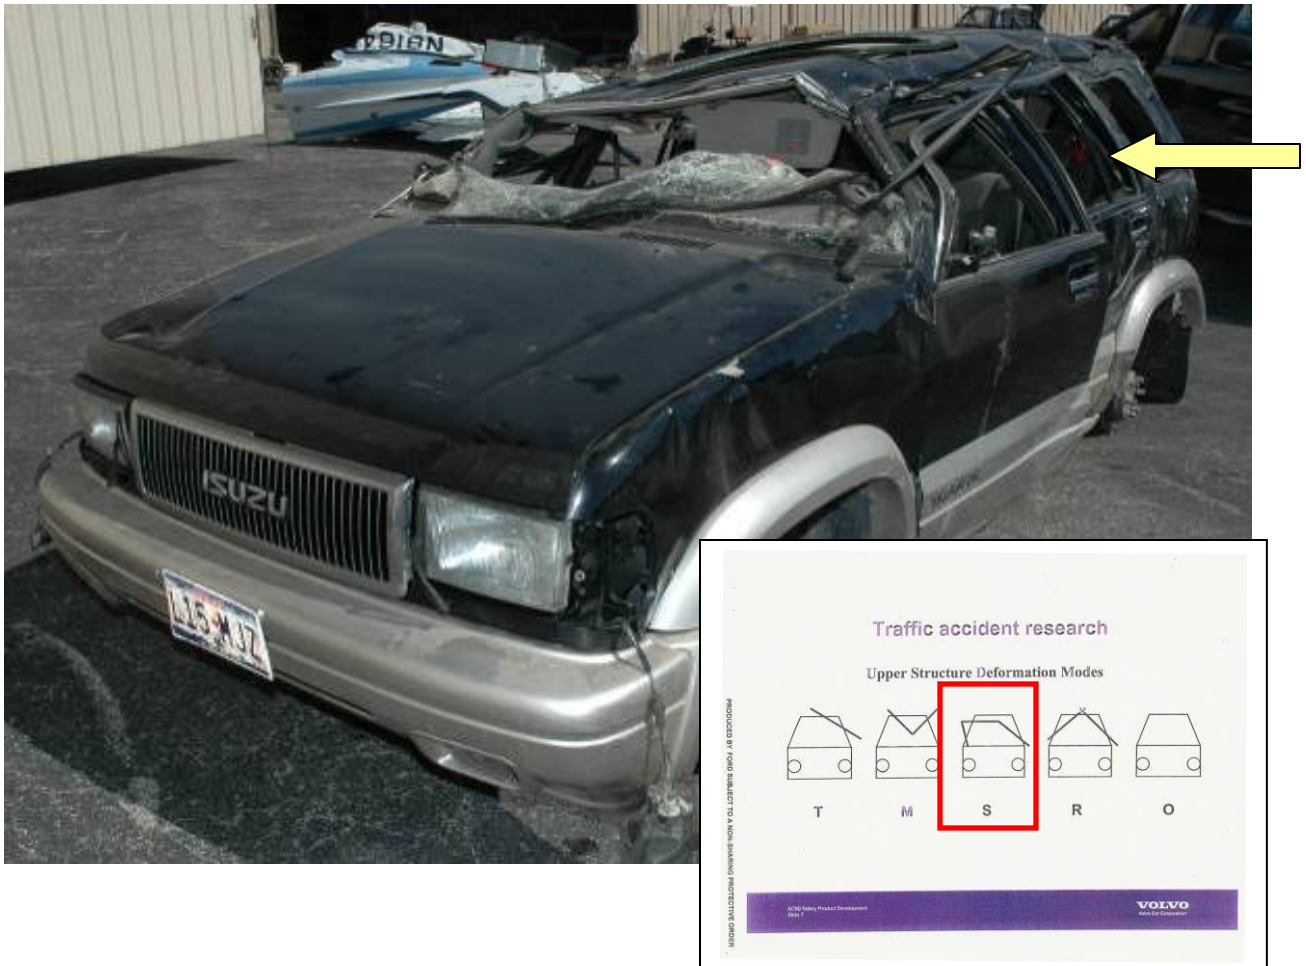
**FIGURE 26**  
**1996 Isuzu Trooper**

A 1996 Isuzu Trooper (Figure 26) was on a highway in the southern US, when the tread came off the left rear tire. The driver lost control of the vehicle and it rolled, coming to rest wheels up.

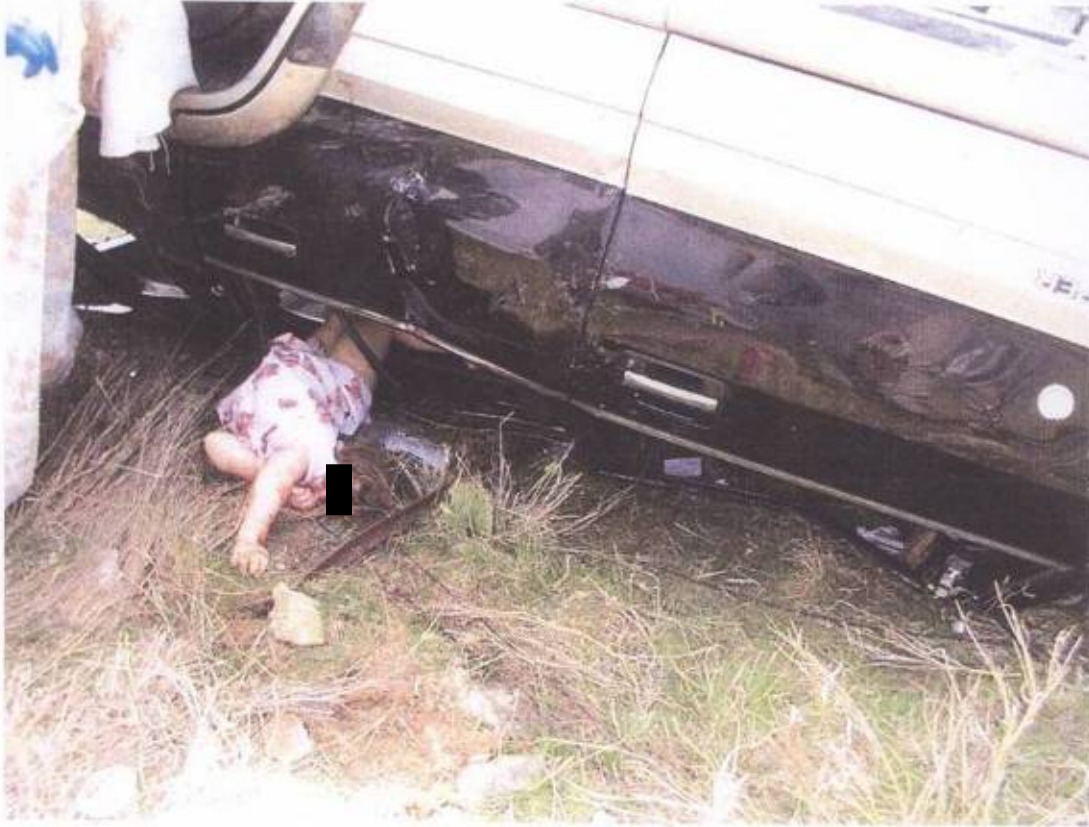
During the crash, a female child (5 yrs, 36 inches, 65 lb) was ejected out of her belt positioning booster seat, through the left rear window and was crushed by the overturning sport utility vehicle (Figure 27a,b). She died of “massive blunt force trauma,” including basilar skull fracture with massive bruising and trauma to right side of face.

**a. Five Year Old Child Ejected From Belt Positioning Booster Seat**

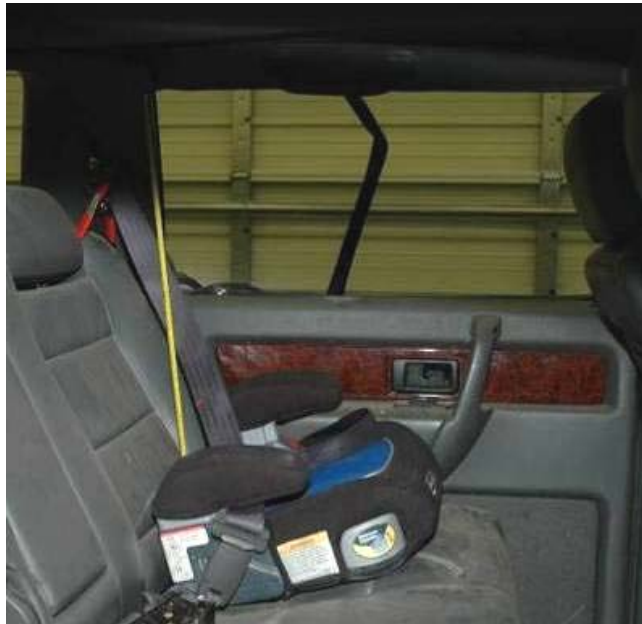
**b. Belt positioning booster seat used to restrain the child, according to vehicle and booster seat manufacturer's instructions**

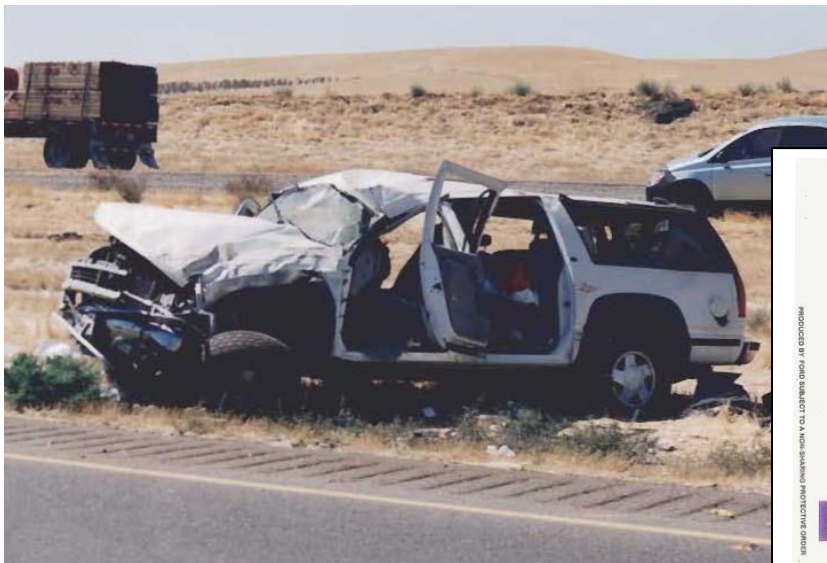
A woman driving her 1997 Chevrolet Suburban, with her husband, mother-in-law and four children, were traveling down a four-lane divided highway, at about 65mph. As it traveled, the right rear tire of the Suburban experienced tread separation, causing it to go flat. The driver applied the brakes and attempted to maintain control. She lost control of the Suburban; it traveled into the grassy median where it rolled. The Suburban came to rest wheels down in the median. A female child (8 yrs, 56 inches, 110 lbs) was the properly lap-shoulder restrained passenger seated directly behind the driver. During the rollover crash, her torso rolled out of her shoulder belt and the left frontal aspect of her head violently impacted the unpadded forward window frame/B-pillar structure. (Figure 26) She sustained a depressed skull fracture in the frontal bone as well as a significant basilar skull fracture, with catastrophic brain injury.

**FIGURE 26**  
**Head Contact for left, second row occupant of Suburban**

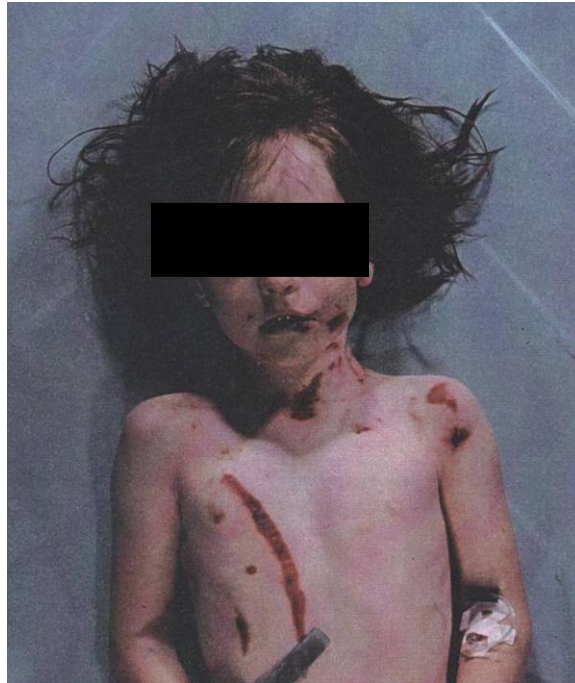
**FIGURE 28**  
**5 Year Old Girl Fatally Ejected from 5-Point Harness Booster Seat in 1994**  
**Chevrolet Suburban Rollover**
