National Park Service Cultural Landscapes Inventory 1998

Revised 2002

Quitobaquito
Organ Pipe Cactus National Monument

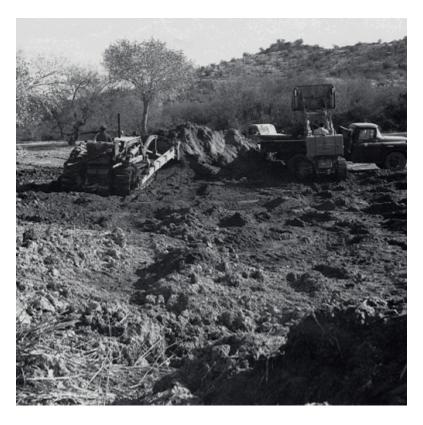
The National Park Service deepened the pond in 1962. This created an unfavorable environment for the Quitobaquito pupfish (Photo by Waren Steenbergh, Jan, 1962, ORPI file W-34C).

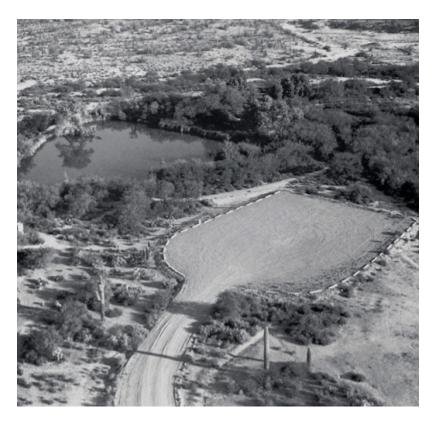
The National Park Service constructed a parking lot adjacent to the pond in the early 1960s. (Photo by Richard Begeman, 1968, ORPI file W-46).

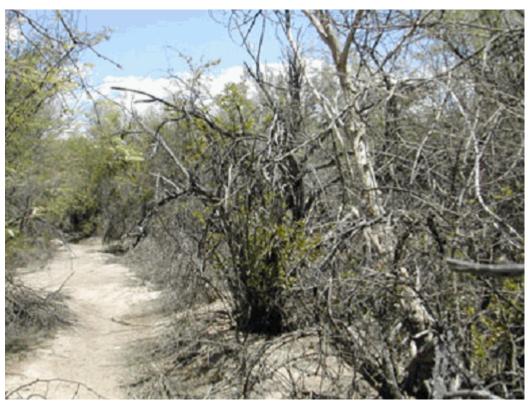
Historic pomegranates are dying off due to neglect (Photo by J. Galbraith, 2002)

maintained and their health is deteriorating. Some specimans have died. Historic irrigation channels have not been maintained. Vegetation cleared from channel transporting water from springs to pond is piled at sides of channel disturbing existing vegetation.

The condition of the Quitobaquito cultural landscape is categorized as Fair. Corrective action is needed within 3-5 years in the areas of erosion control, vegetation management, historic orchard and irrigation channel maintenance, trail deliniation, and unauthorized access in order to prevent further harm to the cultural and natural values of the landscape.

Stabilization costs include fence repair, foot trail construction and maintenance, land reclamation, orchard maintenance, and conducting oral histories.

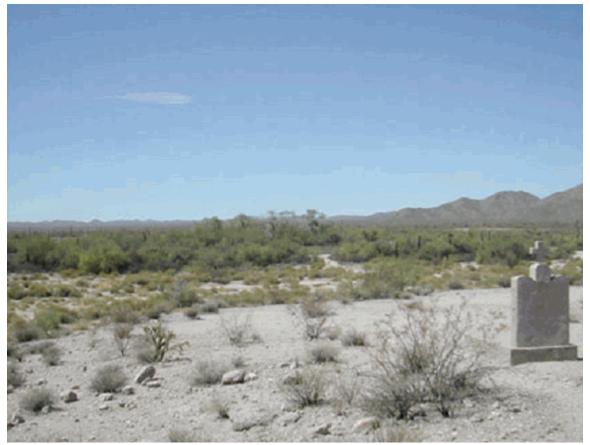
View from Sestier's Grave in 2002, looks much the same as the 1982 photograph (Photo by J. Galbraith, 2002)

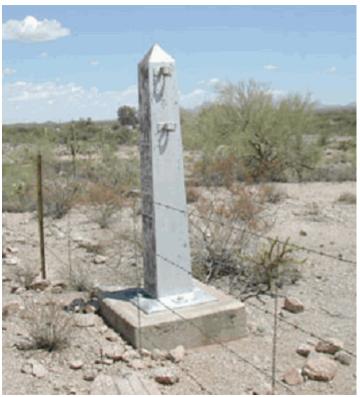
International Boundary Marker 172 (Photo by J. Galbraith, 2002)

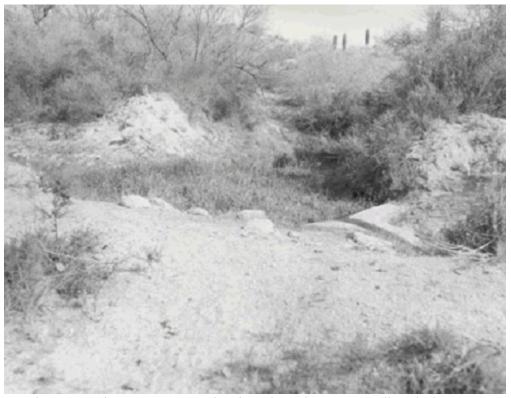
Quitobaquito 'south spring' in 1961. This photo shows the concrete spillway built in 1949 by Bureau of Animal Industry to impound Jim Orozco's water supply for their own use (Photo by Budge, 1961, W-25)

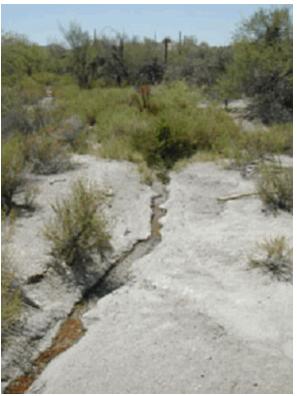
Concrete channel constructed in 1989 to direct water from springs to pond (Photo by J. Galbraith, 2002)

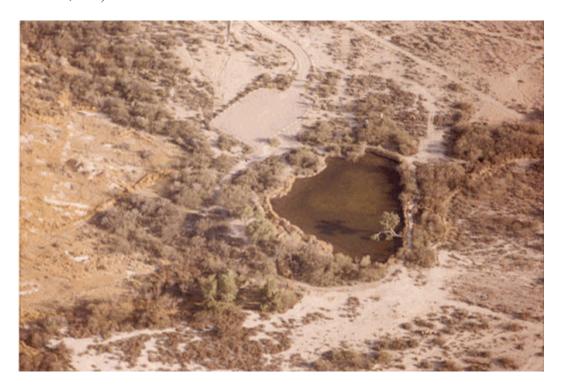
Quitobaquito Pond in 1974. The earthen dam is located along the lower left edge of the pond in this photo (parking lot is no longer adjacent to the pond-Photo by Fred Mang, negative series 74-1467)

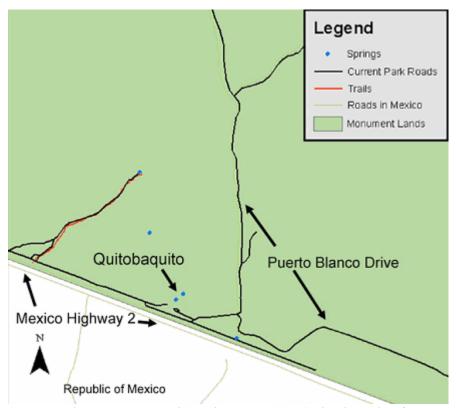
Major circulation routes around Quitobaquito in 2002 (undated GIS data from ORPI Park Files)

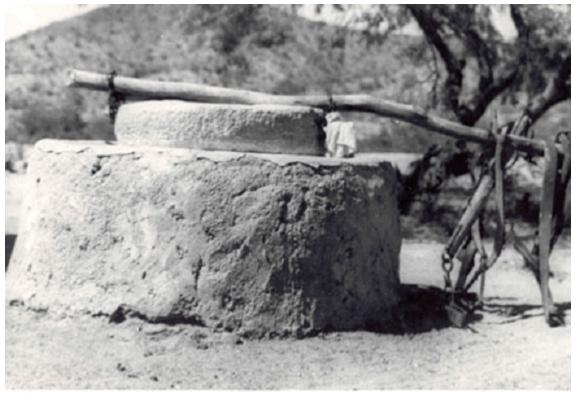
The stone mill (molina de piedra) turned by a burro to grind grain used by the Orozco's at Quitobaquito (Photo undated, no author. ORPI #818)

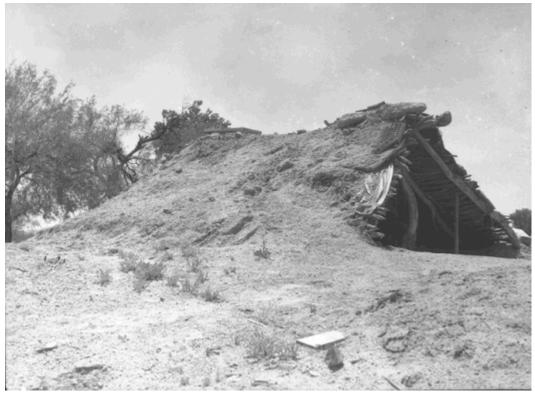
"Pithouse" owned by the Orozco family at Quitobaquito. This structure was razed after 1957 (Photo by N. Dodge, F. Pinkley, and J. Miller, May, 1939, ORPI #1924/WACC #3542)

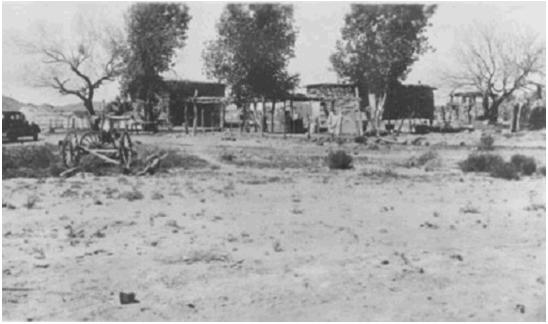
Corrals and buildings used by the Orozco family at Quitobaquito. Structures were razed after 1957 (Photo by N. Dodge, F. Pinkley, J. Miller, May, 1939) ORPI#507)
