# The Ins and Outs of Roundabouts

Safety Auditors' Perspective

April 2000

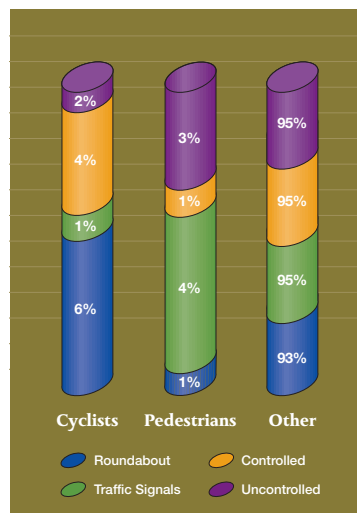
As shown, cyclists account for 6% of accidents at roundabouts, 1% at traffic signals and 4% at priority controlled intersections, further highlighting the need for special consideration for cyclists at roundabouts.

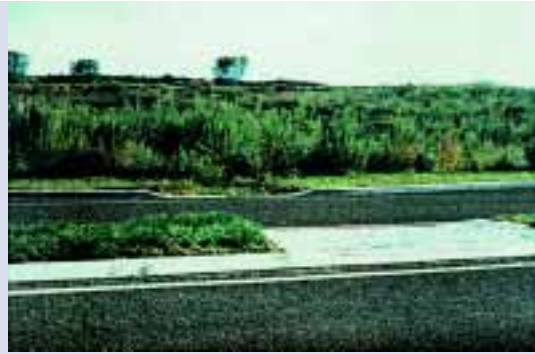
- Rear end accidents resulting from poorly sited crossing locations.
- Severance of existing pedestrian routes without making suitable alternative provision.

*Pedestrian ramps leading nowhere*

- Clear, safe guidance of pedestrian to appropriately located facilities.
- Provision of guard fences and hand-rails to control pedestrian movements.
- Locating pedestrian facilities as far from the roundabout as possible without reducing the attractiveness of facility.

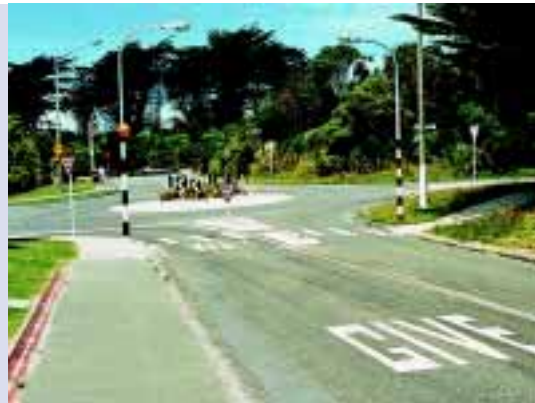
*Good pedestrian design with linking paths and clear visibility*

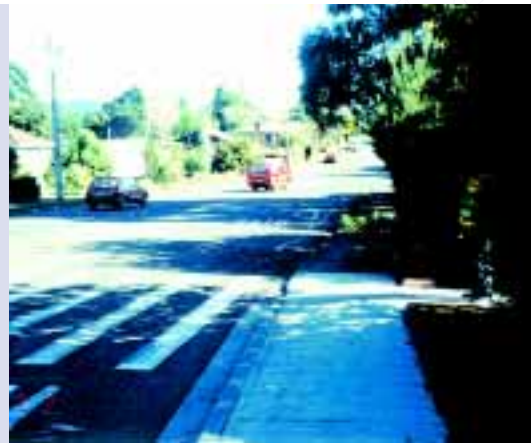
- Poor intervisibility with approaching drivers.
- Inadequate stopping sight distance for motorists.
- Crossing points not being located on pedestrian desired routes.
- Poor design or lack of provision of drop-crossings.

*Shadow across crossing and vegetation hiding pedestrian*

- Always ensure adequate intervisibility between drivers and pedestrian facilities.
- Realign adjacent footpaths to guide pedestrians to crossing locations.
- Judicious planting/street furniture/fences to discourage pedestrians from crossing at hazardous locations.
- Ensure that all pedestrian crossing points have smooth kerb ramps.

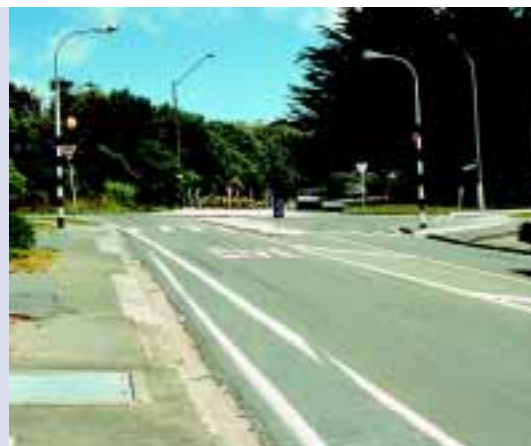
*Good clear sight lines with pedestrian and motorist*

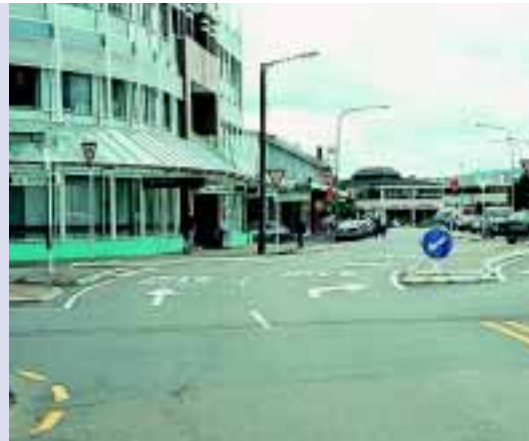
Inadequate deflection on approaches will result in higher approach speeds and this may lead to:

- Failure to give way to vehicles already on the roundabout.
- Rear end collisions when vehicles brake suddenly.
- Loss of control accidents within the area of the roundabout.

*No deflection for straight through traffic*

Depending upon when this deficiency is identified, the most satisfactory solution will be to redesign the roundabout so as to meet established guidelines. This may include:

- Moving the centre of the roundabout.
- Increasing the diameter of the central island.
- Modifying the approach geometry .
- Increasing the deflection by realignment of the approach kerblines or splitter islands.
- Greater use of roadmarkings, including raised reflective pavement markers.

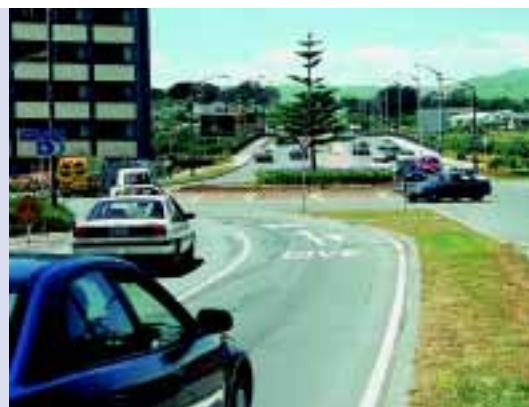
*Deflection provided*

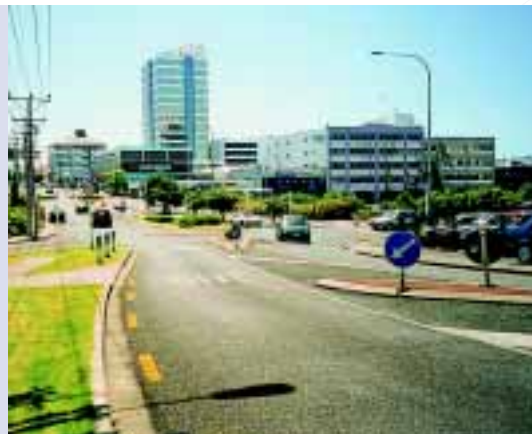
- Loss of control accidents.
- Drivers incorrectly assessing appropriate approach paths.
- Failure to give way accidents.

*Badly aligned median with sharp transition.  
Roadmarking needs to be altered*

- Ensure drivers are guided around the roundabout and not through it.
- Smooth transitions must be provided along edge of the splitter island to ensure approach speeds are reduced gradually (ie avoid abrupt deflection at entry to the roundabout).

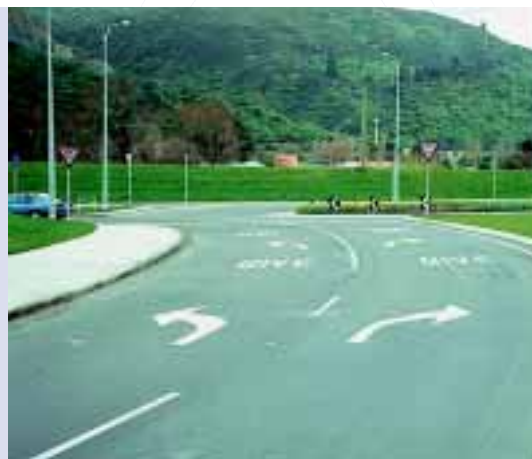
*Good deflection of median further  
highlighted by roadmarking*

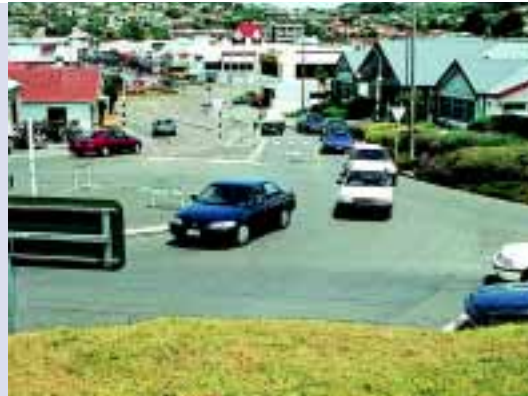
- Lead motorists into unsafe situations and confuse motorists.
- Reduce the capacity of the roundabout to handle the intended traffic volumes.
- Increase speeds through the roundabout.
- Lead to unexpected weaving manoeuvres through the roundabout or on the approaches.

*Multi-lane roundabout providing no guidance to motorists in the circulating roadway*

- Ensure roadmarkings provide a clear indication of what is expected of the driver and other users of the roundabout.
- Remove old roadmarkings to avoid confusion.
- Provide roadmarkings within the circulating roadway.
- Adopt a consistent marking style with nearby roundabouts.

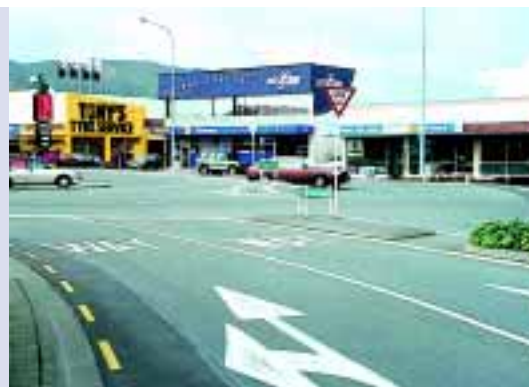
*Good clear roadmarkings provide motorists with clear instructions*

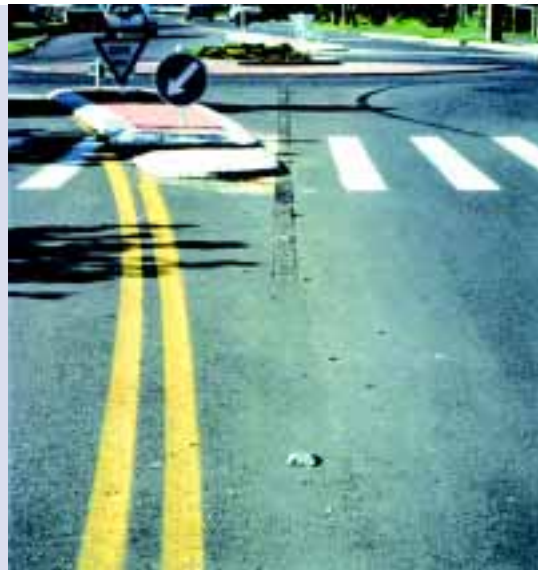
- Old markings can lead motorists into the path of an oncoming vehicle, particularly at night.
- Old signs may incorrectly inform motorists.

*Old markings confuse pedestrians and motorists. Redundant reflective markers misguide motorists*

- Permanently remove all old markings.
- Remove all redundant signs.

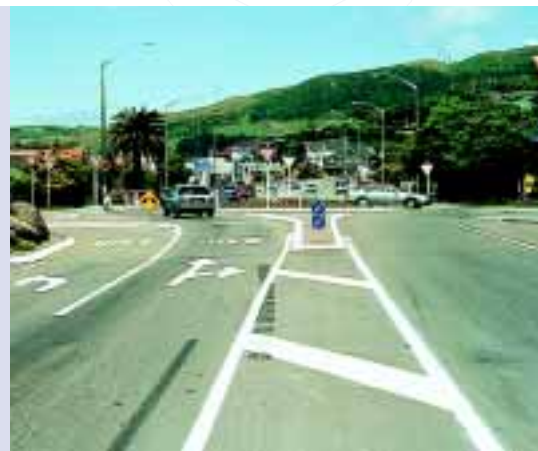
*Good clear roadmarkings*

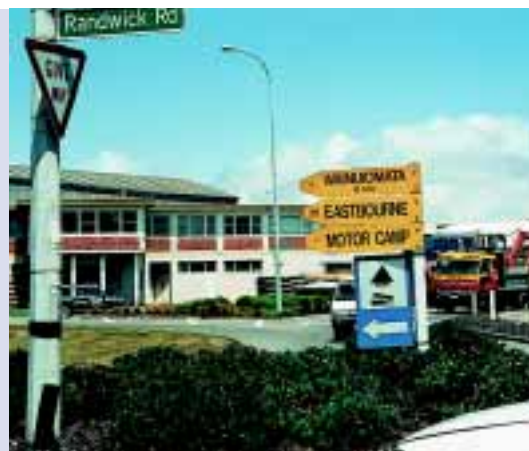
- Confusion for unfamiliar drivers seeking a particular location.
- The inability of the motorists to anticipate the type of junction ahead.
- Reduced driver's vision.
- Last-minute or unexpected lane changing when destination information is provided too late.

*Destination signs hide approaching vehicles*

- Provide larger warning signs on high speed approaches to a roundabout and/or increase the number of warning signs; ie one on each side of the roundabout approaches.
- Install large advance directional signs for major urban and rural roundabout junctions especially at high speed locations.
- Ensure signs do not obstruct critical sight lines.

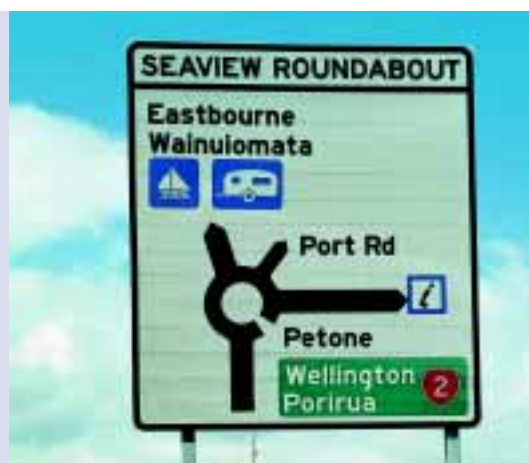
*Good clear directions given to motorists in advance of the roundabout*

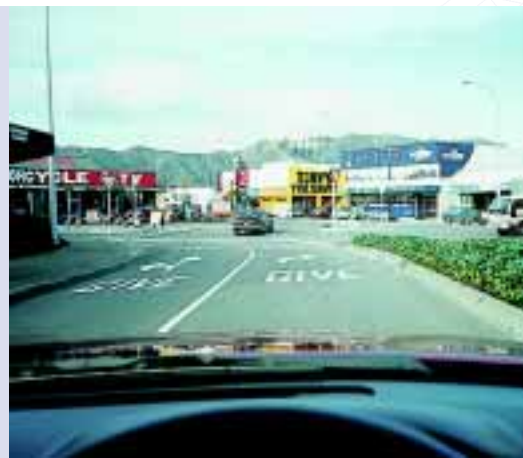
- Motorists losing control because of failure to see central island.
- Vehicles driving through central island.
- Rear-end accidents due to sudden braking.
- Inability to determine appropriate roundabout speeds leading in turn to accidents resulting from failure to give way.

*Poor central island design leading to a lack of island recognition*

- Raising central island to improve its visibility.
- Chevron signing to highlight central island radius.
- Lighting of central island at night.
- Design of splitter islands to guide motorists around central island.

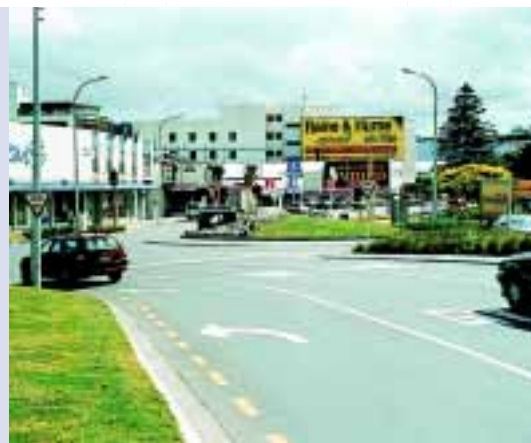
*Raised central island improves the intersection control and its recognition*

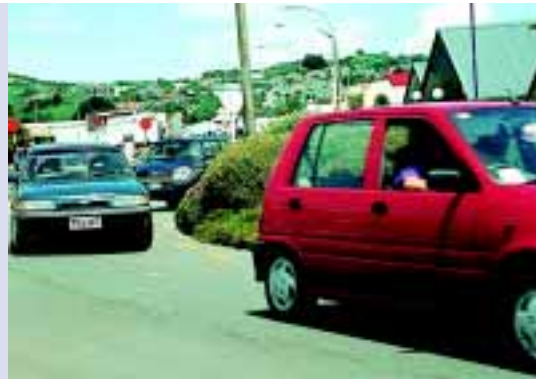
- View is obstructed by signs/vegetation creating blind spots for drivers.
- Efficiency of the roundabout is affected because of extra delays associated with poor visibility.
- Signs and vegetation hide smaller and/or slower moving road-users such as pedestrians or cyclists.

*Approaching vehicles are hidden by vegetation*

- Ensure a regular maintenance programme is in place such that the height of any vegetation does not intrude on sight lines.
- In critical areas provide hard surfaces rather than planting.
- Relocate vegetation away from critical line of sight triangles.
- Remove inappropriate vegetation and plant low ground cover plants.

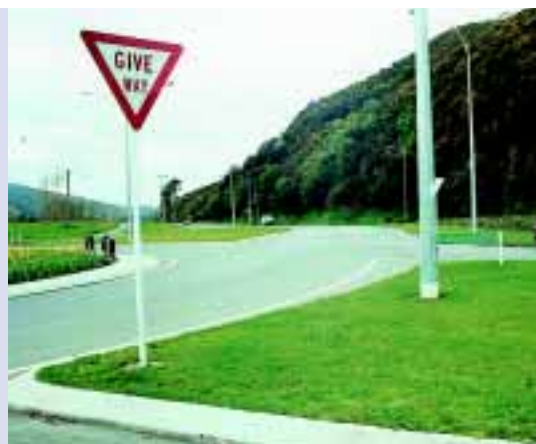
*Excellent visibility provided for motorists*

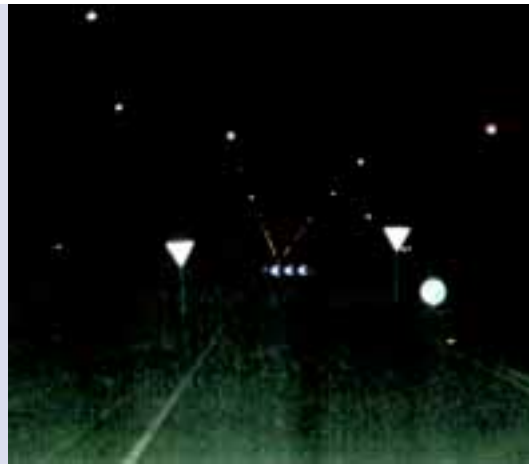
- Confusion, causing emergency braking and/or collision
- Loss of control night-time accidents
- Delays due to poor guidance to motorist

*Streetlights lead motorists straight through the roundabout*

- Consider more lanterns and/or greater luminance.
- Consider central island lighting column.
- Use of reflectorised paint on kerbs and install reflective markers around islands.
- Ensure that all physical elements including splitter islands are clearly lit.
- Adjust lighting on approaches, as necessary to ensure that the junction is recognised.

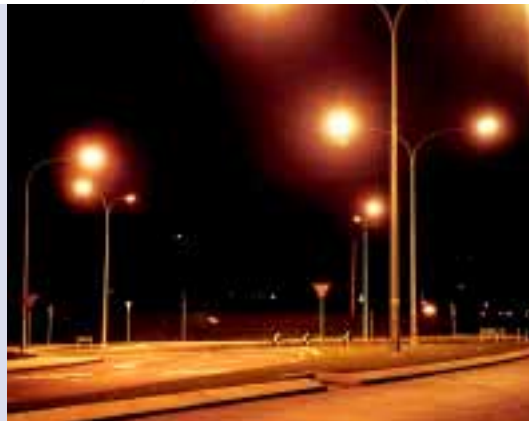
*Street lighting highlighting roundabout and its approaches*

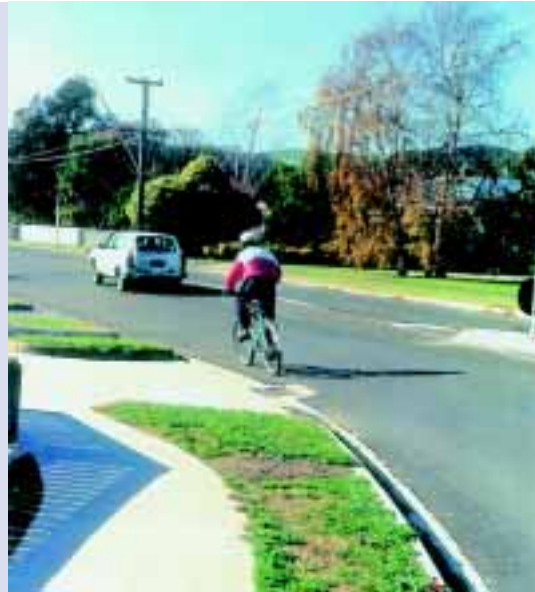
- Stormwater grates, particularly where the grates are orientated parallel to the roadway, are a real hazard for cyclists.
- Cycle lanes, where they are provided along a route typically stop short of roundabouts.
- Large roundabouts with higher circulating speeds create difficulties for cyclists.
- Inadequate lane widths, particularly on circulating roadways shared with heavy commercial traffic.

*End of splitter island is beyond sump forcing rider to the left and onto stormwater grate*

- Avoid use of stormwater grate patterns which are parallel to the direction of travel.
- Avoid locating any service covers within the travelled way.
- Provide adequate clearances to heavy vehicle tracking paths in the design phase.
- Provide adequate circulating lane widths to properly accommodate cyclists.

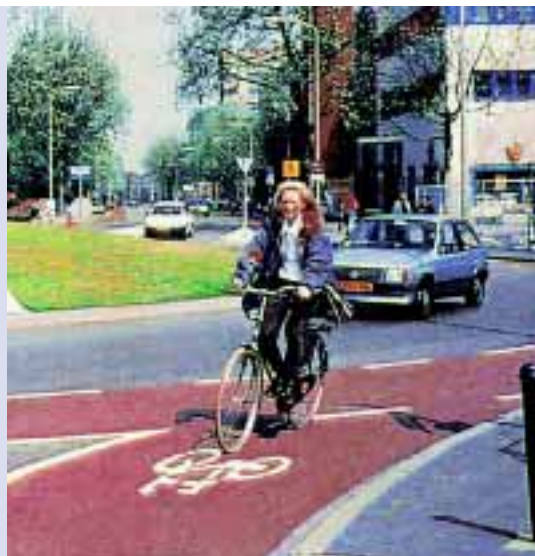
*Typical cycle treatments used overseas*

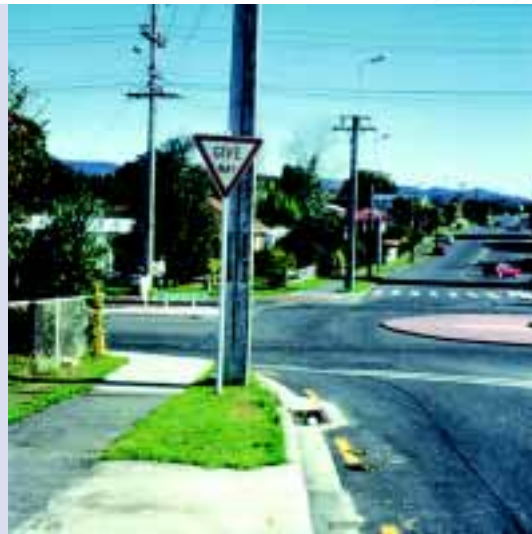
- Motorists hitting obstructions.
- Poor intervisibility with other road users.

*Poor location of solid concrete lamp-post on approach*

- Move lighting columns to back of footpath and use frangible poles
- Ensure signage is kept clear of sight lines.

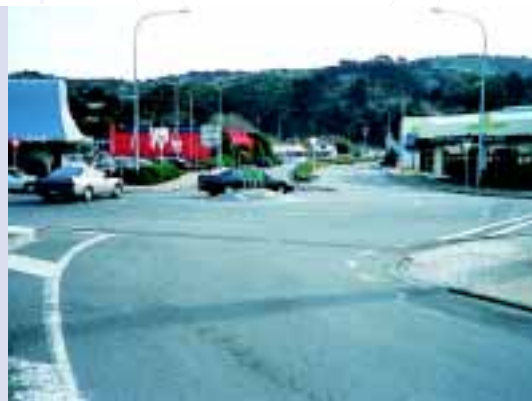
*Street lighting poles located well clear of kerbs*
