1999 AH PAH AND TECTAH CREEKS WATERSHED RESTORATION TRAINING AND IMPLEMENTATION PROGRAM

EXECUTIVE SUMMARY

The purpose of this report is to summarize the restoration work completed by the Yurok Tribe, as part of the Lower Klamath Restoration Partnership's 1999 projects. From July through October 1999, the Yurok Tribe conducted a Watershed Restoration Training and Implementation Program within the Ah Pah and Tectah Creek drainage basins. This is part of a multi-year restoration effort, which is intended to remediate man-caused sediment sources from 30 tributary sub-basins within the Lower Klamath River Basin.

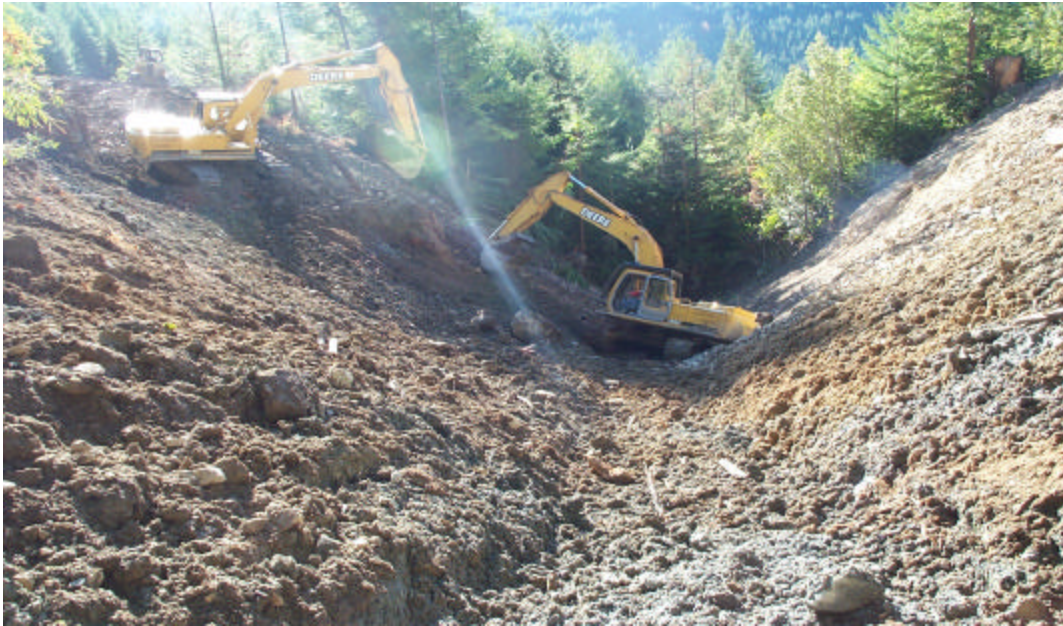
Pair of excavators

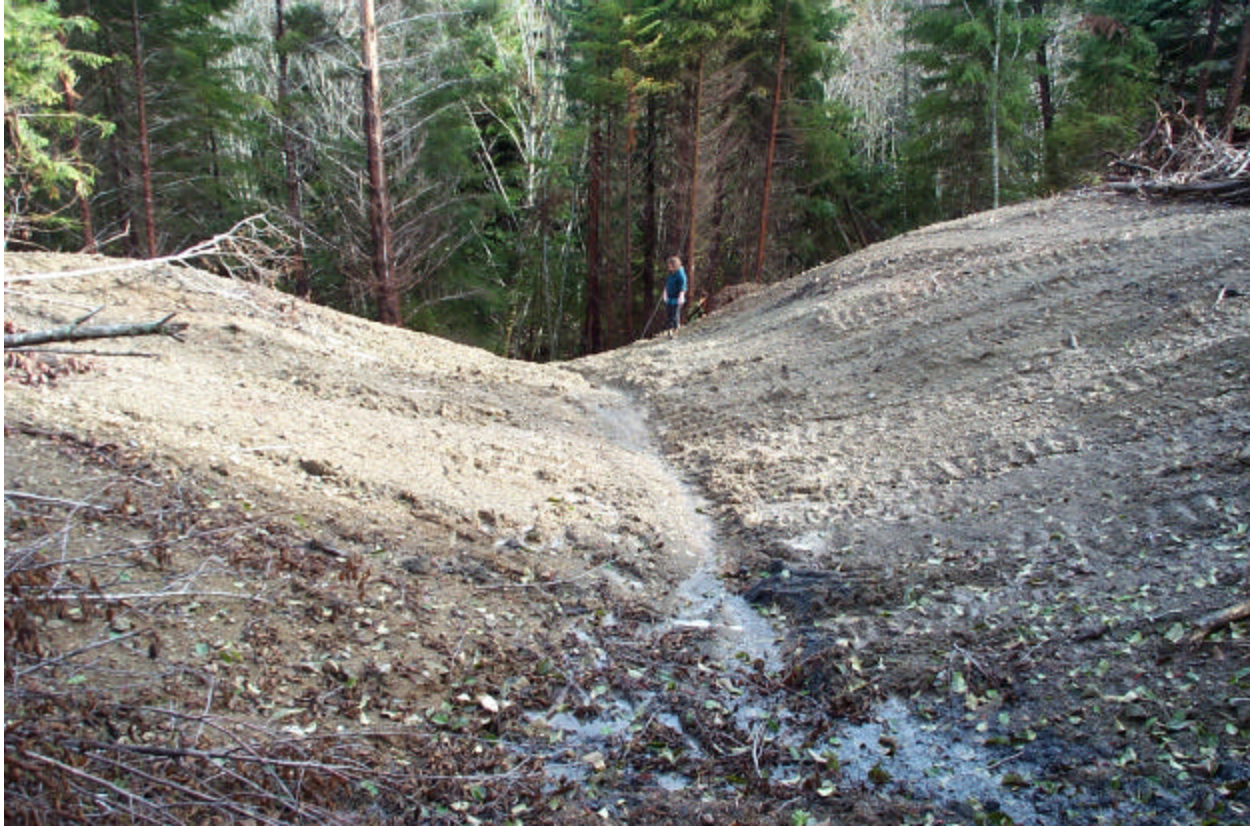
Stream crossing has been pulled.
