**Project Offshore Deep Slope
Phase II**

Progress Report

March 2004

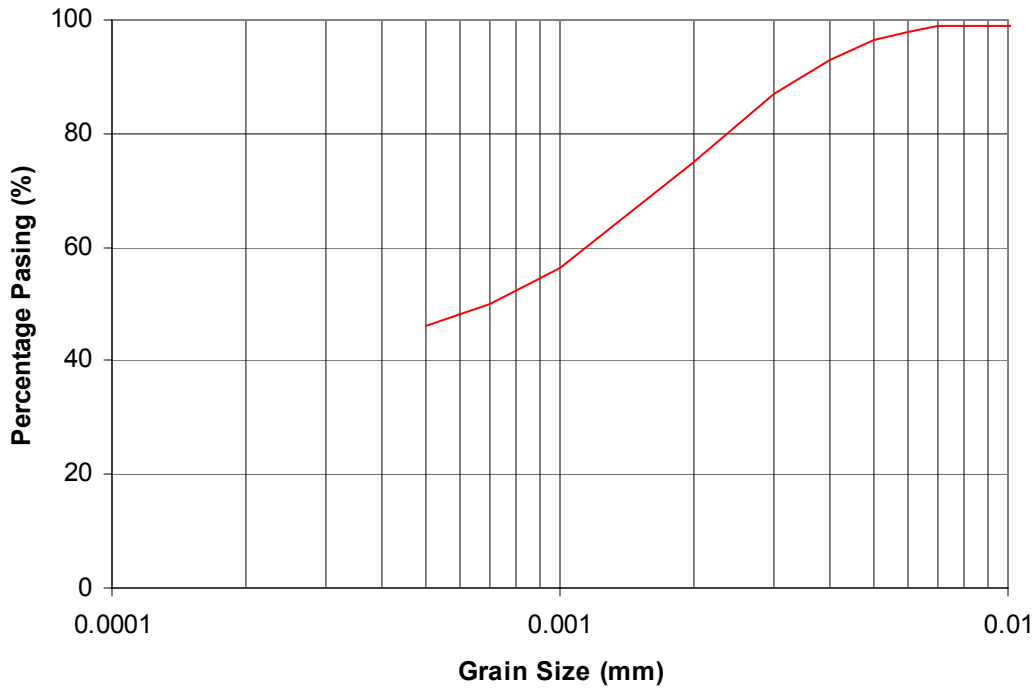
Figure 3: Grain Size Distribution for Speswhite Kaolin

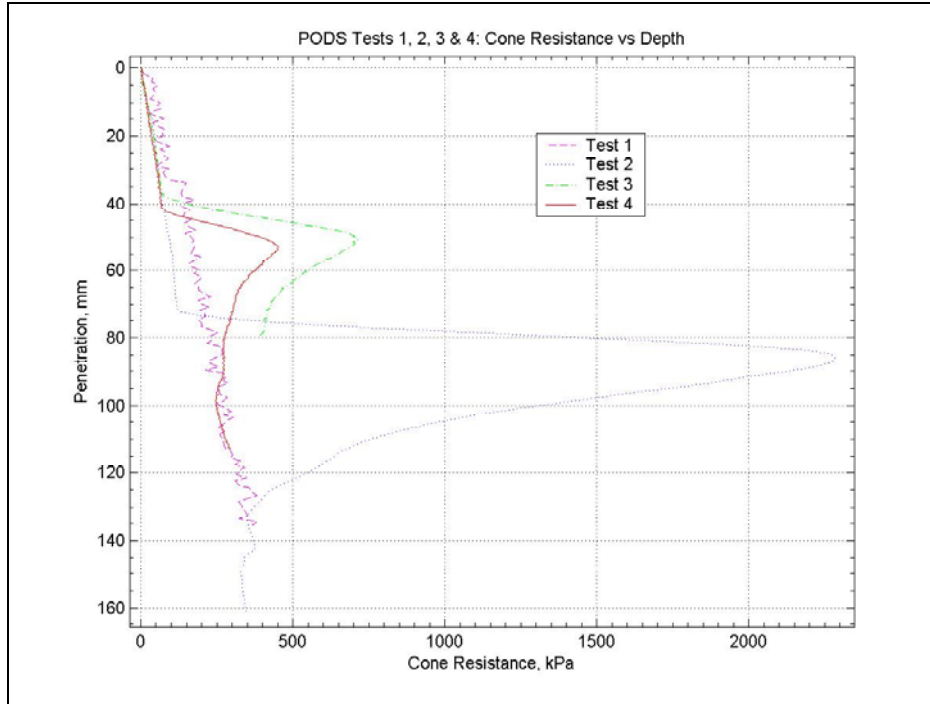
Figure 4: Composite Plot of CPT Cone Resistance

Figure 4 shows a composite plot of the CPT results for each of the 4 test packages. Test 1 was prepared using a slurry at 65% moisture content compared to 90% in tests 2 to 4. This low moisture content was initially used to provide sufficient strength to allow LVDTs to measure surface settlement without embedding themselves into the slurry. The resulting shear strength was, however, greater than targeted, suggesting an effectively over-consolidated profile near the surface. Subsequent tests were therefore mixed at 90% to ensure a normally consolidated profile. The effect of the sand layer in Tests 2 to 4 is evident, with sharp increases in cone resistance at the level of the sand layer.

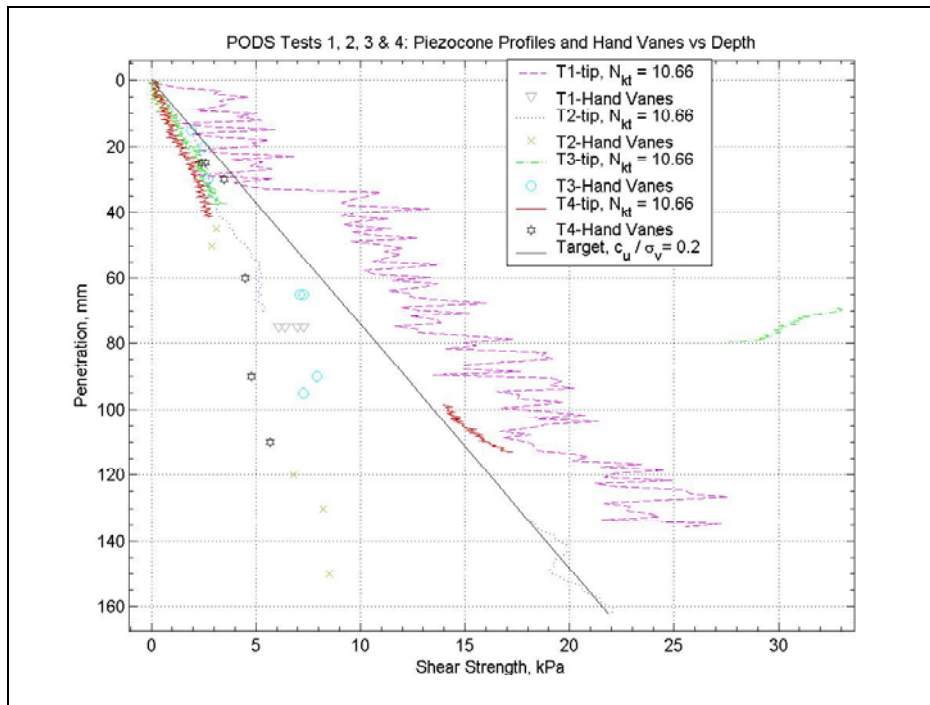
Figure 5: Composite Plot of Interpreted Shear Strength from CPT and Vane Data

Figure 5 shows the interpreted shear strength profile from CPT data and vane test results for each test. Interpretation of shear strength can be unreliable at shallow depths of less than about 4 cone diameters due to differences in penetration mechanism, and so the data provided serves primarily to illustrate consistency in soil strength between tests. A reference line is also included in Figure 6, giving a ratio of 0.2 between shear strength and overburden pressure. The value of 0.2 is commonly referenced for normally consolidated clay, although a range of values is often quoted. Almeida, M.S. and Parry, R.H. (1985), for example quote 0.226 for normally consolidated kaolin clay.

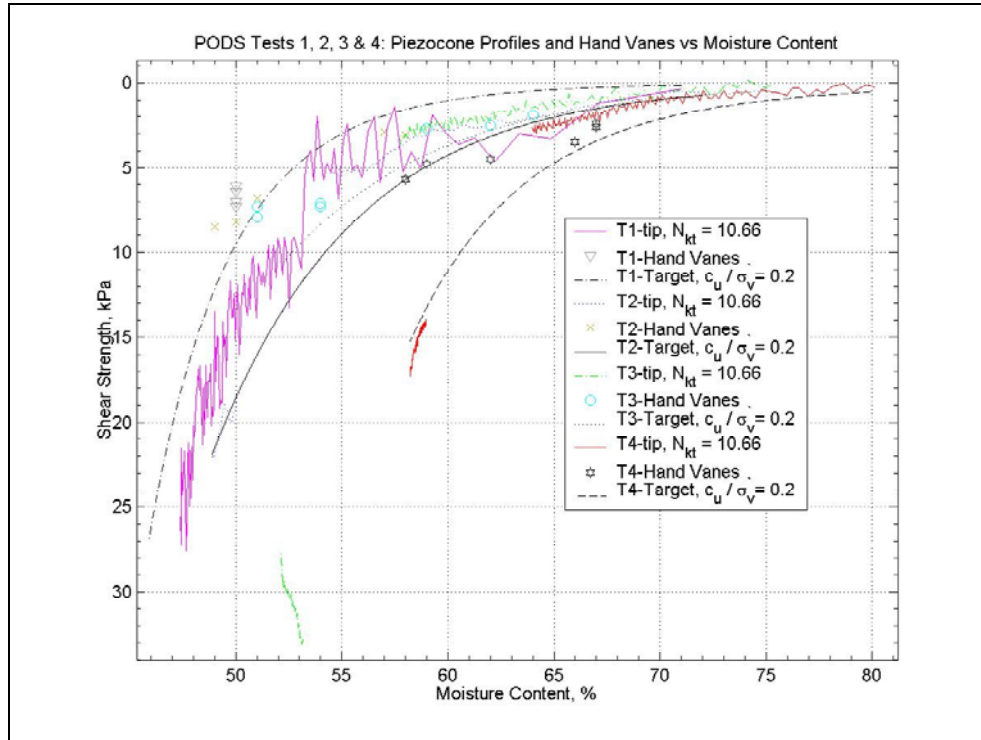
Figure 6: Plot of Shear Strength vs. Moisture Content

The moisture content profile of each testbed was also used to provide interpretation of the soil conditions. Figure 6 is a composite plot relating moisture content to shear strength interpreted from CPTs and vane tests. An overall relationship was developed to provide a consistent approach to interpretation.

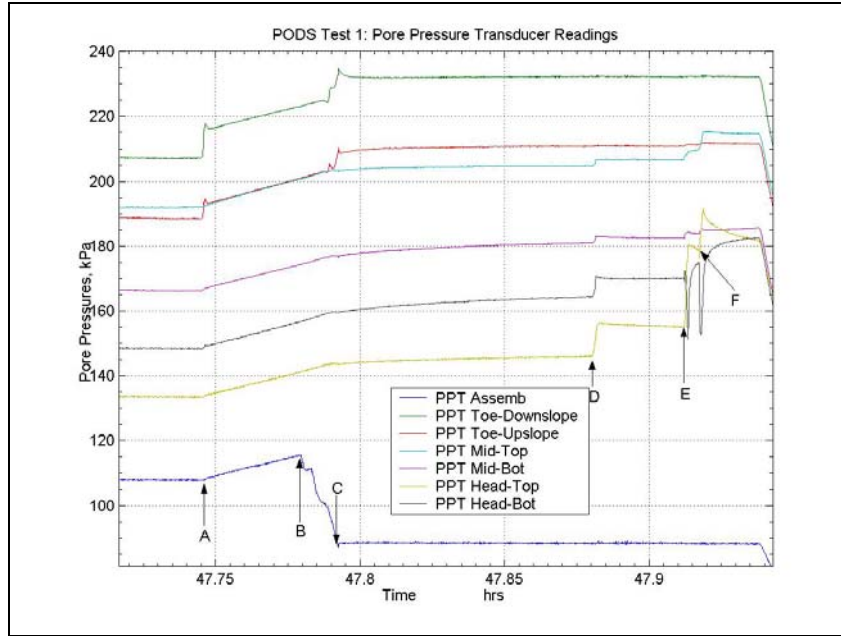
Figure 9: Pore pressure transducer readings of test 1.

Once the water pressure was applied, it was found that the injected water created short-circuiting paths to the soil surface, rather than causing general fluidising of the clay in the vicinity. Figure 9 presents the pore pressure measurements during this phase of the test, with each PPT labeled according to its position in given in Figure 8. The linear increase of PPT_{Assemb} in Figure 9 indicates the addition of surface water due to water short-circuiting from the pipe. In Figure 10 which shows excess pore water above hydrostatic conditions for each PPT, the initial increase of excess pore pressures in $PPT_{Toe-Downslope}$ and $PPT_{Toe-Upslope}$ at position A demonstrates the injection of water. The time scale in Figures 9 and 10 is based on the complete centrifuge test, including the two phases of consolidation, the CPT, and slope failure testing.

With the injection water remaining on, the toe injector was pulled vertically approximately 30mm at a rate of 1mm/s, which did not cause slope failure. It is considered likely that the gap behind the pipe was quickly filled with slurry as it flowed around the pipe as it was pulled upward. Movement of the toe injector is represented by the decrease in pore pressure of PPT_{Assemb} between positions B and C in Figures 9 and 10. The toe injector was stopped and the water turned off at position C.

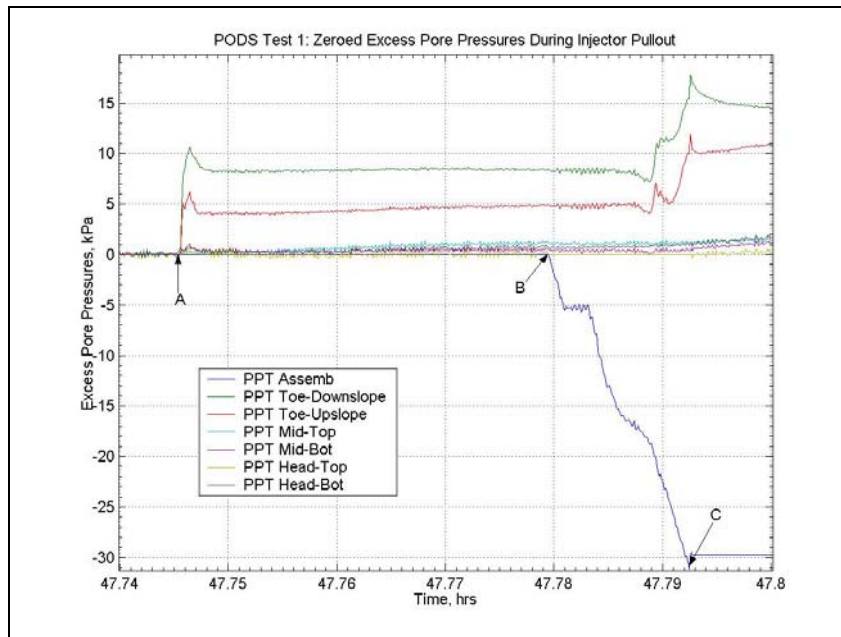
Figure 10: Zeroed excess pore pressures of test 1 during toe injector pullout.

Although there was no slope failure due to the movement of the toe injector, there were significant excess pore pressure responses at $PPT_{Toe-Downslope}$ and $PPT_{Toe-Upslope}$ at position C in Figure 9, indicating some response within the slope, although insufficient to cause failure.

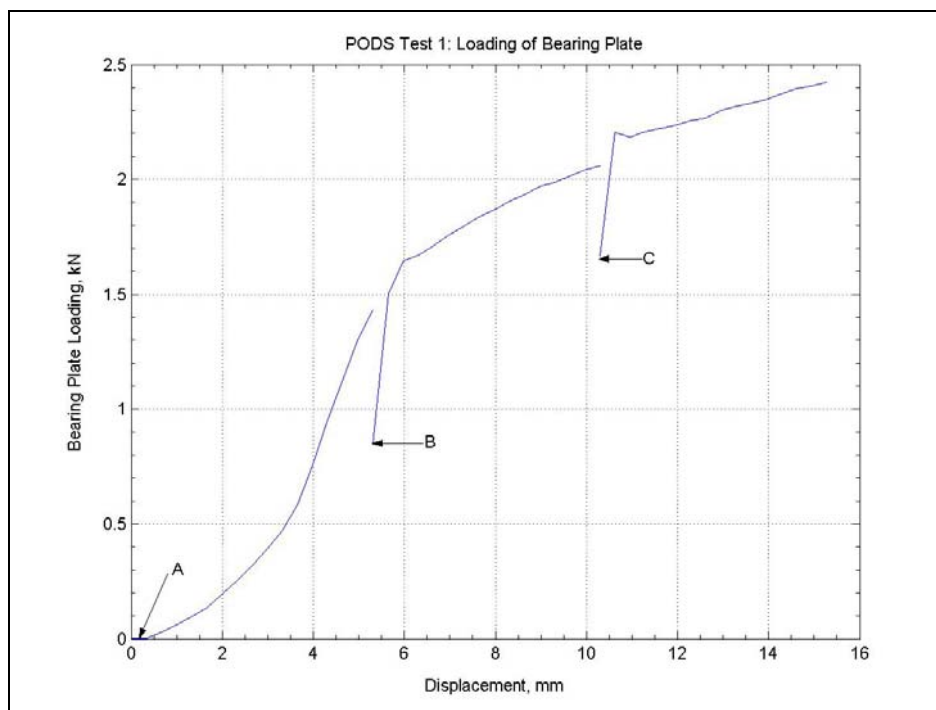
Figure 11: Loading of bearing plate on head of the slope.

The data in Figures 11 and 12 suggests that the soil beneath the plate failed during loading events B and C. The resistance load continued to increase as the test progressed suggesting that the slope instability did not occur. Shearing did take place, however, as shown by the pore pressure response in the two head PPTs directly below the plate. Figure 13 shows the response of the LVDT placed just in front of the plate, between it and the crest of the slope. The upward movement is consistent with a bearing capacity mechanism rather than a slope failure. Observation of spaghetti movement was inconclusive and no obvious shear plane was identified, as shown in Figure 14.

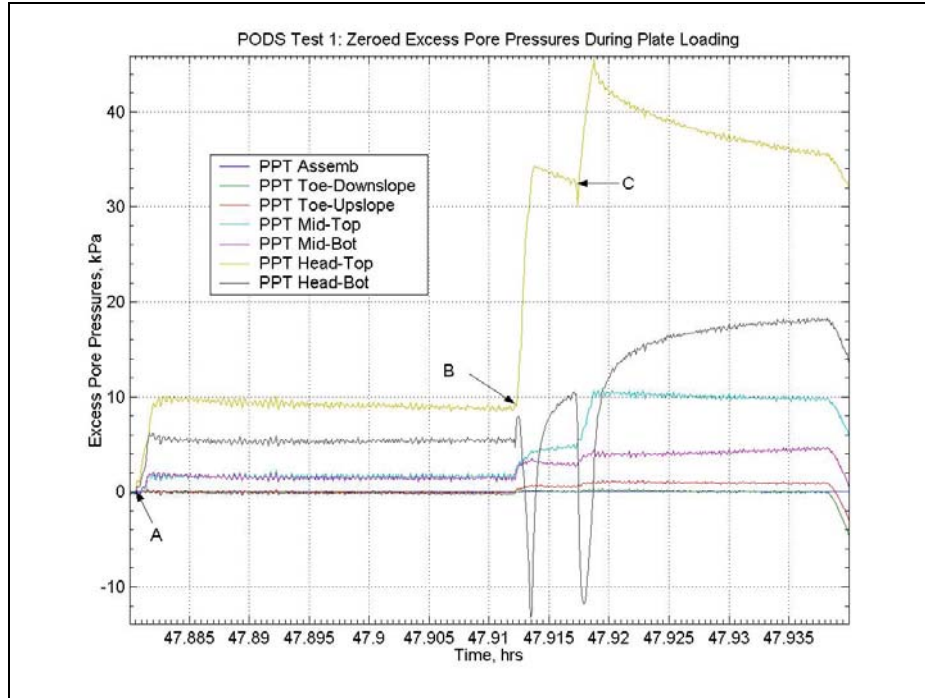
Figure 12: Zeroed excess pore pressures of test 1 during bearing plate loading.

Loading of the crest of the slope using the bearing plate was used as a back-up to the toe erosion process. The bearing plate is an aluminium plate 198 mm x 284 mm in plan with a thickness of 5 mm. Rib strengthening was incorporated to prevent flexure during loading. A 10kN load cell was connected above the plate to record the applied load. The soil surface was loaded in three increments, shown labeled as A, B, and C of Figure 11. The total loading displacement into the soil was approximately 15 mm. The pore pressures response due to the plate loading increments can also be seen at positions A, B, and C of Figure 12.

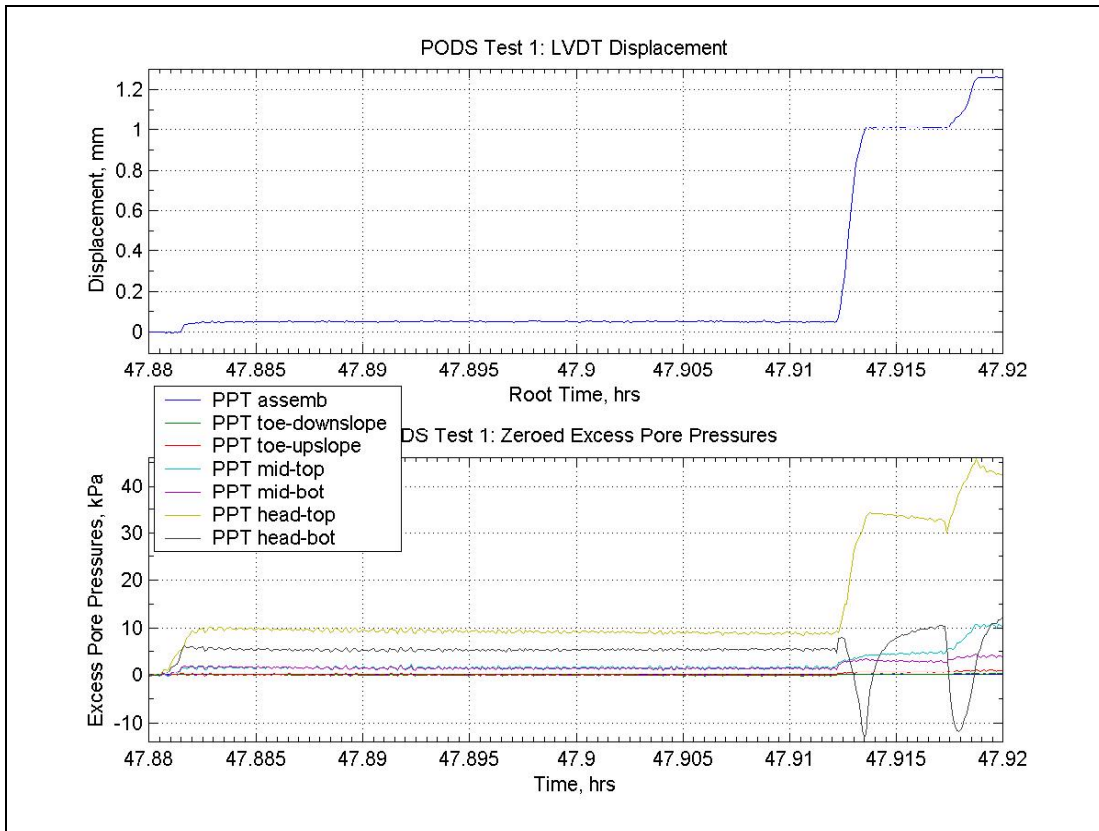
Figure 13: LVDT Readings during Plate Load Application

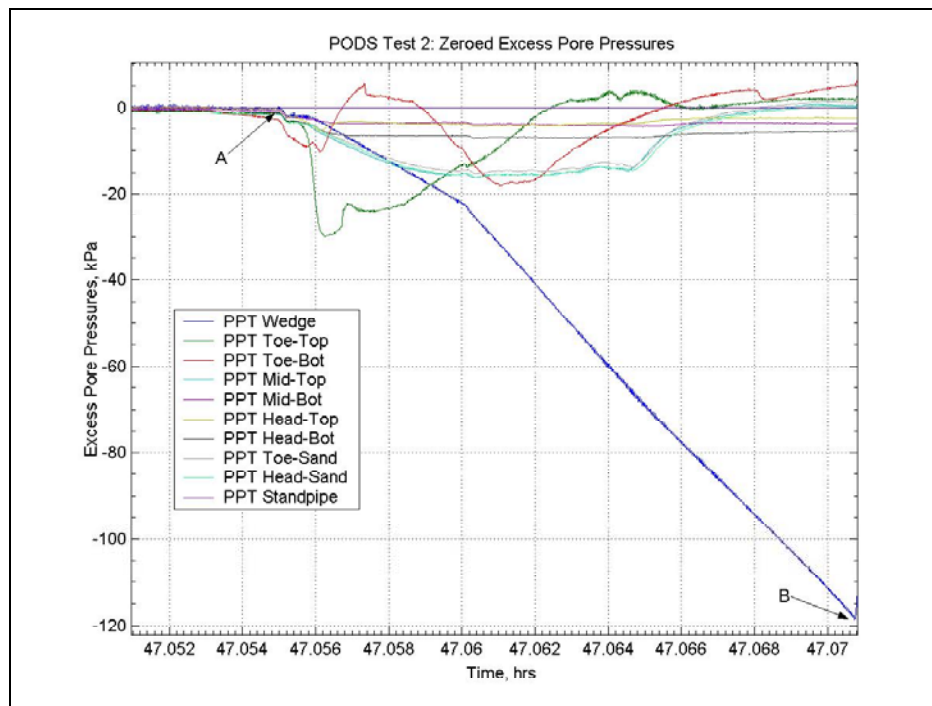
Figure 20: Zeroed excess pore pressures during aluminium wedge pullout of test 2.

On completion of the consolidation phases, slope failure was initiated by extraction of the aluminium wedge at a constant rate of 2.5mm/s. Figure 20 shows the PPT response as the wedge is extracted. Vertical movement of the aluminium wedge can be seen at position A as the pressure measured by PPT_{Wedge} decreases as it rises through the water column. PPT_{Toe-Top} and PPT_{Toe-Bot}, nearest to the wedge show significant pore pressure response as the wedge is removed. At point B the wedge was completely extracted from the soil and the servo-motor was turned off.

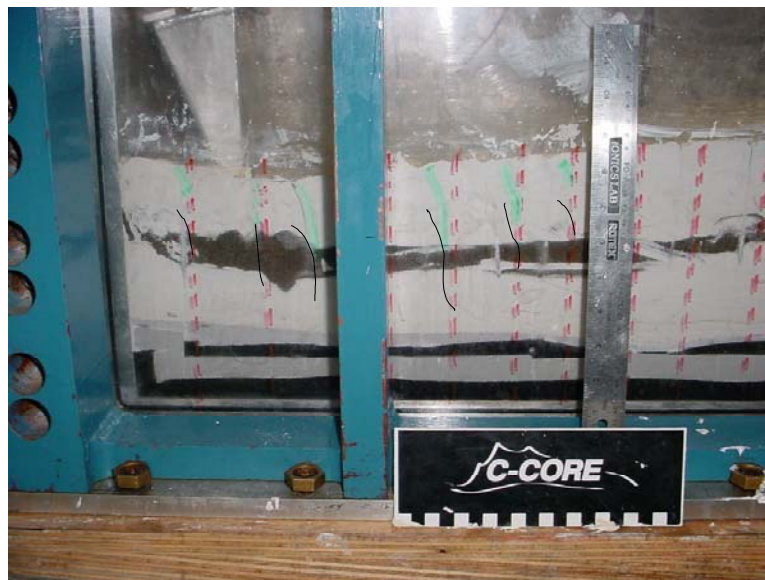
Figure 22: Photo of toe of slope after slope failure in test 2.

Figures 22 and 23 respectively. Lines were drawn on the Perspex window before the test to indicate the initial position of the markers, with the final position highlighted. The final position of the markers suggests a flow type movement rather than rigid block rotation along a failure plane, although a distinct depth limit can be established near the top of the sand layer. The top of the zone of soil movement corresponds approximately with the position of the CPT, and a slight curvature can be seen at that position. It is therefore considered possible that disturbance associated with this cone penetration may have been enough to create a weakness in the soil structure and define the extent of the mass soil movement.

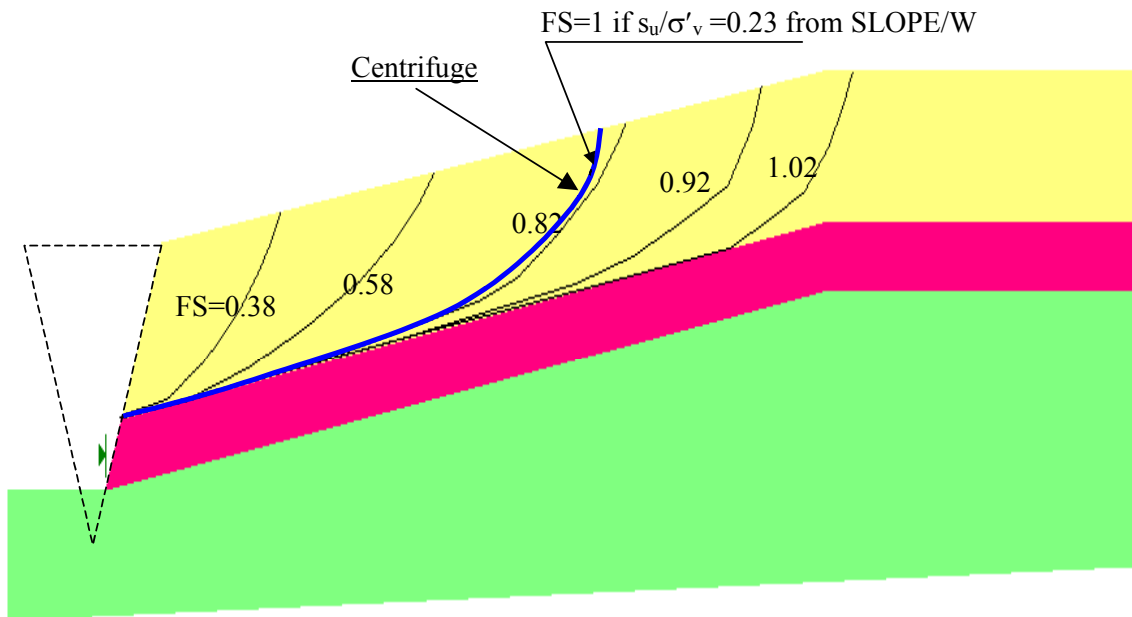
Figure 25: Numerical Analysis using SLOPE/W - Test 2

The test configuration was analysed using limit equilibrium methods in Geoslope's SLOPE/W software. The initial geometry was considered, and a number of failure planes generated corresponding to a range of calculated factors of safety. The generation of slip planes was limited in depth to the top of the sand layer. Figure 25 shows the resulting slip circle generation with associated factors of safety. It is expected that the sudden loss of support at the face would cause a retrogressive type failure, in which an almost vertical slip surface develops and fails into the trench left by the wedge. The resulting profile is still unstable and so further failures are generated until the resulting geometry is stable. This is represented by the surface having a factor of safety of one in Figure 25. The mechanism and exact sequence is unclear, but the above description appears to be consistent with the observed final marker positions.

The analysis was performed using a shear strength profile of $c_u/\sigma'_v = 0.2$. The sensitivity of the shear strength profile used in the analysis was investigated by applying a range of strengths to ascertain the final geometry. A shear strength ratio of $c_u/\sigma'_v = 0.23$ compares well with the observed centrifuge test behaviour, indicating that this analysis provides a reasonable interpretation of the observed mechanism.

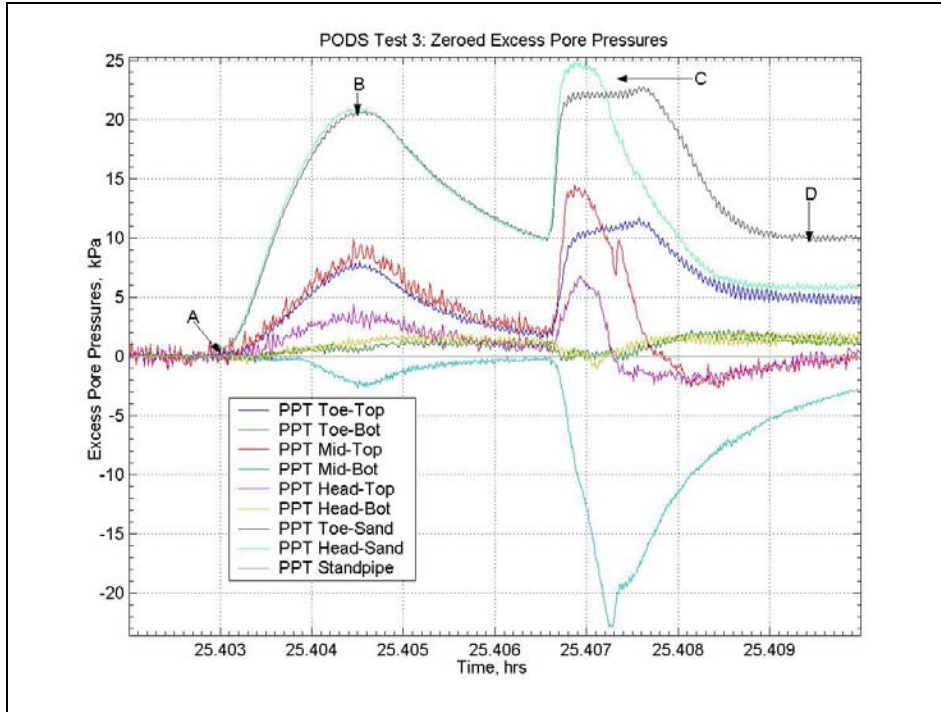
Figure 28: Zeroed excess pore pressures during test 3.

The valve was opened at position A in figure 28. As the applied water pressure was increased, pressure in the sand layer underwent a corresponding increase, which continued to point B. Smaller increases in pore pressure in the clay layers were also recorded. The pressurization of the sand layer can easily be seen by the large pore pressure responses of $PPT_{Toe-Sand}$ and $PPT_{Head-Sand}$. The subsequent decrease in pore pressures of $PPT_{Mid-Bot}$ can be attributed to possible soil shearing. At position C another failure event occurred, which can be confirmed by corresponding LVDT displacements as seen in Figure 29 in which settlement of the soil surface at the top of the slope was measured. Compared to the first failure event at position B, larger strains were observed for the second failure event. Also at position C, the short-circuiting of pressurized water from the sand layer to the surface water occurred, evidenced by the sudden observation of a sediment cloud in the surface water. This limited the pressures of the injected water in the sand layer, causing it to drop off at position D.

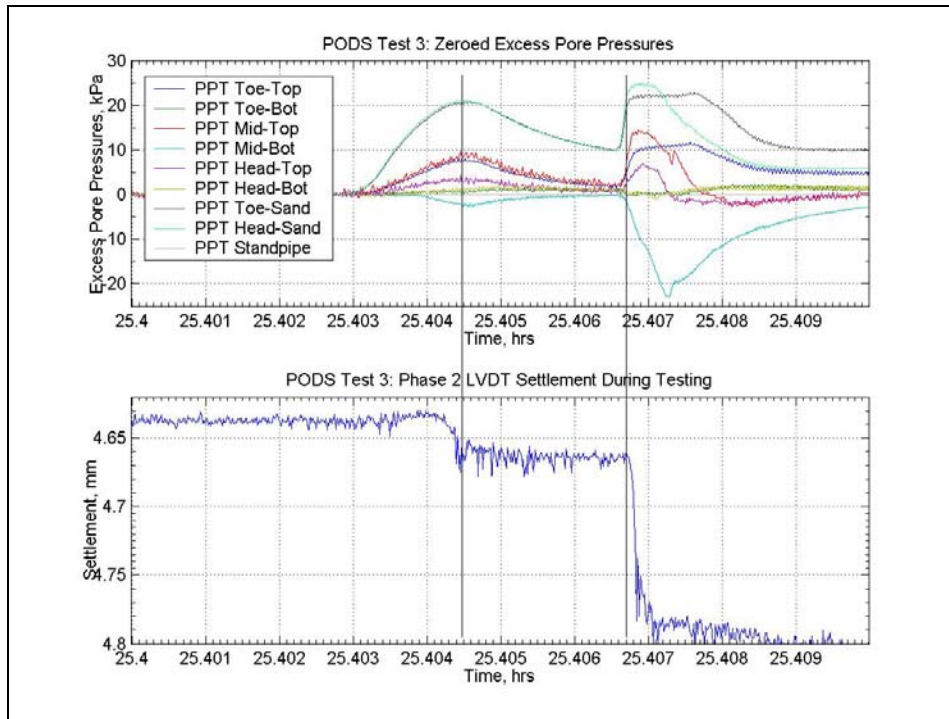
Figure 29: Test 3 LVDT displacements corresponding to excess pore pressure.

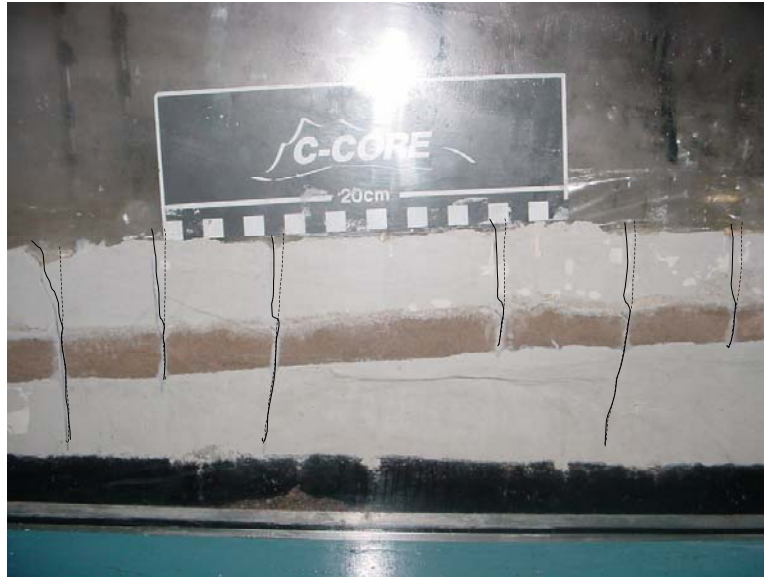
Figure 31: Slope Movement shown by Spaghetti Markers, Test 3

Figure 30 clearly demonstrates the spaghetti marker displacements and confirms the slope did experience failure under the applied water pressure to the sand layer. The spaghetti markers indicated that movement was located mainly at the centre of the slope, with 3-5mm of movement recorded. The limited soil movement is a function of the constraints imposed by the finite size of the box, and also the limited period of time at which high pore pressures were maintained before being released to the surface water. Little discernible movement was observed at the crest or toe of the slope. Also, there was little sign of remolding at the soil surface or any measurable change in the slope angle. Figure 31 shows more clearly the soil movement through the viewing window.

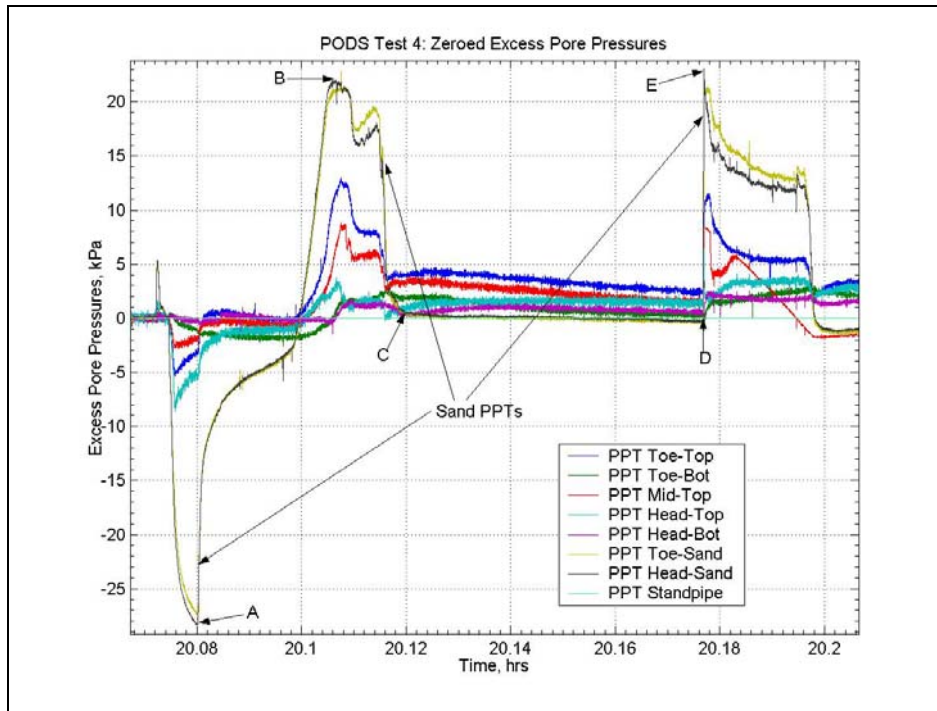
Figure 37: Zeroed excess pore pressures during test 4.

The test procedure of Test 4 was identical to that of Test 3, with the aim of inducing slope failure by increasing the pore pressures in the sand layer. The initial height of the head leveller was positioned slightly lower than hydrostatic inside the strongbox, leading to a negative pressure as the valve was opened. This can be seen by $PPT_{Toe-Sand}$ and $PPT_{Head-Sand}$ at position A of Figure 37. The head leveller, which controlled the pressure at which water was delivered to the sand layer, was then moved upwards, as shown by the increase in pore pressures between positions A and B.

Slope failure occurred at position B, after which the head leveller was stopped and the water supply turned off at position C. It was not clear at that time whether the slope had failed since there was no clay suspension observed in the surface water to indicate flow through the overlying clay. The water was reactivated at position D and the head leveller continued upward. Almost immediately clay disturbance in the surface water was observed at position E, indicating that the pressurized water in the sand layer had short-circuited to the surface water and the pressure in the sand layer dropped.

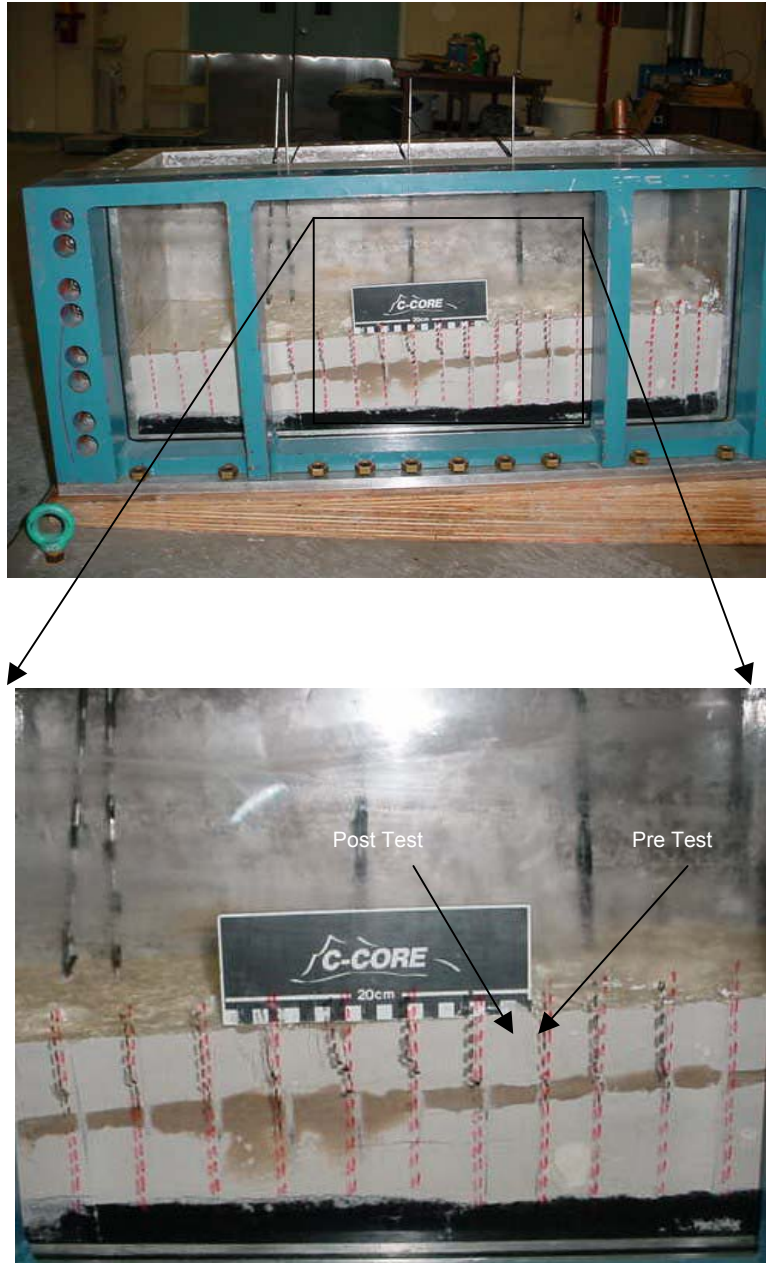
Figure 39: Observation of Slope Movement, Test 4.

Figure 39 demonstrates the spaghetti marker displacements and confirms the slope did experience some form of lateral movement. As in Test 3, the slope failure was characterized planar slip plane along the top of the sand layer, with greatest movement near the centre of the slope. Smaller movements were observed at the crest and toe. Also similar to Test 3, there was little sign of soil accumulation at the base or significant changes of slope angle. To visually assist the original and post-failure positions of the spaghetti markers are highlighted in Figure 39.

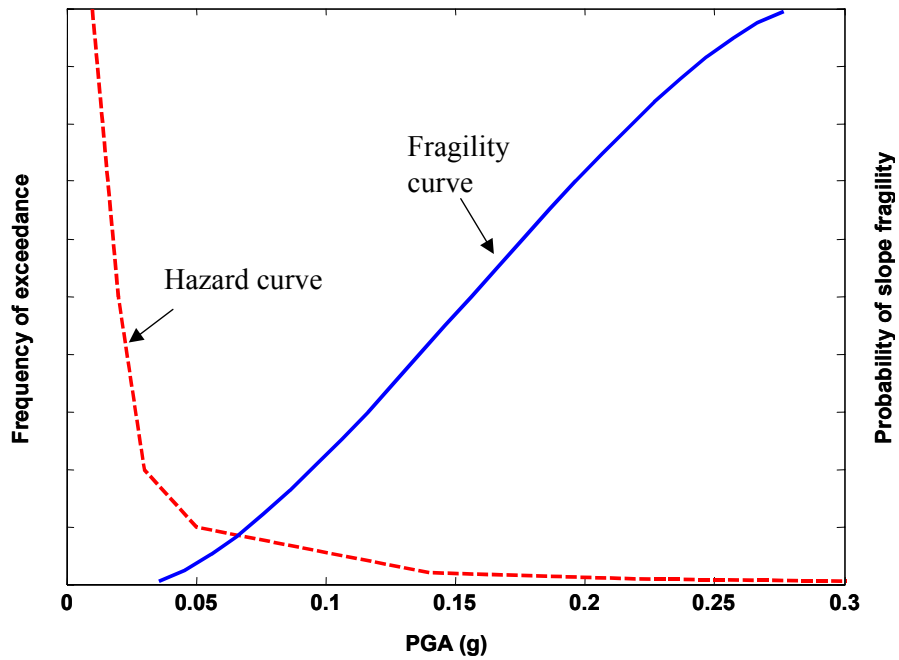
Figure 48: Sketch of hazard and fragility curve

The fragility curve for a limit state is the cumulative probability of exceeding that limit state for a given value of ground motion intensity (cumulative probability of failure). The fragility curve characterizes the probabilistic distribution of the system stability (resistance) for a given limit state. Figure 48 shows a typical hazard and fragility curve. Fragility curve is essentially the cumulative probability distribution of resistance.

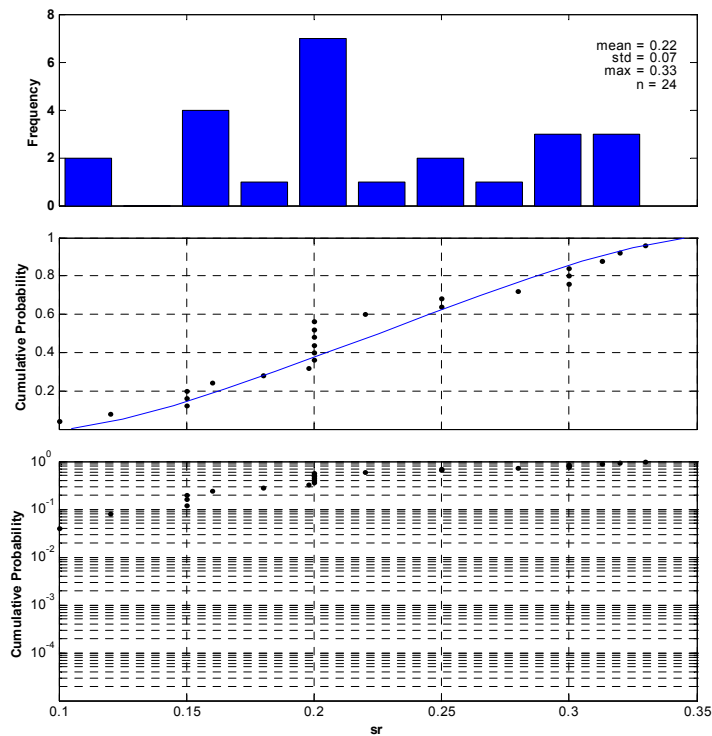
Figure 51: Probability distribution of sr_c and fitted Beta distribution

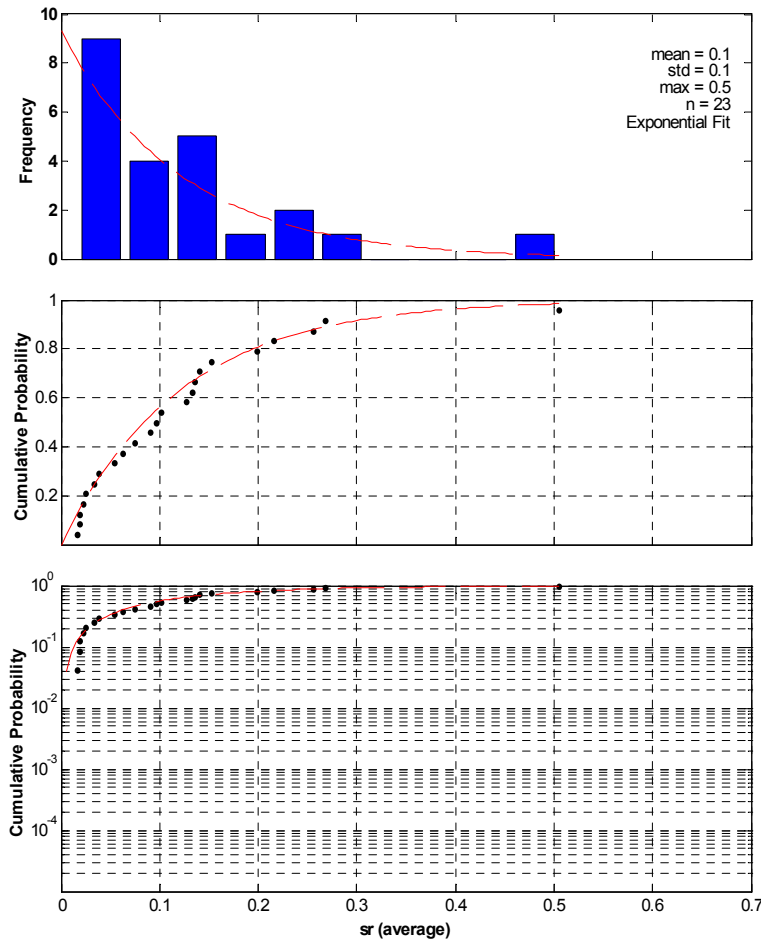
Figure 1: Probability distribution of sr_a and fitted Beta distribution
