Responses of Conventional Ring Closures of Drum Type Packages to Regulatory Drop Tests with Application to the 9974/9975 Package

A document prepared for ASME PVP CONFERENCE at Vancouver, , Canada from 8/5/2002 - 8/9/2002.

Response of Conventional Ring Closures of Drum Type Packages to Regulatory Drop Tests with Application to the 9974/9975 Package

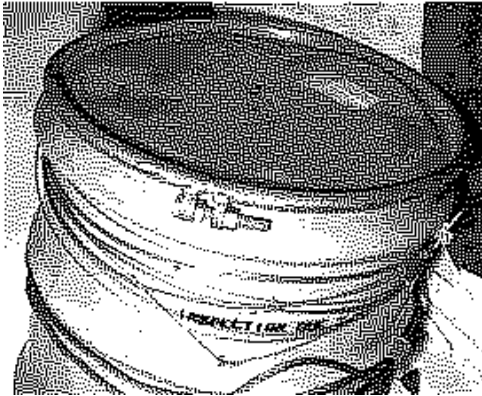
Figure 1 Conventional Clamp Ring Closure

The top closure for the drum overpack has typically consisted of a standard formed drum lid, having a dished center and a raised rim of inverted "J" cross section. The channel of the "J" section contains a gasket and engages the curl or rolled rim of the drum when it is installed. The lid is retained by a "C" section clamp ring which is pulled tight, circumferentially, by a bolt, which passes through lugs located on either side of the gap in the ring, Figure 1. For RAM packages, the ring and lugs are typically of greater cross section than those used in standard commercial applications.

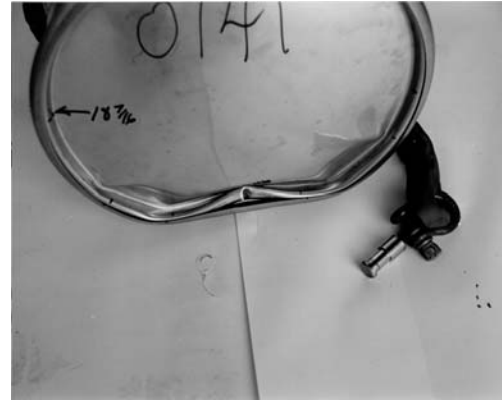
Figure 7 9975 Closure Deformation

Testing of the 9975 resumed in September 1998 to demonstrate pressurized containment vessels were not susceptible to leakage following the HAC 30 foot drop, Smith 1998. The objective of these tests was resolution of issues associated with gas generation by proposed contents. While the performance of the containment vessels under pressurized conditions was demonstrated in these tests, the response of the clamp ring closure was unexpected and caused concern. The damaged package was dropped at an angle of 8° to 10° inclination from horizontal, shallow angle. The impact buckled the drum rim inward, causing a reversed curvature, over a small distance, at the center of impact, Figure 7. The clamp ring was deformed but not to the extent of the drum rim. Consequently, the clamp ring was not engaged with the drum rim and top, over

much of the span of the deformed region. The concern that this could result in loss of the top, under some conditions (e.g., puncture test) led to additional testing, directed at the drum closure arrangement.

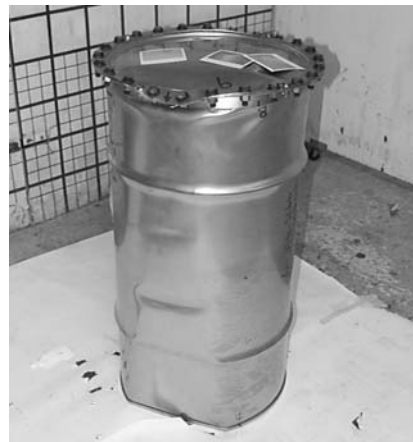
Figure 9 9975 Drop Tested Redesigned Bolt Ring Closure

To verify the performance of the new design, a series of three 9-m drop tests, with 1 m preconditioning tests and subsequent puncture pin tests, were performed. The bolted flange

design successfully withstood the test sequence, Figure 9.

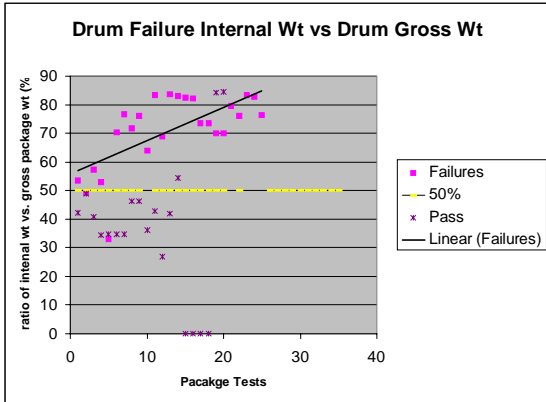
Figure 10 Drum Failure Trend

Table 1 lists test data and package characteristics for 45 drops of 17 different style drums. The tested drums range in weight from 130 to 880 lbs. and drum sizes from 30 to 140 gallons. Available test data was compiled in Table 1 to quantitatively determine a lid failure mechanism. On inspection of the test results a notable trend can be discerned for the various drum package failures. This trend reveals that conventional clamp ring closures are not suitable for packages where the weight ratio of the internals (containment vessels, contents, shielding, etc.) to the gross package weight is greater than 50%, Figure 10. It is clearly evident in this figure that the failure rate for packages exceeding this limit is nearly 100% for the packages evaluated. Additionally, the failure trend line superimposed on the data indicates that as the weight ratio

increases so does package failures. Approximately 25% of the reported failures were similar to the damage shown in Figure 8. The remaining 75% of failures were of packages where the lid detachment was over 180 degrees or complete, Figures 5 and 6, respectively.

The failure limit can be used as a design rule for packaging. If in the course of design the limit is reached then a standard closure lid should not be used.

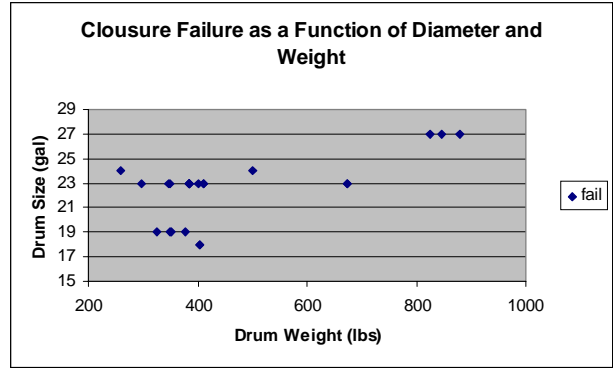
Figure 11 Drum Closure Failures

Other conclusions can be drawn from the evaluation of the test results. Results indicated that larger diameter and heavy packages were more susceptible to lid loss than smaller diameter, lighter packages, Figure 11. Heavy packages are those with weights above 300 lbs, Figure 12. By inspection of Table 1, angle of impact data tends to indicate that packages dropped from CG are more prone to failure. Additionally calculations by Wu, indicate that a larger diameter drum opening is stiff compared to the more flexible smaller diameter drums. The stiffer closures are less adaptable to drum deformation and therefore more prone to lid failure.
