DOT/FAA/AR-08/2

Aircraft Wiring Degradation Study

January 2008

Final Report

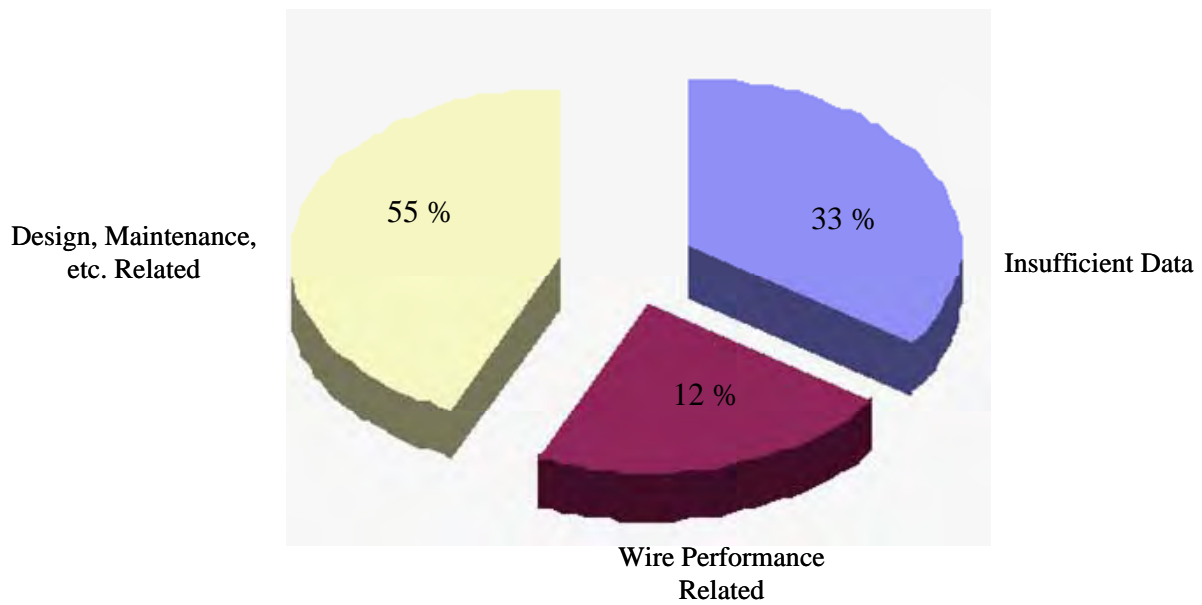
Figure 2. Types of Wire Failures

Failures from design, installation, and maintenance issues create stresses that are much more difficult to control and model. Many of these wire failures are due to physical and mechanical damage and are often exacerbated the wire age. Aircraft service data from the National Transportation Safety Board Accident and Incident database, the Aircraft Service Reporting System, Service Difficulty Reports database, and the Navy safety and maintenance data were evaluated. It is important to know how the condition of the wire may be degrading in normal service and the number of failures due to poor design, installation, or maintenance in order to select a wire for an application and ensure that it is installed and maintained properly. A query of these service databases show many accidents and incidents reports were caused by the wire's inadequate performance in normal service environments, and by application issues related to the design, installation, and maintenance, as shown in figure 2.

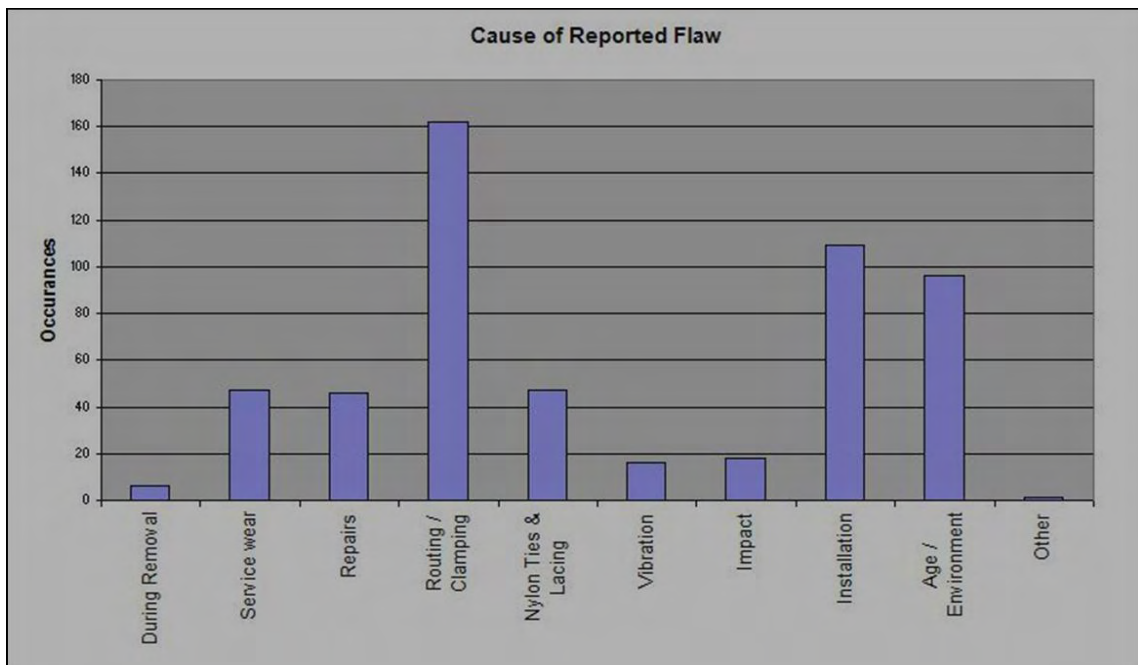
Figure 3. Stressors Found in Aircraft

A Federal Aviation Administration (FAA) research program on aircraft maintenance evaluated multiple aircraft from multiple commercial operators and identified a number of stressors that were present. These stressors shown in figure 3 were reviewed for implementation into the research study.

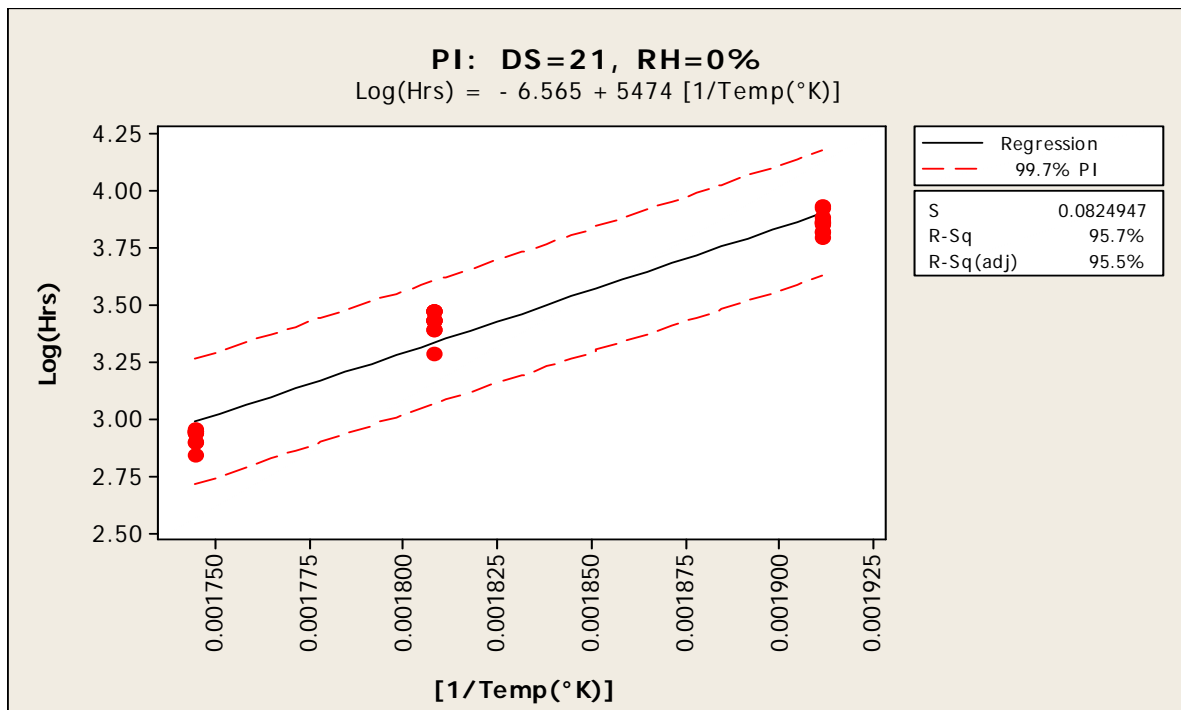
Figure 5. Inverse Temperature Arrhenius Relationship of PI Wire

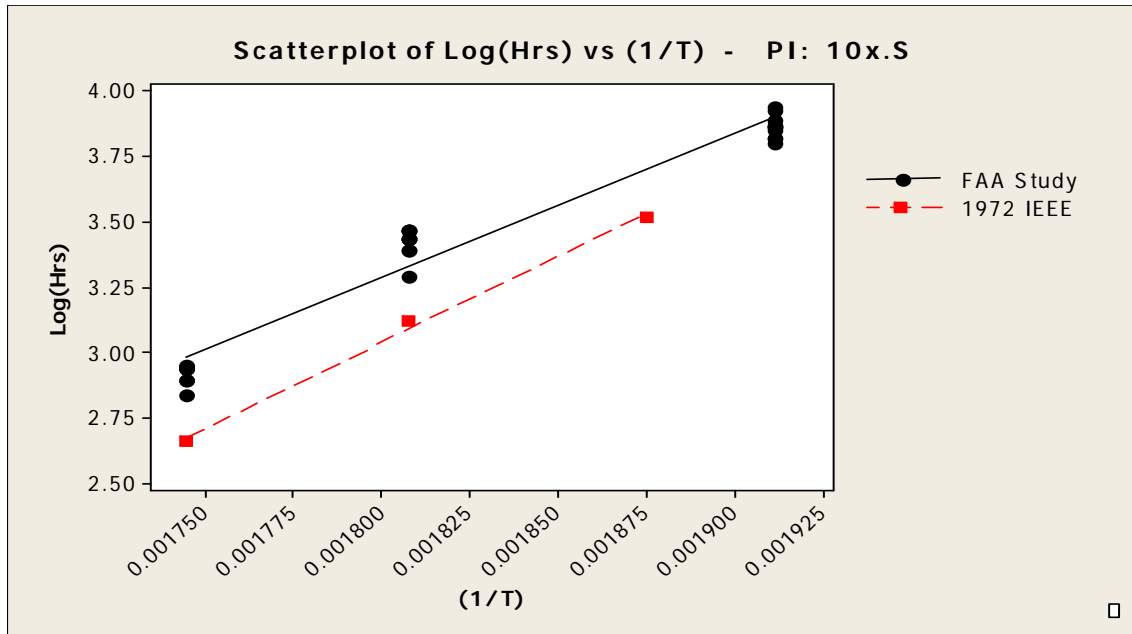
Figure 6. Arrhenius Relationship of PI Wire

Insulation with a higher activation energy (steeper Arrhenius slope) and a higher temperature index would be preferred for better longevity in a general application with thermal oxidative environment, since this leads to an increased time-to-failure at lower temperatures. The concept of desiring a high E_A for temperature slope and high-temperature index can also be extended to desiring a high humidity slope and a high humidity index. The E_A , as classically defined, could not be determined from the models developed. The Arrhenius plot for the 11 samples that failed at each of the three setup temperatures is shown figure 5. An approximation in the activation energy ($E_A = 25.1$) and the temperature index could be estimated at a specific time from the plot. A comparison to the IEEE [3] data is shown in figure 6.

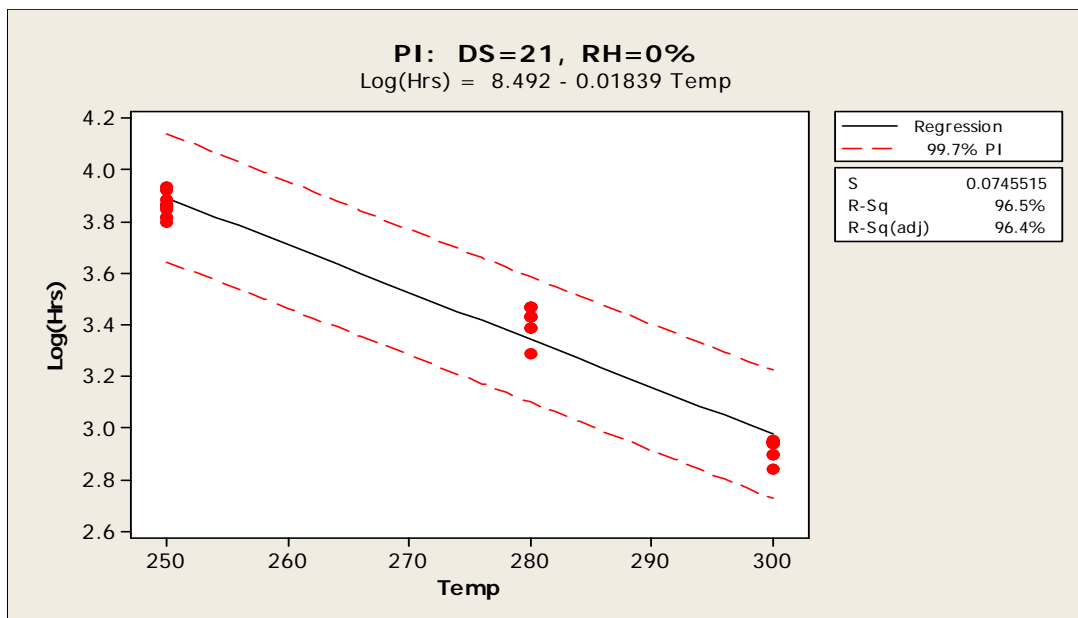
Figure 7. Temperature Arrhenius Relationship of PI Wire

When plotting the individual log life values from each sample against the direct temperature ($^{\circ}\text{C}$) at each of the three setups, a simplified Arrhenius relationship can be seen. The linear fit of the failure data is shown in figure 7. Traditional approaches plot log life against inverse Kelvin temperatures ($1/^{\circ}\text{K}$). An extrapolation of the log life versus temperature fit from the figure 7 results in a temperature rating of 244°C at 10,000 hours and 200°C at 60,000 hours. While figure 5 uses the traditional Arrhenius model approach, the extrapolation results in the same temperature rating of 245°C at 10,000 hours, but a slightly higher 209°C at 60,000 hours.

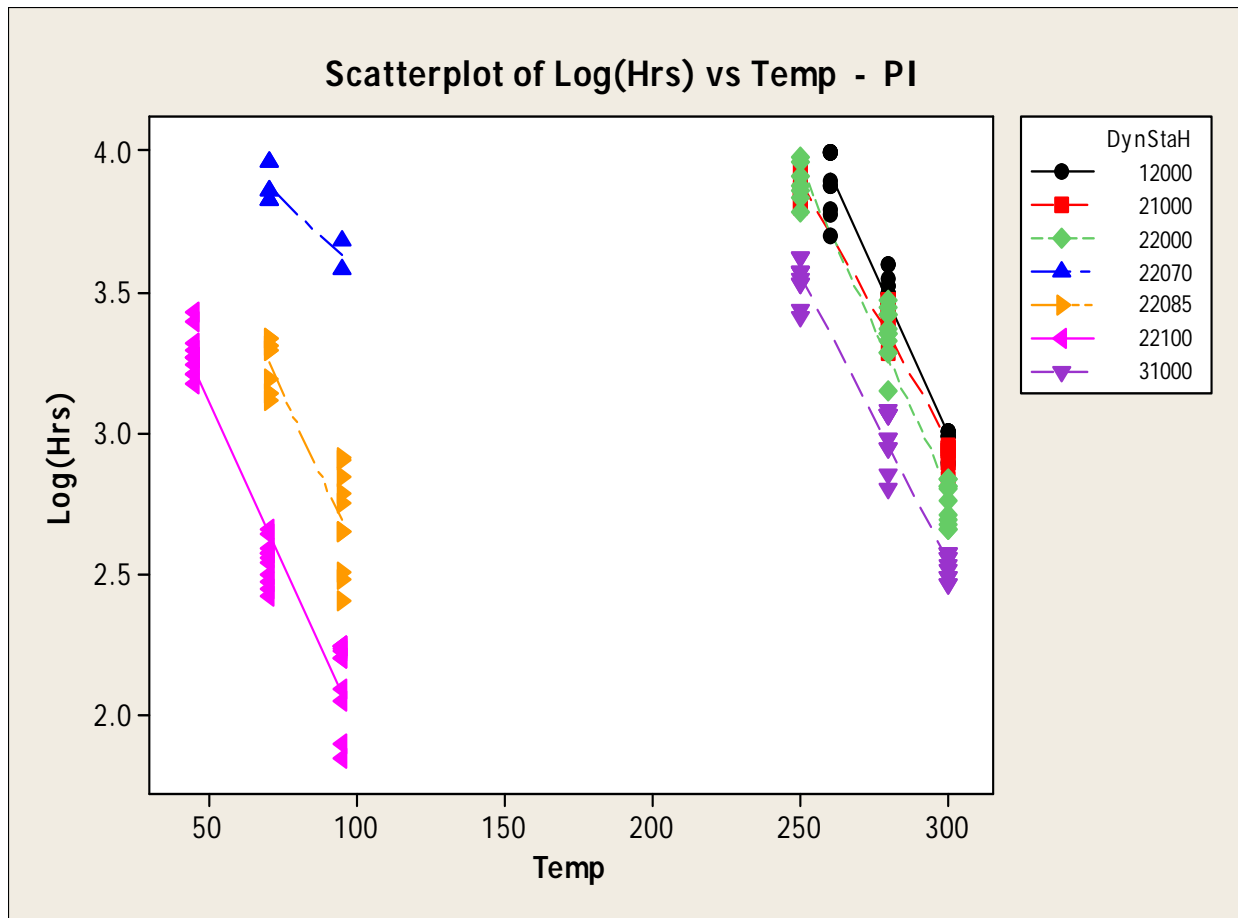
Figure 10. Polyimide Stressor Relationships at Multiple Temperatures

The relationships of dynamic and static stressors and the effects of temperature and humidity are shown in figure 10. Individual failure times are plotted, and a simple linear fit is used whenever a specific dynamic-static-humidity stress combination crosses at least two temperatures. Several of the stressor curves versus temperature are parallel straight lines, but shifted up or down, while other lines have different slopes.

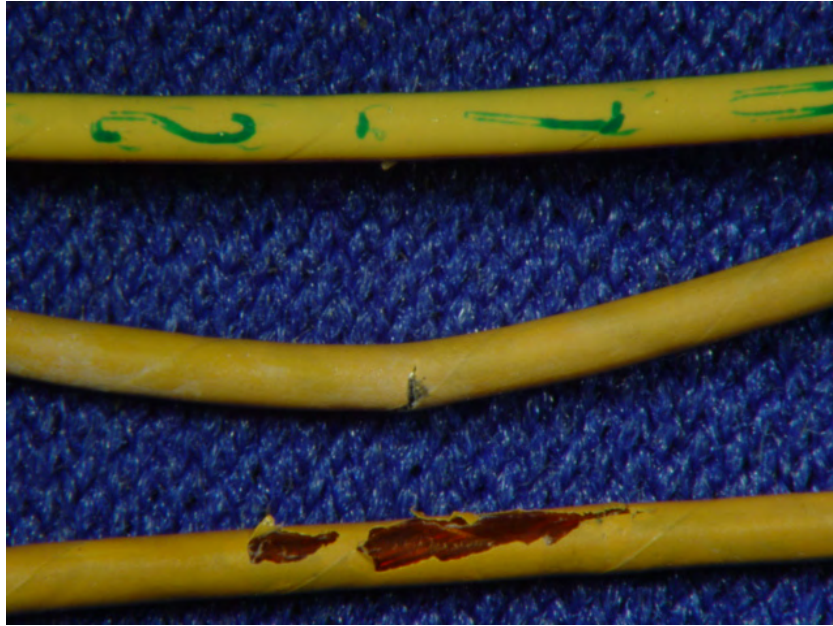
Figure 14. Progression of Insulation Damage, Aged at 250°C

10-times dynamic bend test. The top wire was not aged, and the middle and bottom wires were aged for approximately 6670 hours (first life specimen DWV failure) and 8730 hours (last failure), respectively. Cracking of the insulation through to the conductor, flaking of the insulation top coat, and changes in the insulation color were noted as the aging progressed.

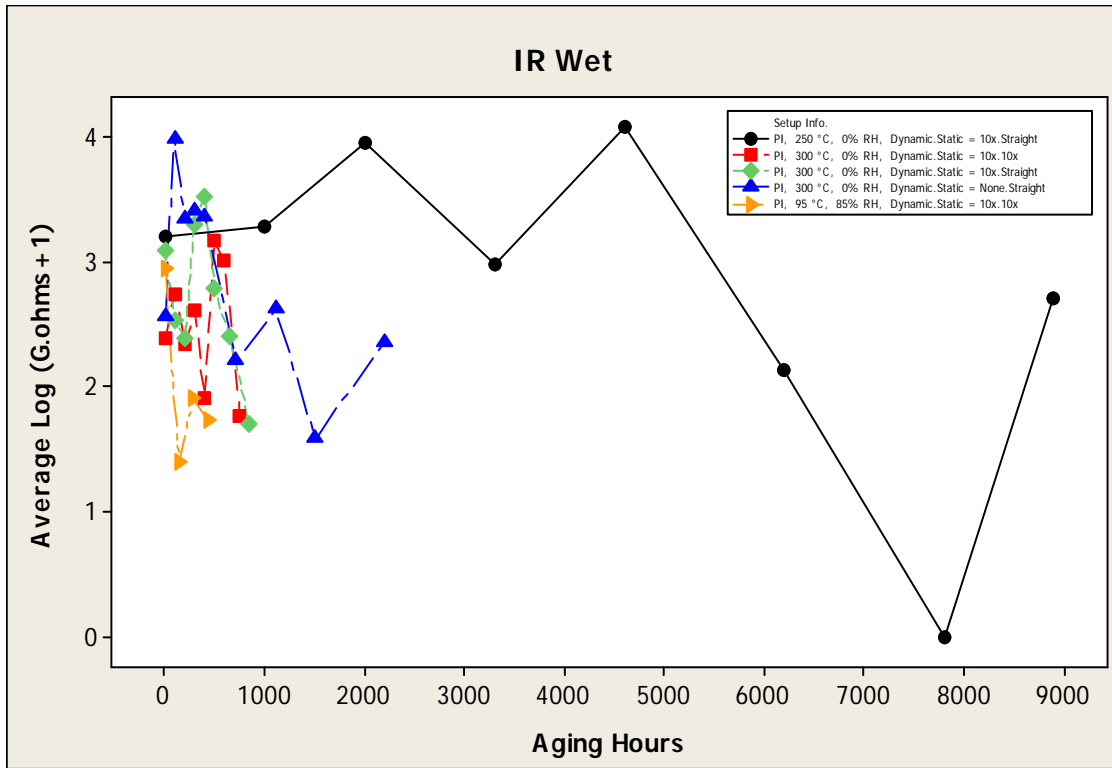
Figure 20. Wet IR Results for PI

plots. Although the figure shows some fluctuation from cycle to cycle, the general trend shows a decrease in the wet IR as the wire aged.

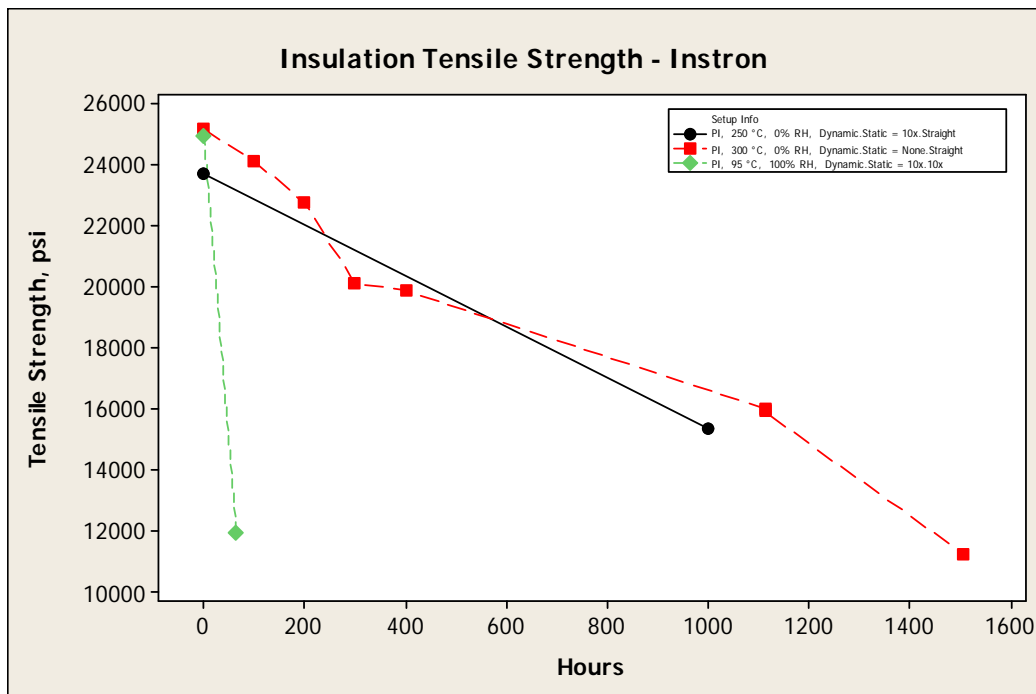
Figure 23. Tensile Strength Results for PI Wires

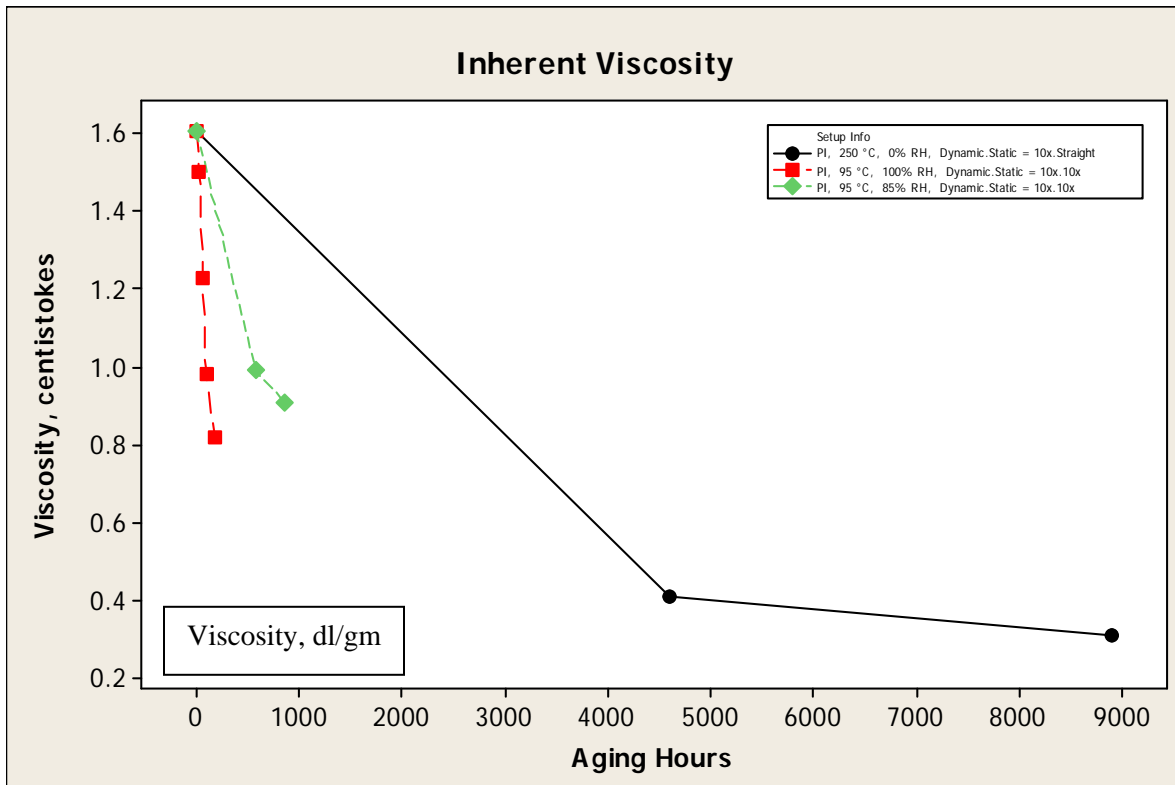
Figure 26. Inherent Viscosity Results for PI Wires

Inherent viscosity results for three PI wire setups are shown in figure 26. Specimens from test runs at aging temperatures of 95°C or lower easily dissolved. The findings from these determinations followed a nice trend with the specimens having less exposure time at a given condition having a higher inherent viscosity, which correlates to higher weight average molecular weights. Samples aged at 100% RH showed a sharper decline in the inherent viscosity than the samples aged at 85% RH.

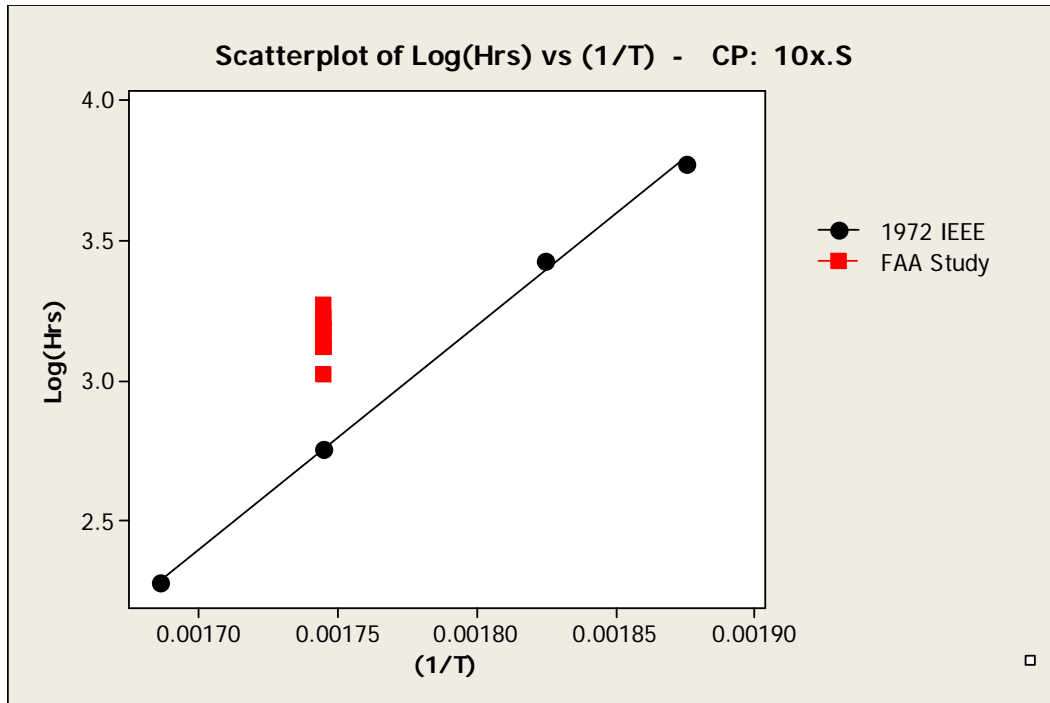
Figure 33. Arrhenius Relationship of CP Wire

Aging data was initially analyzed using the AS4851 test method. The log average life of the specimens for each baseline setup was determined. Using the log average life of the specimens across multiple temperatures, the aging relationship based on the Arrhenius model was determined, as shown in figure 33. Unfortunately, many of the aging groups did not reach the failure point and only one setup from the stressor combination was completed to failure. Therefore, a full Arrhenius plot could not be generated. A lognormal distribution was used throughout the data analysis since it captured the failure distribution well for most of the test setups. The activation energy could not be determined with only one data point, but a temperature index could be estimated at a specific time using the same slope as the IEEE study [3].

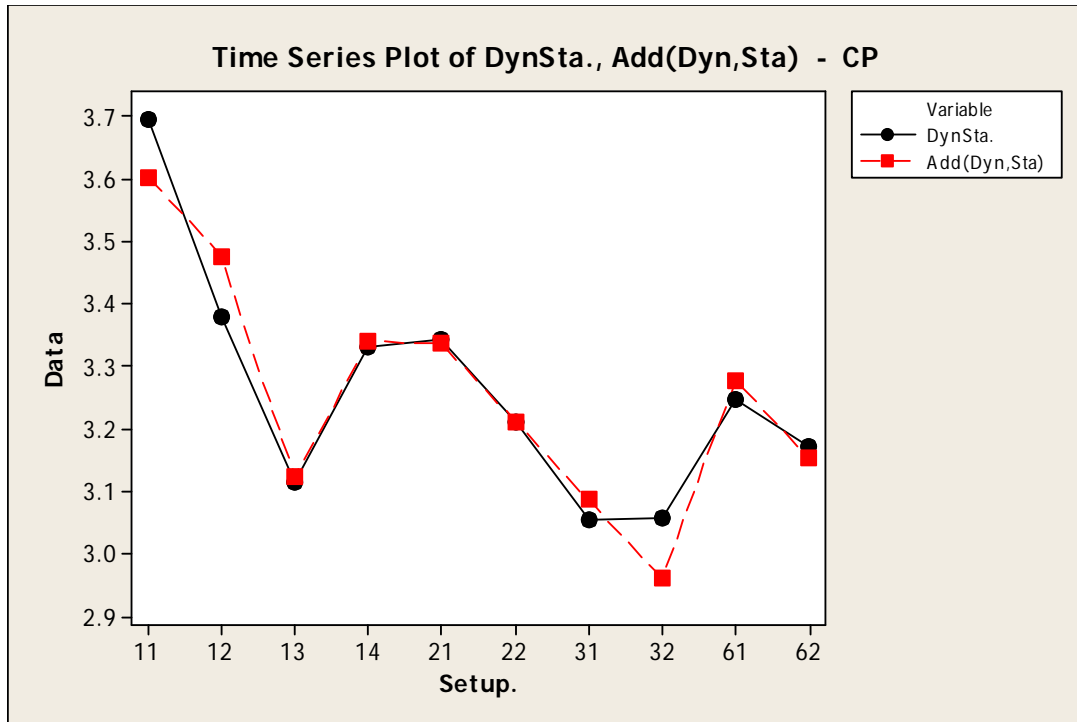
Figure 35. Additive Effect of CP Dynamic and Static Stressors

Figure 35 depicts the additive effects from each of the dynamic and static stressors for each setup. The black points are the means of aging based on the actual test result determined in this test program, while the red points are the predicted means based upon the resulting model. As shown in the figure, the model tracks the actual aging fairly well except for the dynamic stressor (DS) (3,2) stress combination. This difference could be due to the tendency of the wire samples to turn and follow the same track when performing the wrap, in effect, not subjecting the samples to the full stress, and allowing the time-to-failure to increase more than it otherwise would.

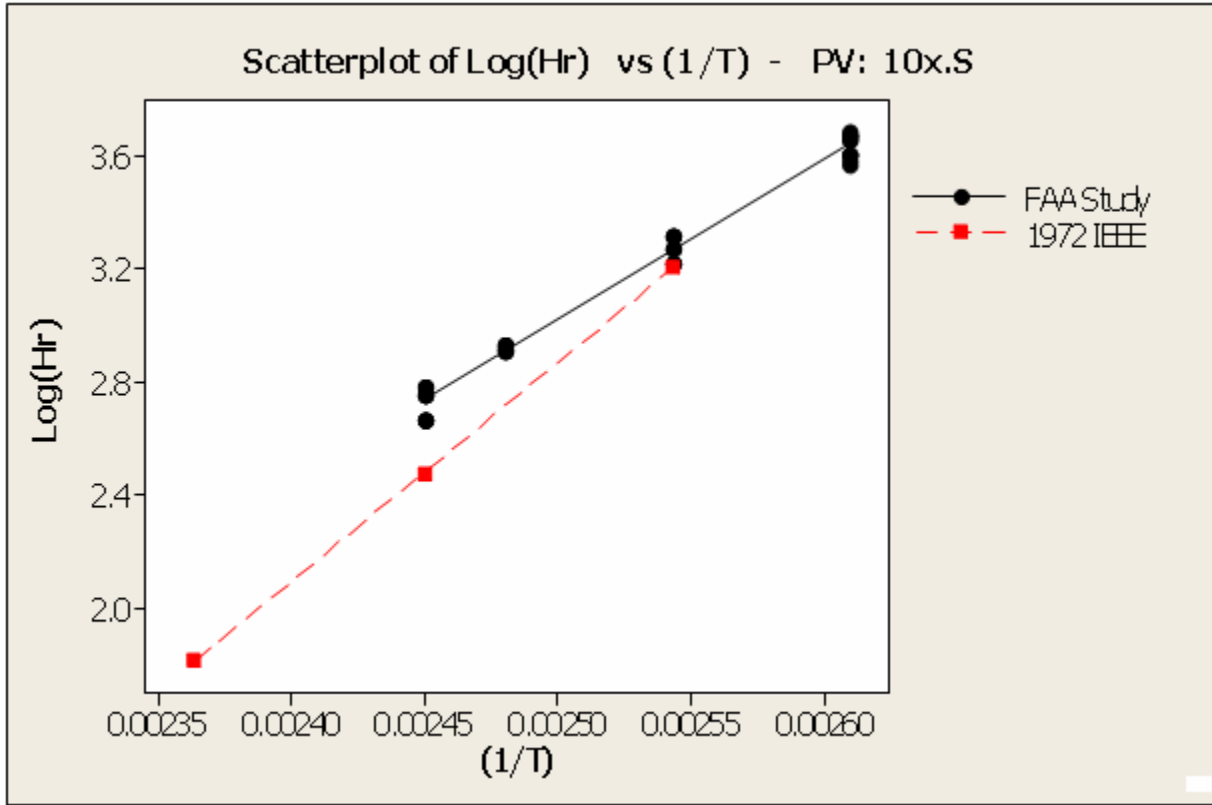
Figure 57. Time-to-Failure Curve Compared to IEEE [3] Data for PV

Figure 57 shows an extrapolation of the log average time-to-failure versus temperature from the results in a temperature rating of approximately 101°C at 10,000 hours and 82°C at 60,000 hours. For comparison, the final PV model resulted in 101.5°C for 10,000 hours and 82°C for 60,000 hours. The temperature was plotted from this point forward using °C rather than 1/°K, since the resulting relationships modeled better.

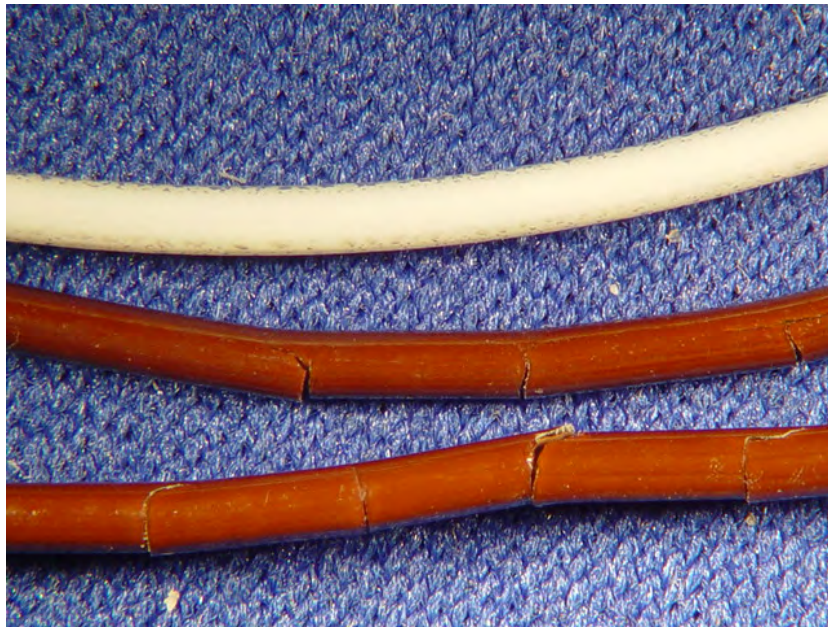
Figure 62. Unaged PV Wire (Top) and Aged Wires (Bottom) for 560 and 640 Hours

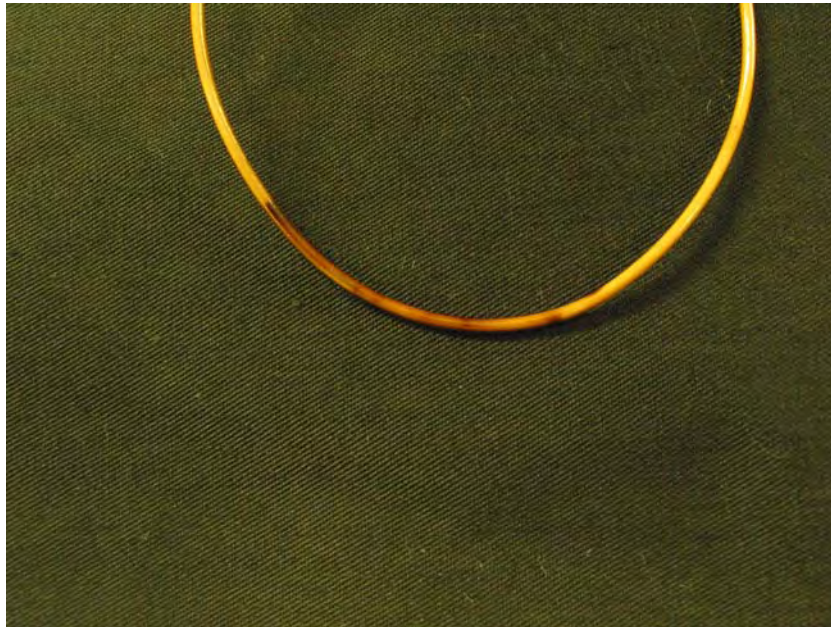
Figure B-1. Localized Discoloration on PV Wire

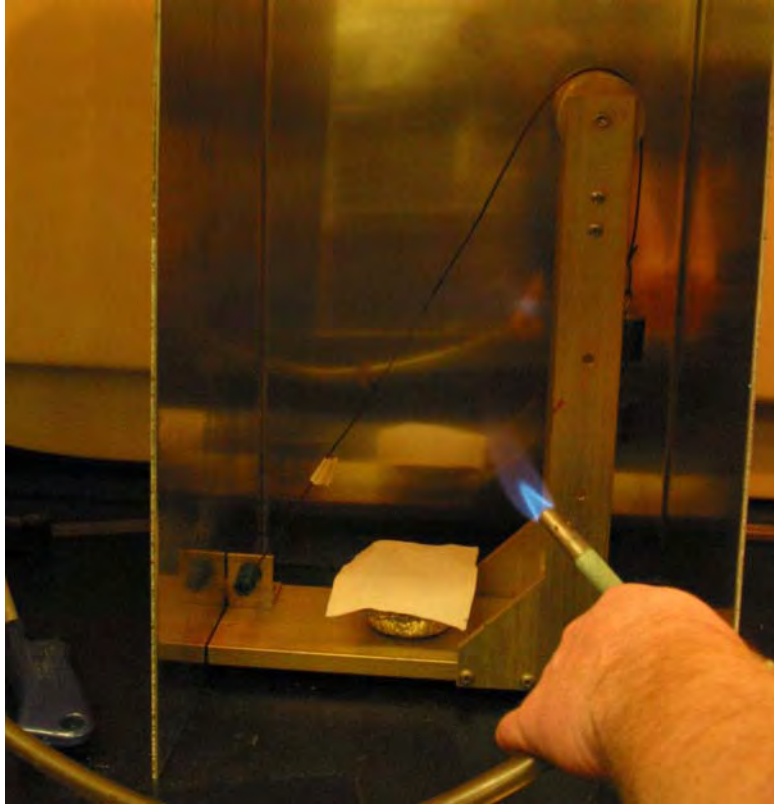
Figure G-38. Flammability Test Setup
