Stream Restoration Program: Cherokee Indian Reservation, NC

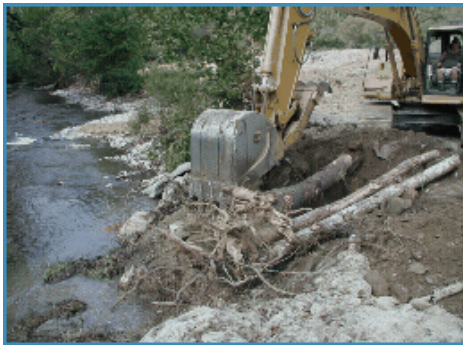
Sites on Soco Creek and the Oconaluftee River have undergone stream bank restoration by stabilization techniques. Two sites on the Oconaluftee River where stream bank restorations have been completed are Bradley Campground and Standingdeer Campground. At these sites, erosion from overland flow resulted from land disturbance due to the high level of foot traffic by campers. A large part of the problem was campers creating foot paths and removing riparian vegetation on stream banks. This made the banks vulnerable to erosion during storm events.

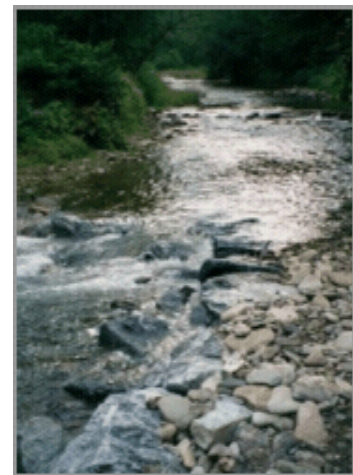
To reduce erosion, native riparian trees and shrubs were planted along with grass seeding, and coconut erosion control fabric was installed to hold the soil in place until the vegetation was established. Access for campers to the stream was provided by making a modification to rock vanes (method developed by Dave Rosgen of Wildland Hydrology, Pagosa Springs, Colorado). Without compromising the hydraulic design of the rock vanes, they were extended approximately three feet above their normal design elevation to the top of the stream bank. This is now at the level of the rest of the campground. The purpose of extending the vanes was to make solid rock (boulder) stair steps that serve as access points for campers to enter the stream corridor.

In this project revegetation and rock vane construction were successfully employed for stream bank restoration at Bradley and Standingdeer Campgrounds. Revegetation solved the erosion problem from overland storm flow while construction of rock vanes addressed undercutting of the stream banks. The constructed vanes slow flood water velocities near the banks and

As of the summer of 2003, rather than experiencing bank erosion, stream sediment is redepositing along the banks, the vegetation has successfully established and the campers continue to use the rock vanes as stair steps. Over 3000 feet of natural channel restoration has occurred on Soco Creek and over 1.5 miles has been completed reservation-wide.
