Improvement of Cabin Equipment to Enhance Cabin Safety against Turbulence

March 2002

Research Committee on Aircraft Safety Enhancement

commissioned by
Civil Aviation Bureau of Japan
(JCAB)

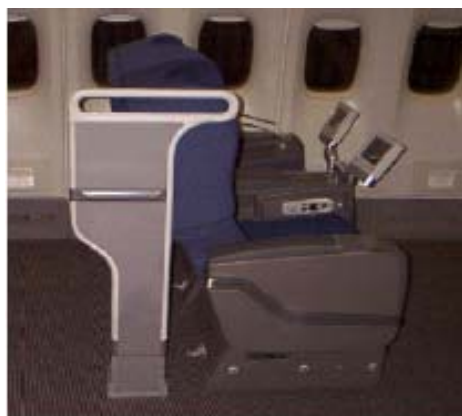
Figure 1 ANA seats with handholds

Since first class seats are distributed with a large pitch and the seat backs can be declined to almost flat position, it is considered that the seat backs of first class seats do not conform to the requirements of FAR 25.785(j). To solve the problem, ANA installs Supplemental Hand Hold Stand beside the seats as shown in Figure 1 and JAL installs partitions around the seats as shown in Figure 2.

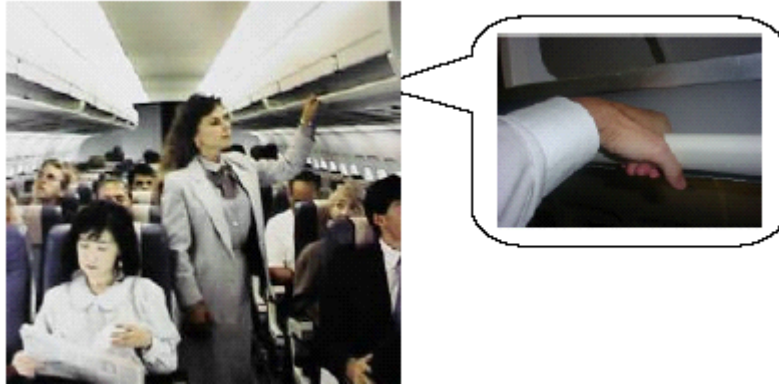
Figure 3 Handrails under the overhead stowage on MD90

Handrails/handgrips are installed under the overhead stowage in the cabins of MD90s, A300-600s and A320/321s. The handrails of MD90s are installed throughout the cabin without any gap at 160cm height above the floor that is almost as high as eye levels of flight attendants and designed to be easily recognized and gripped as shown in Figure 3. MD90 handrails are well recognized and used by flight attendants. Handgrips of A300-600s and A320/321s are installed at 169cm height that is a little too high for average Japanese female flight attendants and not so recognizable.

MD90 overhead handrail is given higher evaluation than that of A300-600 because MD90 handrail is a bar and can be grasped easily and firmly, and installed at convenient height.

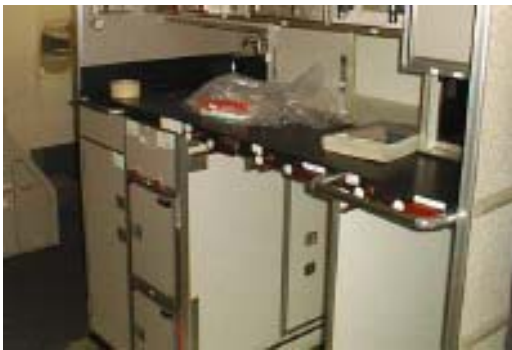
Figure 4 Handholds at the galley counter

Relatively many handholds are installed in the galleys. Horizontal bars are installed at the counters as shown in Figure 4. These bars are designed as handholds against turbulence and well recognized and used by cabin attendants. Vertical bars are installed at the upper stowage as shown in Figure 5. These bars are designed to assist flight attendants to access to the upper stowage. They may be a little too high to be used as handholds against turbulence. Some galley partitions have holes as shown in Figure 5. These holes are not designed as handholds but may be useful to grip in turbulent conditions.

The horizontal bars at the counters are found effective through the accident/incident analysis and the questionnaire survey. However, there is a report that a flight attendant gripped the bar but was swung around the bar up and down then got injured in a severe turbulence. In order to prevent this kind of injury, it should be considered a measure to stabilize the body such that installation of another bar at the upper or lower position of existing bar.

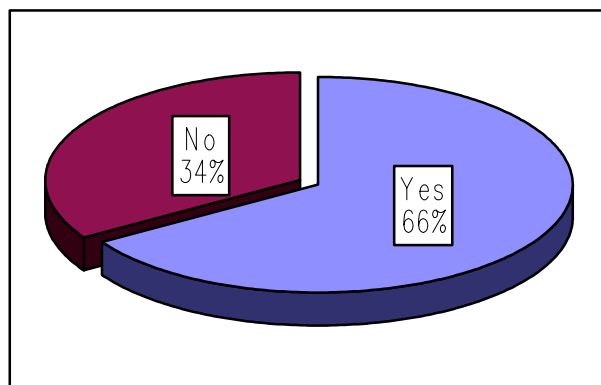
Figure 7 Experience of jolt

As shown in Figure 7 approximately two thirds of flight attendants answered that they experienced a jolt of the airplane onboard, that is strong enough to get injured.

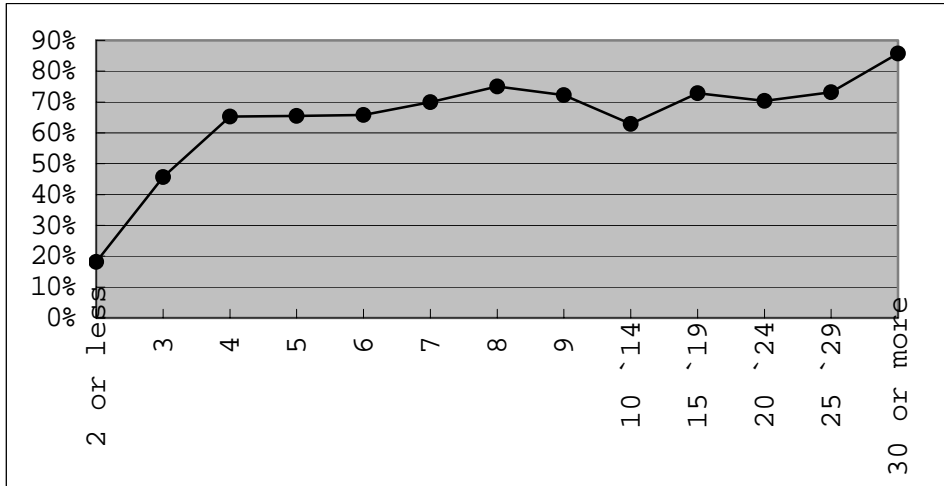
Figure 8 Percentages of flight attendants who have experienced jolt, by flight years

The percentage of the flight attendants who experienced a jolt increases as their flight experiences increase, as shown in Figure 8.

Approximately 70% of flight attendants who have flight experiences of 4 years or more experienced a jolt at least once in their lifetime. It implies that the majority of flight attendants are always exposed to a risk of encountering strong turbulence in flight.

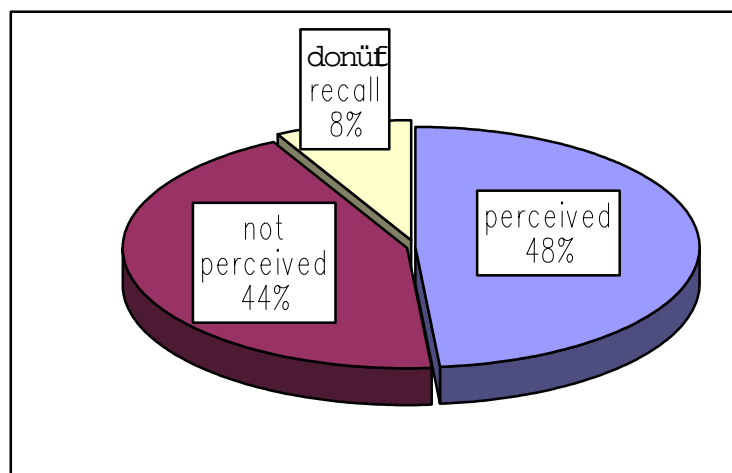
Figure 9 Perceiving a sign of jolt

Among the flight attendants who experienced a jolt, about half of them perceived a sign of jolt and another half did not, as shown in Figure 9.

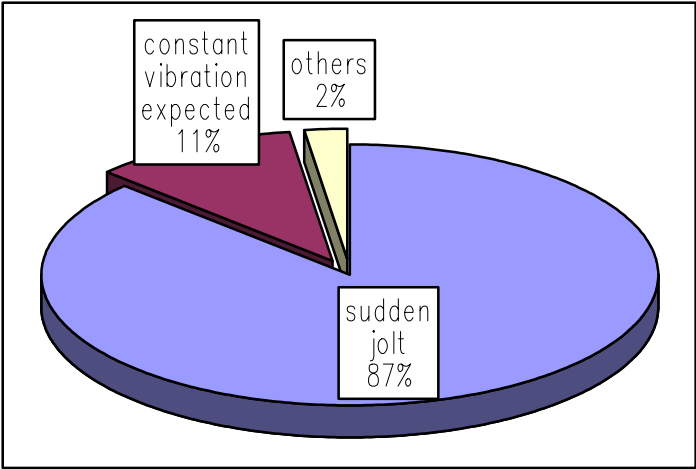
Figure 10 Reason why the sign of jolt was not perceived

Among flight attendants who answered that they did not perceive a sign of jolt, the most of them said the reason was that the jolt occurred all of a sudden, as shown in Figure 10. It means that the chance of encountering unexpected strong turbulence such as Clear Air Turbulence is

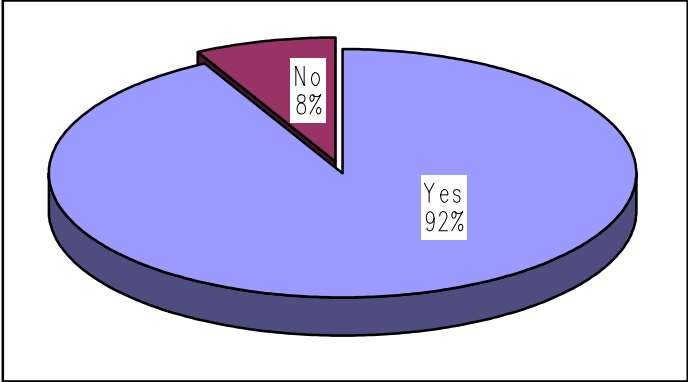
Figure 11 Experience of escaping injury by grabbing handholds

In order to find out whether the handholds currently installed in the cabin are effective or not against the jolt caused by turbulence, flight attendants who experienced large jolts were asked whether they had escaped from injuries by holding to the handholds. The result is that almost all attendants answered “yes” as shown in Figure 11. It is presumed that the existing handholds are effective to some degree.

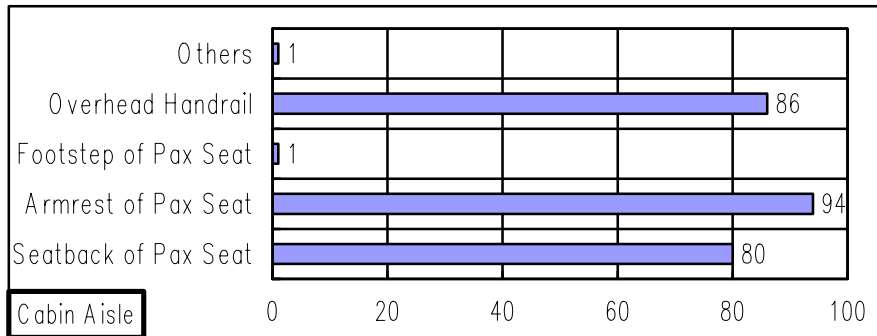
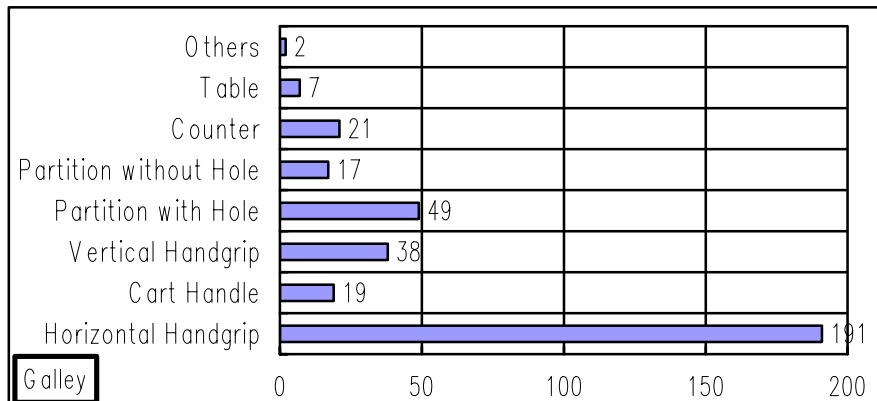
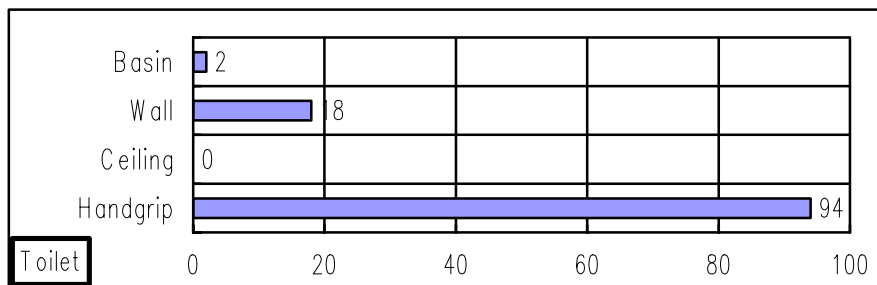
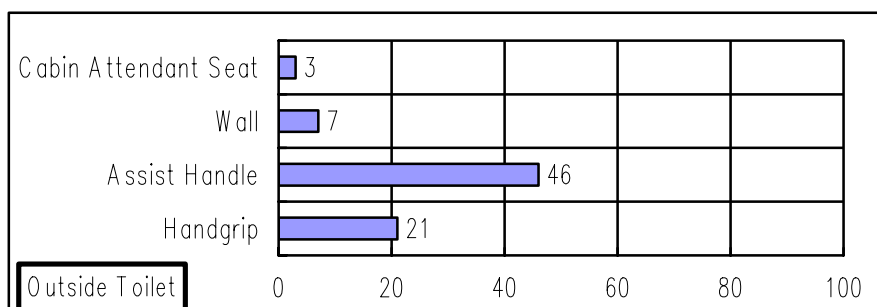
Figure 12 Handholds that flight attendants held to

Flight attendants hold to various handholds in the cabin as shown in Figure 12.

In the cabin aisle, the numbers of flight attendants who held to seatbacks of passenger seats, armrests of passenger seats and overhead handrails were almost the same. However, the numbers are much different among airlines as shown in Figure 13. The figures reflect the differences in cabin interior designs of aircraft models.

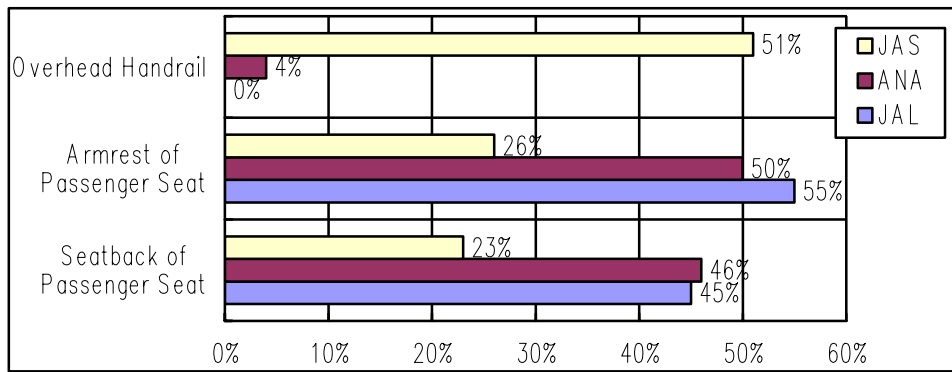
Figure 13 Favorite handholds in cabin aisles, by airlines

JAS is operating MD90s and A300-600s that are equipped with overhead handrails. Flight attendants of JAS are trained to use the handrails in case of turbulence and actually use them quite often. ANA is operating A320s that are also equipped with overhead handrails but the percentage of A320 flights in the total of ANA flights are so small that the training is not conducted in fear of inducing human errors when working on other aircraft models. JAL is not operating any aircraft model that has overhead handrails.

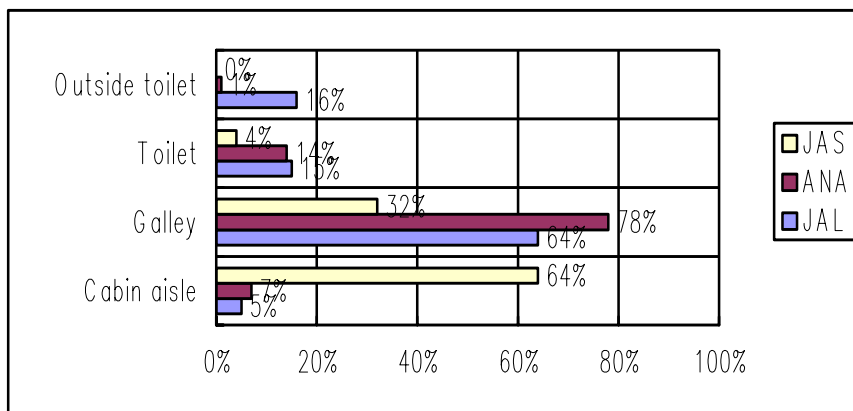
Figure 14 Areas where effective handholds are installed, by airlines

Since about 60% of flight attendants did not give the specific name of handhold, the areas where flight attendants evaluate that the most effective handholds are installed are shown in Figure 14, instead.

While JAL and ANA flight attendants give high evaluation to galleys, JAS attendants give high evaluation to the cabin aisles because JAS is operating MD90s and A300-600s that are equipped with overhead handrails in the cabin aisles and the handrails are used quite often effectively.

JAL fleet is equipped with suitcase handle outside the toilets and it is considered the reason of high estimation of outside the toilet by JAL flight attendants.

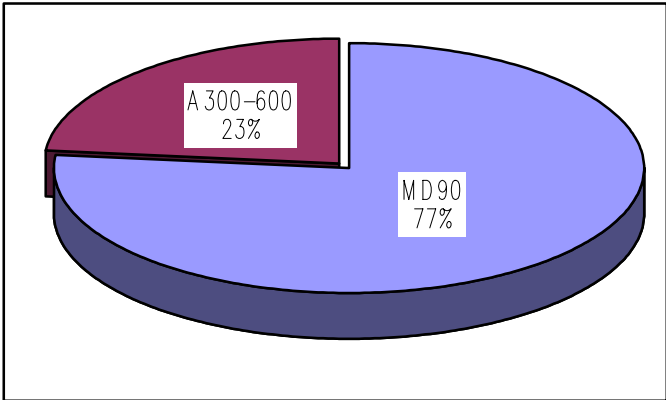
Figure 15 Favorable overhead handrails

Figure 15 shows which overhead handrail is given higher evaluation by JAS attendants, MD90 or A300-600.

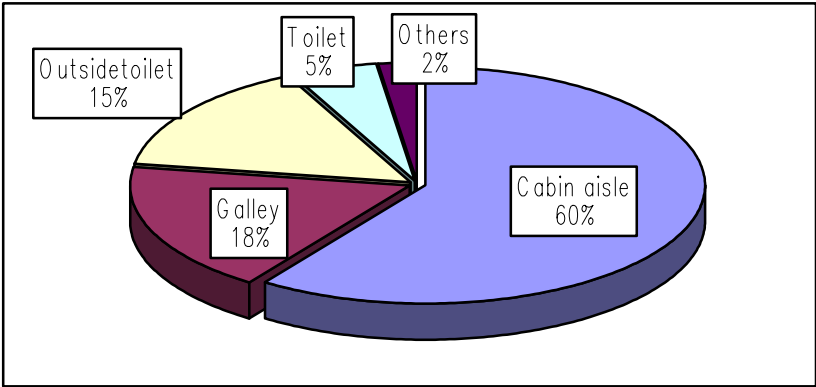
Figure 16 Most uneasy area

Figure 16 shows the areas in the cabin where flight attendants feel most uneasy when turbulence is encountered.

Flight attendants feel most uneasy when they are in the cabin aisles because there are few handholds or handholds are not easy to hold. There are many passenger seats along the aisles and the seatbacks and armrests are available as handholds but they are considered to be inadequate to steady persons in strong turbulence.
