## LUNAR ORBITER I

### EXTENDED-MISSION OPERATIONS

Issued by Originator as D2-100727-4

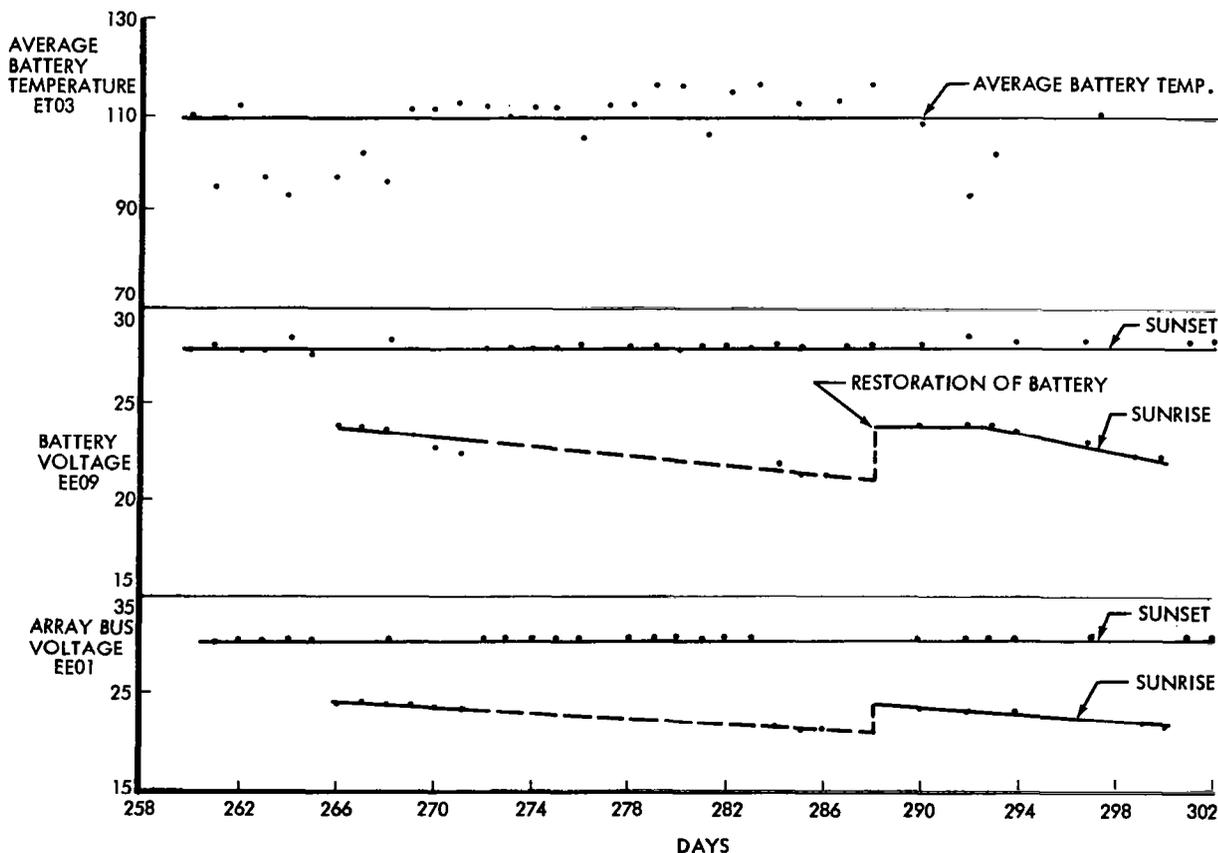
Figure 4-1: Battery Characteristics

The power subsystem performance was monitored very closely during each extended-mission tracking orbit. Figure 4-1 shows no solar panel degradation in power output, and a constant 30.56-volt output while the spacecraft was in the Sunlight. The power system's load characteristics may be seen in Figure 4-5. The battery module experienced an average temperature of 109°F with monitored highs of 129°F, which is 4°F above the acceptable upper limit. Battery degradation was apparent when the battery discharge voltage, prior to Sunrise, slowly decayed from an orbit low of 23.8 volts on September 17 to a low of 21.6 volts on October 13.

at which time, 09:19 GMT, lock was lost (refer to Figure 4-4). No further data was available until 18:22 GMT when it was found that the bus voltage was 30.56 volts with the battery at 27.8 volts and being charged at 2.28 amps, tapered charge. The subsequent battery end of discharge voltage was 23.8 volts, as shown in Figure 4-1, indicating an improvement in battery performance.

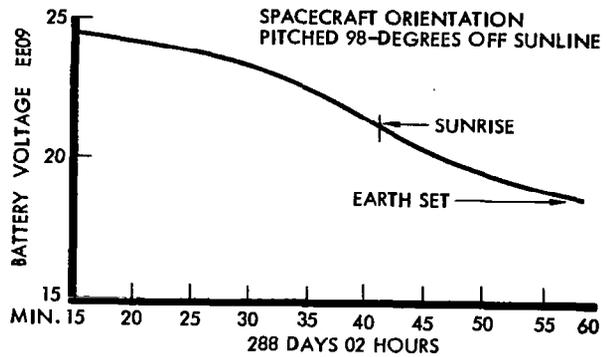
Figure 4-2: Battery Discharge Voltage, Orbit 382

On or about September 30 it became obvious that the battery end of discharge voltage was falling rapidly and that within a short time the battery voltage would fall below 20 volts, or 1.0 volt per cell. On the advice of Dr. Harvey Seiger of Gulton Industries, the manufacturer of the battery cells, and on the basis of results obtained by RCA during multicycle tests on the Lunar Orbiter battery, it was decided to discharge the battery below its normal level during one orbit. This was accomplished by pitching the spacecraft approximately 98 degrees off-Sun prior to Sunrise of final Orbit 383 October 15. The average battery discharge current at night was 5.0 amps, and with an orbital nighttime period of 48 minutes, the normal discharge capacity was 4.0 amp-hours. By remaining off-Sun for 18 minutes after Sunrise it was hoped to discharge the battery an additional 1.2 amp-hours, providing the battery voltage did not fall below 20.0 volts. Figure 4-2 shows the battery voltage versus time.

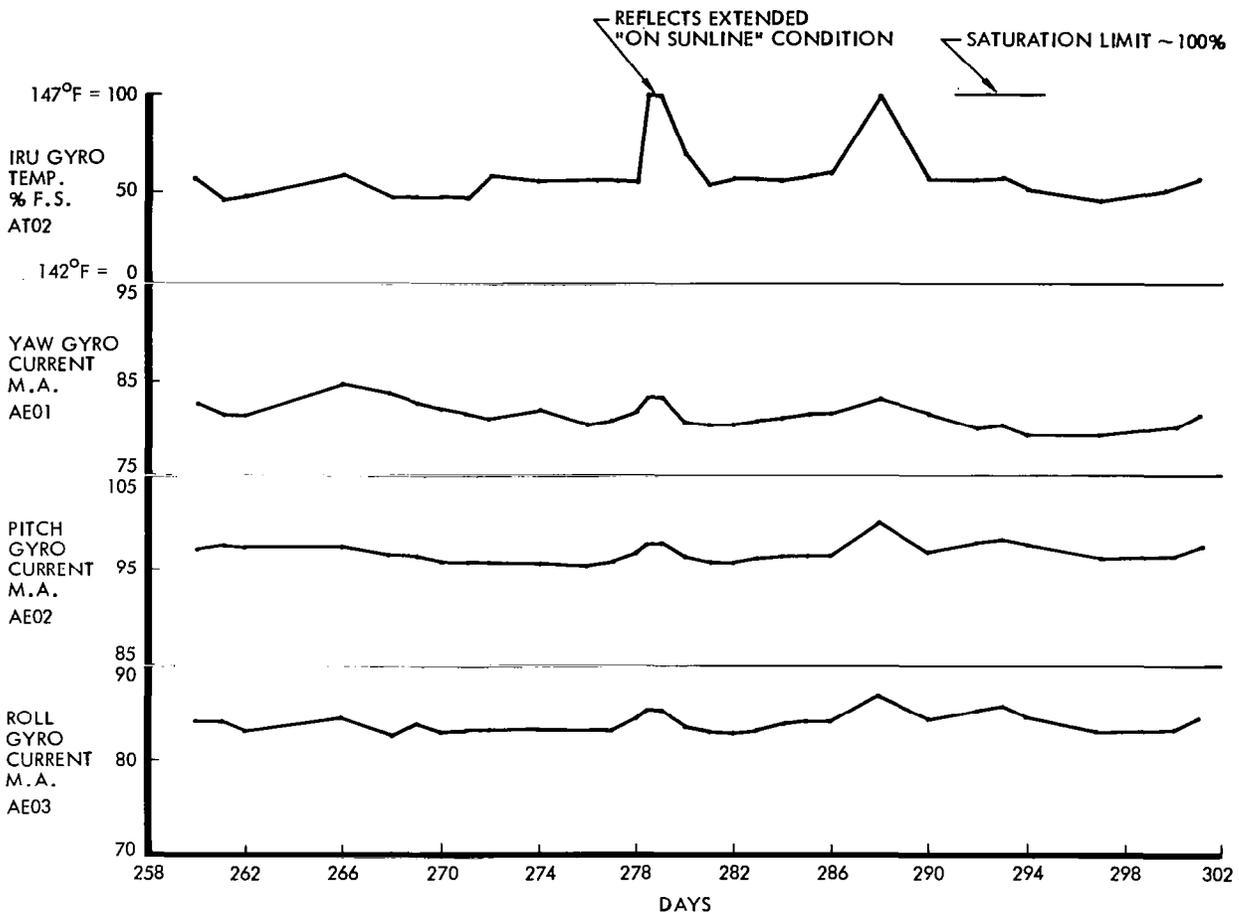
Figure 4-6: Gyro Electrical Characteristics

gyro currents remained within operating tolerances and did not develop any degrading trends. However, the current readings increased with increases in spacecraft temperatures. It is shown in Figure 4-6 that gyro temperatures exceeded the upper operating limit of 69% and reached a telemetry saturation value of 100%. Although the gyro currents reflected this increase, they still remained within tolerance.

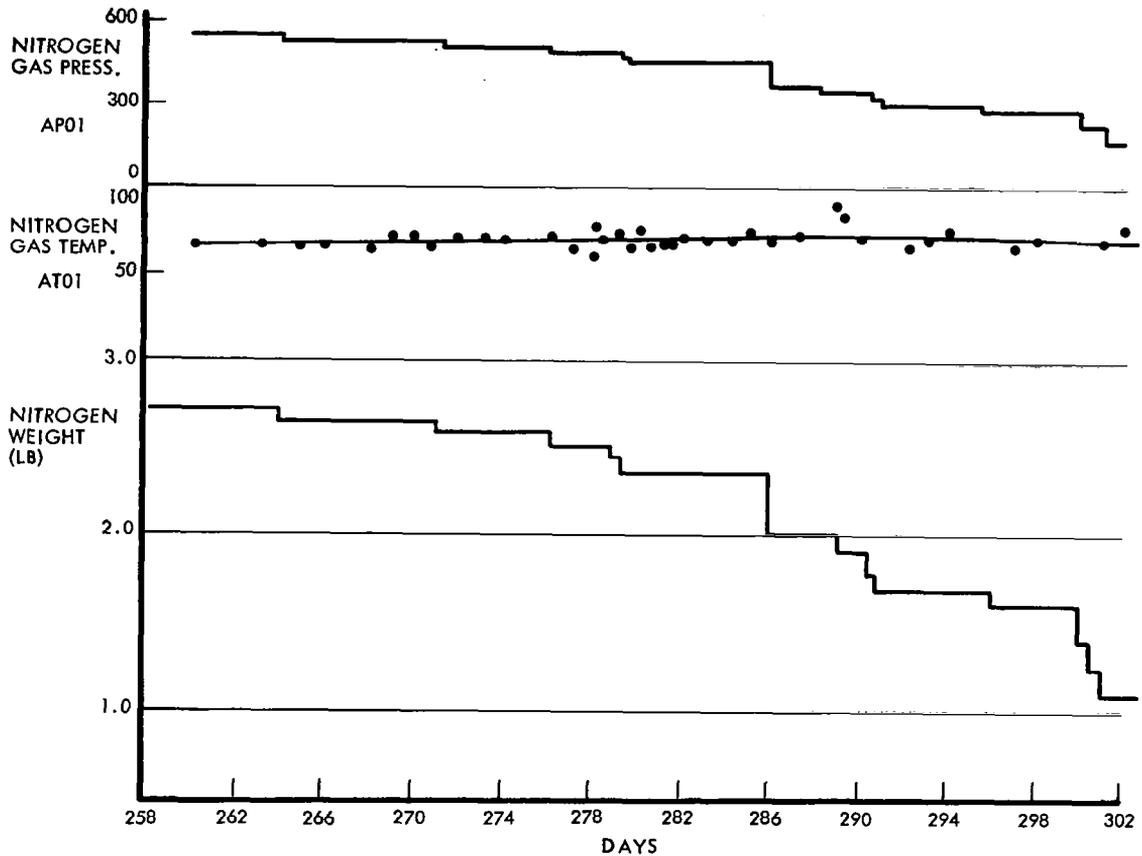
Figure 4-7: Nitrogen Usage Trends

$$WT_{GN_2} = \frac{P V}{12 Z R T}$$

- P = PRESSURE IN PSIA ~ AP01 + 60  
(60 PSIA ADDED TO COMPENSATE FOR CALIBRATION ERROR)
- V = VOLUME IN CU. IN. (1600 CU. IN.)
- Z = COMPRESSION CONSTANT (0.995)
- R = CONSTANT (55.2)
- T = TEMP. IN °R (AT01 + 460)

NOTE: N<sub>2</sub> WEIGHTS MENTIONED IN THE TEXT WERE BASED ON A CALIBRATION THAT DID NOT INCLUDE 60 PSIA BEING ADDED TO AP01

The minimum nitrogen gas usage was 0.11 pound per week when the spacecraft was configured in a  $\pm 2$ -degree deadband. However, when attitude maneuvers were performed, the gas consumption greatly increased. Figure 4-7 indicates the gas usage for the extended mission. The average weekly consumption for the extended mission was 0.275 pound. Therefore, it was apparent that spacecraft operating life was severely reduced when attitude maneuvers were performed, especially when the  $\pm 0.2$ -degree deadband was employed.

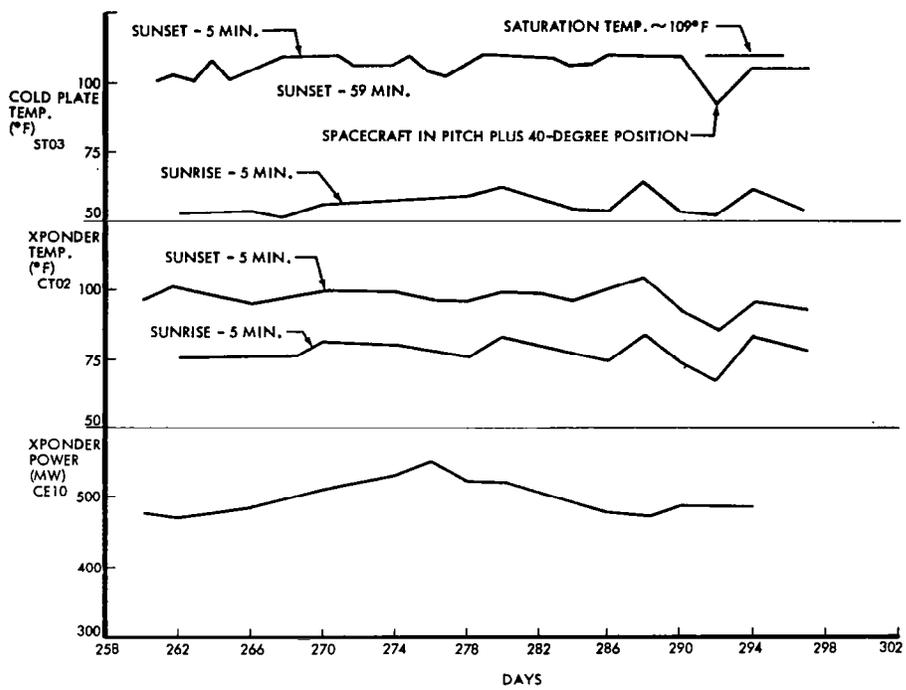
Figure 4-8: Transponder Data

No communications subsystem anomalies were observed during the extended mission. This subsystem continued to perform within its operating limits except for the period of time that the battery power output dropped below the minimum operating limits. Also, the spacecraft drifted through an antenna null position and the DSIF lost lock with the spacecraft for an extended period of flight. The power and temperature characteristics of the transponder may be seen in Figure 4-8.

line. However, during the period of spacecraft flight on the Sunline, the cold-plate temperature transducers frequently reached saturation. As shown in Figure 4-8, the cold-plate temperature transducers frequently reached and exceeded the upper limit of 108.1°F and remained above this saturation limit until Sunset occurred. During the most severe flight periods, the temperatures of ST01, ST02, and ST03 would exceed 116°F and could not be monitored. Also, the spacecraft paint characteristics continued to degrade as predicted.

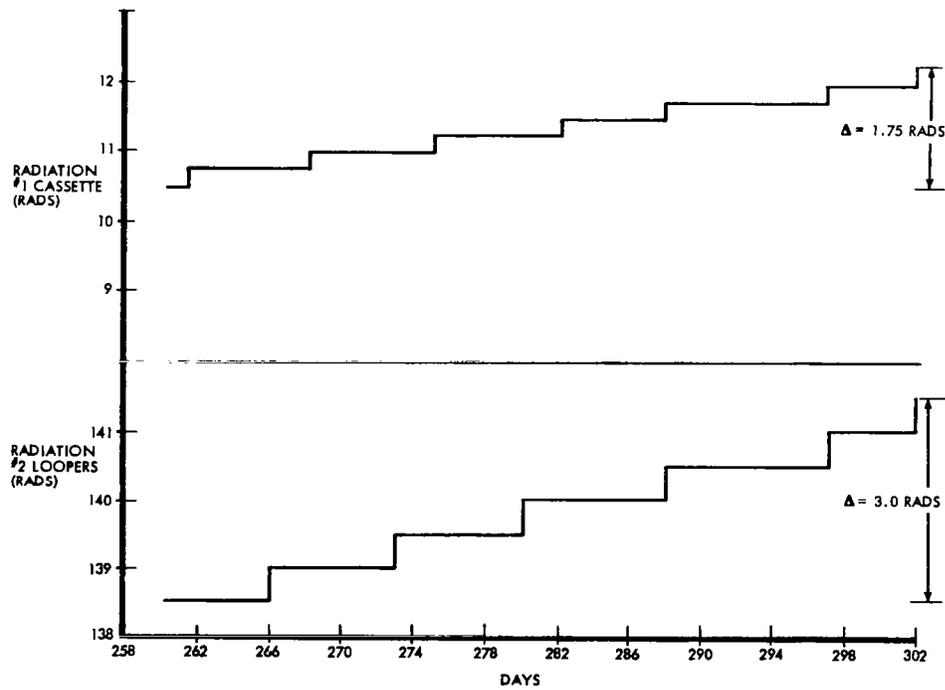
Figure 4-9: Spacecraft Radiation Levels

The spacecraft radiation detectors did not record any major solar flares or micrometeoroid hits during the extended mission. Figure 4-9 shows that the radiation level in the No. 1 cassette increased linearly from 10.50 rads to 12.25 rads and the radiation level in the No. 2 loopers increased linearly from 138.5 rads to 141.5 rads. Although the radiation increases were linear, the plots of Figure 4-9 are shown as a step-function which con-

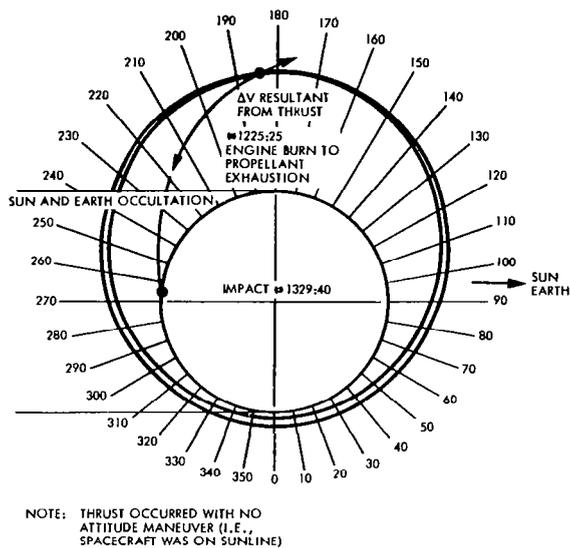
Figure 4-10: Impact Trajectory

no actual engine burn occurred but an additional 2.77 mps were imparted to the spacecraft. The trajectory to lunar impact and the impact dispersions are shown in Figures 4-10 and 4-11 respectively.

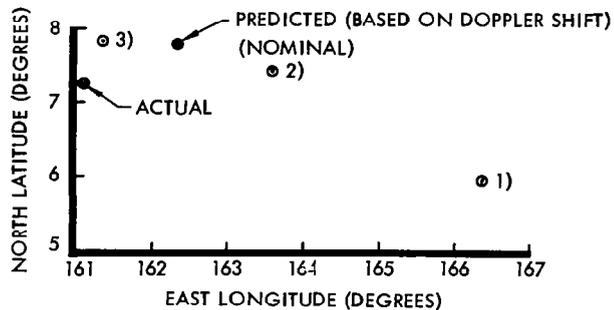
Figure 4-11: Impact Dispersions

BURN DURATION (SECONDS)	V (M/SEC)	IMPACT TIME	LATITUDE (DEGREES)	LONGITUDE (DEGREES)	APPROACH ANGLE (DEGREES)
1)	86.8	156	13:31:18.7	5.81	166.28	28.7
2)	92.9 (NOMINAL)	167	13:30:21.0	6.38	163.70	29.9
3)	99.0	179	13:29:26.8	6.90	161.25	31.0
ACTUAL		182	13:29:06.3	6.35	160.71	31.0

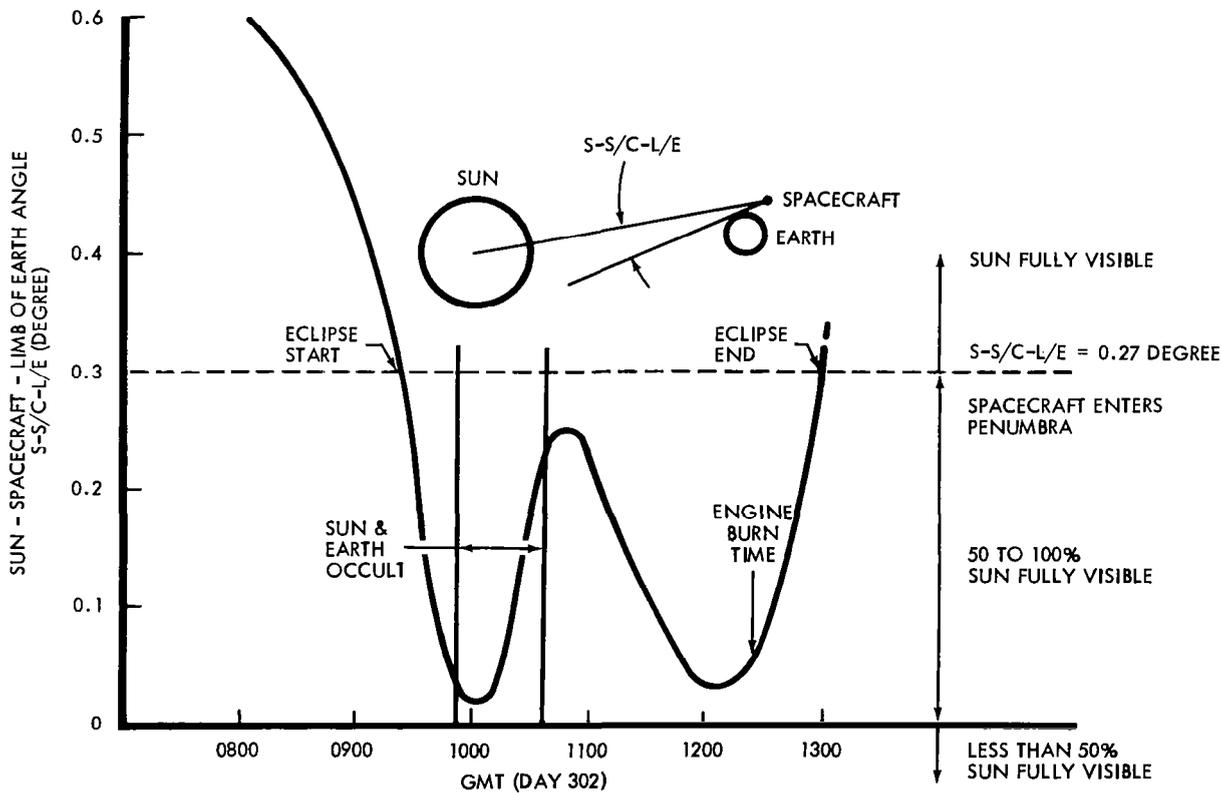
Figure 4-12: Sun-Spacecraft-Near Limb of Earth Angle during Penumbra Eclipse

The spacecraft power profile during the eclipse is shown in Figure 4-13. The trace of the "Sun-Spacecraft-near limb of Earth" angle as it passed through the eclipse is shown in Figure 4-12. The spacecraft was pitched off

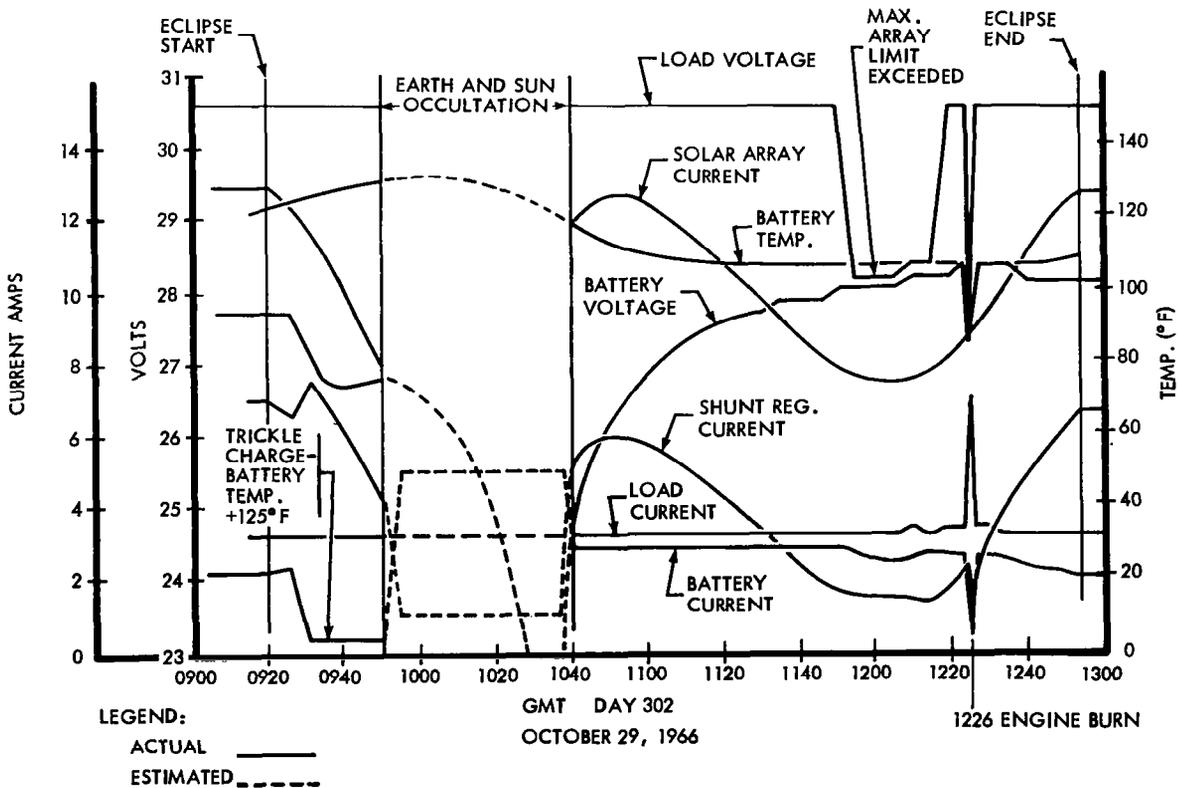
Figure 4-13: Spacecraft Power Profile during Penumbra Eclipse

the Sunline plus 35 degrees when it entered the solar eclipse. From the time that the spacecraft entered the solar eclipse until telemetry was terminated by Earth occultation, the solar array current dropped from 12.67 amps to 7.93 amps. The battery temperature increased from 125°F and then reached an estimated high of 129°F following Sunset. When the battery temperature reached 125°F, the battery current dropped to a trickle charge value, as designed. The battery voltage dropped 1 volt and the shunt regulator current dropped about 3 amps. The cold-plate temperature saturated at 108°F prior to Sunset. Earth and Sun occultation occurred simultaneously, which prevented monitoring the battery performance during the Sun occultation period. It is estimated that the battery voltage dropped to about 20 volts prior to Sunrise. Shortly after Sunrise the array current began to drop again. This time the battery temperature was lower and the battery current did not drop to the trickle charge level. However, the solar array power limits were exceeded and the solar array voltage dropped to near the battery voltage level of 28 volts. The solar array output current began to increase, as may be seen in Figure 4-13, and then the solar array voltage returned to its normal level of 30.56 volts. At the end of the eclipse, the power system performed normally and apparently survived the eclipse without any degradation.
