DOT/FAA/AR-04/26

Flammability Assessment of Bulk-Packed, Nonrechargeable Lithium Primary Batteries in Transport Category Aircraft

Final Report

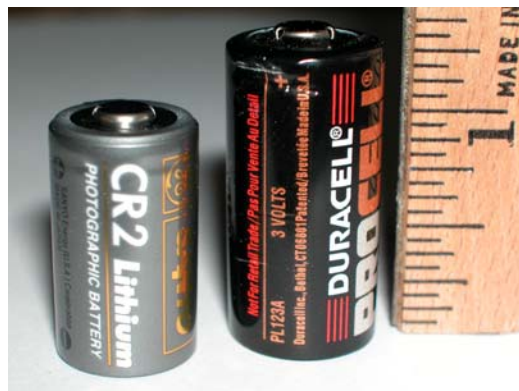
Two common types of primary lithium batteries were used in this investigation: CR2 and PL123A, as shown in figure 1. These are small batteries often used in cameras and other small electronic appliances.

FIGURE 1. CR2 AND PL123A PRIMARY LITHIUM BATTERIES

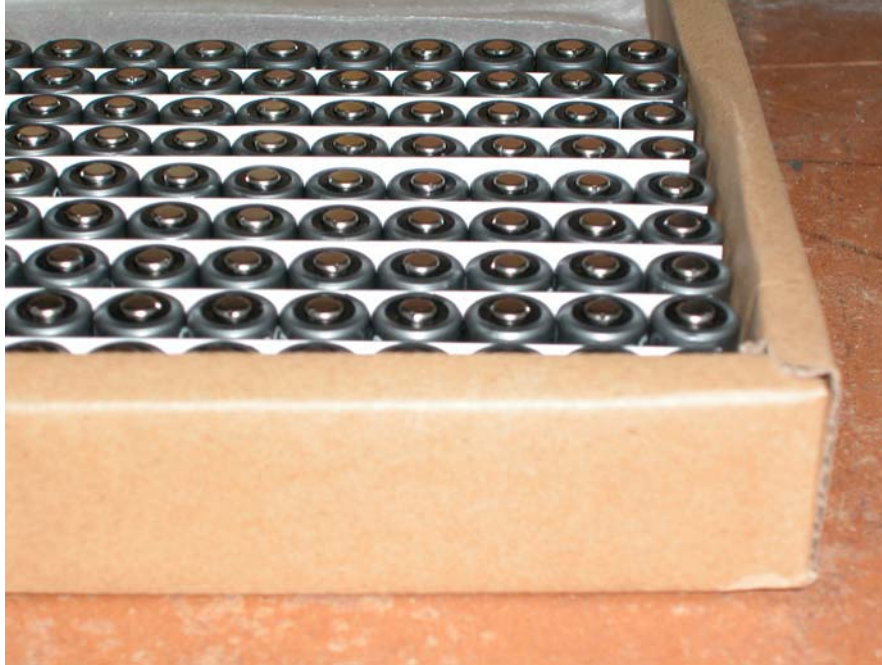
A series of tests were conducted to determine the effect of the packaging materials on the ignition and propagation of CR2 batteries when exposed to a 1-propanol fire. The tests used corrugated cardboard cases, smooth cardboard separators, and polyurethane foam cushions from actual CR2 shipping boxes, as shown in figure 6. The batteries and shipping materials were suspended 3" above the fire pan. Tests were conducted using 32, 64, and 128 CR2 batteries. The tests using 32 and 64 batteries used the 5.25" fire pan and 50 ml of 1-propanol. The test using 128 batteries used the 10.75" fire pan and 220 ml of 1-propanol. The 10.75" fire pan allowed for better flame exposure to the test carton.

FIGURE 6. SANYO CR2 BATTERIES PACKED IN A STANDARD BULK SHIPPING CONTAINER

The packing material had several noticeable effects on the battery flammability compared to the multiple-battery tests conducted without packing material. The packing material is quite flammable, igniting easily when exposed to the 1-propanol fire. The packing material fire was sufficiently intense to ignite the CR2 batteries. It does, however, delay the ignition of the batteries by 30 to 60 seconds. In addition, the packing material kept the batteries in close proximity to one another, allowing the heat of the fire to fuse them together. This fusing facilitated the fire propagation between batteries once a single battery was ignited.

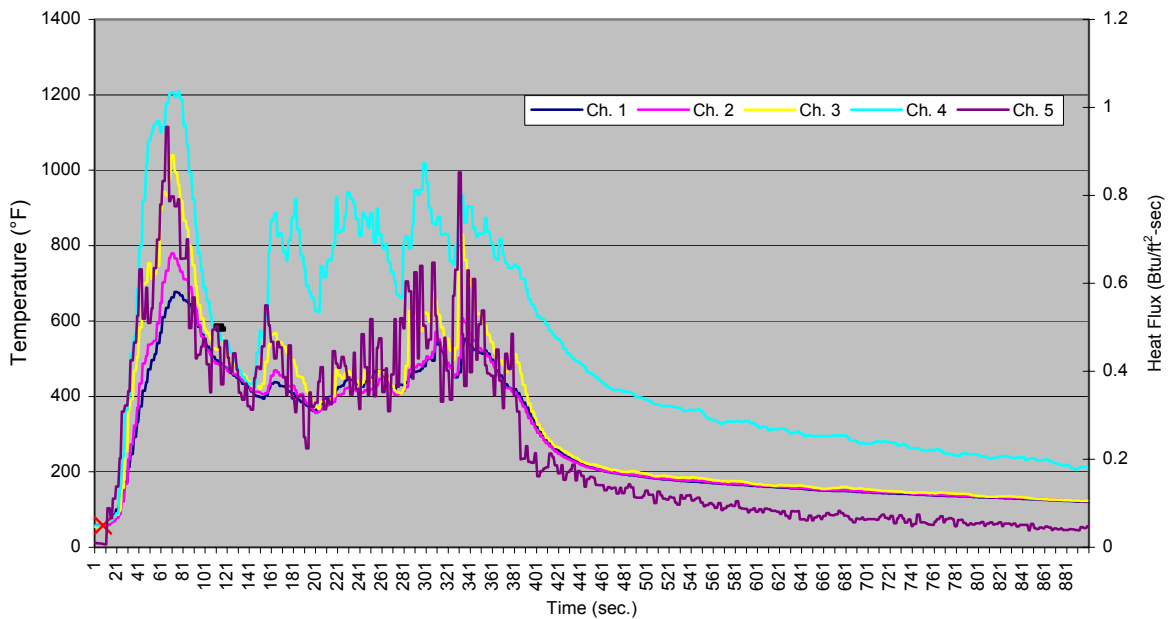
The peak temperatures generated by the 32-, 64-, and 128-battery tests were similar, but the duration of the peak temperature was greater with the higher number of batteries. The initial temperature peak is caused by the packing material burning and the second peak by the lithium batteries burning. Figure 7 shows the temperature profile generated by the 128-battery test.

FIGURE 7. PACKING MATERIAL TEST, 128 SANYO CR2 BATTERIES

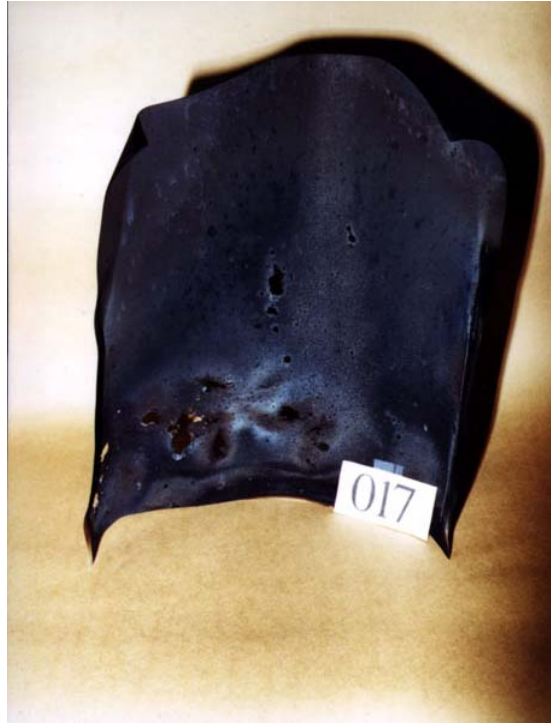
In each test, the battery fire ignited the resin, causing a secondary fire fueled by the cargo liner. The molten lithium penetrated the thin-wall liner, burning small holes in the liner that ranged from pinpricks up to 0.5" in diameter. The thick-wall liner was better able to contain the molten lithium, sustaining damage to the inner layer of fiberglass cloth but not penetrating the liner. Figure 8 shows the typical damage sustained by a thin-wall liner as a result of these tests.

FIGURE 8. THIN-WALL CARGO LINER PENETRATION

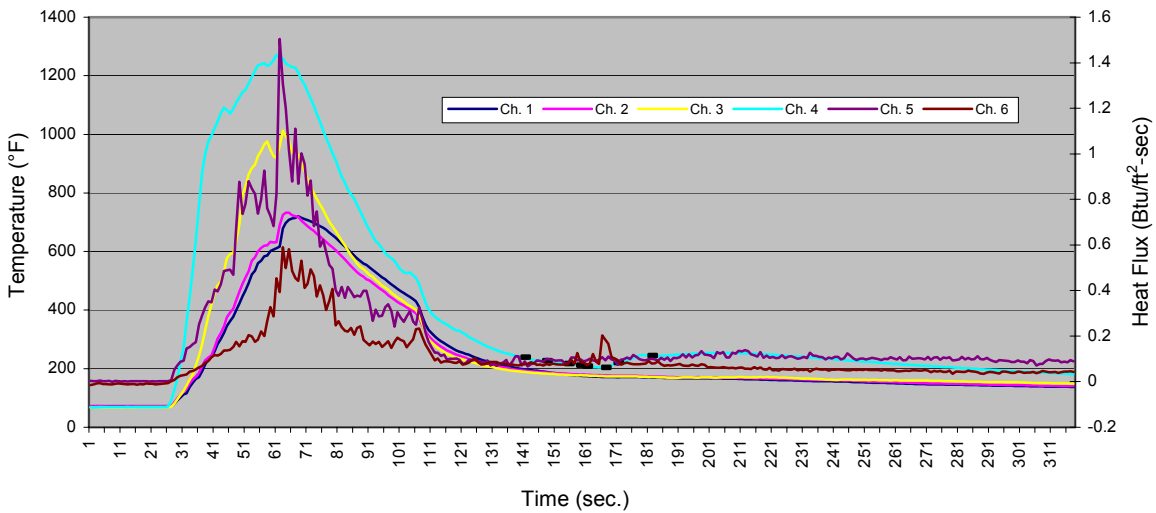
Two tests were conducted in the 64-cubic-foot test chamber using the 10.75" fire pan and 220 ml of 1-propanol. Each test was run using 16 Duracell PL123A batteries and 1.8 pounds of Halon 1301, which was discharged after the first battery was ignited. The results in each test were similar to those found in the halon suppression tests with Sanyo CR2 batteries. The halon immediately extinguished the 1-propanol fire and reduced the overall temperature profile in the chamber but did nothing to impede the progress of the battery fire once a single battery had ignited. The normally white molten lithium sparks turned bright red. The battery fire propagated until all batteries were consumed. Figure 11 shows the temperature profile generated by the 16-battery test suppressed with Halon 1301.

FIGURE 11. DURACELL PL123A 16-BATTERY HALON 1301 SUPPRESSION TEST

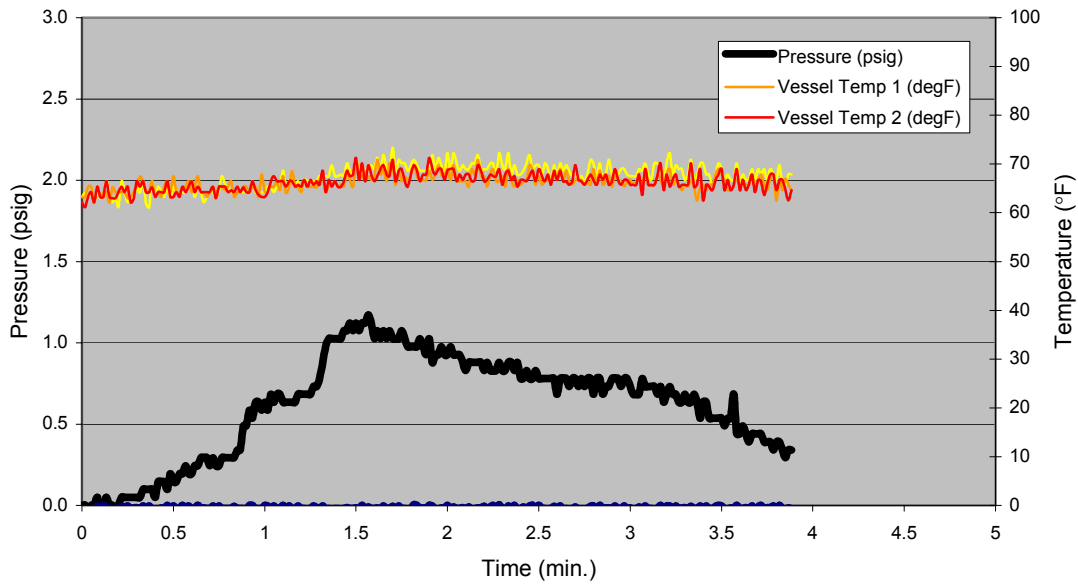
One test was conducted with four Duracell PL123A batteries. The conditions were the same as the Sanyo CR2 battery test. The pressure rise in the chamber was approximately 1.2 psi (see figure 16).

FIGURE 16. DURACELL PL123A FOUR-BATTERY EXPLOSION TEST

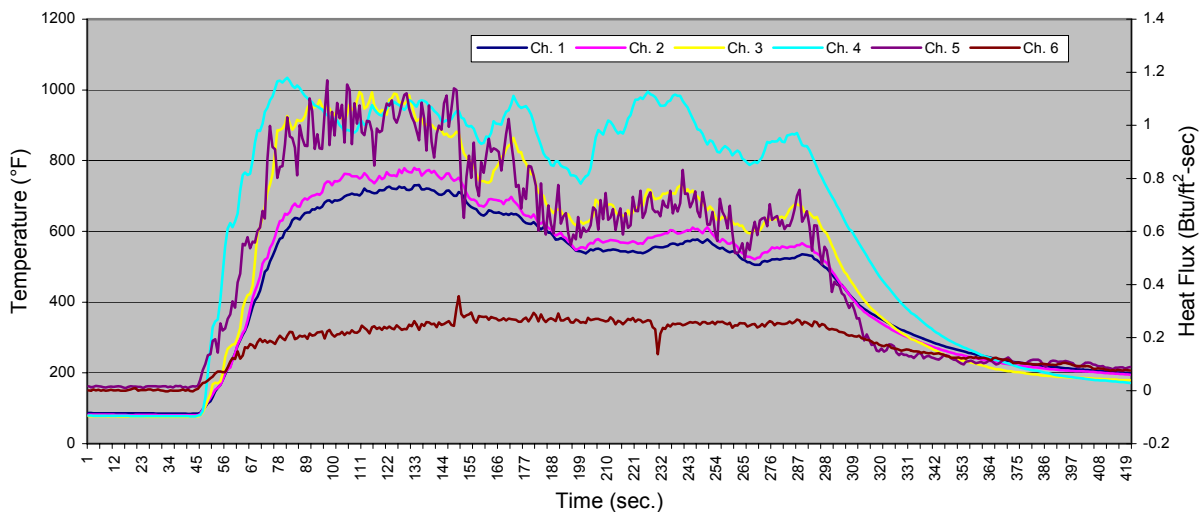
The batteries were subjected to the 10.75" fire pan with 220 and 300 ml of 1-propanol and tested in the 64-cubic-foot test chamber. The amount of 1-propanol was increased in the second test to provide an increased fire duration. In each case, the results were the same. The batteries did not burn with an open flame. The plastic case deformed and melted and eventually charred. There were some small amounts of venting and tiny sparks of lithium. The case did not self-sustain any fire once the 1-propanol was consumed. Peak temperatures, measured 12" above the fire pan, were not significantly greater than those measured in a 1-propanol fire without batteries, peaking at about 1000°F. The shape of the temperature curve indicates that there was some heat release due to the charring of the battery case (see figure 18).

FIGURE 18. RECHARGEABLE COMPUTER LAPTOP BATTERY TEST
