Geologic Impacts of the 2004 Indian Ocean Tsunami on Indonesia, Sri Lanka, and the Maldives

Bruce M. Richmond, Bruce E. Jaffe, Guy Gelfenbaum and Robert A. Morton

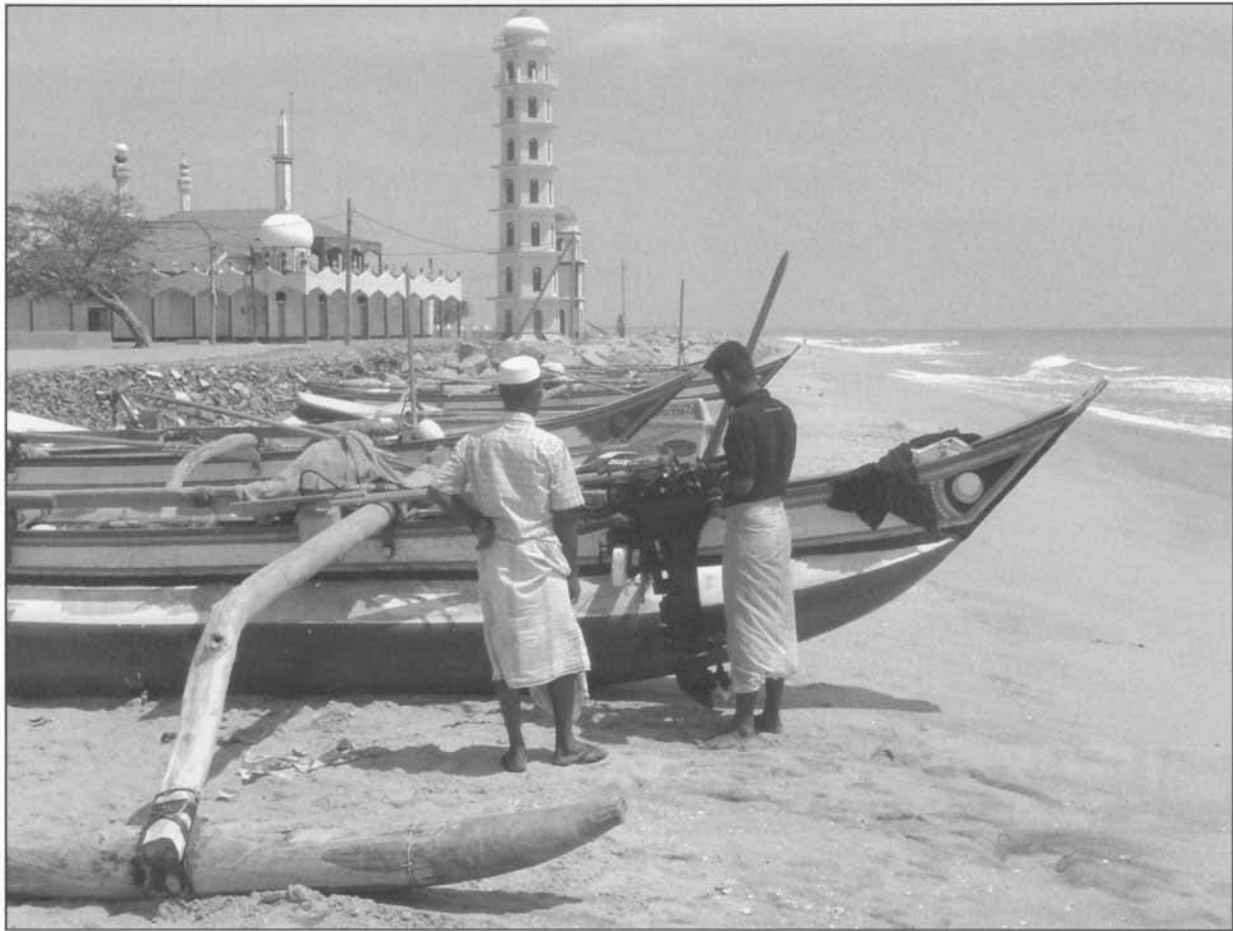
Fig. 7. The east coast of Sri Lanka near Kalmunai in August of 2005 showing recovered beach (foreground), pre-tsunami revetment (center right) as evidence of a prior erosion problem, and post-tsunami debris emplaced along coast (center left). The mosque survived relatively intact but most coastal homes in the area were severely damaged.

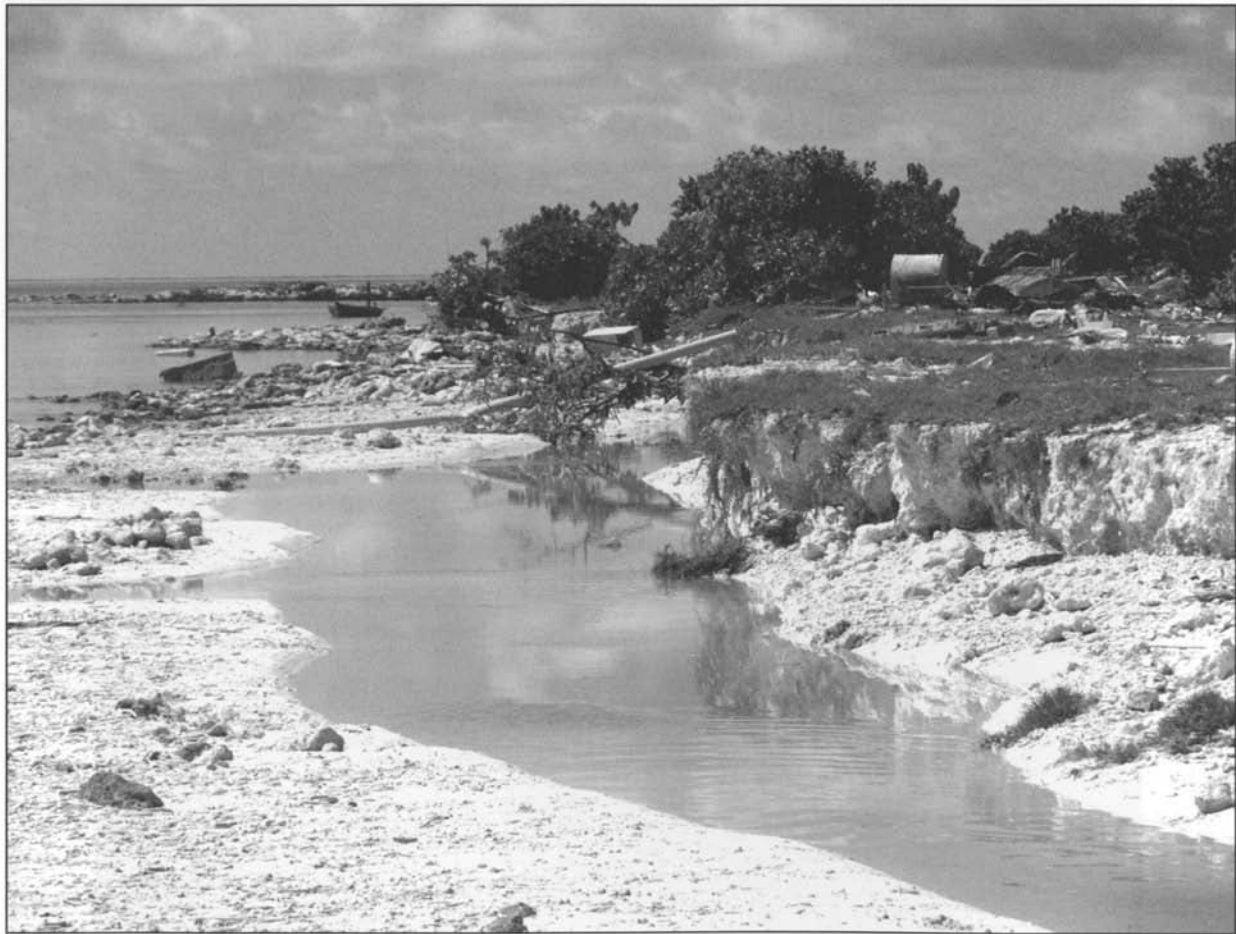
Fig. 9. Photograph of the southwest coast of Vilufushi Island (Thaa Atoll) in an area overwashed by the tsunami. The erosional scarp (right), scoured depression (center; filled with seawater in the photograph), and lagoonal deposit (left) were formed as the tsunami flowed over the island. Sediment in the lagoon includes both natural and manmade debris.

prominent scarps developed along western sandy shorelines (Fig. 9) and were accompanied by sediment deposition westward into adjacent reef flat/lagoon areas (Fig. 10). Changes to island interiors was generally limited to local scour around obstacles, such as buildings, and development of thin patchy sediment deposits. Overall, shoreline change as a result of the tsunami was relatively minor with serious erosion generally confined to within 5 m of the shoreline. These observations are consistent with pre- and post-tsunami topographic profiles and observations as presented by Kench et al. 2006.

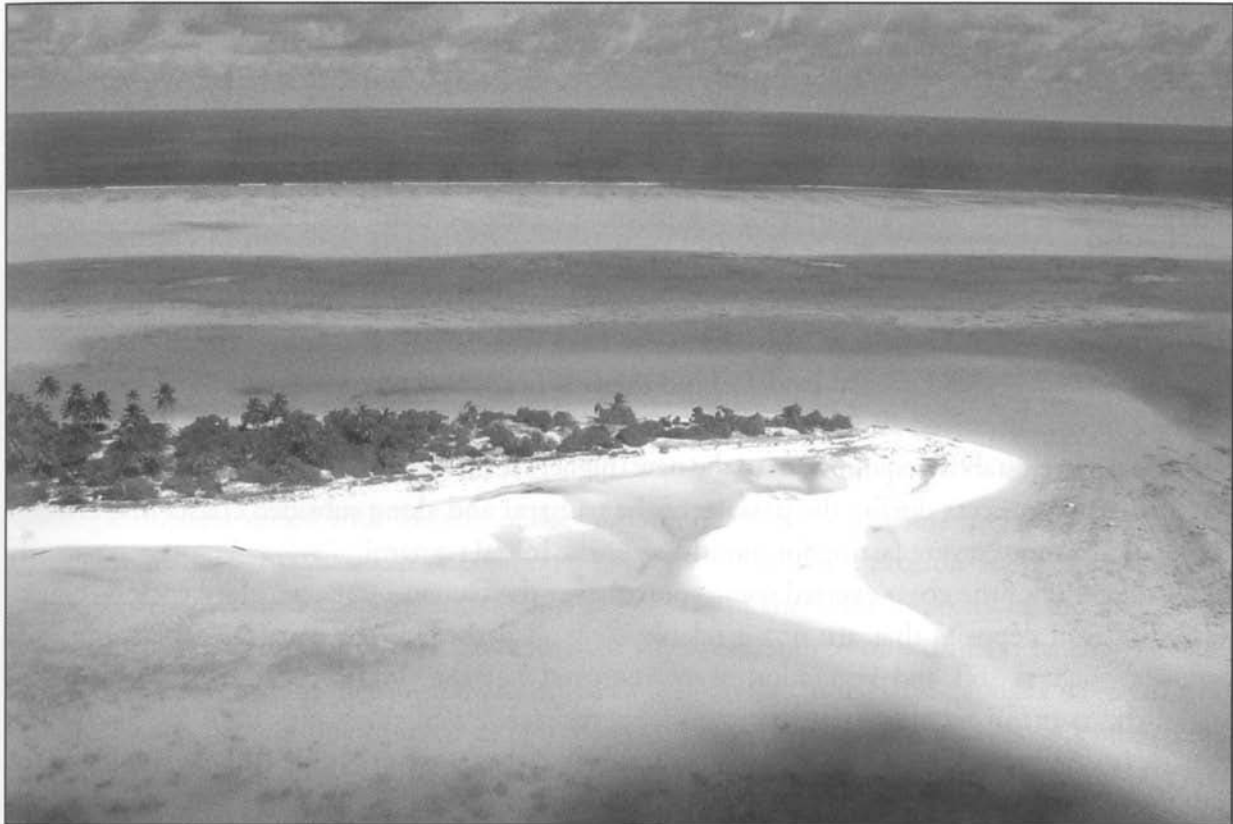
Fig. 10. Oblique aerial photograph of the southern end of Kalhufahalafushi Island (Thaa Atoll) showing a large sediment body deposited towards the west into the lagoon. View to the east.
