Table VII-1. WATER QUALITY TREATMENT AND CONTROL TECHNOLOGIES CURRENTLY BEING USED IN DRYDOCKS

Table VII-2. WATER QUALITY TREATMENT AND CONTROL TECHNOLOGIES UNDER DEVELOPMENT OR NOT BEING USED IN DRYDOCKS

Table VII-3. REPORTED APPLICATION OF THE TREATMENT AND CONTROL TECHNOLOGIES

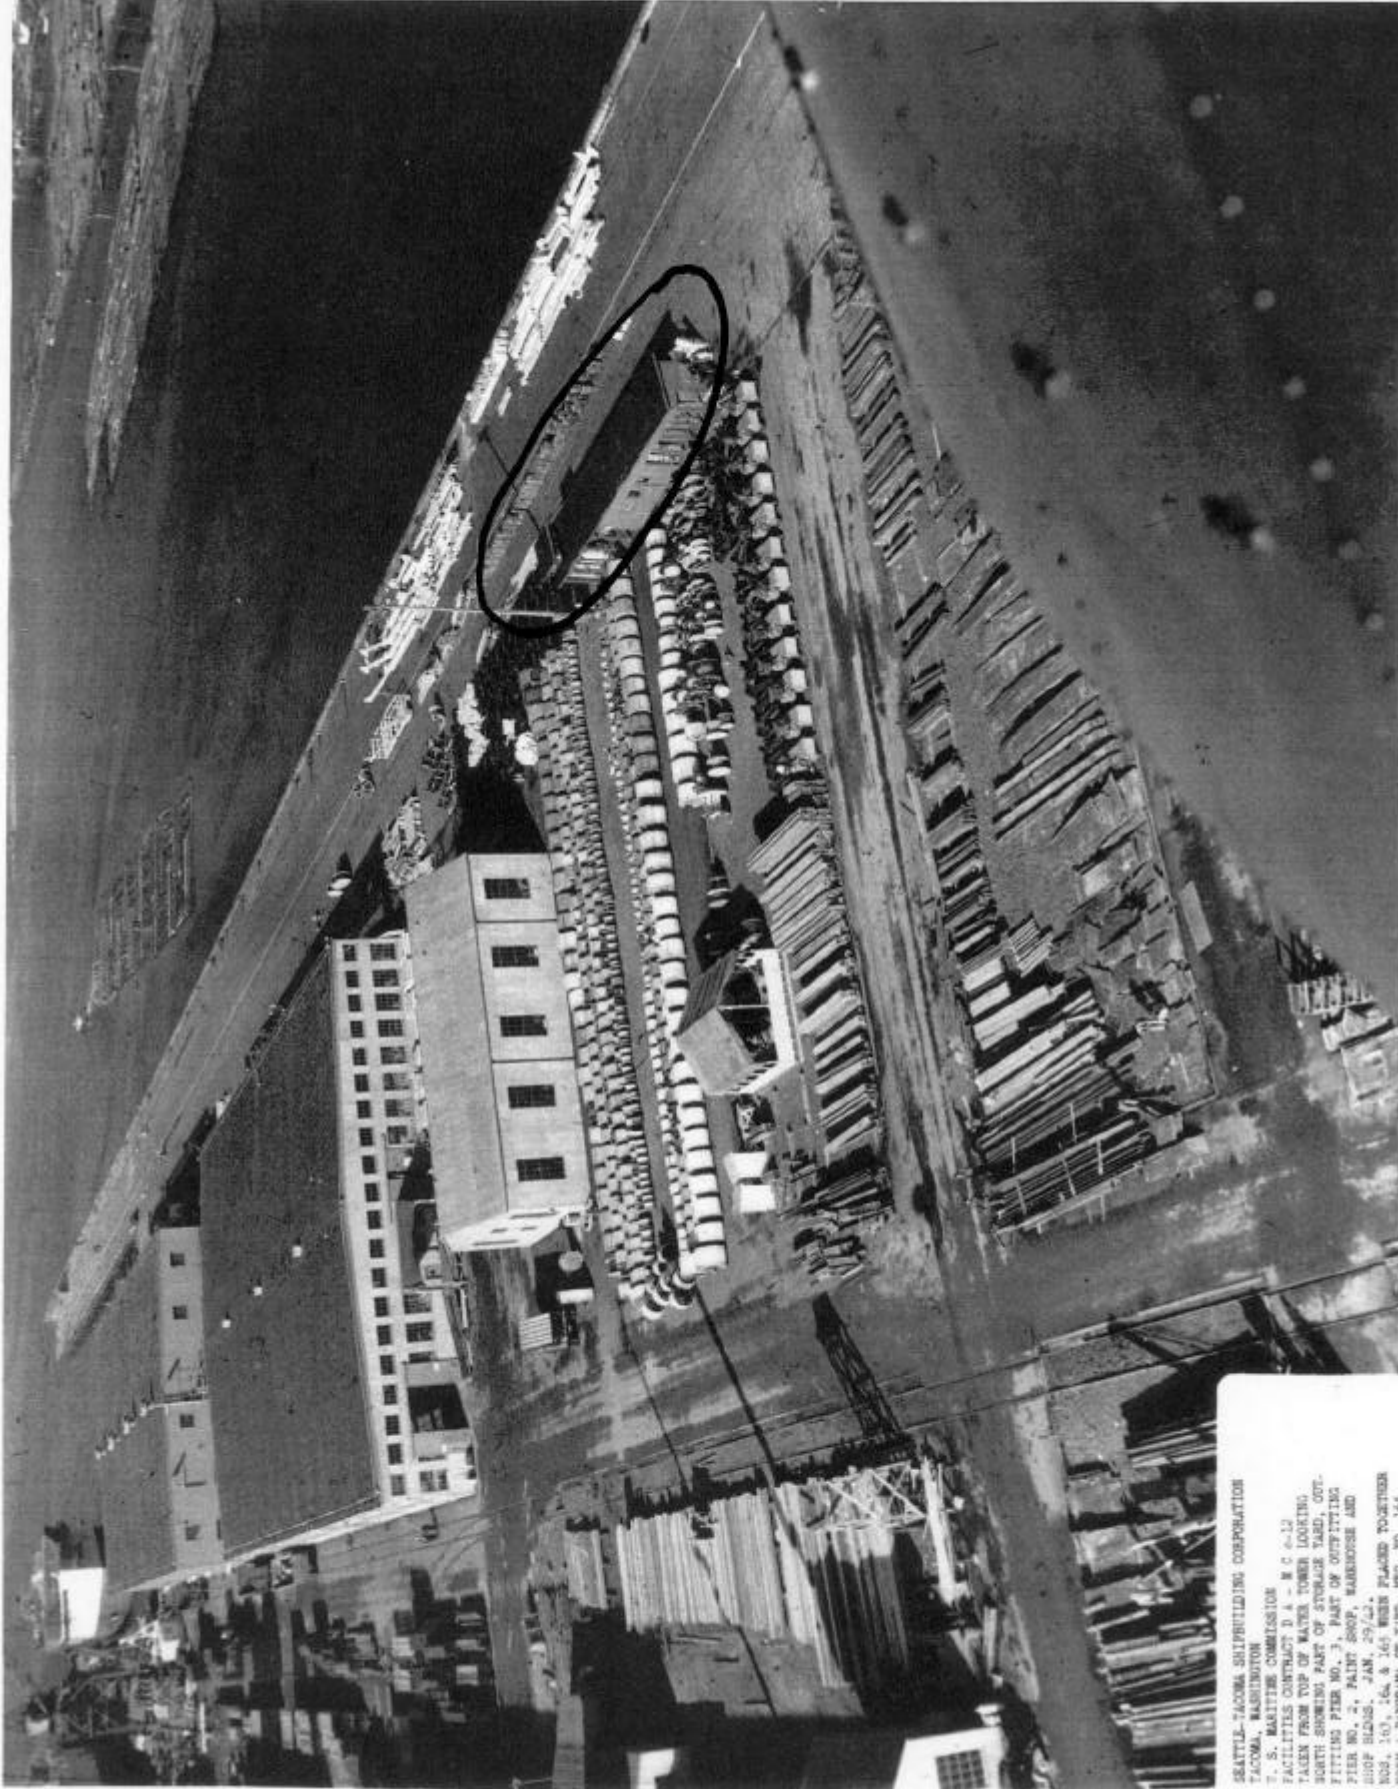
Tab 8

Photograph dated January 29, 1942 looking north towards the Mouth of the Hylebos, with a transformer house circled on the overlay. This is Transformer House No. 98 on Archives Map #6. This and other transformer locations are highlighted in yellow on the maps numbered 1, 2 and 6 in the Archives Report. This and the other transformer houses along the Hylebos Waterway on Parcel #1 were constructed directly on top of the wooden-planked pier, thus allowing transformer oils to leak directly into the Hylebos Waterway. This is also Building No. 547 labeled "Switch and Transformer Shed" in the legend to the Archives Report Map No. 8.

SEATTLE-TACOMA SHIPBUILDING CORPORATION
TACOMA, WASHINGTON
U. S. MARITIME COMMISSION
FACILITIES CONTRACT D 4 - W C 6-12
TAKEN FROM TOP OF WATER TOWER LOOKING
NORTH SHOWING PART OF STORAGE YARD, GOV.
PIERING PIER NO. 3, PART OF OUTFITTING
PIER NO. 2, PAINT SHOP, BARRACKS AND
SHOP BLDGS. JAN. 29/32.
NO. 103, 104, & 105 WERE PLACED TOGETHER
FROM A PANORAMA OF YARD. REF. NO. 105

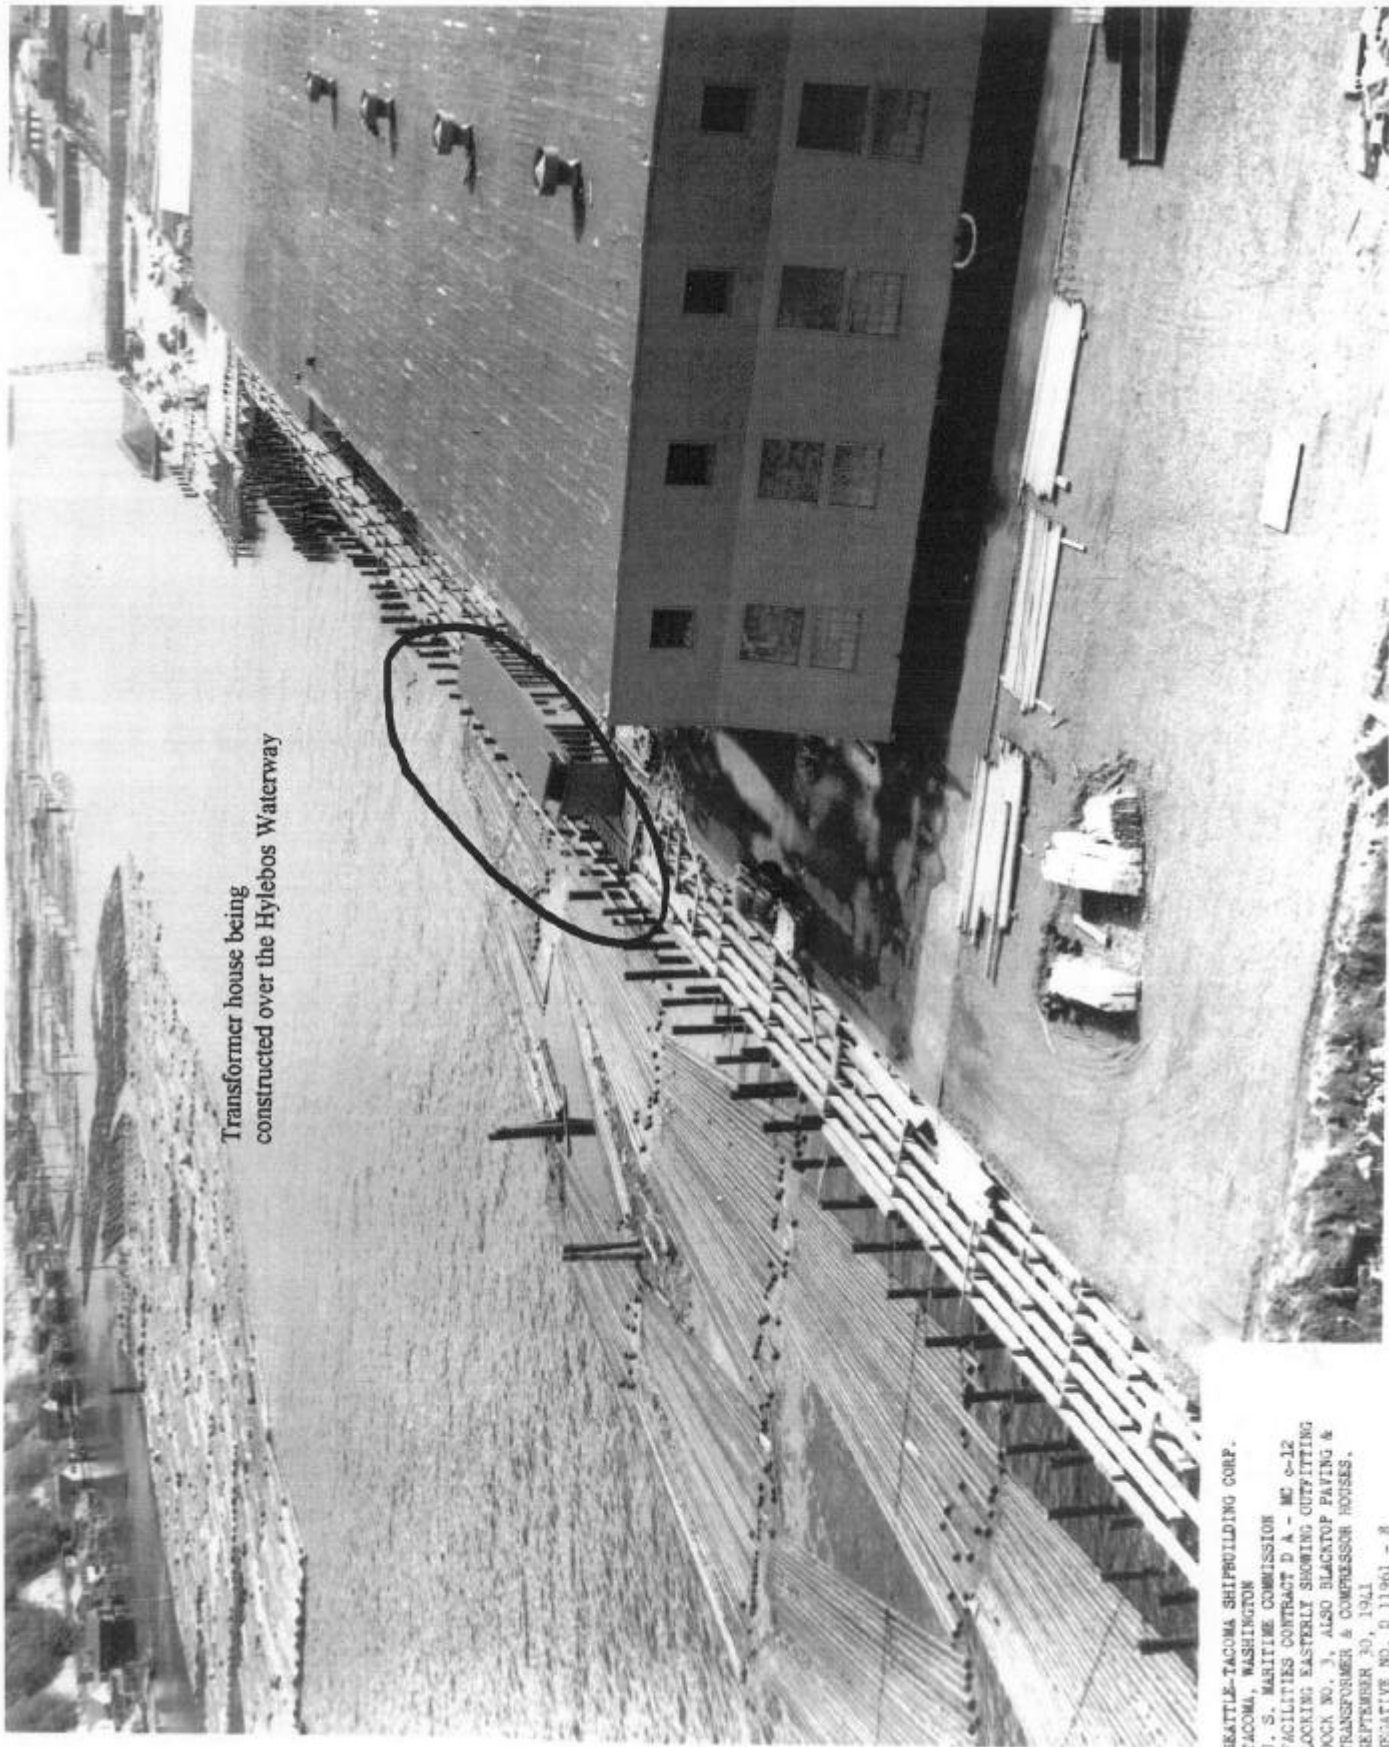
Tab 9

Aerial photograph dated September 30, 1941, looking southeast up the Hylebos, showing a transformer house being constructed directly over the Hylebos Waterway. This is the same structure as the "Transformer House" on the Hylebos side of the "Shops Building" in Map 1 in the Archives Report. This same structure is also shown on Maps 2, 6, and 8 from that Report. It was located on yet-to-be-completed Outfitting Pier No. 3.

Transformer house being
constructed over the Hylebos Waterway

SEATTLE-TACOMA SHIPBUILDING CORP.
TACOMA, WASHINGTON
U. S. MARITIME COMMISSION
FACILITIES CONTRACT D.A. - MC 6-12
DOCK NO. 3, ALSO BLACKTOP PAVING &
TRANSFORMER & COMPRESSOR HOUSES.
SEPTEMBER 30, 1941
SPECIATIVE NO. D 11961 - 8
