**NIST NCSTAR 1-6 (Draft)**

**Federal Building and Fire Safety Investigation of the  
World Trade Center Disaster**

**Structural Fire Response and  
Probable Collapse Sequence of the  
World Trade Center Towers (Draft)**

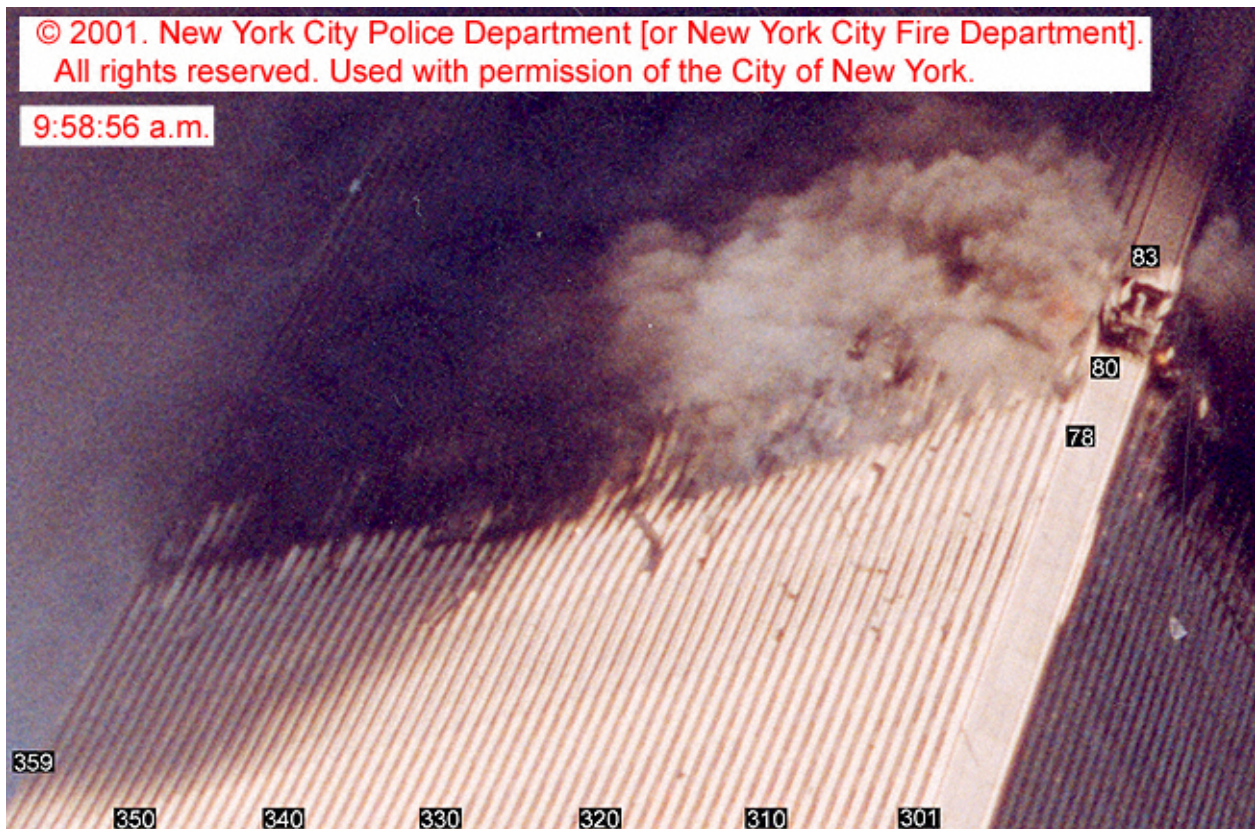
Figure E-7. View of WTC 2 buckling of east wall near northeast corner as collapse initiates from southeast.

- Collapse initiated 56 minutes after the aircraft impact (9:02:59 a.m. to 9:58:59 a.m.).
- From a northeast viewpoint, initial downward motion was observed as columns moved inward on the north side of the east face, as shown in Fig. E-7. Tilt of the building section above the impact and fire area appeared to take place near Floor 82. Column buckling was then seen to progress across the north face.

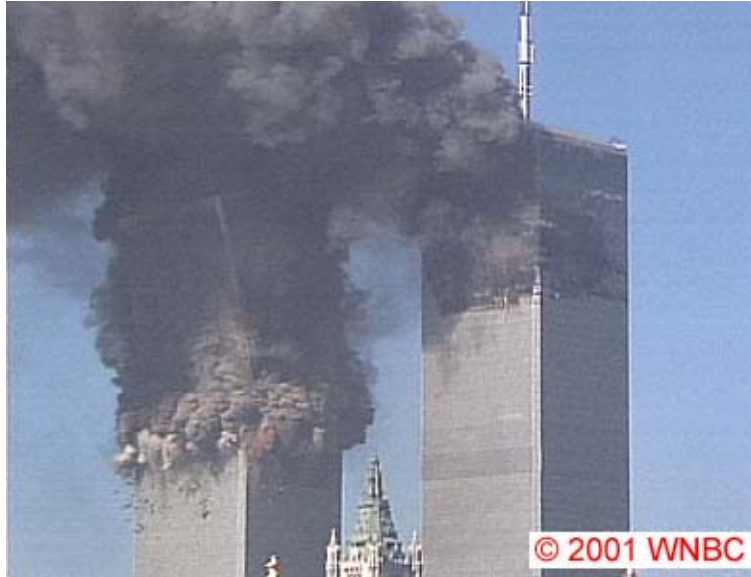
**Figure E–8. View of upper building section of WTC 2 tilting to the east.**

- The building section above the impact and fire area tilted to the east and south as the structural collapse initiated as shown in Fig. E-8. There was approximately a 3 to 4 degree tilt to the south and a 7 to 8 degree tilt to the east prior to significant downward movement of the upper building section.
