**Heavy Truck into Left Side of
1995 Blue Bird Bus
TRC Test Number: 990525**

**Prepared by:
Transportation Research Center Inc.
10820 State Route 347
East Liberty, OH 43319**

**Final Report
May - July 1999**

**Prepared For:
Vehicle Research and Test Center
P. O. Box 37
East Liberty, OH 43319**

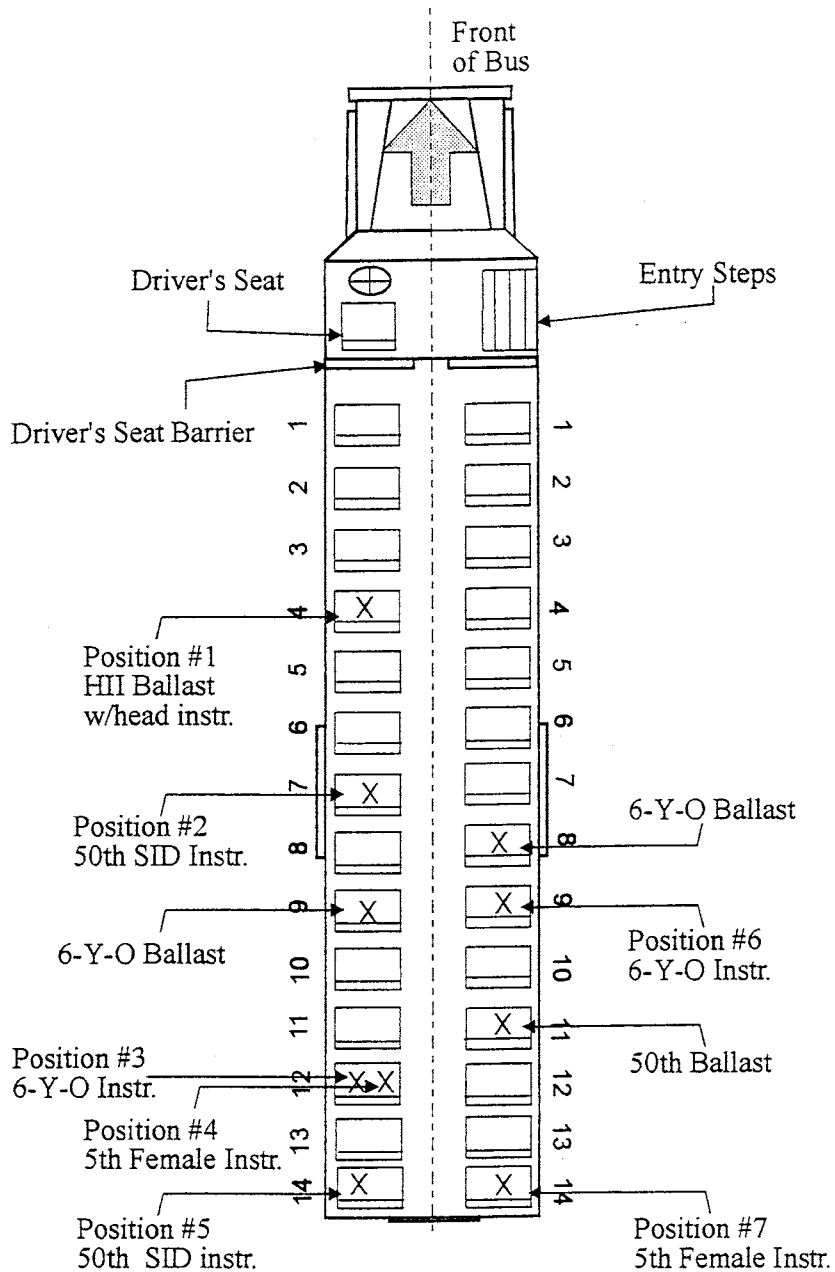
Figure 1 Dummy Positioning Data

The test vehicle contained seven (7) instrumented anthropomorphic test devices (dummies) and three (3) uninstrumented anthropomorphic test devices (dummies). The dummies were positioned according to Figure 1.

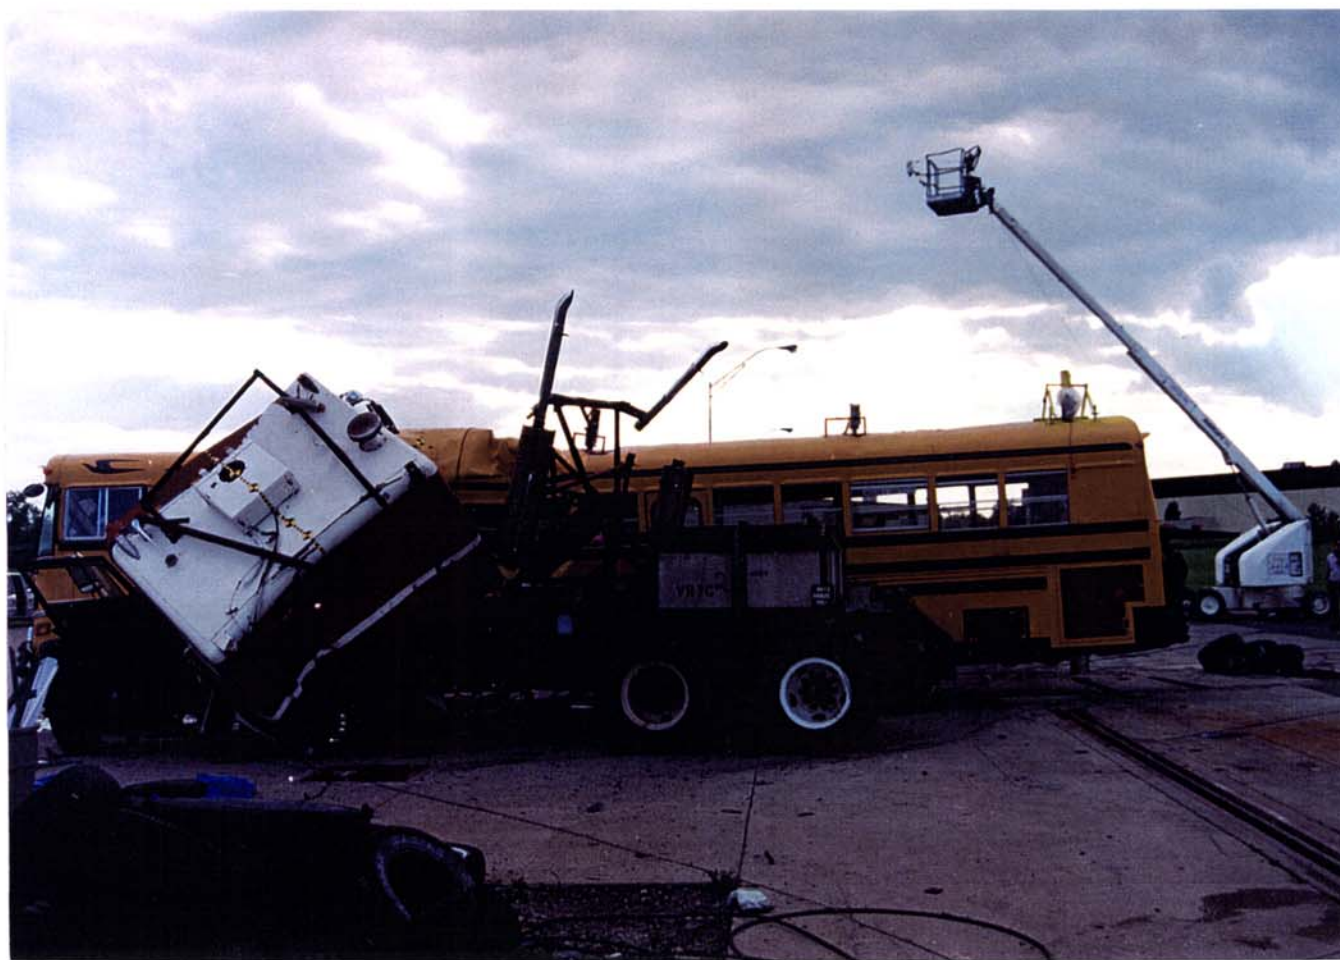
Figure A-5 Post-Test Left Side View

The target vehicle was a 1995 Blue Bird Bus. The target vehicle's test weight was 9,965.5 kg. The vehicle's maximum static crush was 1705 millimeters at the bottom of the window sill.
