Testing of a Microwave Blade Tip Clearance Sensor at the NASA Glenn Research Center

Mark R. Woike¹, James W. Roeder², Christopher E. Hughes³, and Timothy J. Bencic⁴
NASA Glenn Research Center, Cleveland, Ohio, 44135

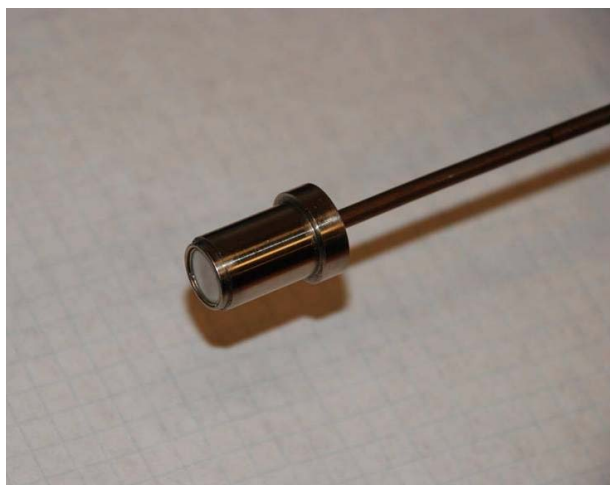
The high temperature tip clearance probe shown in Fig. 1 is approximately 14 mm in diameter and 26 mm long. It contains the transmitting and receiving antenna and is designed to be installed in the casing of the engine where it can measure the radial clearance between it and the turbine blade tips. The probe is made of high temperature material and is designed to withstand temperatures up to 900 °C uncooled, 1200 °C with cooling air. The associated sensor electronics and data acquisition system for the microwave tip clearance system are shown in Fig. 2. This hardware contains the RF generator, RF detector, and all of the associated hardware required to generate, measure, and condition the microwave signals. It also contains a rack-mounted PC that runs the data acquisition and display software. It is intended that the sensor electronics be located away from the engine in an environmentally benign area. The probes are connected to the electronics using a microwave rated co-axial cable. Cable distances up to 15 m can be currently supported between the probes and the sensor electronics. The data acquisition computer is connected to the sensor electronics through a network switch. This computer can be remotely located away from the sensor electronics to an area such as a control room using a CAT5E connection.

Figure 1. Microwave tip clearance probe.

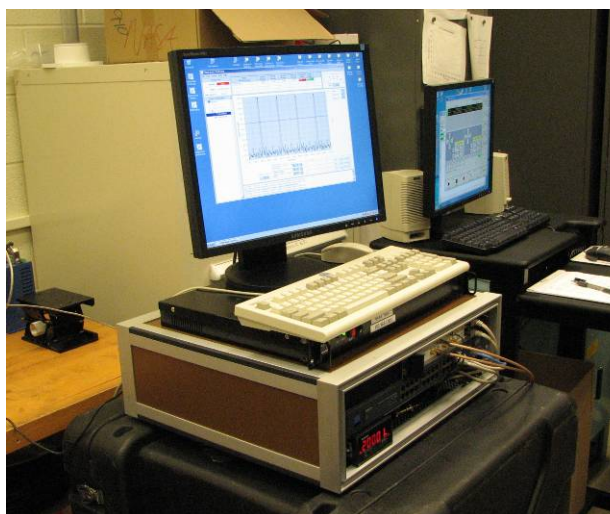
Figure 2. Microwave sensor electronics and data computer.

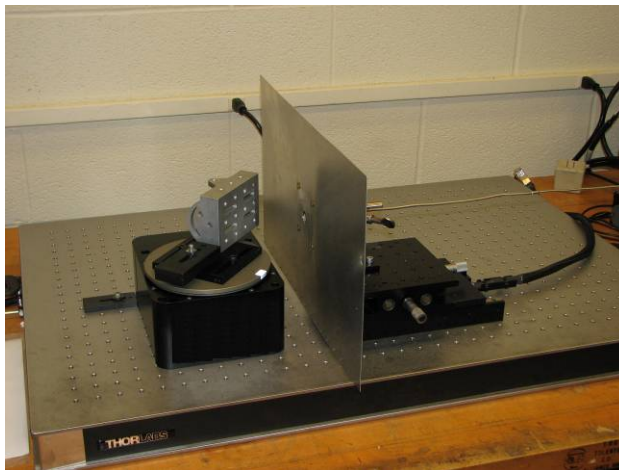
The calibration rig setup shown in Fig. 3 consists of a rotary stage and a linear stage controlled by a programmable motion controller. The candidate blade for the calibration was mounted on the rotary table where it could be operated up to 300 RPM. The microwave probe was mounted on the linear stage where it could be moved to a desired distance from the blade tip for calibration. This linear table used an optical encoder with an accuracy of 4 μm for position indication. A typical calibration involves installing the probe and blade on the stages at a known baseline distance apart from each other using a precision metric gauge block. Typically, the baseline distance chosen was the largest distance for the calibration. Once this baseline distance was established, the setup was confirmed by moving the linear stage over the entire calibration range and verifying the distances between the blade and sensor using the precision gauge blocks at several distance settings. The metric gauge blocks used had an uncertainty of 0.14 μm . Once the setup was confirmed the blade was operated at 200 RPM using the rotary stage and the probe was moved to the desired gap distances using the linear stage and encoder. At each desired distance, the "measured" or uncorrected reading was recorded. This was done over the entire calibration range.

Figure 3. Microwave Probe Calibration Rig.

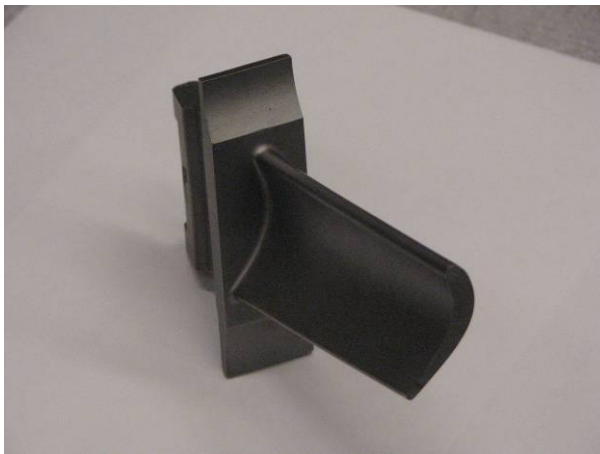
Figure 4. Compressor blade used for calibration.

For this experiment, calibration was done against two different blade geometries. The first geometry that was tested was a relatively thin first stage compressor blade. This blade shown in Fig. 4 is ~105 mm long, ~6 mm thick at its widest point, and has a chord length of ~37 mm. This blade was chosen to see how well the probes would calibrate against a blade's geometry that was smaller than the diameter of the probe. The second geometry tested was a flat box. This box, shown mounted on the rotary stage in Fig. 3, was ~26 mm thick, ~76 mm high, and ~107 mm long. It was chosen to simulate a blade that was thicker than the diameter of the probes. In addition, it mimicked the thickness of the blades of an axial vane fan that the probes were used on to measure tip clearances. The results of the experiment on the axial vane fan will be discussed in section IV of this paper.

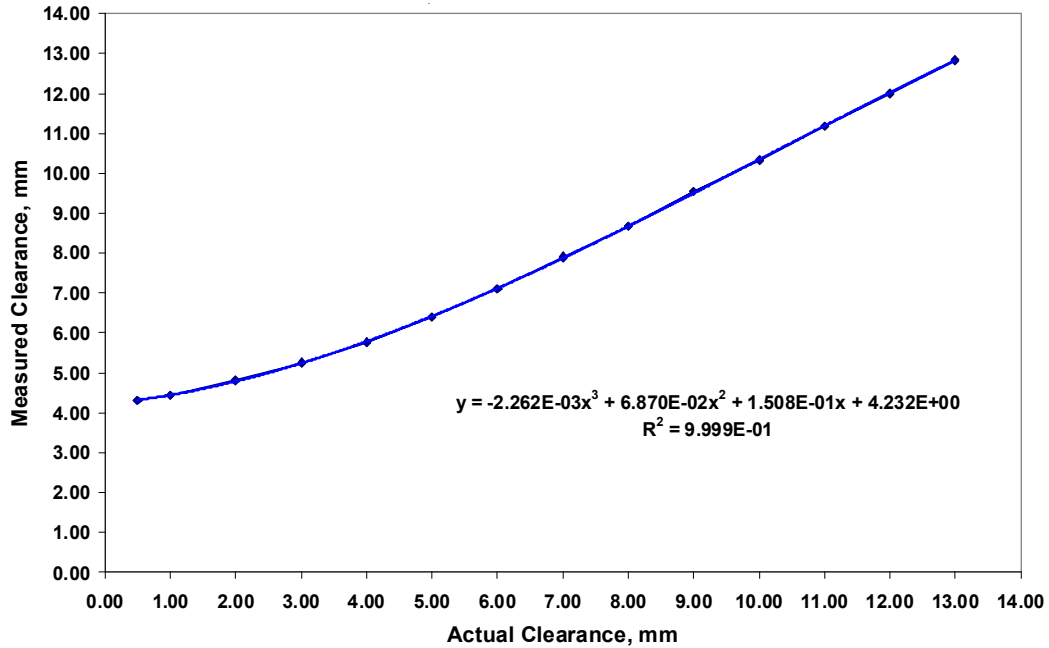
The calibration curve for a microwave probe using the thin compressor blade is shown in Fig. 5. The y-axis is the "measured" or uncorrected clearance reading that was acquired from the probe. The x-axis is the actual clearance. It represents the distance between the simulated fan casing, with sensor, and the tip of the blade. The calibration was done over a range of 0.5 to 13.0 mm. The resulting curve is a third-order polynomial and has fairly good sensitivity at clearances above 2 mm. At clearances lower than 2 mm, the response flattens out and the sensor becomes less sensitive. This effect is believed to be caused by the near field properties of the probe's antenna and its interaction with the geometry of the relatively thin blade. The curve observed in Fig. 5 was a typical response when using the probes on a thin blade when compared to the probes diameter. For this calibration the sensor's polarity was aligned to be parallel with the length of the blade tip to maximize the amount of energy reflected from the blade.

Figure 5. Calibration curve for thin blade.

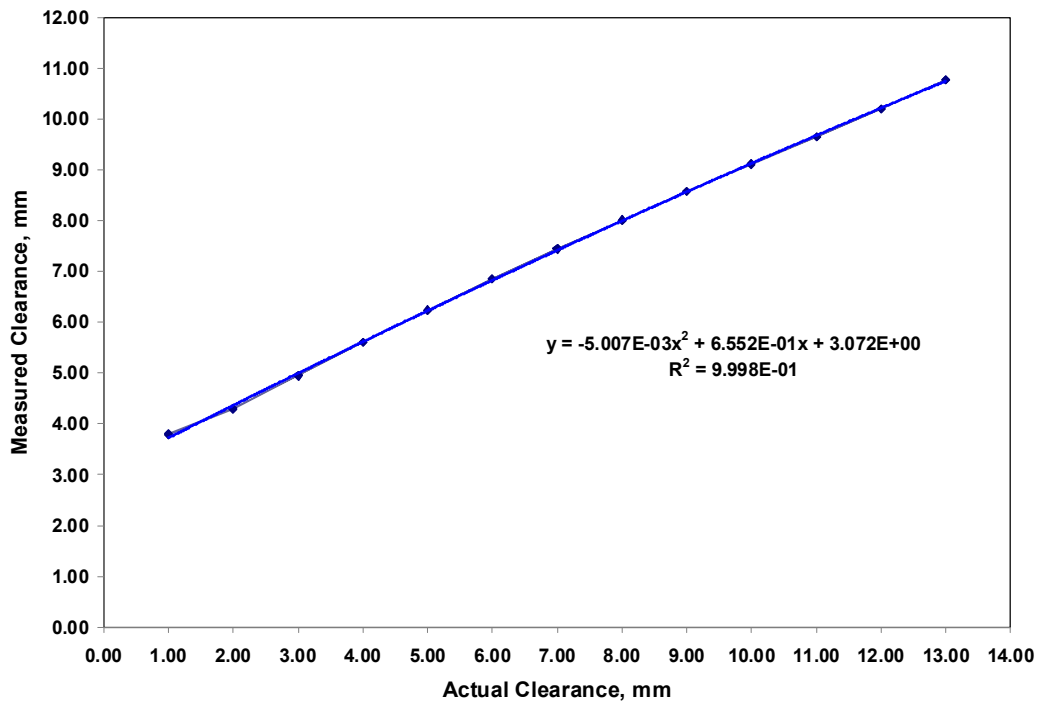
Figure 6 shows the calibration curve for the same probe against the simulated thick blade. This calibration was undertaken as a means of capturing the necessary correction data for measuring the tip clearances on a large axial vane located at the NASA Glenn Research Center. As in the previous case, the y-axis is the “measured” or uncorrected clearance reading that was acquired from the probe. The x-axis is the actual clearance distance between the simulated fan casing, with sensor, and the tip of the blade. The calibration was done over a range of 1.0 to 13.0

Figure 6. Calibration curve for simulated thick blade.

mm. The resulting curve is a second-order polynomial and has a relatively constant sensitivity over the entire range. For this calibration the sensor's polarity was aligned perpendicular to the length of the blade tip. A similar shaped curve, with slightly different values, was observed for the calibration where the probe's polarity was aligned parallel to the thick blade's tip. The curve reported in Fig. 6 was a typical response when using the probes against a blade whose thickness was of the same order of magnitude or greater than the diameter of the probe. As a means of evaluating the overall accuracy and repeatability associated with the calibrations on the thick blade, both the probe and blade were reset and the experiments were repeated across the entire range with the clearance corrections applied to the measurements. The worst case error that was observed between the actual distance and the corrected distance measured by the sensor in these verification tests was ~ 0.15 mm. It is believed that a portion of this error can be attributed to inaccuracies and biases associated with the calibration setup. In subsequent calibrations on a turbofan blade, improvements in the calibration setup resulted in errors that were much smaller. This calibration is presented in section V of this paper. In summary the calibrations against the thin blade and the simulated thick blade were primarily undertaken as a means to better understand the probes and develop techniques for their calibration. These objectives were achieved and the probes were successfully calibrated against two blade geometries.

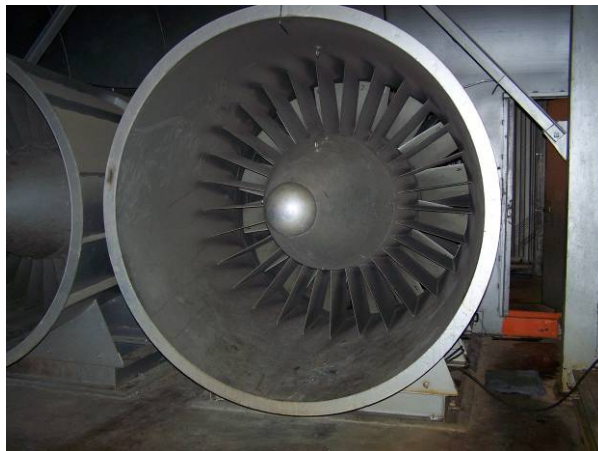
The second experiment was to use a sensor to make tip clearance measurements on a large axial vane fan located at the NASA Glenn Research Center's 10- by 10-Foot Supersonic Wind Tunnel (10 \times 10 SWT) Facility. The purpose of this experiment was to acquire experience in using the sensors on an actual piece of rotating machinery. It was also intended as a means to evaluate how well the calibrations accomplished in the laboratory transferred into an actual use in the field. The axial vane fan that was used is shown in Fig. 7. It is part of the 10 \times 10 SWT's infrastructure and is located in the tunnel's Air Dryer Building⁷. It is one of eight fans that are used to heat, dry, and cool the wind tunnel's alumina beds. The fan is ~ 1.8 M in diameter and has 16 blades. The blades are ~ 362 mm long, with a chord length of ~ 267 mm and a maximum thickness of ~ 26 mm at the midchord position. Provisions were made for the installation of two probes 90 degrees apart in the fan's casing at the midchord position of the blades. A calibrated microwave tip clearance probe was installed in one of the locations. A picture of a probe installed in the fan is shown in Fig. 8.

Figure 7. Axial Vane Fan located at the 10x10 SWT.

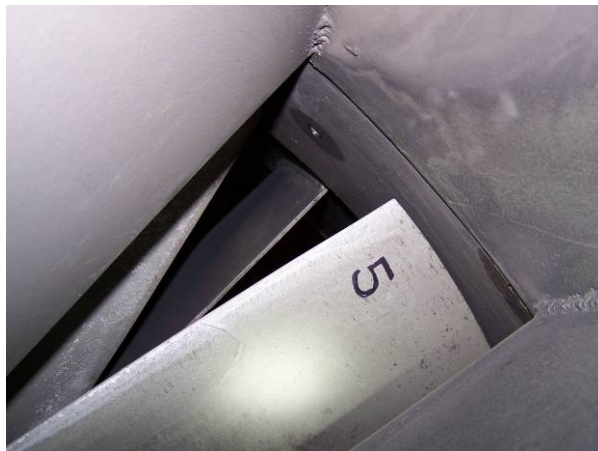
Figure 8. Probe installation on the axial vane fan.

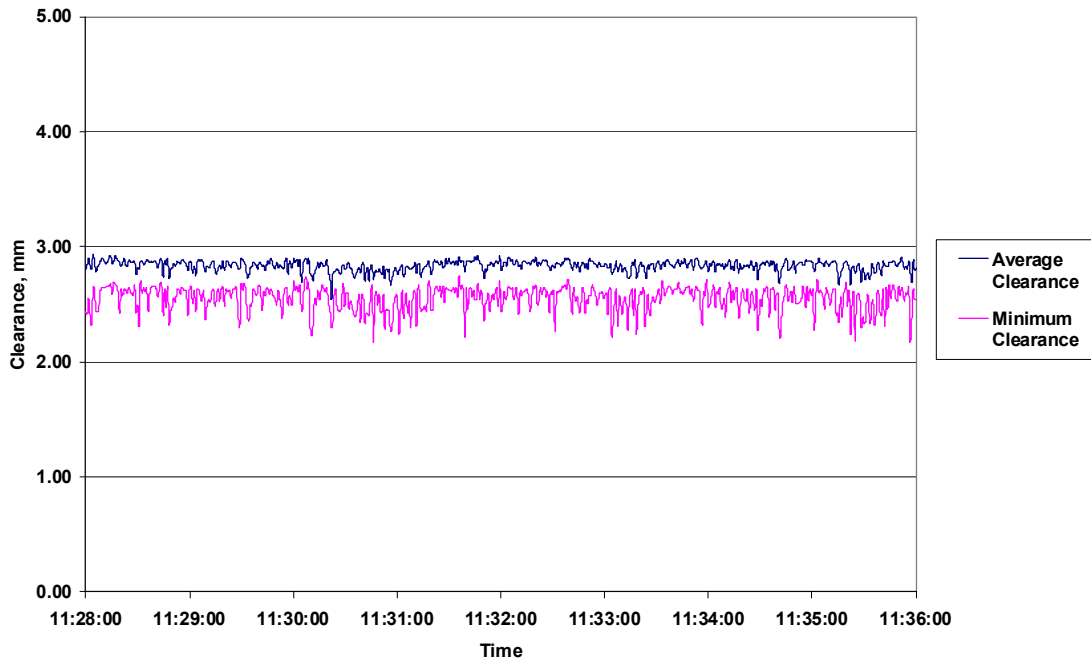
A time history of the average and minimum clearances measured for an operation of the vane fan is shown in Fig. 9. For this particular test run the probe was installed so its polarity was aligned perpendicular to the length of the blade tips. The data was acquired at a fixed sampling rate of 400 KHZ over an 8-minute period of the fan operating at a steady state condition of 1200 RPM. The average blade tip clearance for the 16 blades over this time period was 2.84 mm. The minimum clearance detected over this period was 2.17 mm with average minimum running at 2.55 mm. These measurements were consistent with the expected operation of the vane fan and are in line with the clearance measurements that were made statically. For comparison, the measurements that were made statically at this probe's location yielded a 16-blade average tip clearance of 3.33 mm and a minimum blade tip clearance of 2.87 mm. The approximate half a millimeter difference between the static and running clearance measurements was due to blades locking in their seats during fan operation. This effect is hard to duplicate when making static measurements. Other test runs were accomplished by varying the probe's polarity (parallel to the blade tips) and acquiring data using different acquisition modes (fixed sample rate vs. synchronous sample rate). The results of these runs were similar in magnitude to the results shown below. However, it was observed that for the fan's "thick" blades, a cleaner, less noisy signal was obtained with the probes polarity aligned in perpendicular to the length of the blade tip.

Figure 9. Average and minimum clearance time history for axial vane fan operation.

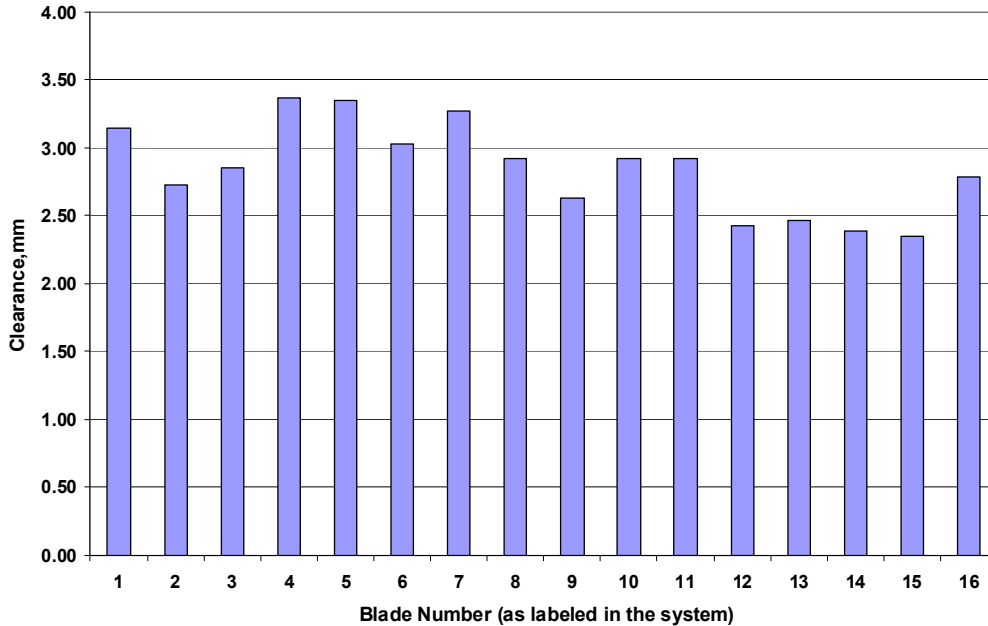
In regards to the sensors' ability to detect individual blade clearances, Fig. 10 shows the individual clearances that were measured for one revolution of the fan. The x-axis displays the blade number and the y-axis displays the measured tip clearances in millimeters. For this particular revolution the measured clearances ranged from 2.34 to 3.37 mm, with the variation in clearances between blades being on the order of tenths of millimeters. As previously indicated these clearances are in-line with the expected operation of the vane fan.

Figure 10. Individual blade clearances on axial vane fan for one revolution.

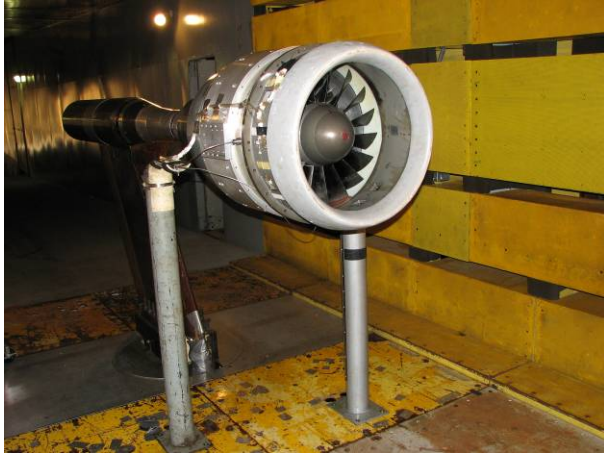
Figure 11. NASA Turbofan.

to evaluate the sensor's ability to acquire data on aero engine size test article and blades. The turbofan has 18 blades and is shown in Fig. 11. It is being used to develop and evaluate noise reduction concepts under NASA's Subsonic Fixed Wing Program. Two probes were installed 90 degrees apart in the turbofan's casing at the midchord position of the blades. The first probe was installed at the 90 degree position, which is on the left-hand side of the casing looking downstream at the fan. The second probe was installed at the 180 degree position, which is on the bottom of the casing looking downstream at the fan.

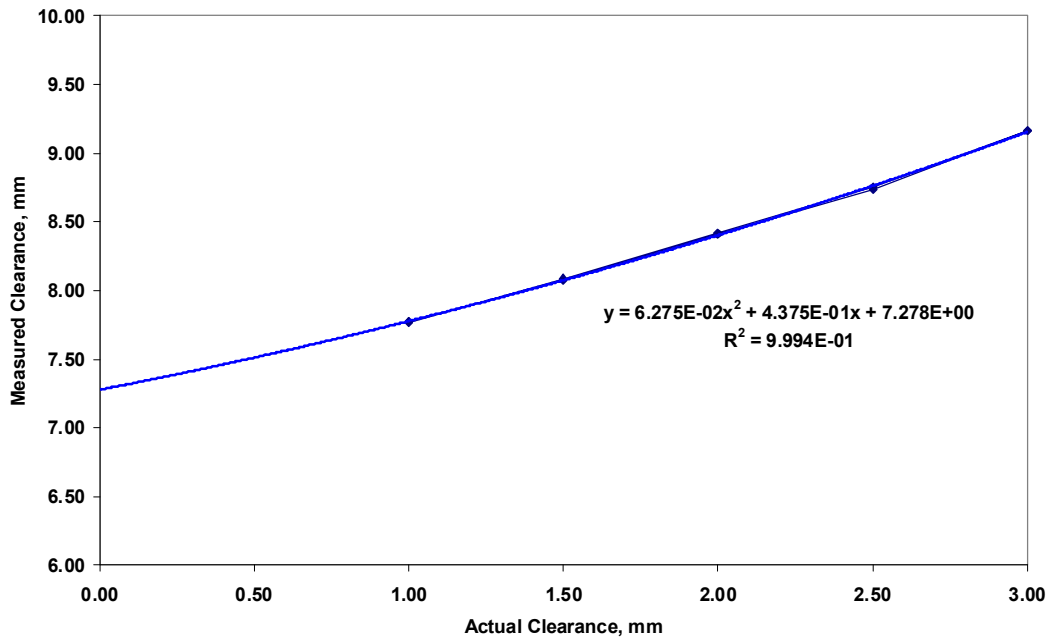
In order to make the tip clearance measurements on the turbofan a series of calibrations were carried out to map the actual clearance to the uncorrected clearance measured by the sensor. The calibration was done using the previously described calibration rig with an actual blade and the probes installed in a section of the fan casing. This setup allowed the calibration to be done in a configuration that was as close as possible to the actual use on the turbofan. It also allowed the offset due to the probe being recessed in the non-ferrous rub strip to be included in the calibration. For this application the sensor's polarity was aligned to be parallel with the length of the blade tip to maximize the amount of energy reflected from the blade. The calibrations were accomplished over a range from 1.0 to 3.0 mm between the tip of the blade and the fan casing. The calibration curve for one of the probes is shown in Fig. 12. The y-axis is the "measured" or uncorrected clearance reading that was acquired from the probe. The x-axis is the actual clearance distance between the fan casing and the tip of the blade. The resulting curve is a second-order polynomial and shows good sensitivity over the range of calibration. One issue involved with the calibration is that the clearances on the turbofan were expected to be a little under a millimeter. Due to the particular geometry of this setup obtaining a repeatable calibration of distances under a millimeter between the fan casing and blade was not possible. However, since the probes had a second-order response in the targeted calibration range, it was determined that accurate results could be obtained in projecting the curve fit for clearances that were a little under the calibrated range. This assumption held true in previous calibrations. As a means of evaluating the calibration and its repeatability, a verification test was conducted by resetting the probe and repeating the measurements across

Figure 12. Calibration curve for nickel tipped composite blade.

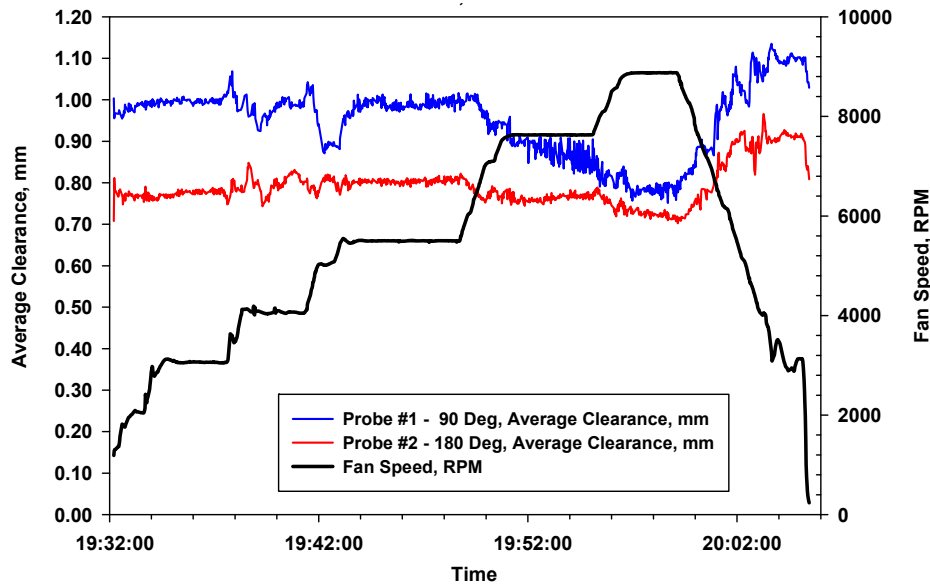
Blade tip clearance and tip timing data was acquired for several test runs of the NASA turbofan. Data was acquired at a variable sampling rate that was synchronized to the fans speed. Each measurement consisted of two revolutions of data with 10,000 samples taken per revolution. Good clearance data was acquired in this experiment. Figure 13 shows the 18-blade average tip clearance measurements and the fan speed for one of the test runs. From these charts it is observed that the average tip clearance decreases as the fan speed is increased. This result is expected and is mostly due to the growth of the composite blades as the fan operates at higher speeds. Probe #1 measured a decrease of 0.22 mm and probe #2 measured a decrease of 0.06 mm as the speed increased to 8875 RPM. The change in clearance observed in this experiment was within the range predicted for these blades. In addition, the change in tip clearances measured by the microwave sensors were very similar to previously observed values. In a previous test entry using capacitive clearance sensors, changes in tip clearances up to 0.22 mm were observed when the turbofan was operated over the same speed range.

Figure 13. Average Blade Tip Clearances and Fan Speed from the NASA Turbofan Experiment.

One anomaly that was observed in the data of Fig. 13 is the difference in the absolute clearance values measured by each of the probes. The average blade tip clearance measurement made at static conditions for probes #1 and #2 was 0.86 and 0.91 mm, respectively. Assuming that the blades do not experience much growth at low speed, the clearances measured at these speeds should be close to the values measured statically. Using this assumption, it is observed in Fig. 13 that probe #1 was reading ~0.14 mm high and probe #2 was reading ~0.13 mm low in absolute clearance values. It is believed that this zero shift in measured clearances is due to dissimilarities between the probes' installation on the turbofan and the installation used for the calibration. Any differences in probe alignment and installation depth will affect the accuracy of the measurement. Improved methods will be used in future experiments to better control these parameters so the installation used in the calibration more closely matches the installation used on the test article. It should be noted that the tip timing data acquired in this experiment is still being processed and evaluated. It is planned to present this data in future reports.

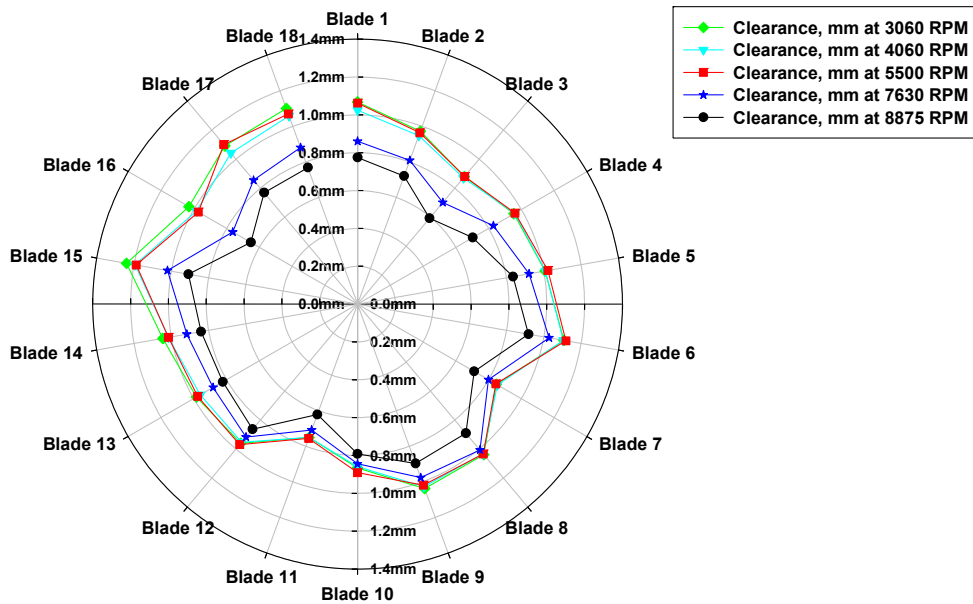
An additional means of viewing the data is shown in the polar plots of Figs. 14 and 15. These plots show the individual blade clearances measured by each of the probes for several fan speeds. As noted previously, these plots show that the individual blade tip clearances decrease as the fan speed is increased. A more noticeable change in the individual clearances can be observed in the polar plot in Fig. 14 for probe #1. This clearly shows the decrease in the individual blade tip clearances as the fan is operated at higher speeds. A less noticeable change is observed in the polar plot in Fig. 15 for probe #2. It still shows the overall trend of the tip clearance decreasing as speed is increased, but it is just not at the same magnitude as observed by the first probe. In reality, the small change in displacement observed by the probe at this location during the run is approaching the measurable limit for using this size of probe on this blade. However, even with this observation, these plots do show that the microwave clearance probes are sensitive enough and have sufficient resolution to pick up the minor variations that exist in the individual blade tip clearances.

Figure 14. Individual Blade Tip Clearances for Probe #1, 90 deg location – NASA Turbofan Experiment.

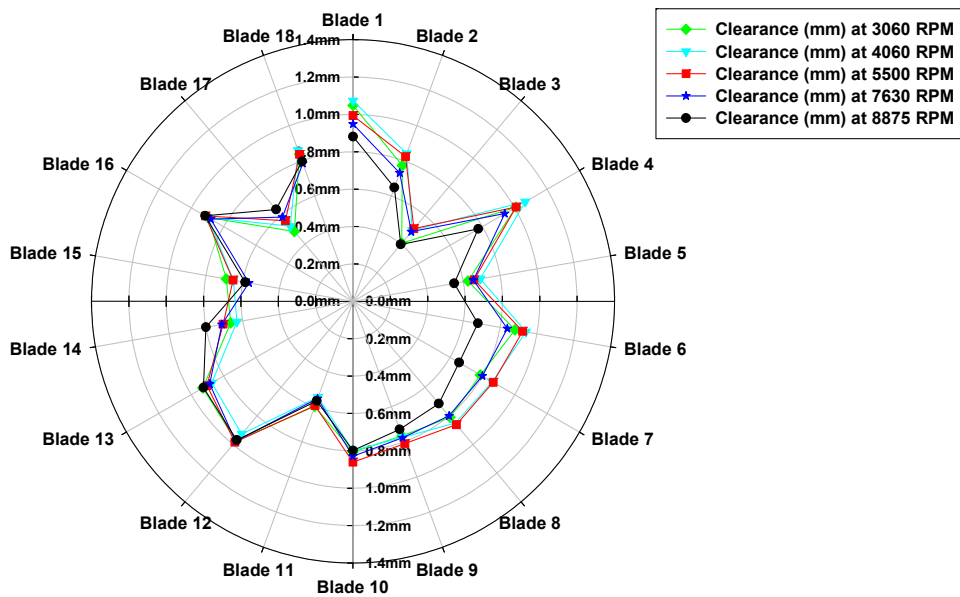
Figure 15. Individual Blade Tip Clearances for Probe #2, 180 deg location – NASA Turbofan Experiment.
