# ***WATER OPERATION AND MAINTENANCE***

***BULLETIN NO. 163***

MARCH 1993

Purple Loosestrife in Reclamation Water Systems  
Salvaging a Severely Silted Intake Structure  
Thermally Activated Valve for Frost Protection  
From the Farm Perspective  
Using Computer Simulation To Analyze Rockfall Hazards  
Penstock and Outlet Works Guard Gate and Valve Testing

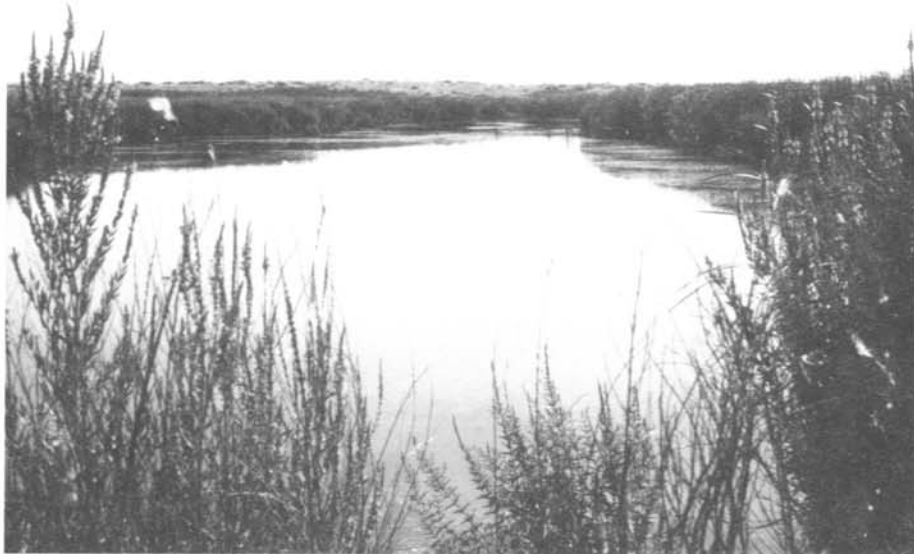
Figure 3.—The Winchester Wasteway in the Columbia Basin Project has approximately 23,000 acres of dense purple loosestrife. This once valuable habitat for waterfowl and other wildlife has been severely degraded by the invasion of this plant.

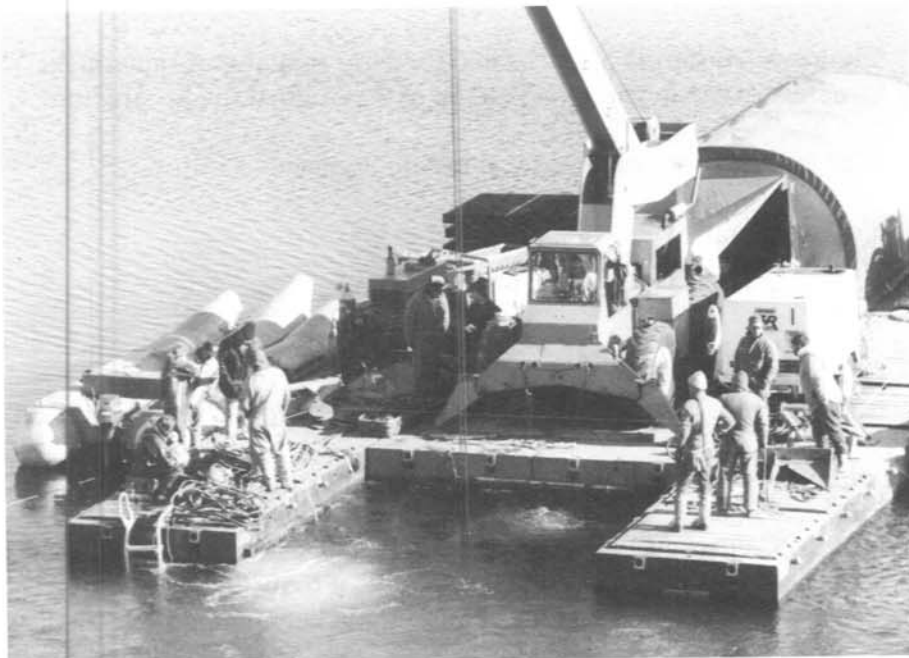
Figure 3.—Hyrum Project, Utah. Installation of new intake structure extension in progress. The crane shown in the photograph is lowering the intake structure as it is guided and secured in place by divers.

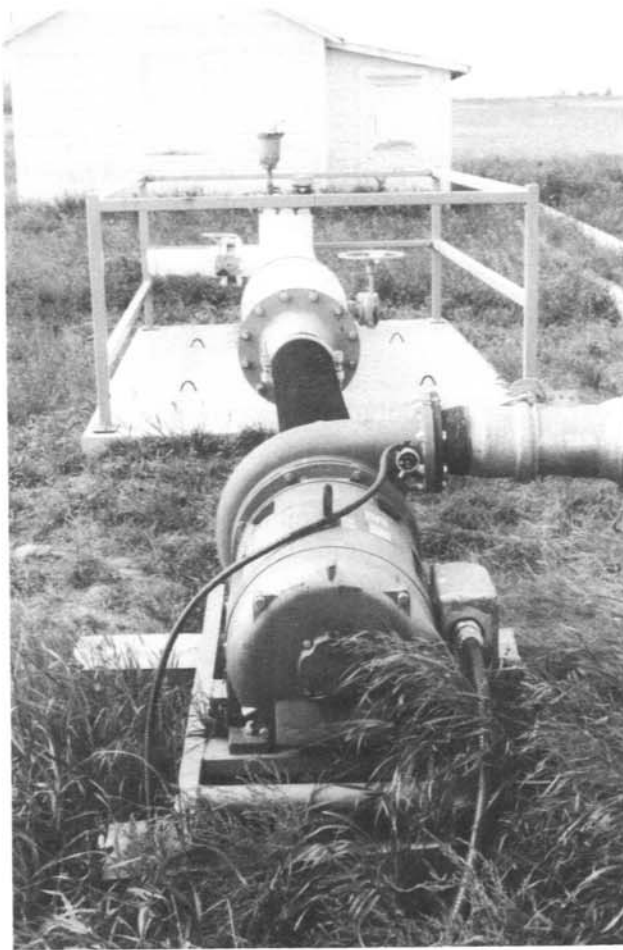
Figure 2.—Electric pump site.
