Monitoring Fine-Grained Sediment in the Colorado River Ecosystem, Arizona—Control Network and Conventional Survey Techniques

Open-File Report 2008-1276

By Joseph E. Hazel, Jr., Matt Kaplinski, Roderic A. Parnell, Keith Kohl, and John C. Schmidt

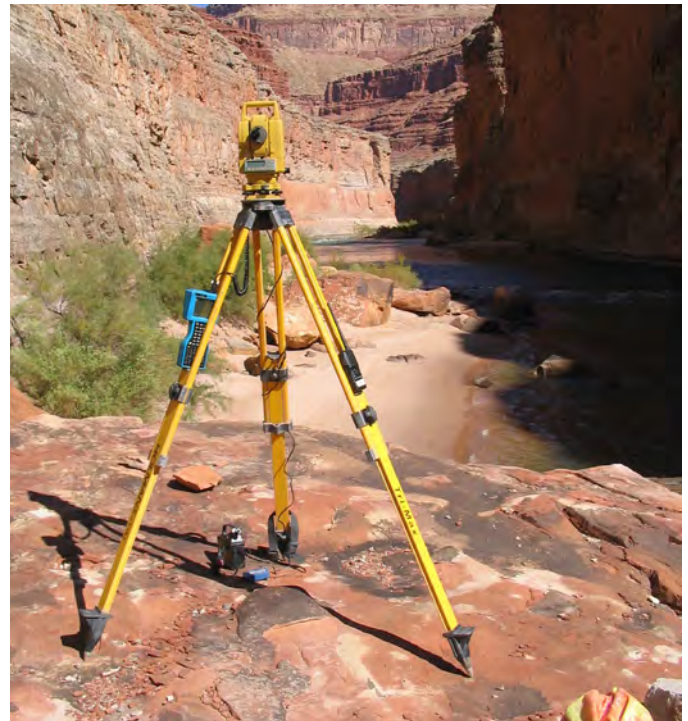
Figure 3. Total station on control point SC0299854R in reach 4 (location shown in fig. 1); view looking upstream (Photograph courtesy of Joseph E. Hazel, Jr., Northern Arizona University).

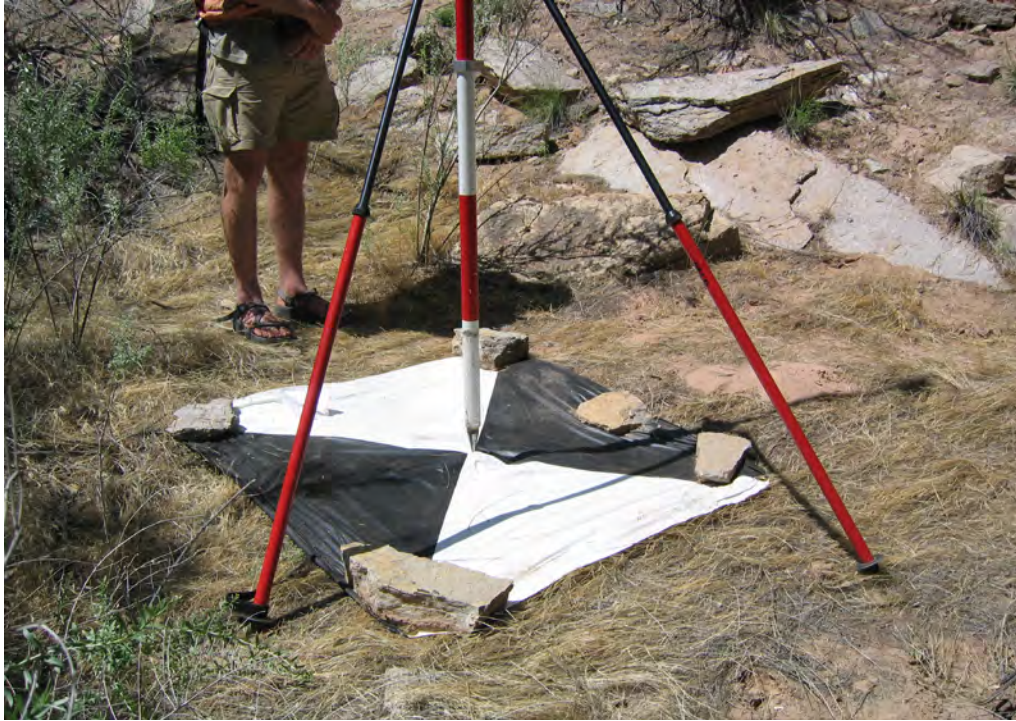
Figure 4. Metal prism pole, equipped with bipod legs for accurate leveling, used to locate each photogrammetry panel. Photograph by T. Gushue, U.S. Geological Survey.

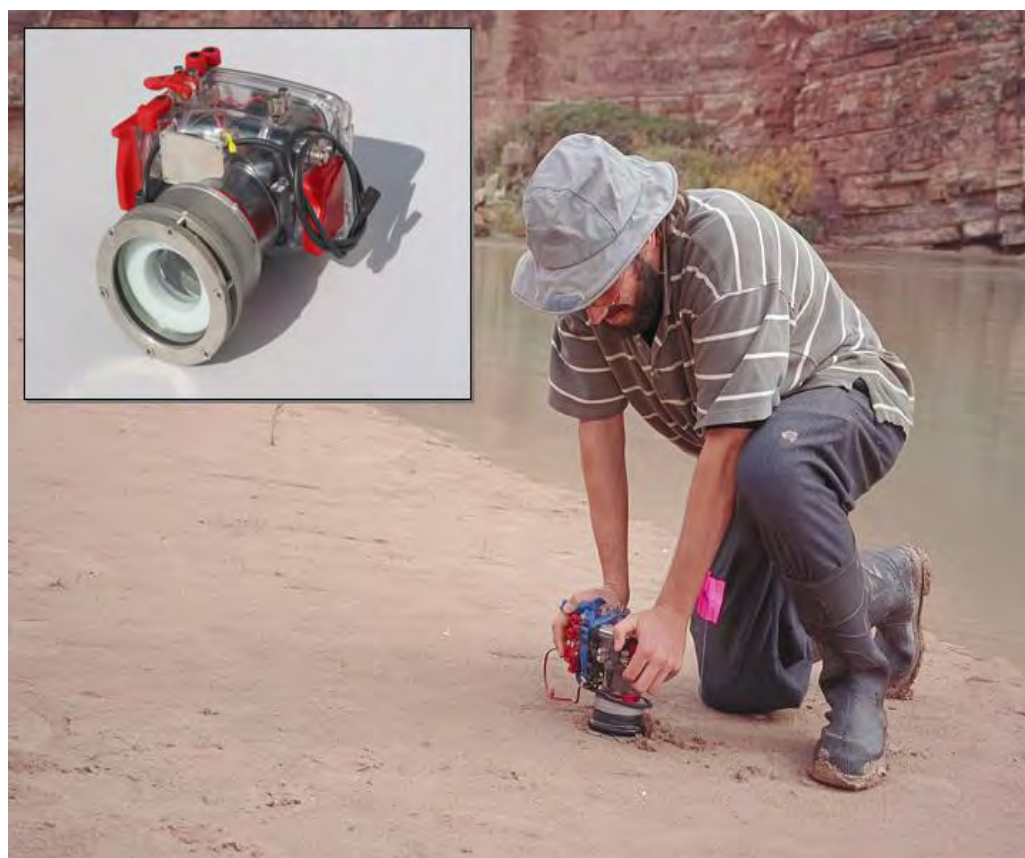
Figure 5. Pinflags used to mark the location of each grain-size measurement. Inset: digital microscope camera. Photographs by D. Rubin, U.S. Geological Survey.

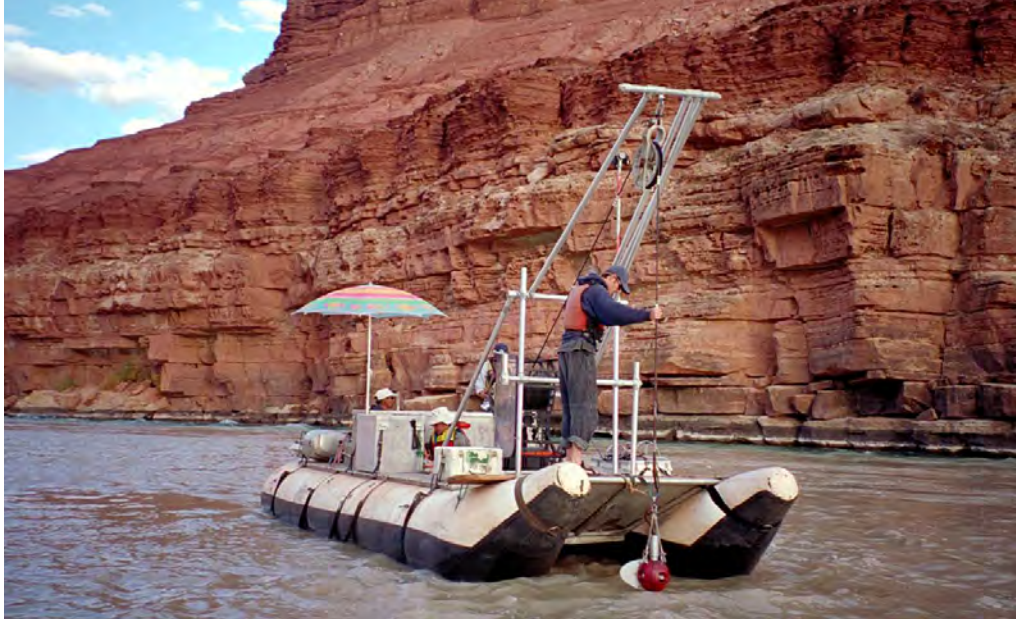
Figure 6. Seven-meter motorized raft equipped with the grain-size microscope system. The approximate position of each measurement was spatially referenced with a total station by targeting the cluster of eight reflective prisms mounted on a mast adjacent to the winch. Photograph by D. Rubin, U.S. Geological Survey.

The underwater version of the grain-size microscope system and a video sled were both tracked and spatially referenced with a total station (fig. 6). Both instruments were winched and lowered to the riverbed from a 7-m motorized raft. The position was targeted with a round cluster of eight reflective prisms mounted on a mast adjacent to the winch. Spatial-location acquisition required close coordination between the camera console operator, the radio operator/notetaker, the boat operator, and the surveyor. Each digital video image of the riverbed was tagged with a number that was then relayed to the surveyor via radio. When a sideshot
