# A Review of Engine Seal Performance and Requirements for Current and Future Army Engine Platforms

Prepared for the  
43rd Joint Propulsion Conference  
cosponsored by the AIAA, ASME, SAE, and ASEE  
Cincinnati, Ohio, July 8–11, 2007

## **Abstract**

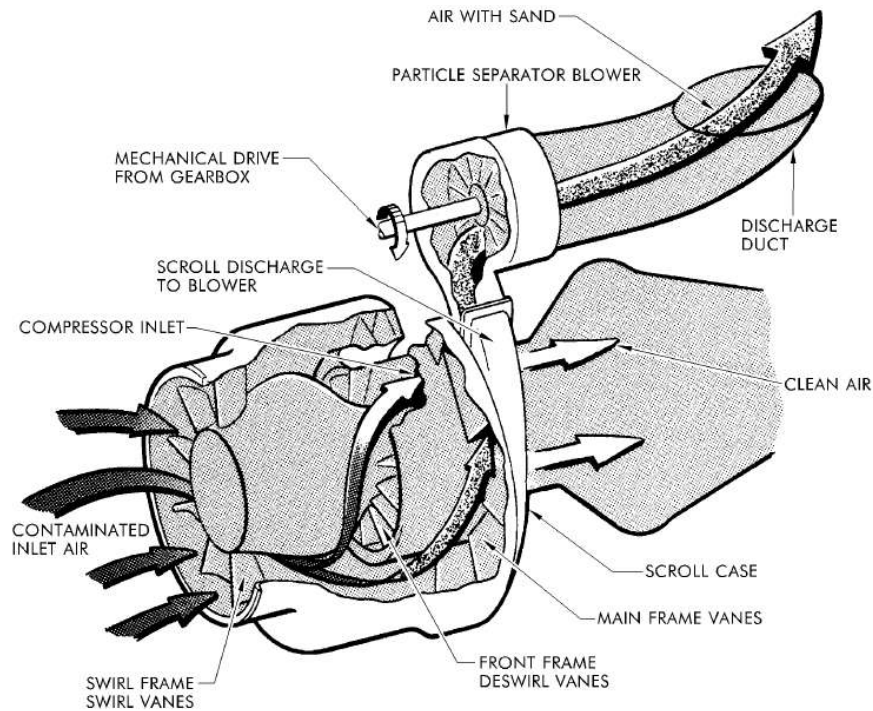
Figure 1.—Inlet particle separator.

The inlet particle separator (IPS), figure 1, on the T-700 is composed of the swirl frame, front frame, and main frame. The swirl frame, at the front of the engine, contains angled swirl vanes which forces the air into a rotational motion. Sand and other debris are separated from the air through inertia. The particles move to the outer diameter of the main frame, into a scroll case, and out of the engine through a blower. The “clean” air in the swirl frame is re-oriented to the compressor inlet via the front frame deswirl vanes (ref. 10). The IPS is designed to provide 90 percent protection from FOD (i.e., stones, ice, metal particles, sticks, leaves, etc.) and separates 85 to 95 percent of sand and dust particles (ref. 4).

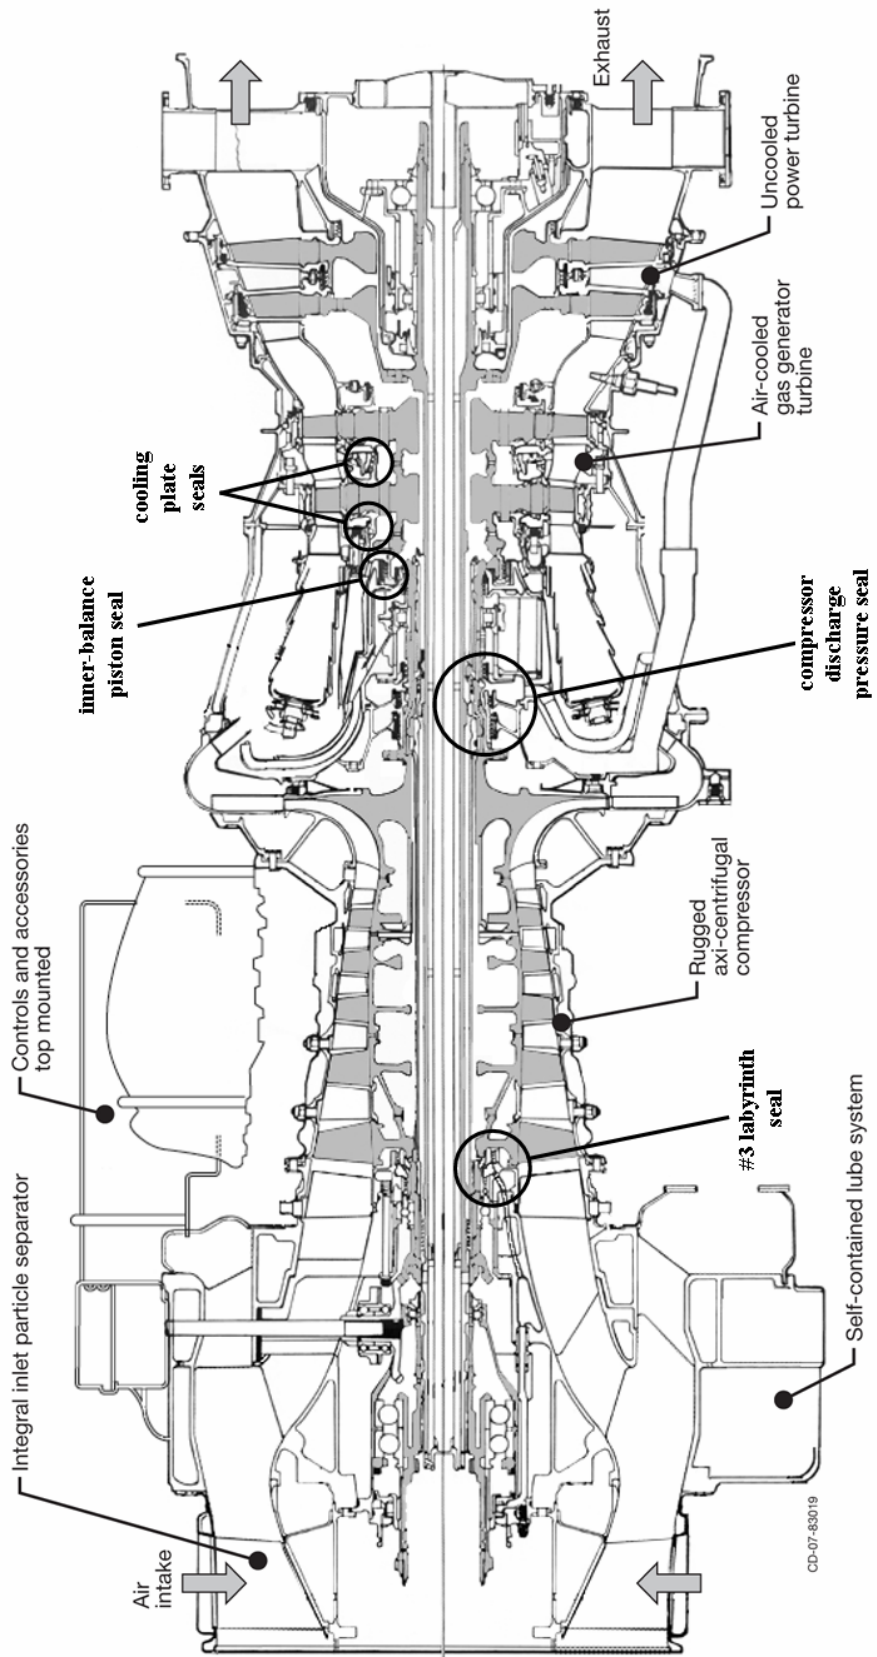
Figure 2.—T-700 Engine schematic showing locations of various labyrinth seals.

Data from 4 labyrinth seals taken from the T-700 overhaul facility at CCAD are discussed. They are the #3 labyrinth seal, the CDP seal, the IBP seal, and the labyrinth seals on the gas generator cooling plates, (fig. 2).

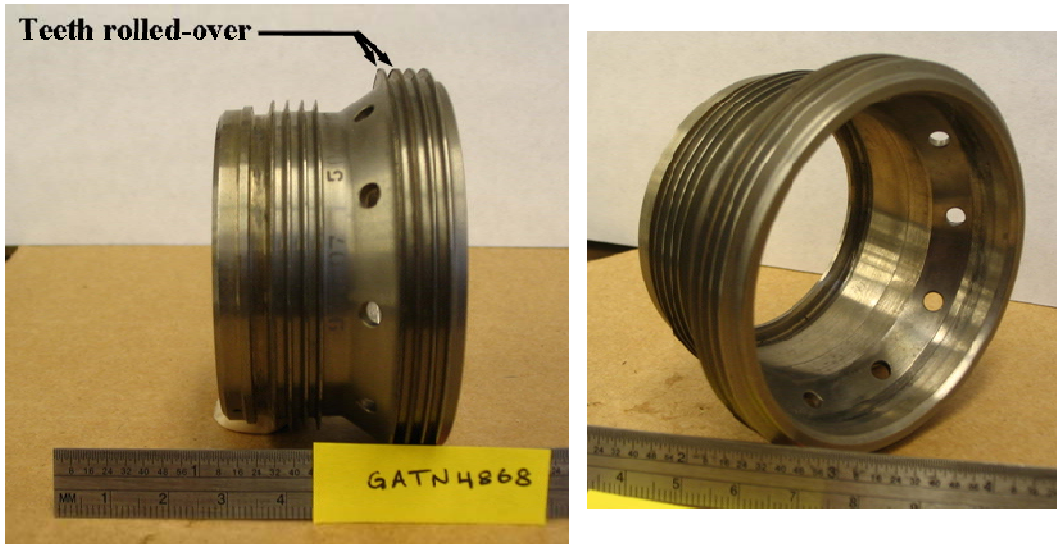
Figure 3.—No. 3 labyrinth seal.

The #3 labyrinth seal (fig. 3), composed of 2 sets of 4-knife labyrinth teeth, is located forward and radially inward from the 1st stage compressor. The forward labyrinth teeth seal the aft end of the forward or A-sump. Purge air is bled from the fourth stage compressor to a space between the 2 sets of teeth to separate the air and oil cavities. Air leakage through the rear labyrinth teeth is fed back into the compressor.

Three #3 labyrinth seals received from CCAD showed no visible signs of sand impaction. Operational hours varied from nearly 2000 to over 6000 hr and all three were marked “undersized”. Two of the three labyrinth seals exhibited labyrinth seal tooth tip roll-over on the first two teeth to the right of the air inlet ports as shown in figure 3.

The #3 labyrinth seal is replaced if diametral wear limits on the labyrinth teeth are exceeded. The wear limits only apply to the labyrinth teeth directly adjacent to the bleed air inlet ports as shown in figure 3.

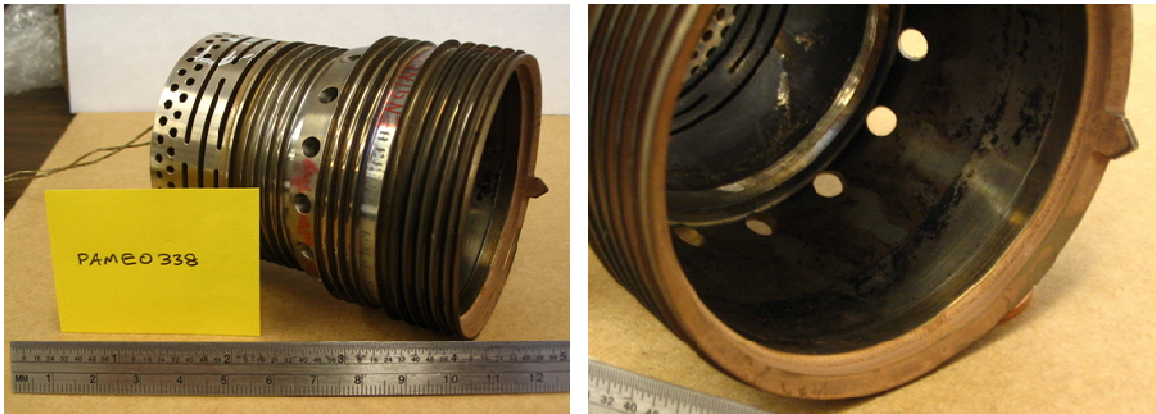
Figure 4.—Compressor discharge pressure seal with impacted sand.

The CDP seal (figs. 4 and 5) is composed of 3 sets of labyrinth teeth. CDP seal air leakage from the forward 7-knife labyrinth comes from impeller tip leakage and is ported to the turbine 4th stage shrouds. Fourth stage compressor bleed air feeds the cavity between the middle and rear CDP seal labyrinth teeth. This provides a positive air pressure to seal the forward end of the middle or B-sump. Air leakage from the middle labyrinth teeth is fed to the turbine 4th stage shrouds.

Three CDP seals were received from CCAD with operational hours ranging from 1600 to nearly 5000 hr. Evidence of impacted sand on the inner surface of the part is shown in figure 4 and in a modified CDP seal shown in figure 5. Sand was also observed in between the labyrinth teeth on the largest diameter of the CDP and modified CDP. It is most likely the sand was present in the air leakage from the centrifugal compressor tip since the labyrinth teeth adjacent to the inlet ports fed by the fourth stage compressor bleed air showed no signs of sand impaction. Micrographs shown in figures 8 and 9 give a rough indication of the size of sand particles taken from the CDP seals in figure 5. The CDP seal labyrinth teeth closest to the impacted sand exhibited some discoloration possibly due to heat exposure, but are otherwise smooth. Some of the remaining teeth on the CDP have nicks possibly due to handling. The modified CDP labyrinth teeth closest to the location of impacted sand are black and rough to the touch. Two of the teeth are slightly rolled-over at the tip.

Coated seals include the CDP, IBP, and cooling plate seals. The CDP seal can be recoated provided that the coating has not worn through the base material and the minimum average seal diameters are met, otherwise the CDP seal is scrapped. Recoating the CDP seal involves a number of operations. These encompass cleaning the part for grease, oil, and dirt, followed by clean-up machining, then grit blasting and welding seal material to the part, rough machining, visual inspection with FPI, heat treatment, followed by abrasive grit blasting, final machining, fluorescent penetrant inspection (FPI), and final identification.

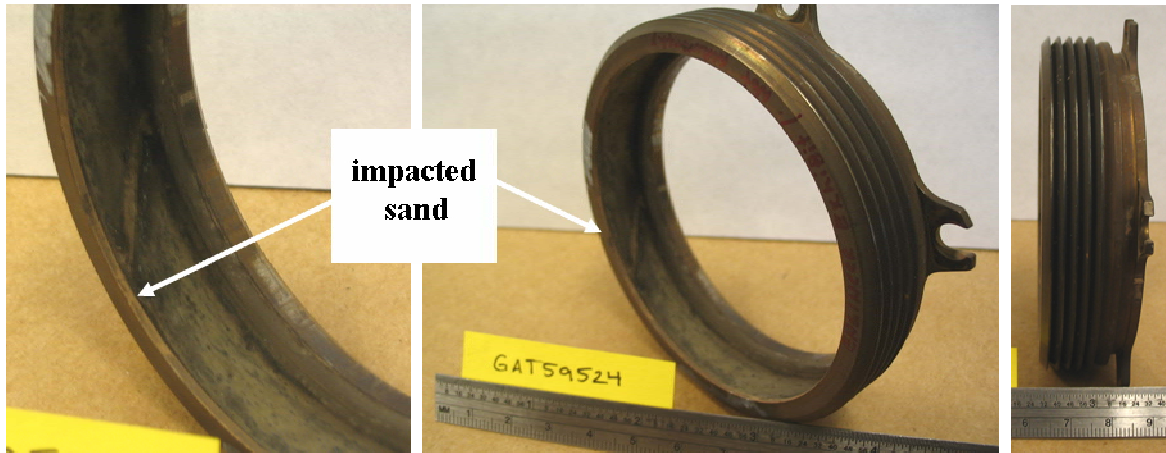
Figure 6.—Inner-balance piston seal.

The inner balance piston (IBP) seal (fig. 6) is a 5-knife labyrinth. A portion of the cooling air from around the combustor is re-directed by the inner balance piston seal to the 3rd stage turbine flowpath.

All three IBP seals were determined to be “undersized” per CCAD with operational hours ranging from 800 to 2000. Some impacted sand was found on the forward lip of one IBP seal as shown in figure 6. A black, oily, soot-like substance was also observed on the inner surface of the IBP. The likely source of the impacted sand is from the cooling air flows past the combustor of the T-700. No sand was observed on or in between the labyrinth teeth.

As with the CDP seal, if usable wear limits on the IBP are exceeded, the seal can be recoated provided that minimum diametral wear limits are met and that the coating has not worn through to the base material. Recoating involves the same operations as the CDP seal.

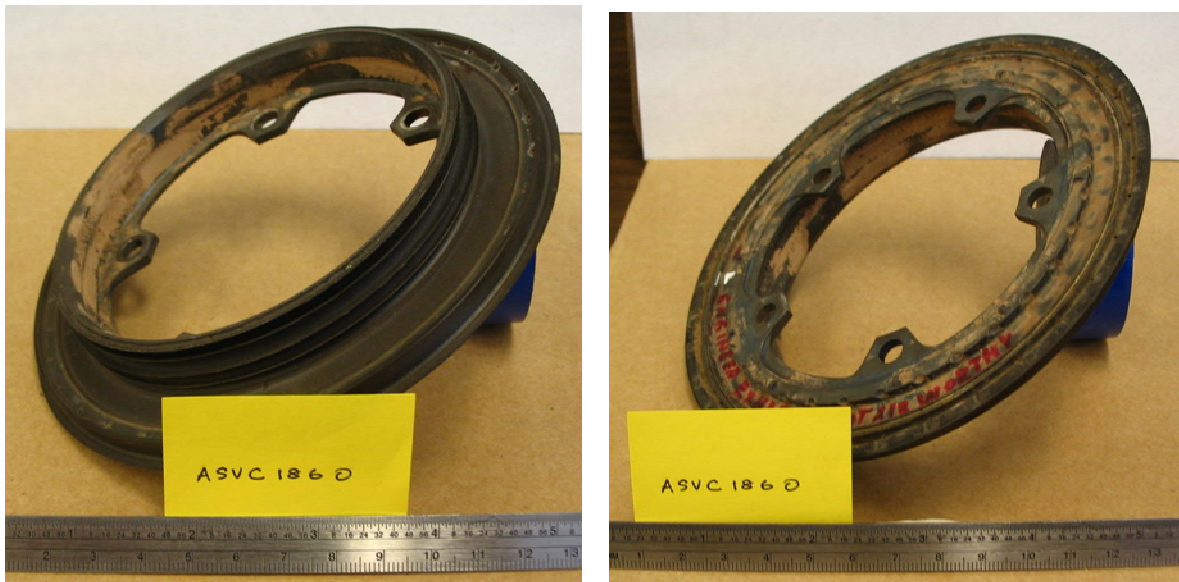
Figure 7.—Forward cooling plate with impacted sand.

Cooling plates (fig. 7) with 4-knife labyrinth teeth are located on the aft and rear of the 1st stage turbine disk. The seals serve to direct cooling air to the 1st and 2nd stage turbine blades. Also, together with the outer balance piston seal they prevent cooling air from escaping to the main gas stream.

Three forward cooling plates were received from CCAD with operation hours ranging from 2000 to 3000 hr. Labyrinth teeth on one cooling plate were blackened and rough to the touch. Coating was chipped on most of the teeth. Another cooling plate, figure 7, showed impacted sand on both the inner surface and backside. Micrographs of the sand taken from this part are shown in figures 10 and 11. The source of the sand is likely from the cooling air flows around the combustor of the T-700.

In addition to usable coating wear limits, the cooling plate labyrinth seals have percent chipped limits before the part is recoated. Recoating involves cleaning, grit blasting, recoating, inspecting the coating for flaws, and final machining the coating to specifications.

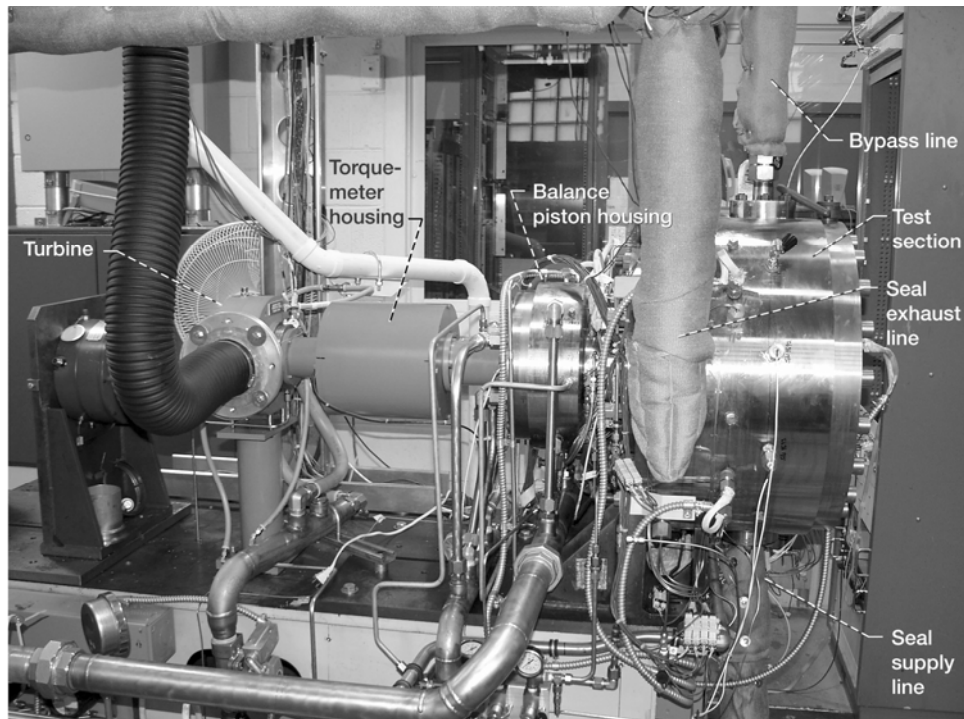
Figure 12.—NASA High Temperature, High Speed Turbine Seal Test Rig.

The High Temperature, High Speed Turbine Seal Test Rig (fig. 12) is designed to measure the leakage performance and power loss of circumferential seals at pressure differentials from 0 to 250 psid, surface speeds in excess of 1200 ft/s and inlet air temperatures from 70 to 1500 °F. The overhung 215.9 mm diameter seal test disk is mounted on a shaft supported by two oil-lubricated bearings and driven by an air turbine. A torque meter is used to measure seal power loss. A more detailed description of the test rig and facility capabilities can be found in reference 21. Comparisons of leakage performance and power loss of brush, finger, and labyrinth seals tested in this facility can be found in papers by Proctor et al. (ref. 22) and Delgado et al. (ref. 23). Generally speaking, brush seals and finger seals have

very similar leakage rates and power losses. Both brush and finger seals have leakage rates substantially less (~50 percent) than labyrinth seals, but wear due to contacting operation. If properly designed for a given application the wear rate of these seal types is sufficiently low to merit using them in an engine to gain the efficiency of the lower leakage rate. The higher temperatures and speeds of some advanced gas turbine engines are sufficient to cause bristle tip melting and excessive wear, which is the motivation for pursuing low leakage, noncontacting seal concepts.

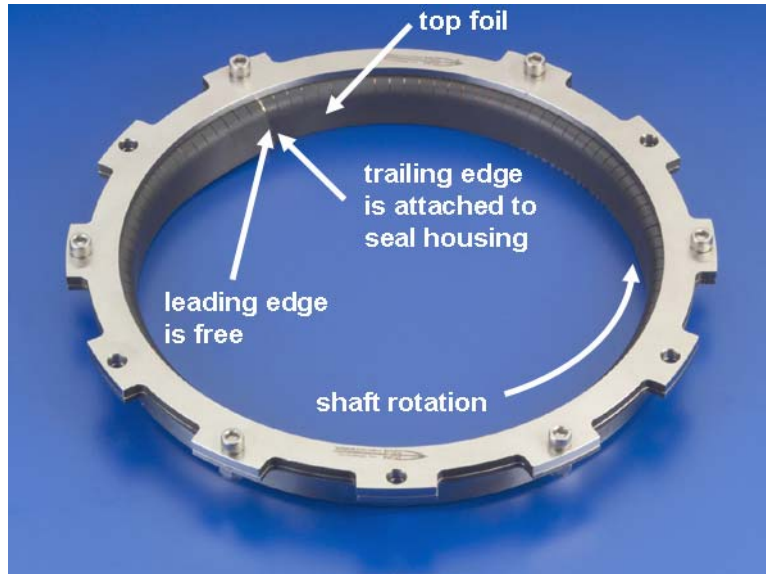
Figure 13.—Mohawk Innovative Technology Inc. foil seal.

The foil seal is one type of noncontacting seal concept that has been investigated (refs. 24 and 25). This circumferential seal is based on journal foil bearing technology in which a top foil anchored at a single circumferential location on the inner diameter of the seal housing wraps around the ID to the anchor point. Corrugated bump foils between the top foil and bearing housing provide stiffness and support to the top foil keeping it close to the rotor, but allowing for rotor growth and dynamic motion. During rotation hydrodynamic forces push the top foil away allowing the rotor to ride on a thin film of air. A foil seal is formed by using two layers of top foils, each with slots on one edge so that it may be formed to block axial flow through the bump foils. The top foils are clocked so that the tabs of one block the flow through the slots of the other. The 8.5 in. diameter seal shown in figure 13 was tested in the NASA facility and was successfully operated up to 25,000 rpm. Its leakage flow factor was about twice that of brush or finger seals. Since this is counter to previous findings with smaller diameter seals it was concluded that there are some scaling issues that need to be addressed (ref. 26).

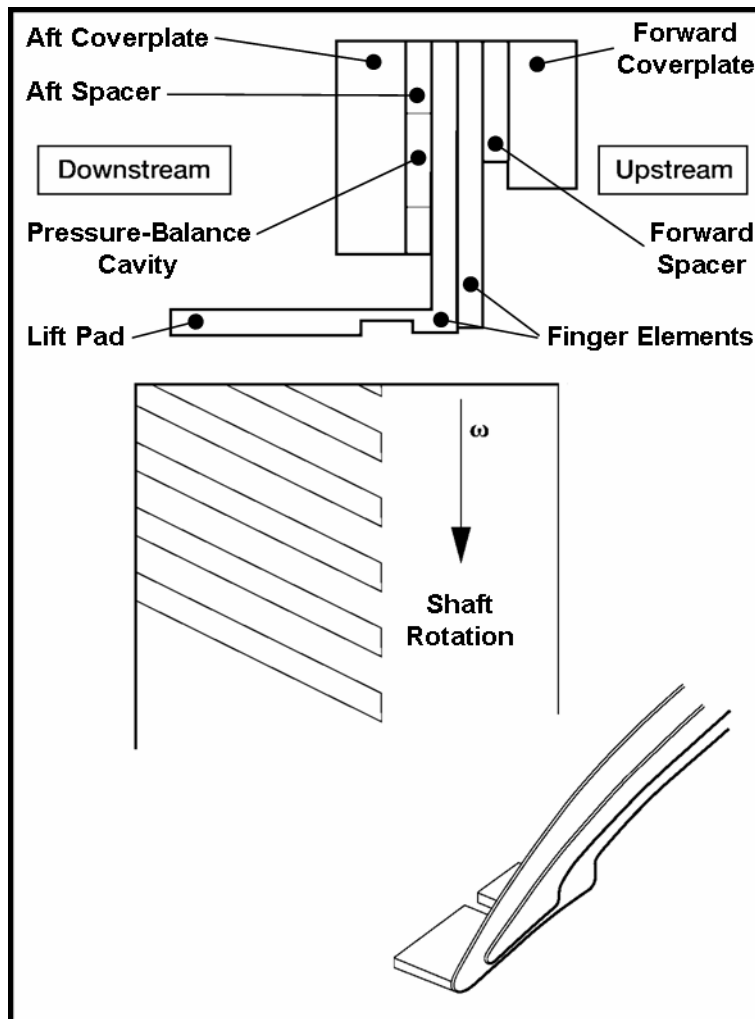
Figure 14.—NASA noncontacting finger seal concept.

The noncontacting finger seal combines the compliant features of the finger seal, which accommodate geometry changes due to thermal and dynamic conditions, with hydrodynamic and/or hydrostatic lift pads, which ride on a thin film of air and prevent contact during rotation. Early noncontacting finger seals had lift pads extending from the fingers in both the upstream and downstream directions (ref. 27). The NASA-patented noncontacting finger seal, shown in figure 14, eliminates the lift pads extending in the upstream direction to reduce hydrostatic closing forces on the upstream finger element (ref. 28). This seal is comprised of a high pressure finger element adjacent to a low pressure finger element with lift pads sandwiched between a forward spacer and cover plate and an aft spacer and cover plate. The high pressure and low pressure finger element are oriented so that the fingers of one cover the slots between

the fingers of the other. A series of slots in the forward and aft spacers and holes in the finger laminates allows high pressure air to flow into the pressure balance cavity formed by the aft spacer and cover plate and low pressure finger laminate. The balance cavity is necessary to minimize hysteresis in the seal due to friction between the fingers and the seal dam (ref. 29). Various geometries on the lift pad inner diameter and on the rotor outer diameter can be used to create an opening force between the rotor and the seal. This opening force must be in balance with the pressure closing force, which is a function of the pressure differential across the seal, finger stiffness, and friction within the seal. The opening force may be hydrodynamic in nature and require shaft rotation to be generated or it may be hydrostatically generated once a pressure differential is applied or it may be a combination of the two. Three-dimensional fluid analysis and some structural analysis has been done to gain understanding and select specific designs for testing (refs. 30 and 31). Room temperature tests of noncontacting finger seals with three different lift pad geometries (circumferential wedge, circumferential and axial wedge, and a Rayleigh step) conducted at pressure differentials up to 30 psid and speeds up to 15,000 rpm have demonstrated noncontacting operation (refs. 32 and 33). Hardware to test a noncontacting finger seal with concentric lift pads adjacent to a rotor with a herringbone groove pattern has been fabricated for testing in NASA's High Temperature, High Speed Turbine Seal Test Facility. Test data will be used to verify, develop, and refine analysis tools and design methodologies.

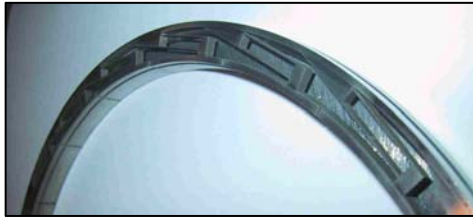
Figure 15.—Hybrid brush seal.

Hybrid brush seal technology continues to be investigated and developed. The hybrid brush seal (HBS) shown in figure 15 is a promising noncontacting, low leakage seal technology that has application to Army engines as well as commercial and advanced gas turbine engines. Hydrostatic lift pads are supported by a spring housing (fig. 16) that is radially soft and axially stiff. A brush seal is used as a secondary seal and provides damping to the hydrostatic bearing surface. Computational fluid dynamic analysis provides a means to determine the HBS functionality, such as stiffness and damping, pad pressure forces, and clearance. The HBS geometry can be modified to provide a larger or smaller operational clearance. Further, the hybrid brush seal can be installed with a larger cold clearance and maintain a smaller operational effective clearance, which means low leakage rates (ref. 34).
