## THE 1891 DRAFTING STUDIO OF THE OFFICE OF THE SUPERVISING ARCHITECT

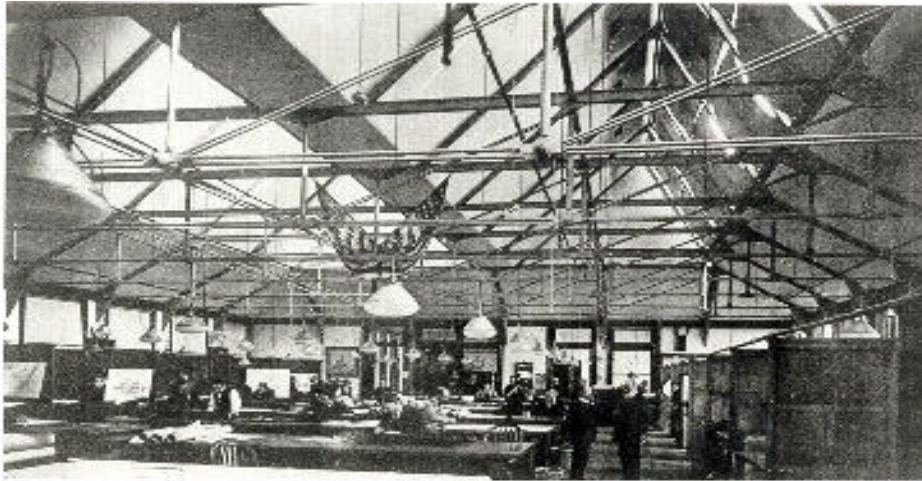
*This photograph was taken soon after the drafting studio was completed -- a time when more than 100 designers worked in this building.  
(National Archives and Records Administration)*

Windrim's innovative structure employed a light structural system of steel posts that supported a series of steel roof trusses. Large skylights on the northern facing gables flooded the drafting room with natural light. The Supervising Architect's structure is presently used for office space.

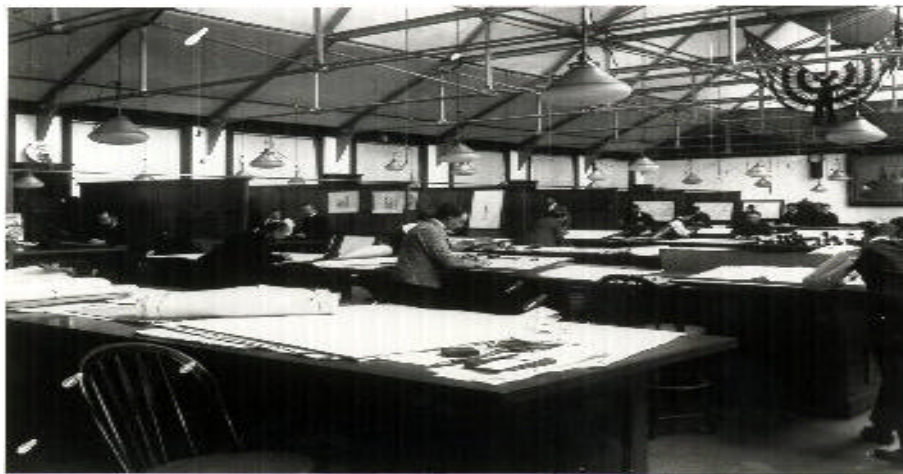
*In the background of this c. 1891 view of the drafting studio can be seen renderings of some of the federal buildings designed by the Supervising Architect in the late nineteenth century. (National Archives and Records Administration)*
