Development of Guidelines for Reduction of
Temperature Differential Damage (TDD) for
Hot Mix Asphalt Pavement Projects in Connecticut

Construction Report

Report No. 2222-1-99-5

Connecticut Department of Transportation
Bureau of Engineering and Highway Operations
Division of Research

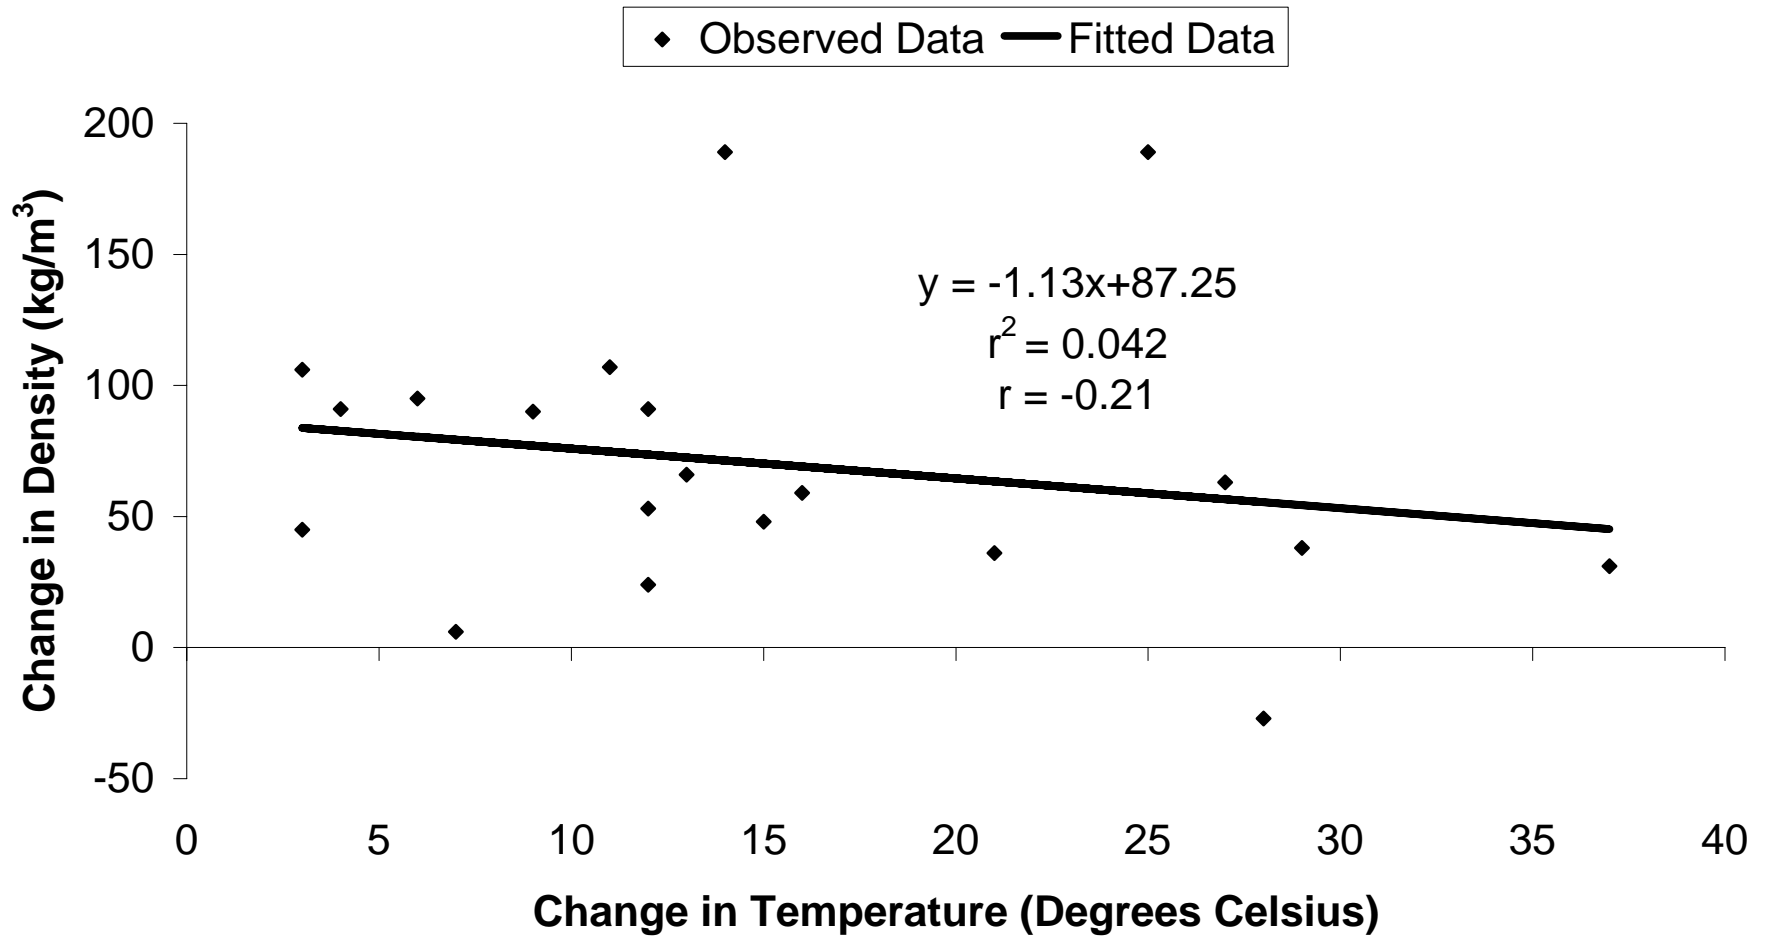
Site 1 - Relationship Between Change in Temperature and Change in Density

While the author agrees that a pavement's density will tend to vary because of concentrations of cold material, a valid linear or curvilinear statistical relationship could not be shown (see Figures 1-6, pages 40-45). The author does not agree that the cause of the problem being called cyclic (particle) segregation is a problem of temperature differentials in the loads of HMA at the job site. The author believes that the problem of particle segregation is a very real problem, capable of existing independently of temperature differentials.

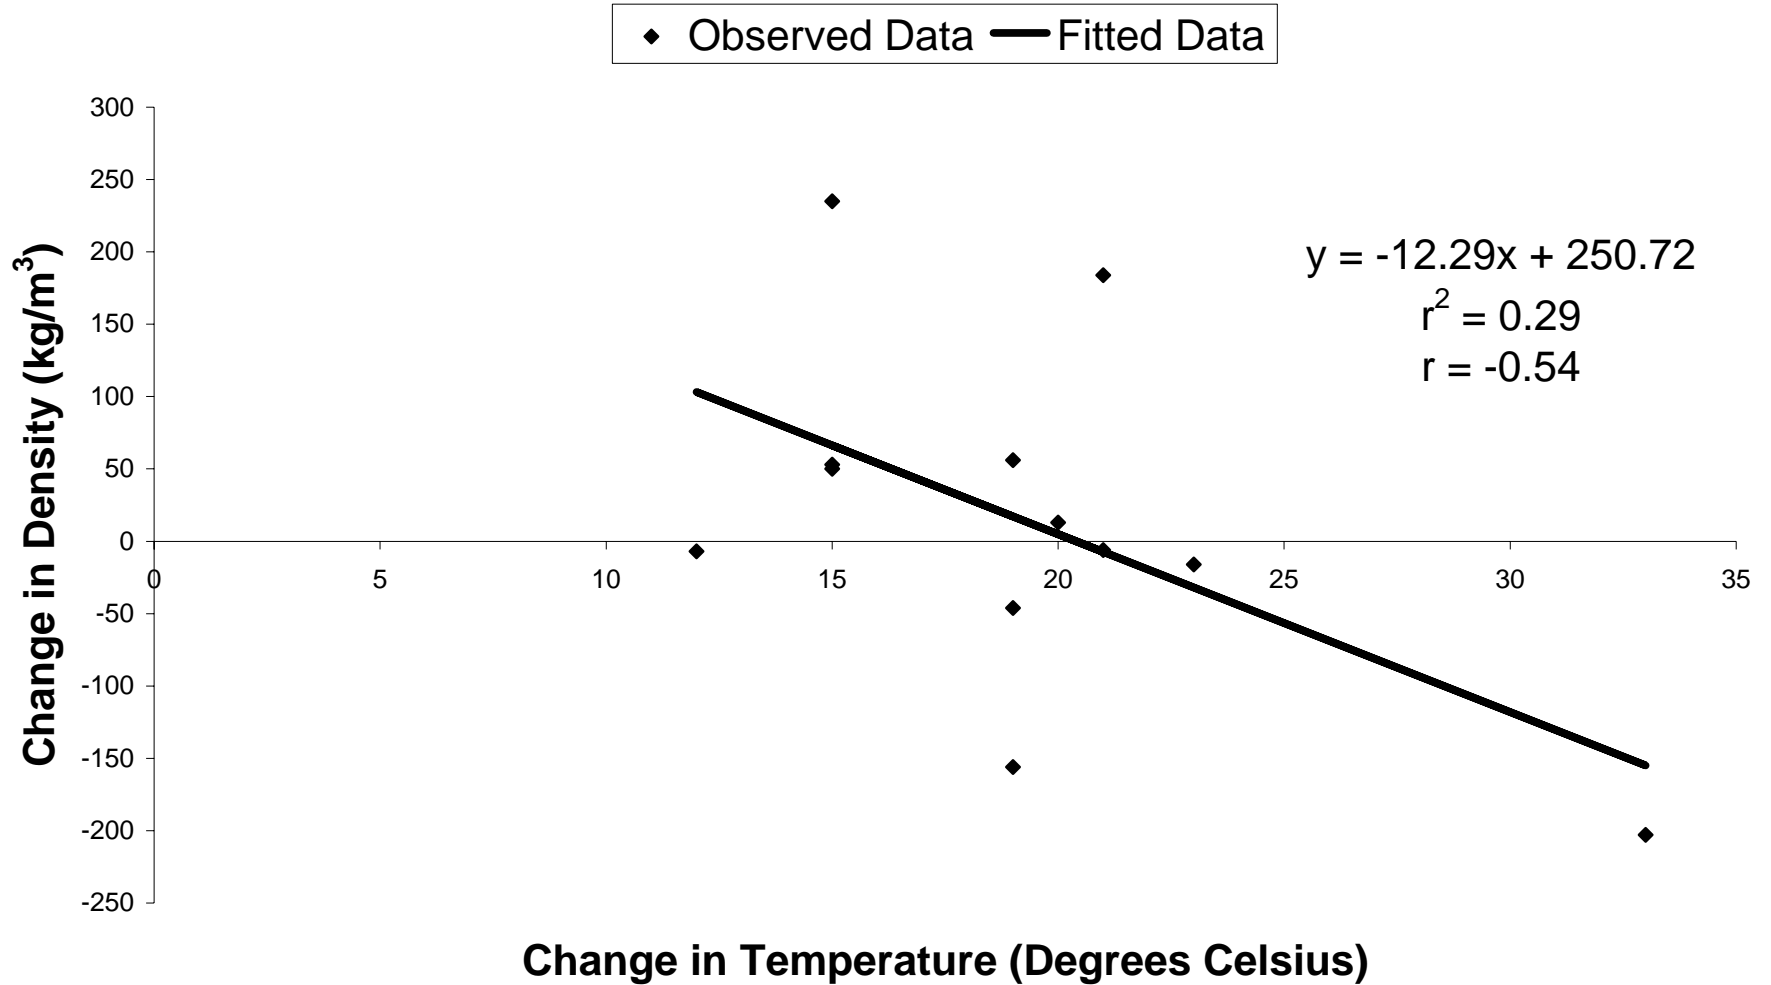
Site 5 - Relationship Between Change in Temperature and Change in Density

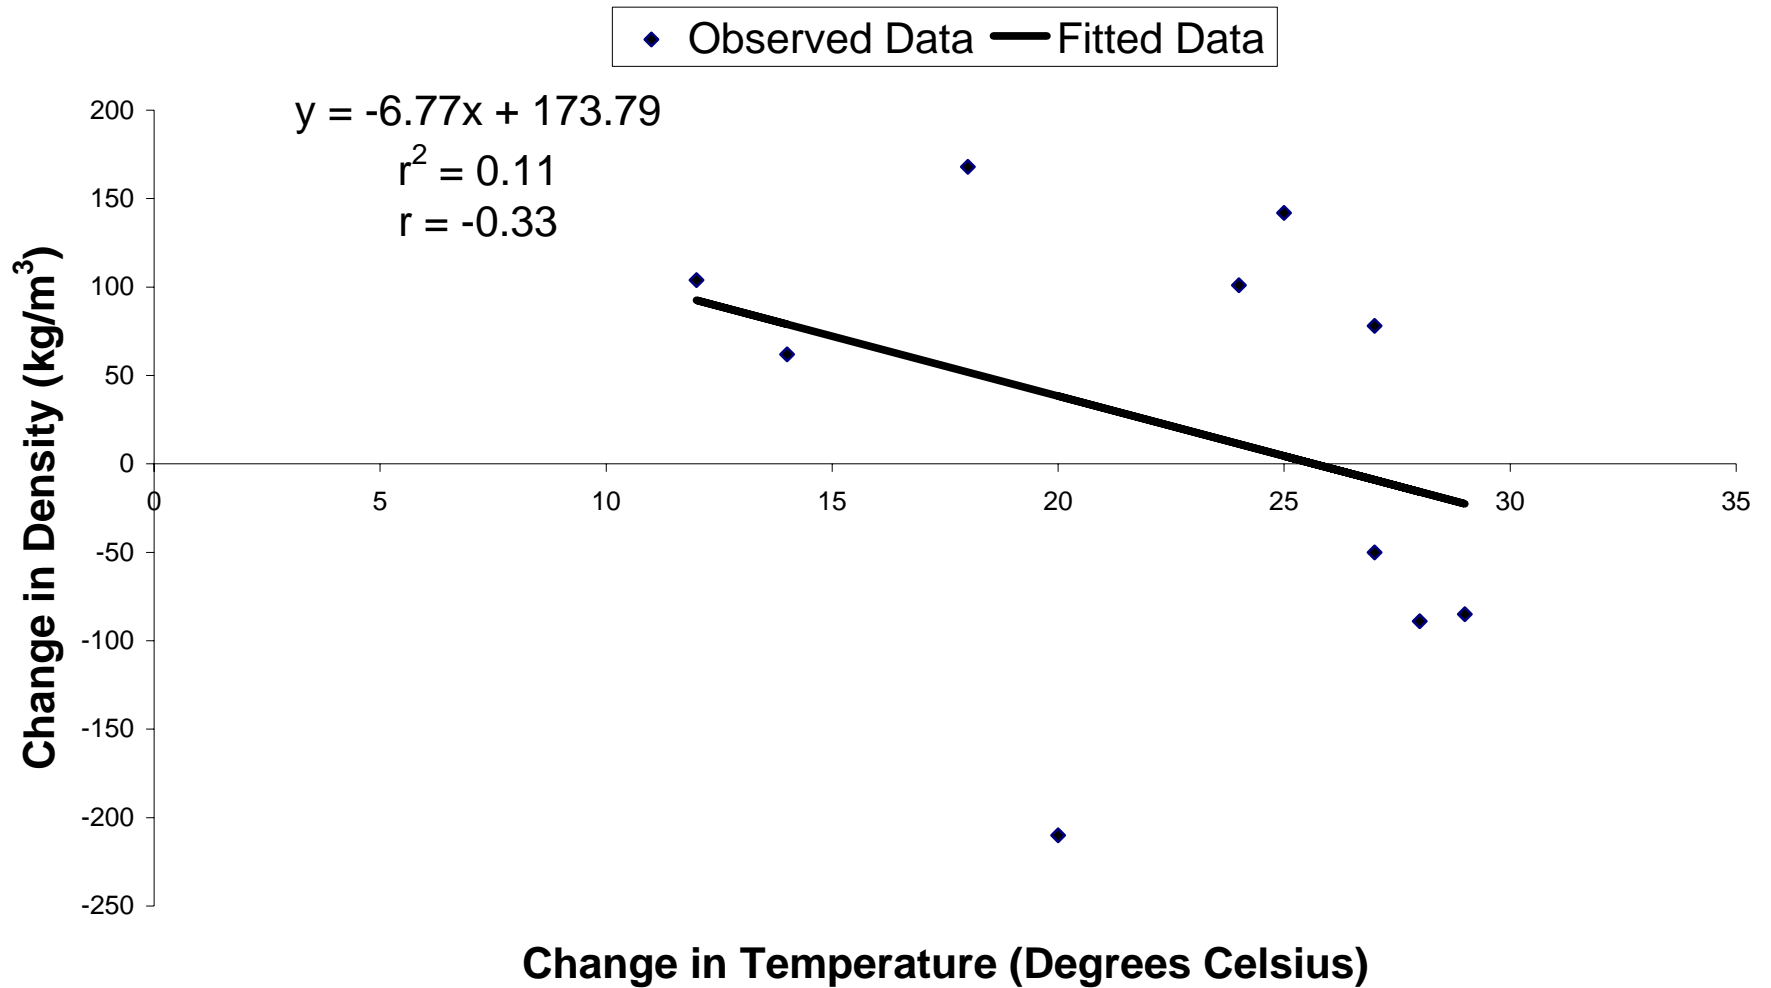
Site 6 - Relationship Between Change in Temperature and Change in Density

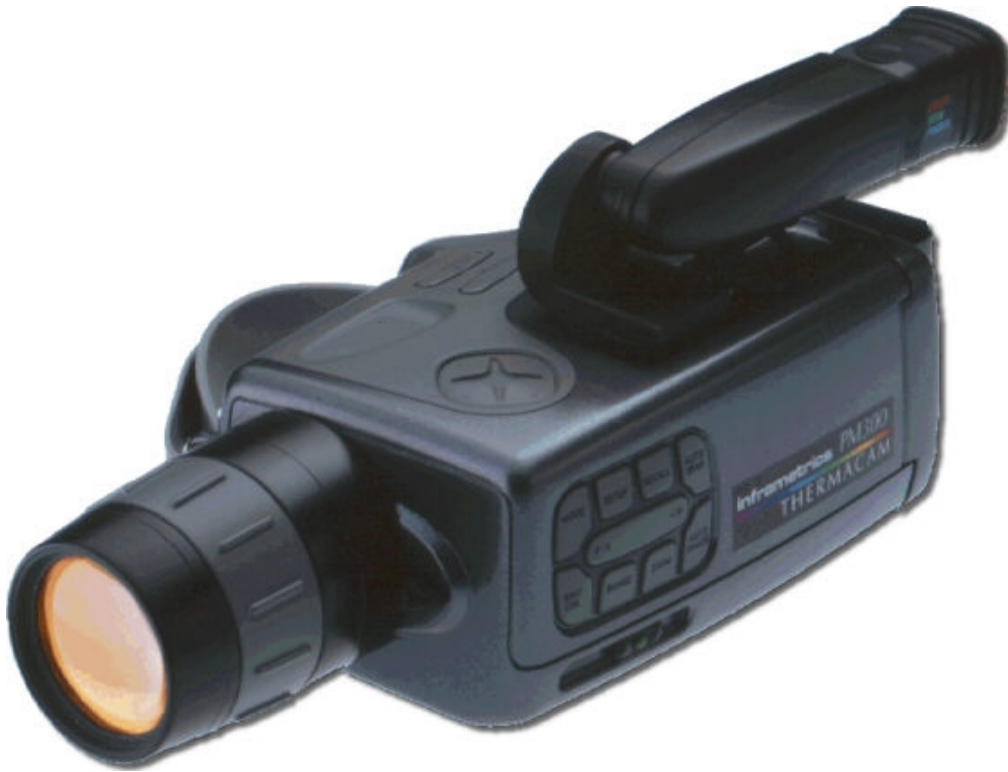
Photo #1. Inframetrics ThermoCAM PM380.

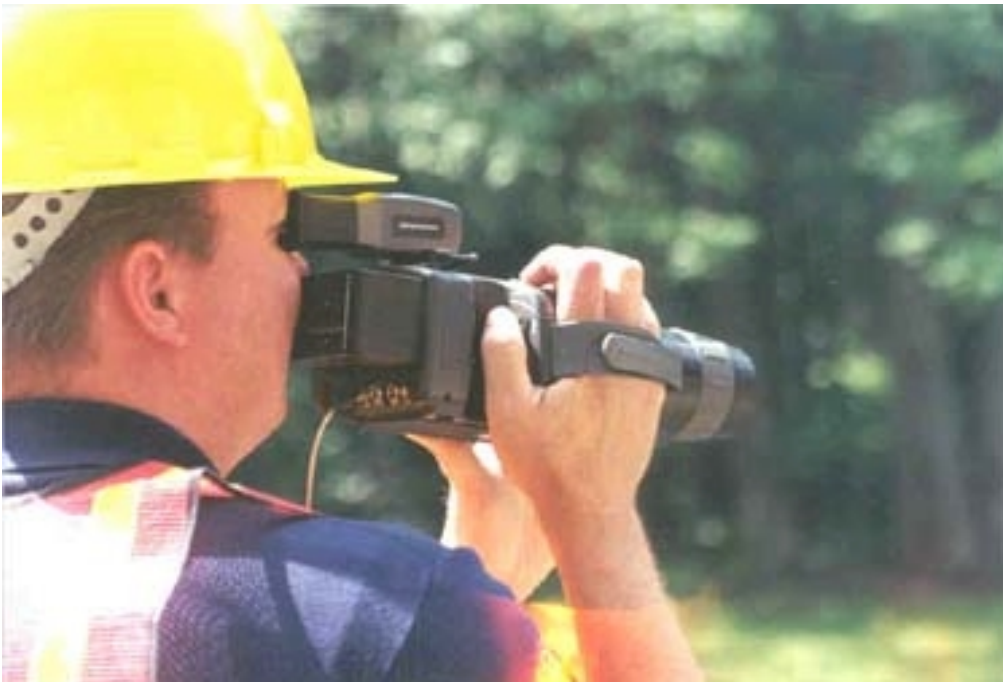
Photo #2. Infrared Camera in Use.

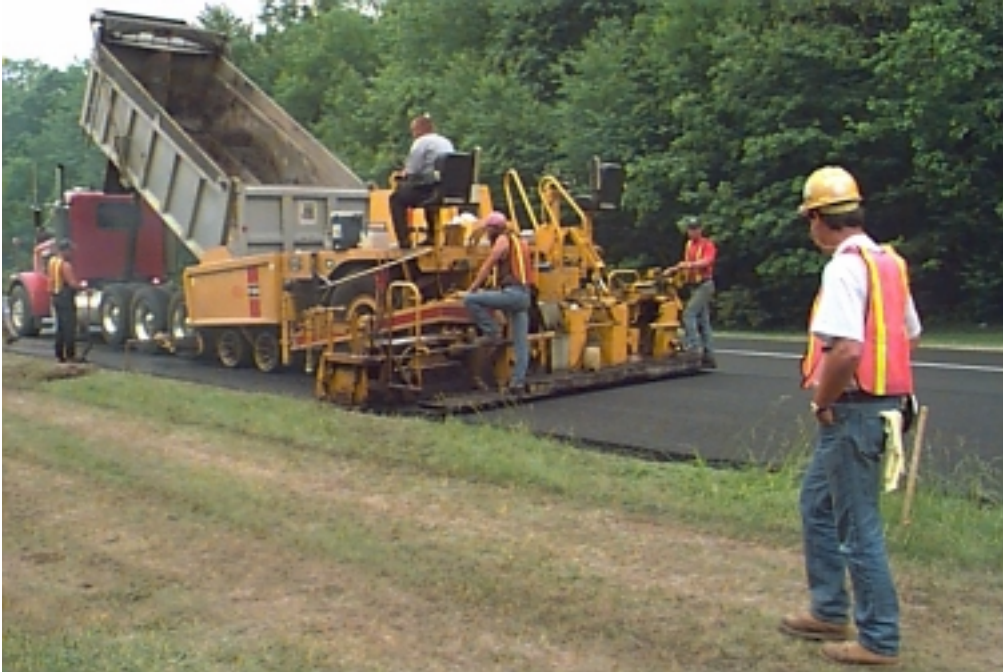
Photo #3. Blaw-Knox PF-180H Paver Used on Sites 1 and 2.

A Blaw-Knox PF-180H paver (see Photo #3), Caterpillar CB-534 breakdown roller, and Hyster C350C finish roller were employed for construction. A 40-mm (1.5-inch) DOT Class 1 surface layer was placed on top of a DOT Class 2 leveling course.

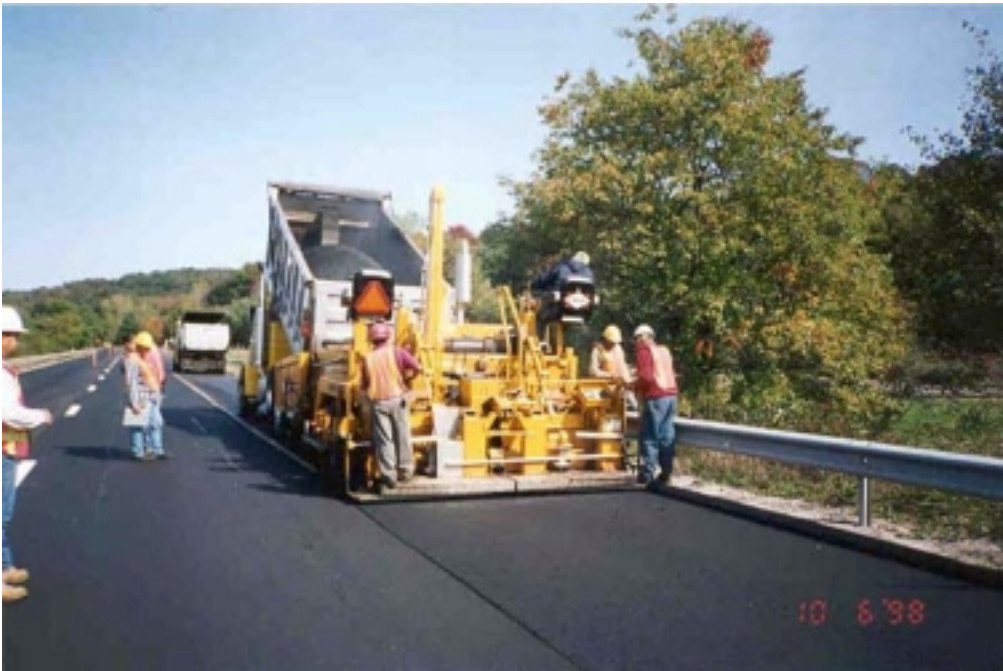
Photo #4. Blaw-Knox PF-3200 Paver Used on Site 3.

A Blaw-Knox PF-3200 paver (see Photos #4 and #5, page 47-48), breakdown roller, intermediate roller and finish roller were employed. A 40-mm (1.5-inch) DOT Class 1 surface layer was placed on top of a DOT Class 2 leveling course.

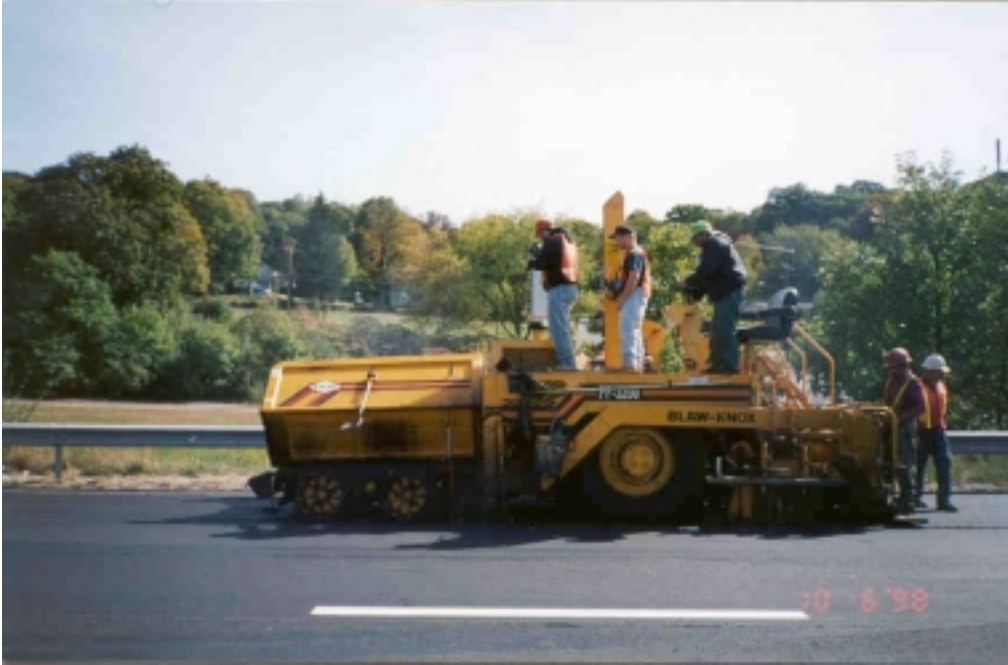
Photo #5. Infrared Video Being Recorded From Top of Blaw-Knox PF-3200 Paver at Site 3.

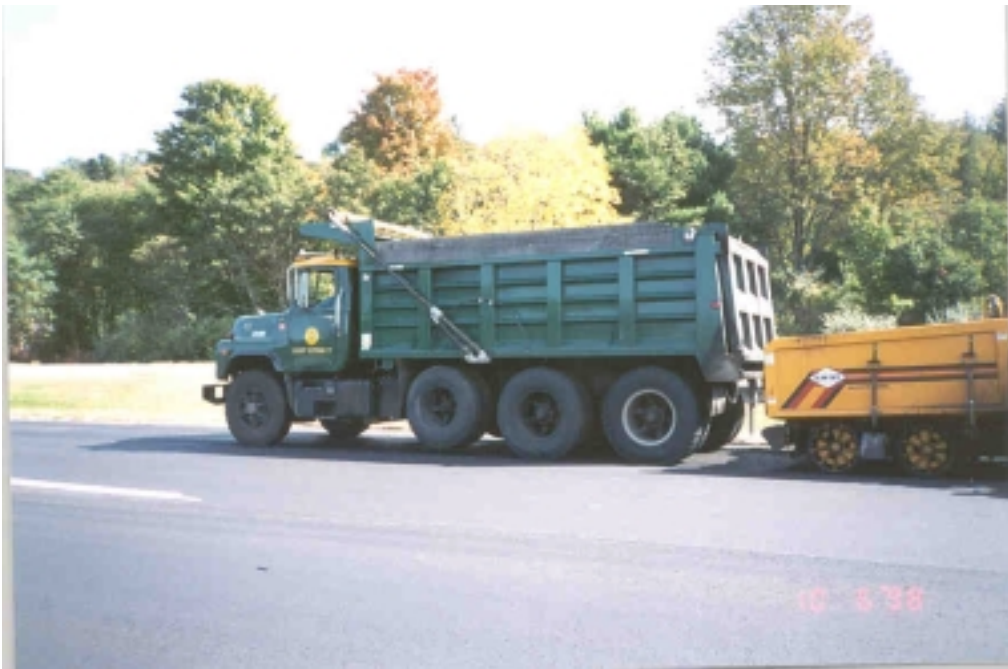
Photo #6. Truck Used at Site 3 Project, Route 8 in Thomaston.

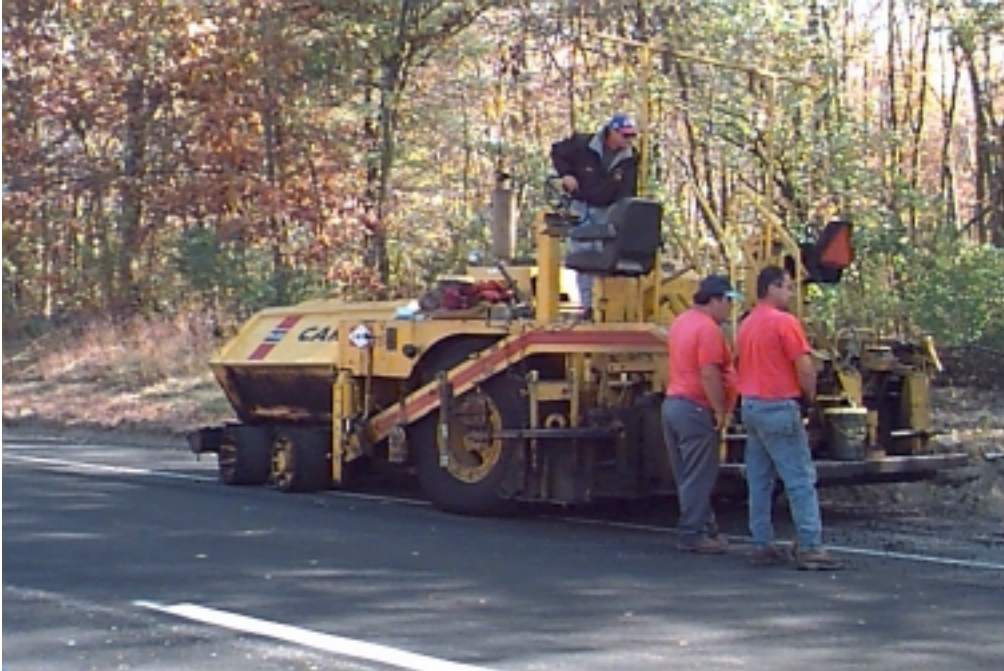
Photo #7. Blaw-Knox PF-200 Paver Used on Site 4.

A Blaw-Knox PF-200 paver (see Photo #7, page 49), Ingersoll-Rand DD-90 breakdown roller, Caterpillar CB-534C intermediate roller, and Ingersoll-Rand ST-75 finish roller were employed. A 50-mm (2-inch) DOT Class 1 surface layer was placed on top of a cold-in-place recycled base course.

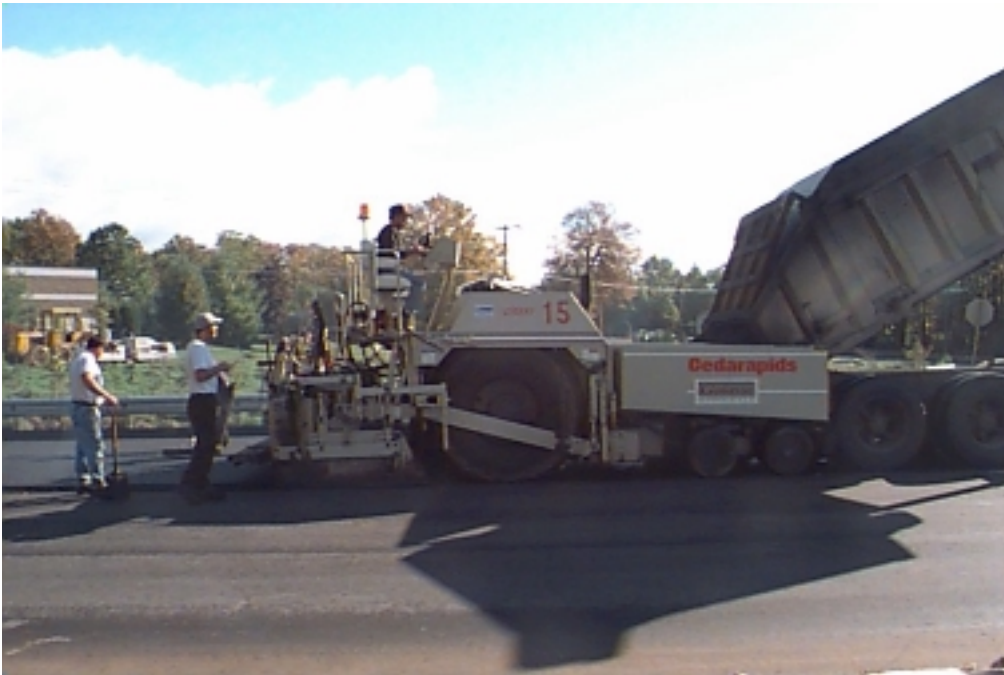
Photo #8. – Cedar Rapids CR-551 Paver Used on Site 6.

A Cedar Rapids CR-551 paver (see Photo #8, page 49), Ingersoll-Rand breakdown roller, and Hyster C340C finish roller were employed. A 40-mm (1.5-inch) DOT Class 1 surface layer was placed on top of a DOT Class 2 leveling course.

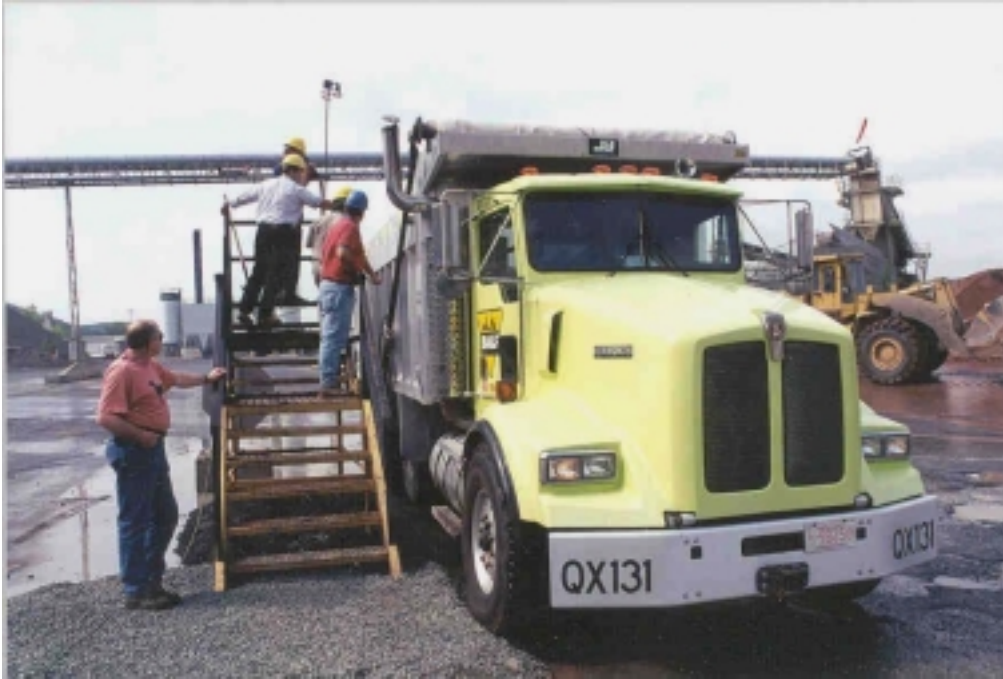
Photo #9. Department Personnel Use Infrared Camera to Look at Truckload of HMA.

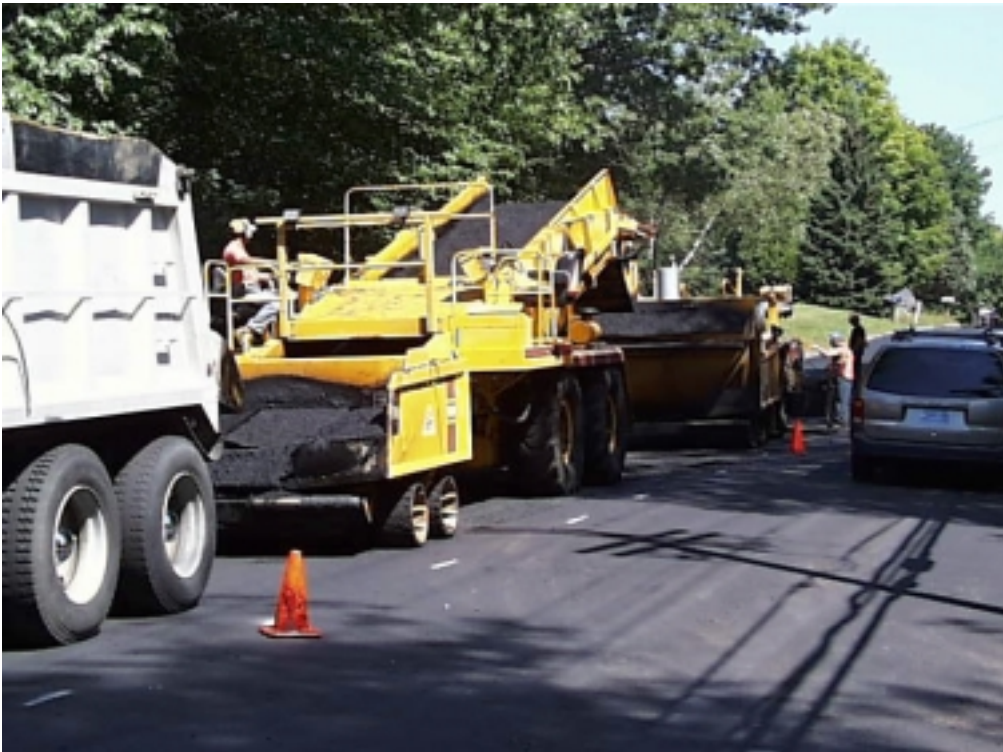
Photo #10. Blaw-Knox MC-30 Material Transfer Vehicle.

A reduction in temperature segregation was also noted for the project paved with the Blaw-Knox MC-30 transfer vehicle; however, an occasional cold spot/area did appear during construction.

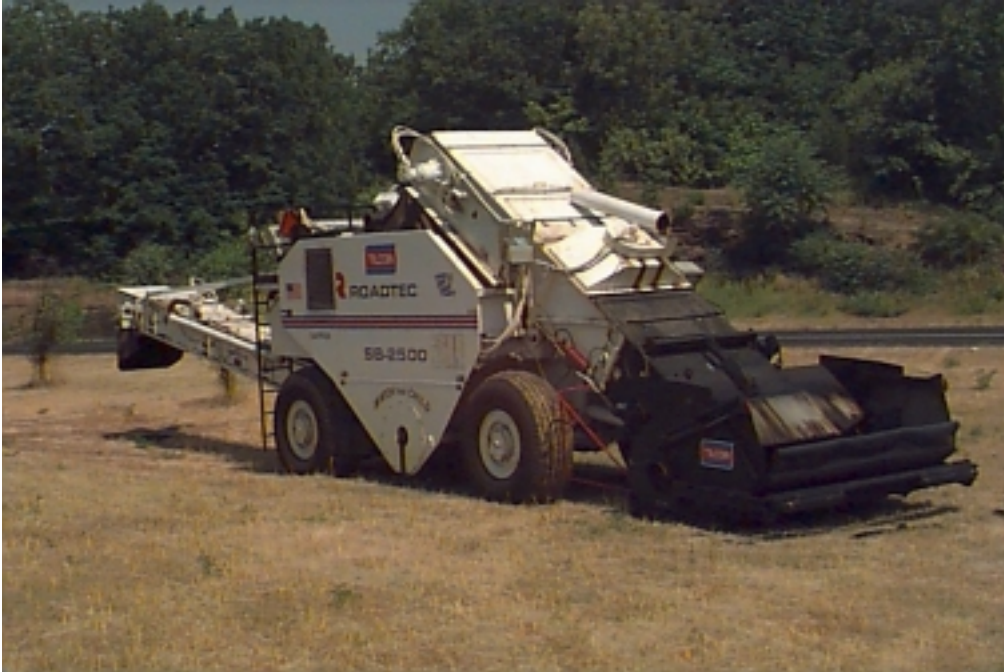
Photo #11. Roadtec Shuttle Buggy Material Transfer Vehicle.

A significant reduction in temperature segregation was observed for the project paved with the Roadtec Shuttle Buggy material transfer vehicle. Department personnel stood on the paver during construction and noted that its operation was much smoother than had been observed for conventional projects, where the paver was in direct contact with the truck. They looked at the freshly placed pavement immediately behind the paver's screed and observed that it was uniform in temperature across the width of pavement. No local areas of cold temperature were seen. It

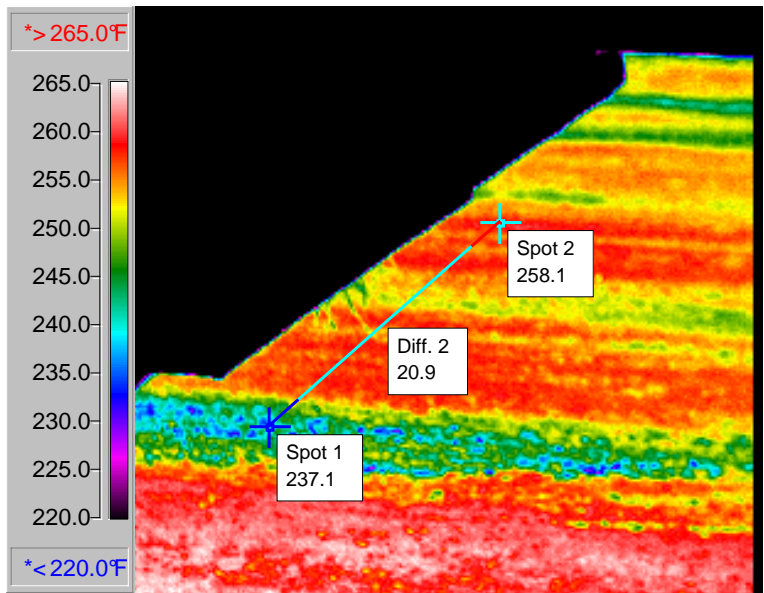
Photo #23. Little Meadow Road – Guilford

The DOT Class 2 (9.5 mm) mix is finer than the Class 1 (12.5 mm) mix and is often used on town roads. A Class 2 project was sought in order to evaluate and compare the thermal behavior of Class 2 vs. Class 1. No significant differences between the mixes were seen. Temperature differentials appeared in longitudinal strips in the same type of random pattern that was observed at sites 1, 2, 5 and 6 (see Photo #23, page 57).
