Draft
RCRA Corrective Measures Implementation (CMI) Report

Lawrence Berkeley National Laboratory
CA-EPA ID No: CA4890008986
ENVIRONMENTAL RESTORATION PROGRAM

January 2007

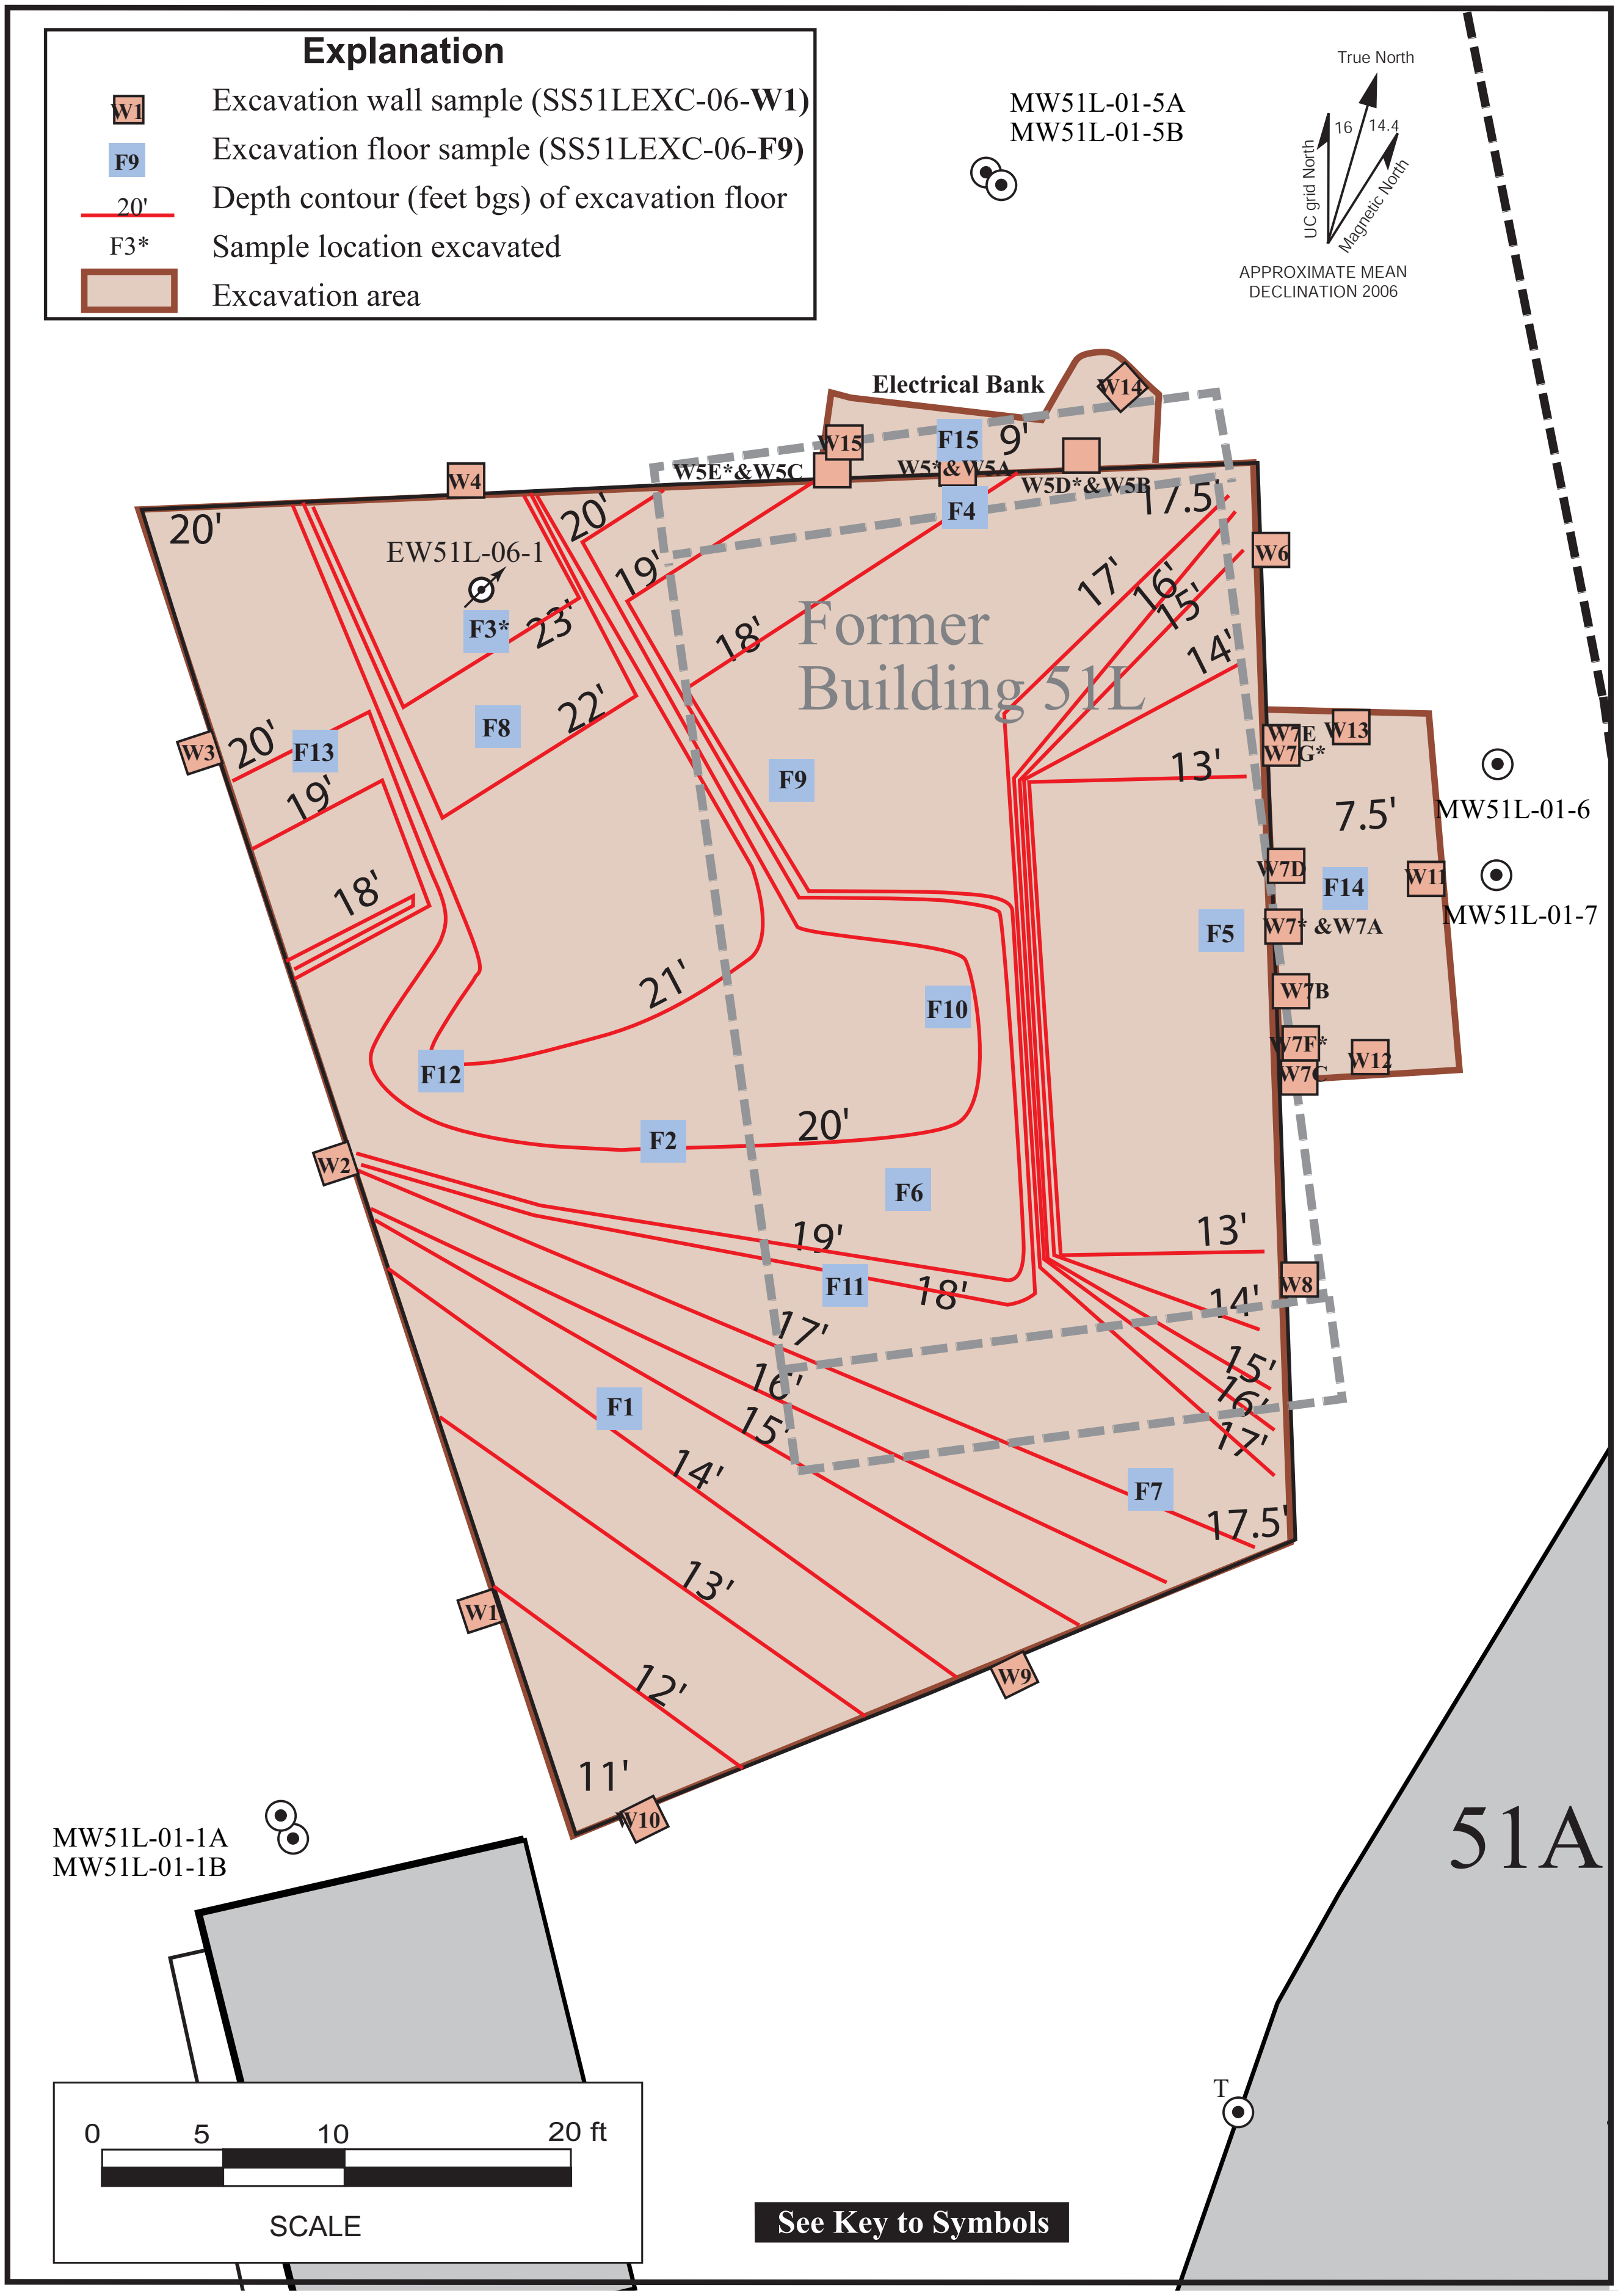
Figure 3.2-4. Locations of Confirmatory Soil Samples .

VOCs detected in post-excavation confirmatory soil samples collected from the walls and floor of the excavation are listed in **Appendix A (Table A-2)**. The locations where the confirmatory soil samples were collected are shown on **Figure 3.2-4.** Samples collected from locations that have been excavated are noted in the tables. These samples are not representative of post corrective measures completion conditions.

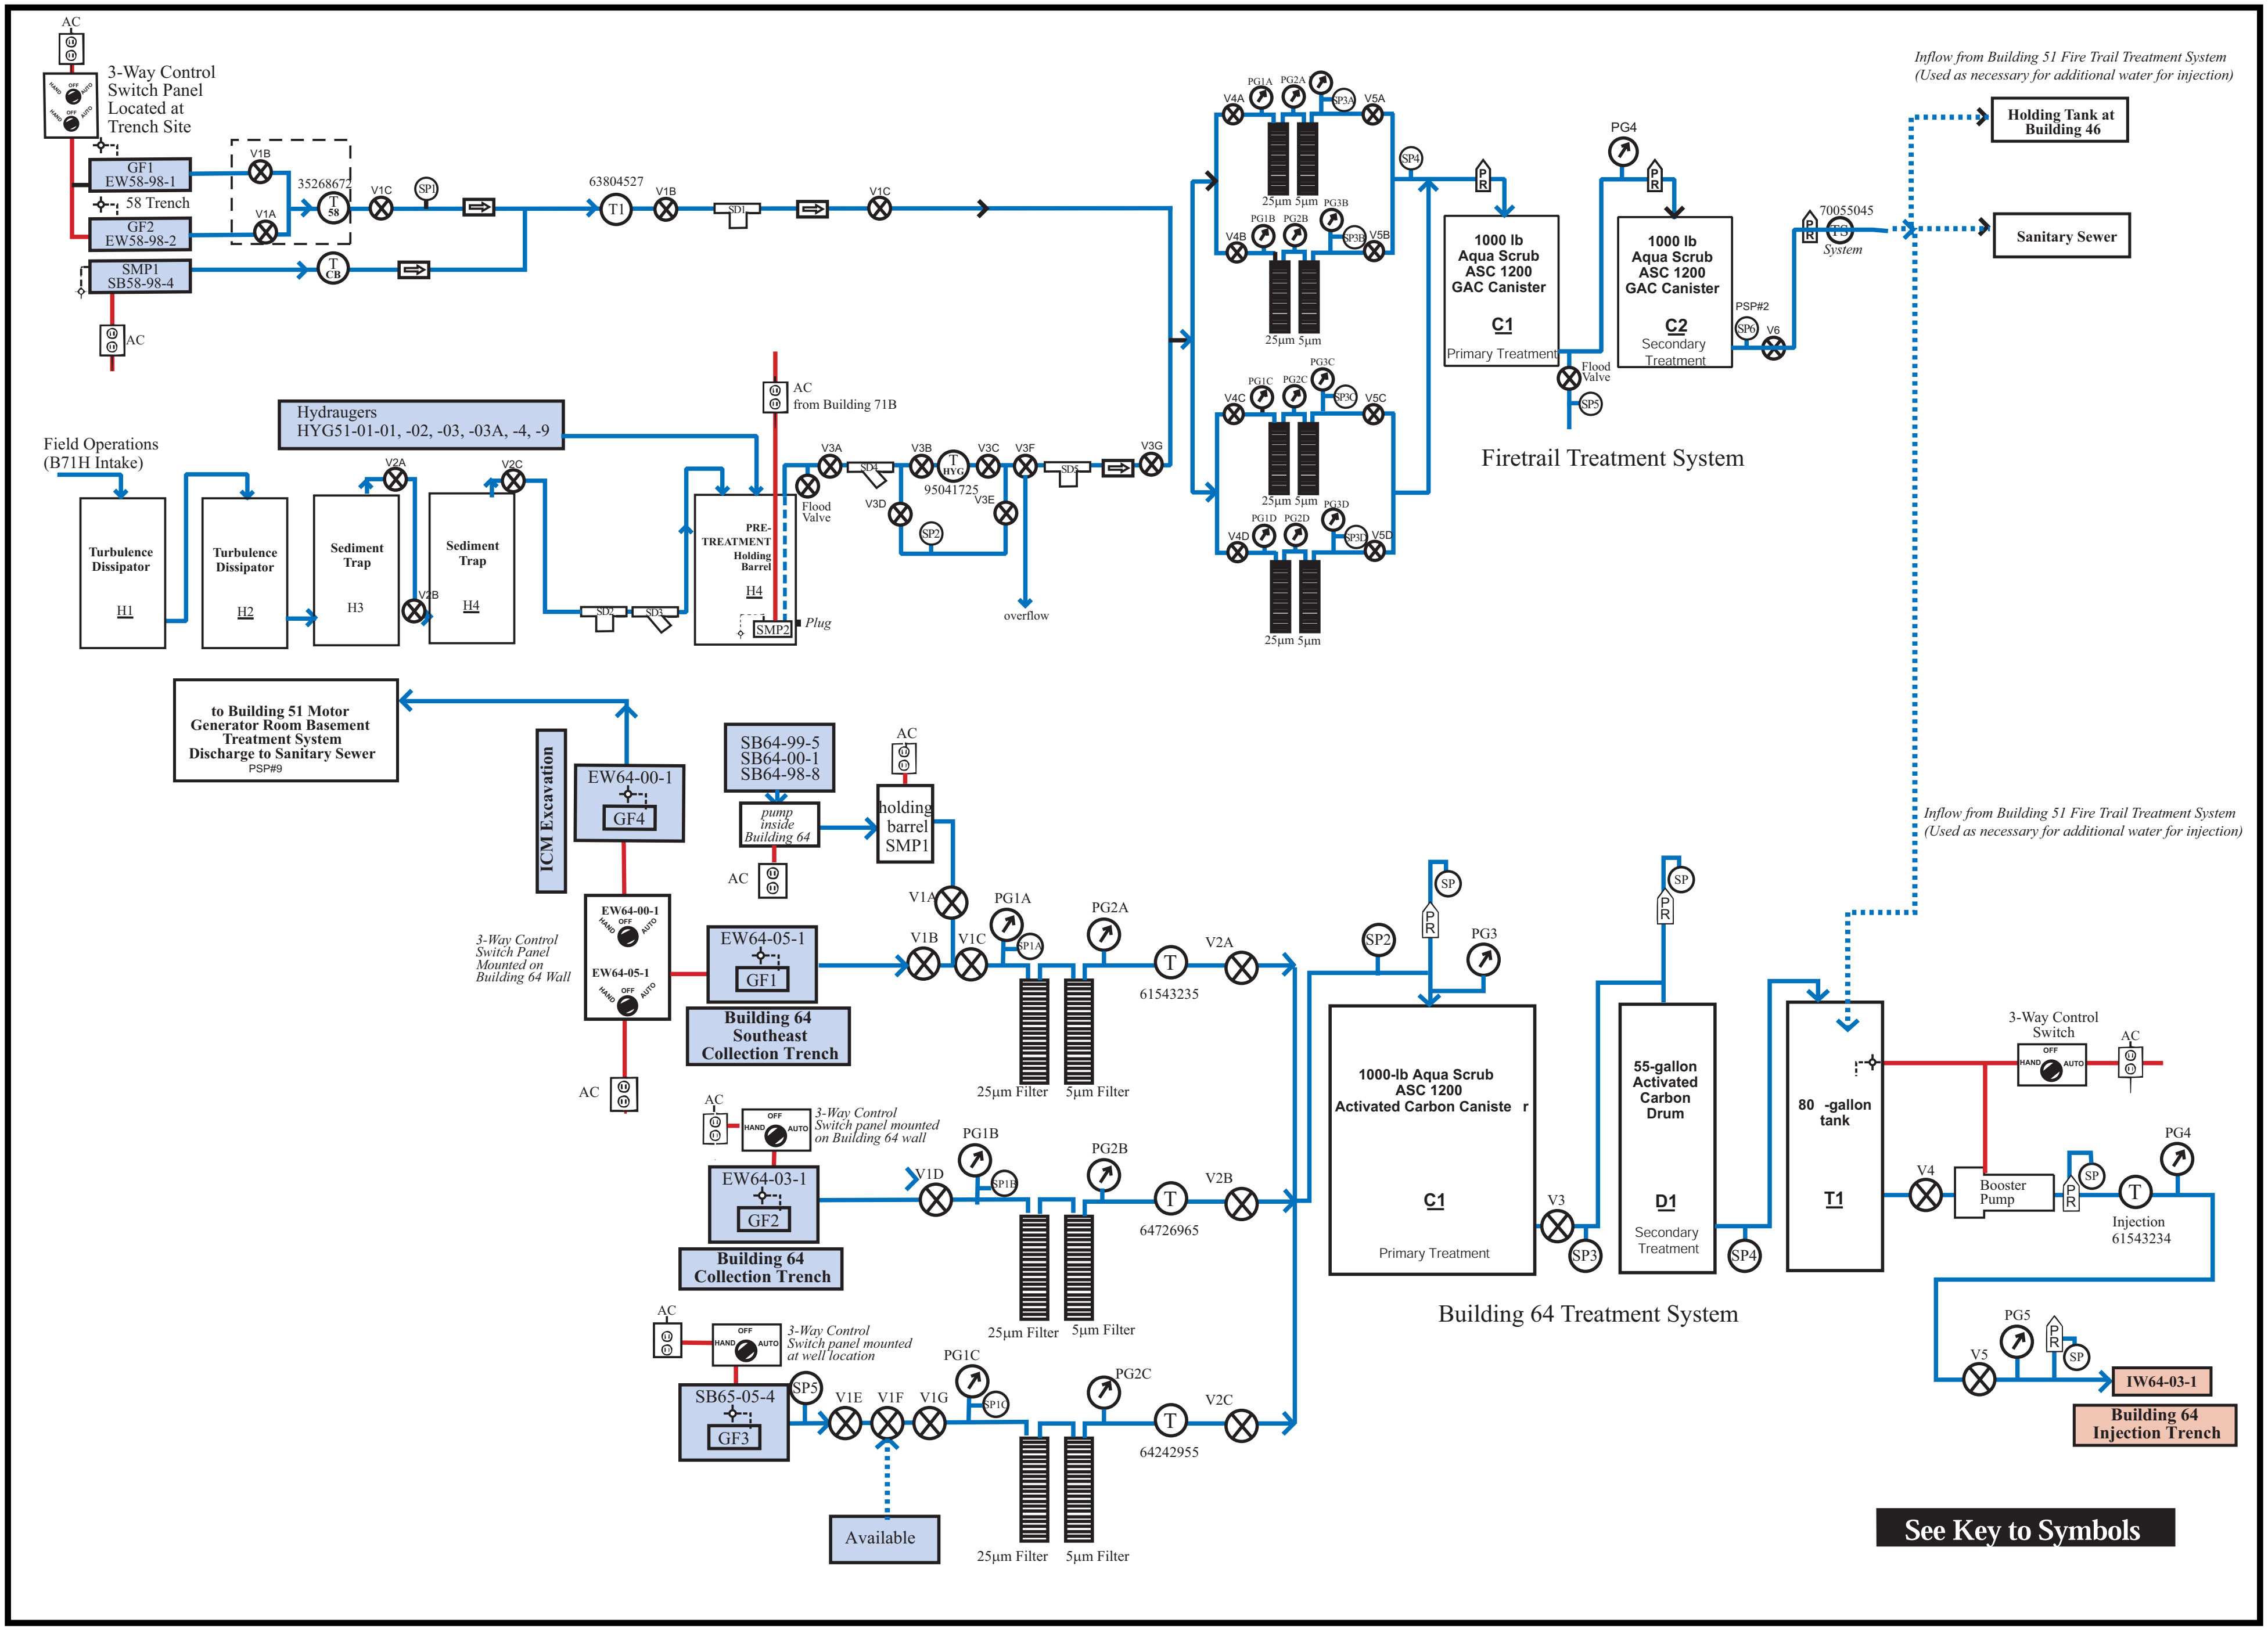
Figure 3.3-2. Soil Flushing System, Building 51/64 Groundwater Solvent Plume Source Area.

In May 2006, three new wells (IW64-06-1, IW64-06-2, and IW64-06-3) were installed to replace the four initial HRC injection wells. The locations of the wells are shown on **Figure 3.3-2**. Two of the wells (IW64-06-2 and IW64-06-3) are currently being used for HRC injection. The HRC system consists of two 55-gallon drums, the first filled with HRC solution and the second with water that is used to flush the HRC solution after it has been injected into the wells. HRC injection has been continuing on an almost daily basis since the wells were installed.

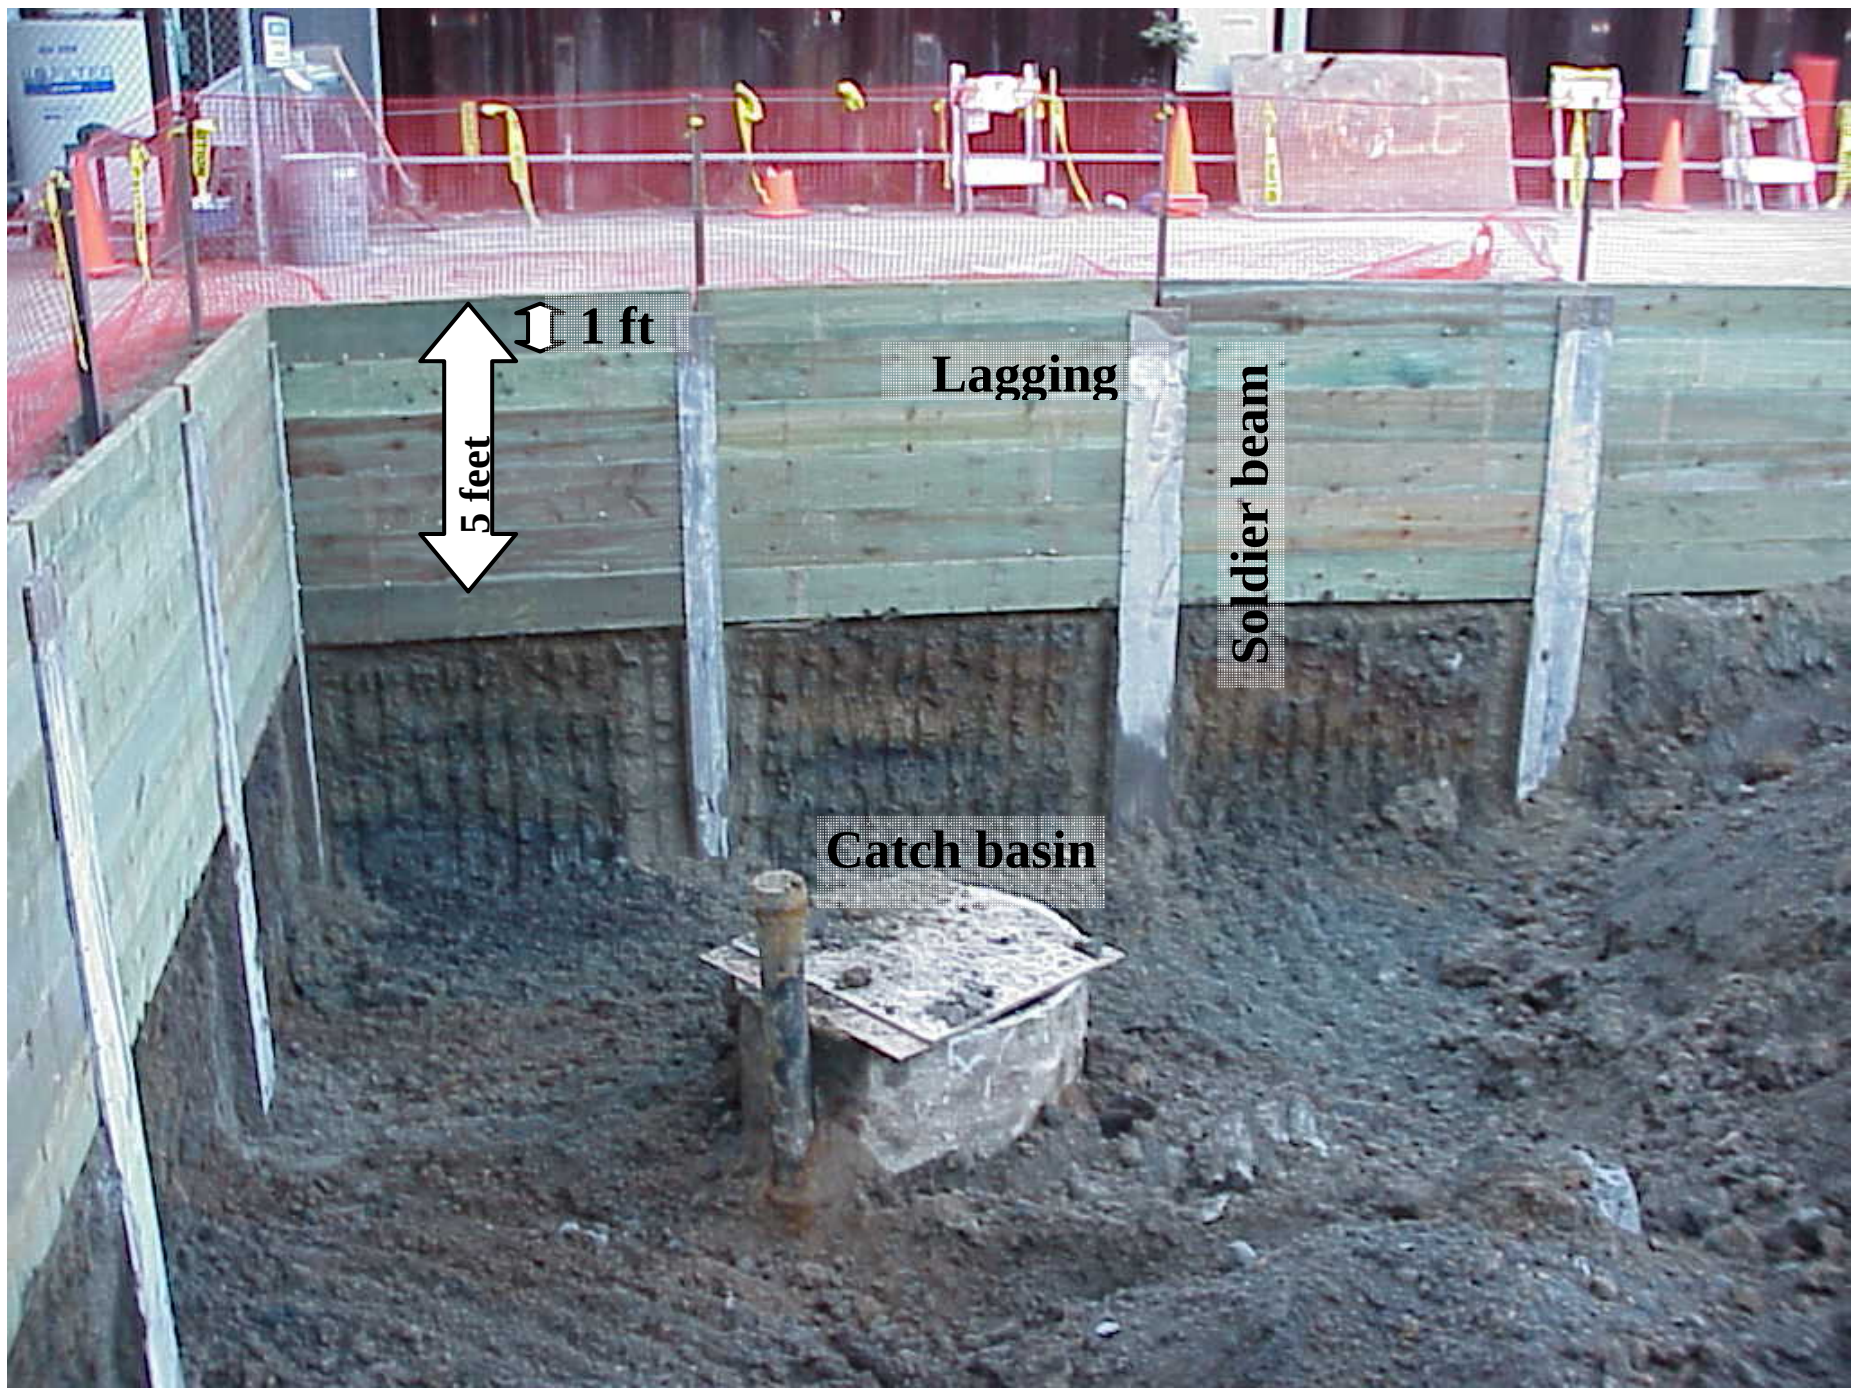
Southwest corner of excavation showing storm drain catch basin prior to removal and replacement.

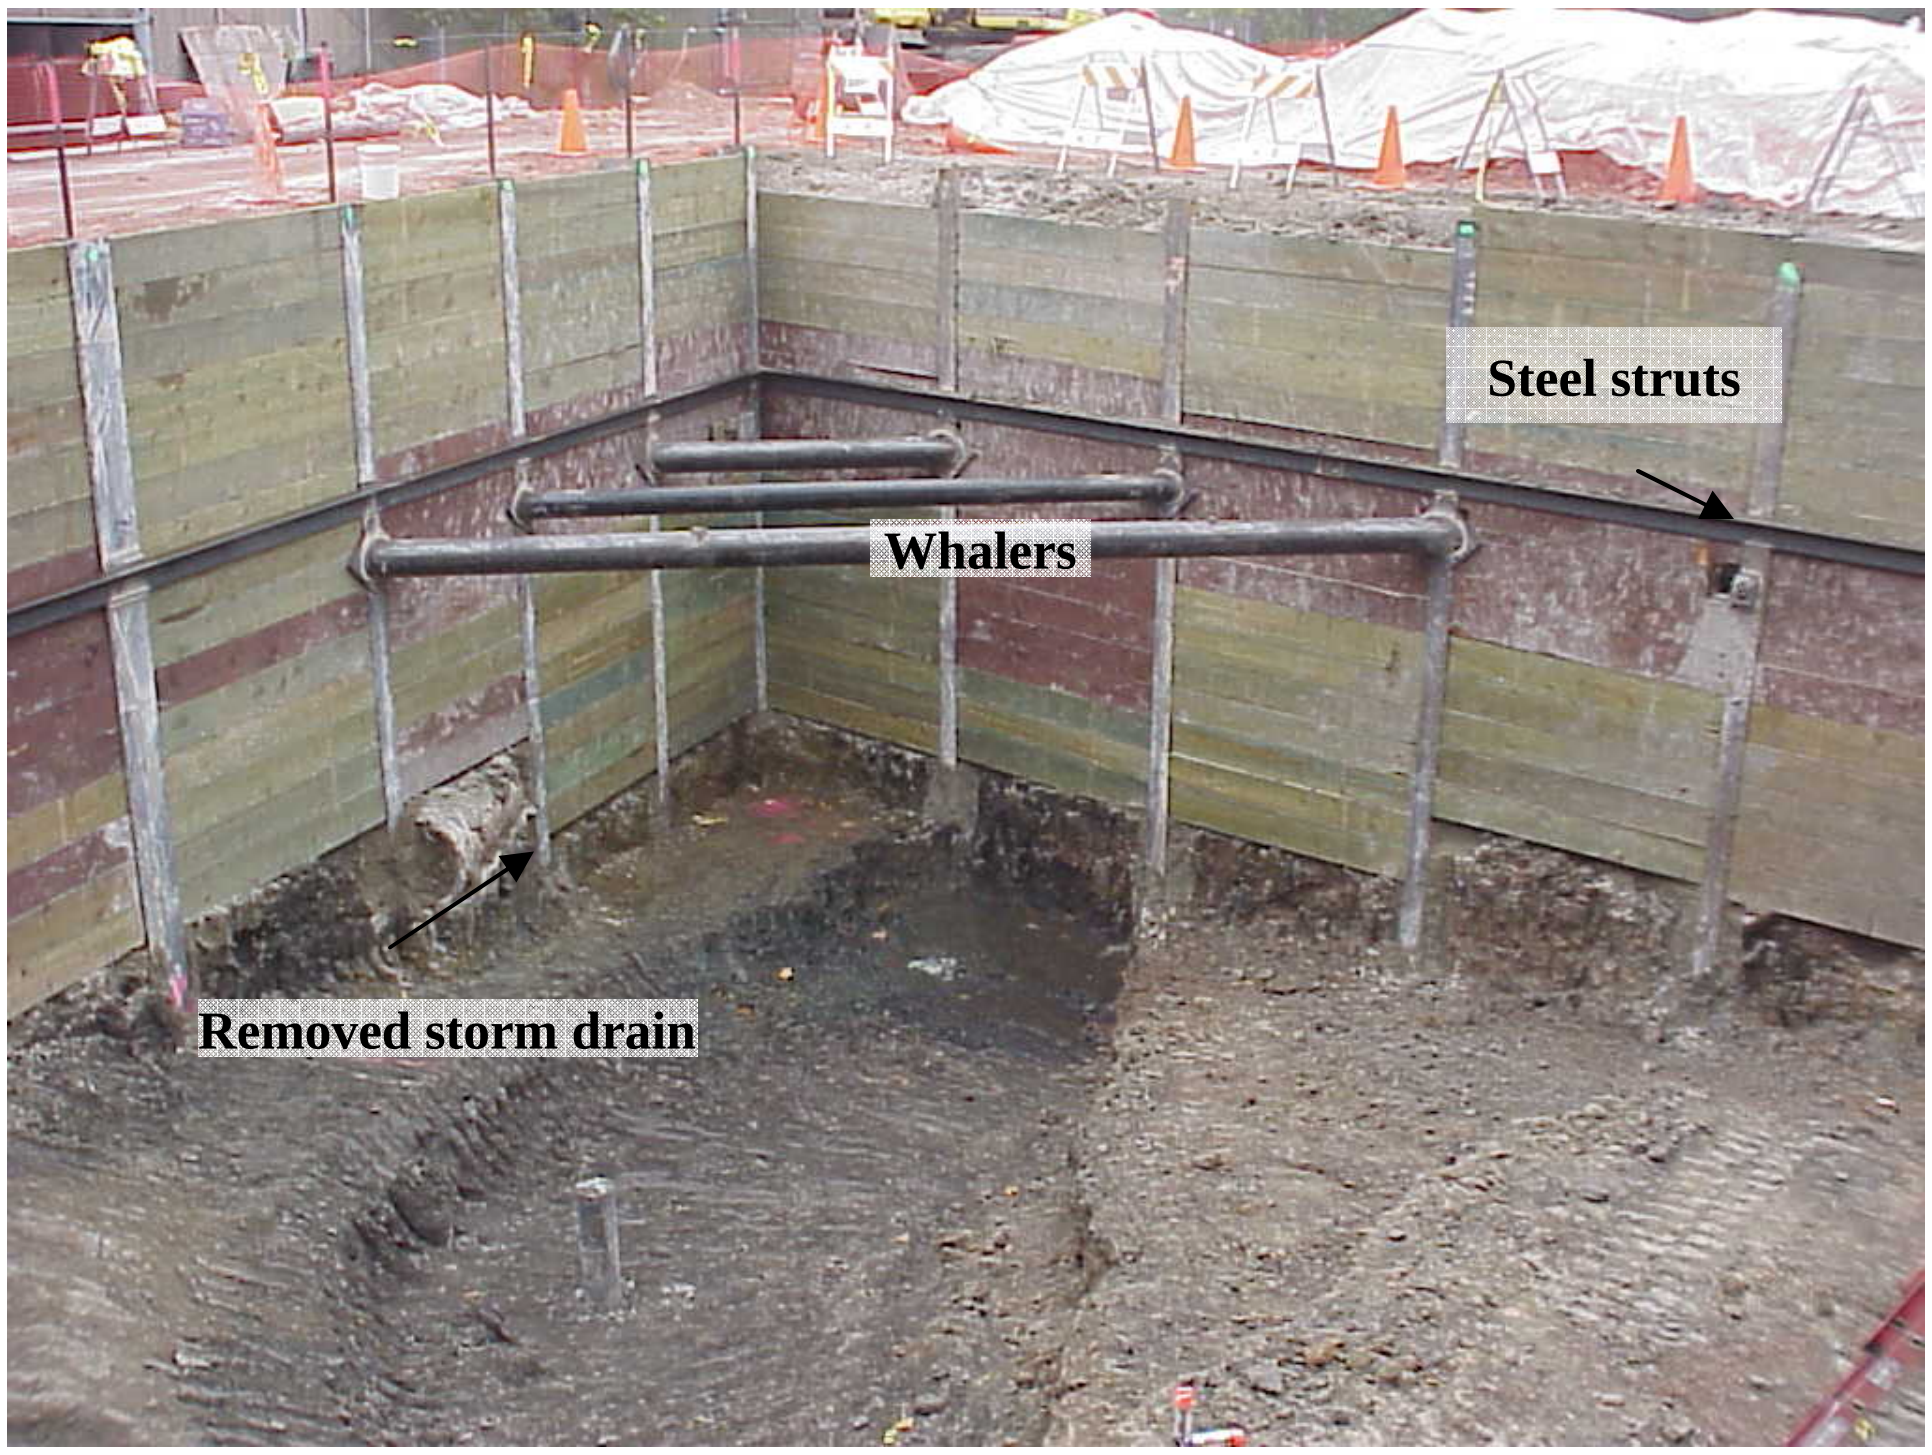
Northwest corner of excavation – September 28, 2006.
