Controlled Velocity Testing of an 8-kW Wind Turbine

Scott Larwood
National Renewable Energy Laboratory

CONTROLLED VELOCITY TESTING OF AN 8-KW WIND TURBINE

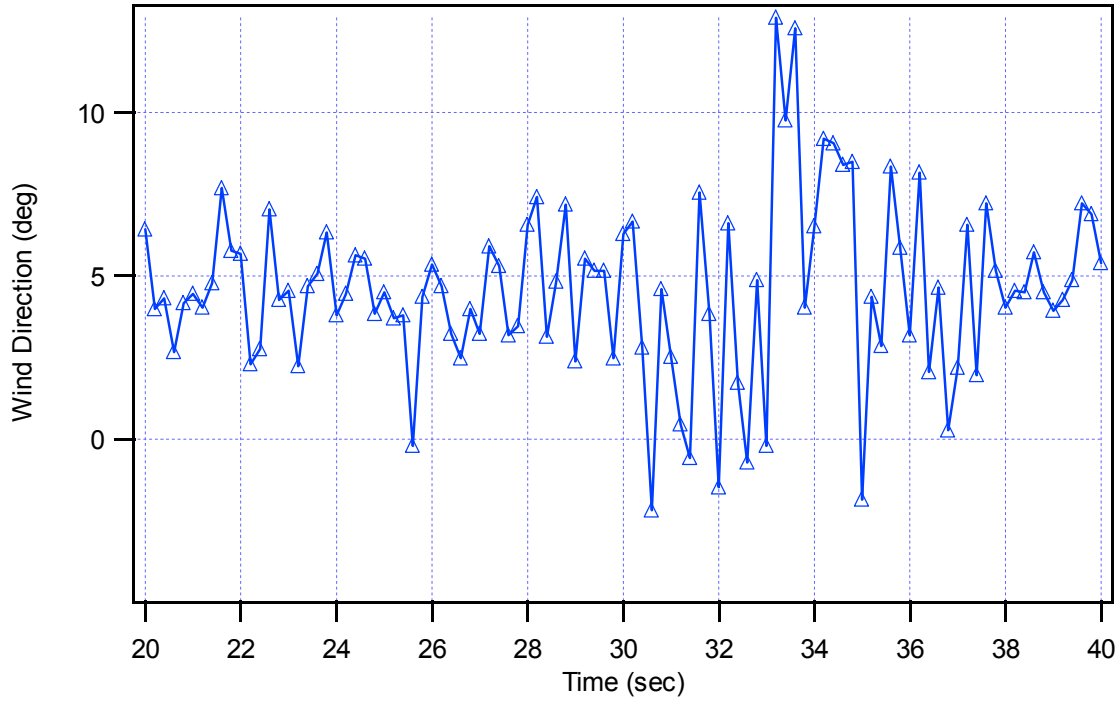
Maintaining wind speed was difficult during the truck runs. Figure 10 shows a compilation of data from several runs for one turbine geometry. The three distinct swarms of data correspond to three nominal

wind speeds. Note the very large variation in wind speed and turbine rpm. At the two lowest test speeds, the wind speed fluctuates ±1 m/s with the turbine speed varying ±20 rpm. At the maximum test speed the turbine speed varies ±40 rpm. Wind direction was also observed to fluctuate rapidly during the truck runs. Figure 11 shows an example time series. The wind direction varies ±5º for this segment. Though we did not think of it at the time of testing, these measurements were under the influence of the turbine.

**Figure 10. Unsteadiness in wind speed and generator rpm during test runs**

The International Electrotechnical Commission guidelines for power performance measurement require anemometer placement from 2 to 4 rotor diameters upstream with 2.5 diameters recommended (IEC, 1998). A scheme to place the anemometer at a sufficient distance upstream can be found in Schoeberl, Kniehl, Wurz and Blaser (1987). Schoeberl placed the anemometer and wind vane on a separate cart at 2.5 diameters upstream of the rotor.

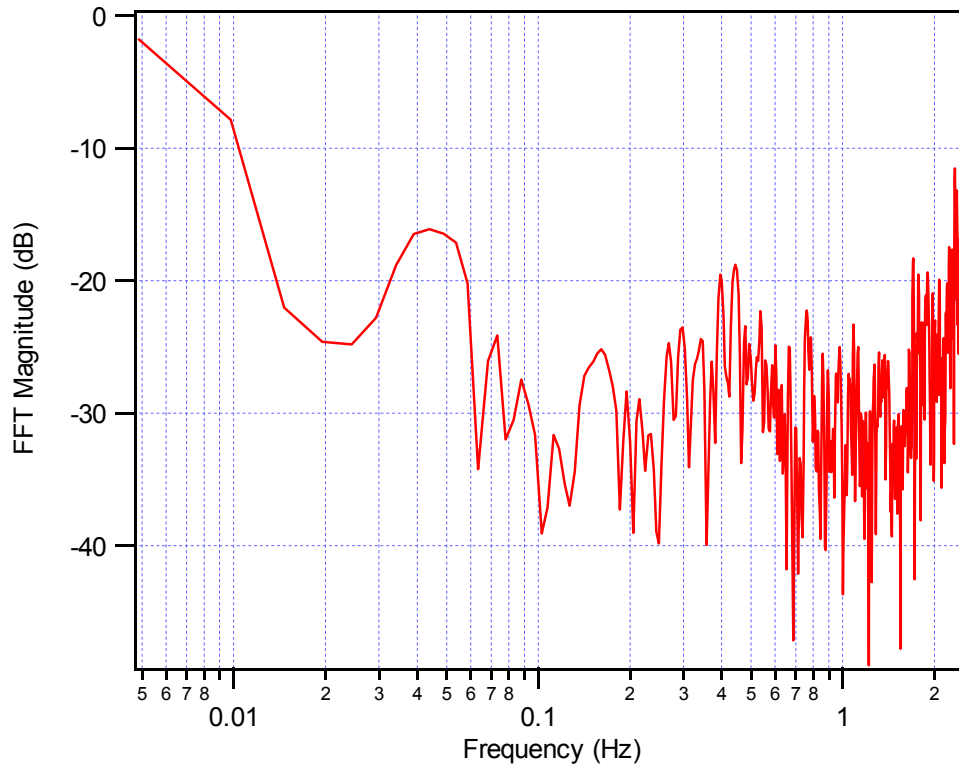
The tower loads data were shown to be of inadequate frequency bandwidth. Figure 12 shows a time history of the lower moment in the lateral tower axis with the signal amplitude peaks at one half the sampling frequency. We expected to digitally smooth the data during the reduction process. However, these data were invalid and irretrievable due to evidence of aliasing. Figure 13 shows a Fast Fourier Transform of the time series. Strong peaks at frequencies near one-half the sampling rate is indication of aliasing (Lyons, 1997). The cause of the aliasing was not determined; however, a dummy channel with a precision resistor possibly could have indicated electrical noise.

Also, the sampling rate of 5 Hz was insufficient for this application. Work by the Center for Renewable Energy Sources in Greece on small wind turbine loads monitoring showed tower loads spectral content up to the blade passage frequency (Zorlos, Theofilogiannakos and Binopoulos, 1996). For the WindLite tower loads this would indicate a required data bandwidth of approximately 15 Hz.

Figure 12. Example tower-bending bridge time series

Figure 13. Fast Fourier Transform (FFT) of tower-bending signal indicating aliasing with significant magnitude at one-half the 5 Hz sampling rate
