Residual Radiation Hints for Aperture and Alignment Issues in the Main Injector

Bruce C. Brown
Accelerator Division, Main Injector Department
Fermi National Accelerator Laboratory *
P.O. Box 500
Batavia, Illinois 60510

30 December 2004

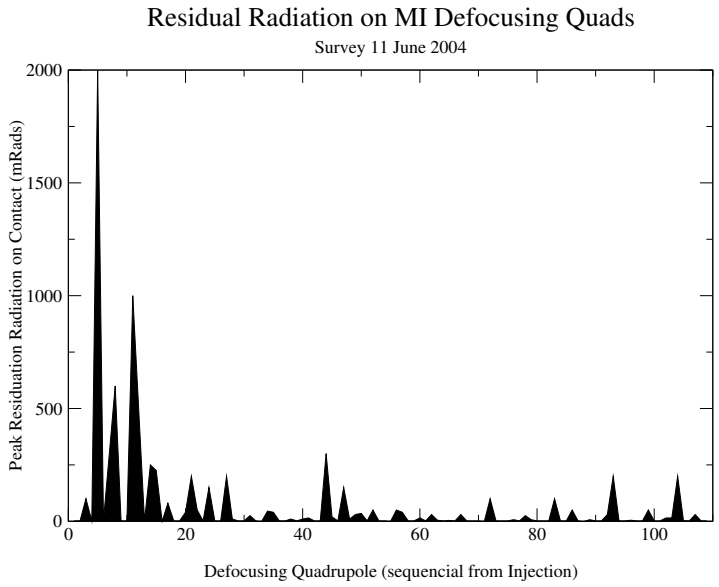
During the survey of the tunnel on June 10, it was noticed that there were unusual patterns of losses which included residual radiation which peaked in bare beam pipe between two magnets. Such a pattern in the Main Ring was occasionally due to an 'obstacle' which was frequently a sliver of beam pipe which remained from a previous repair. However when a second and then a third of these patterns was observed and the location was consistently about 18 inches from the end of the upstream dipole steel, it was recognized that this was a new pattern which was surely not due to an obstacle loose in the

Figure 1: Residual Radiation on Contact at minitube on upstream of Main Injector Defocusing Quadrupoles after few hours cooldown.

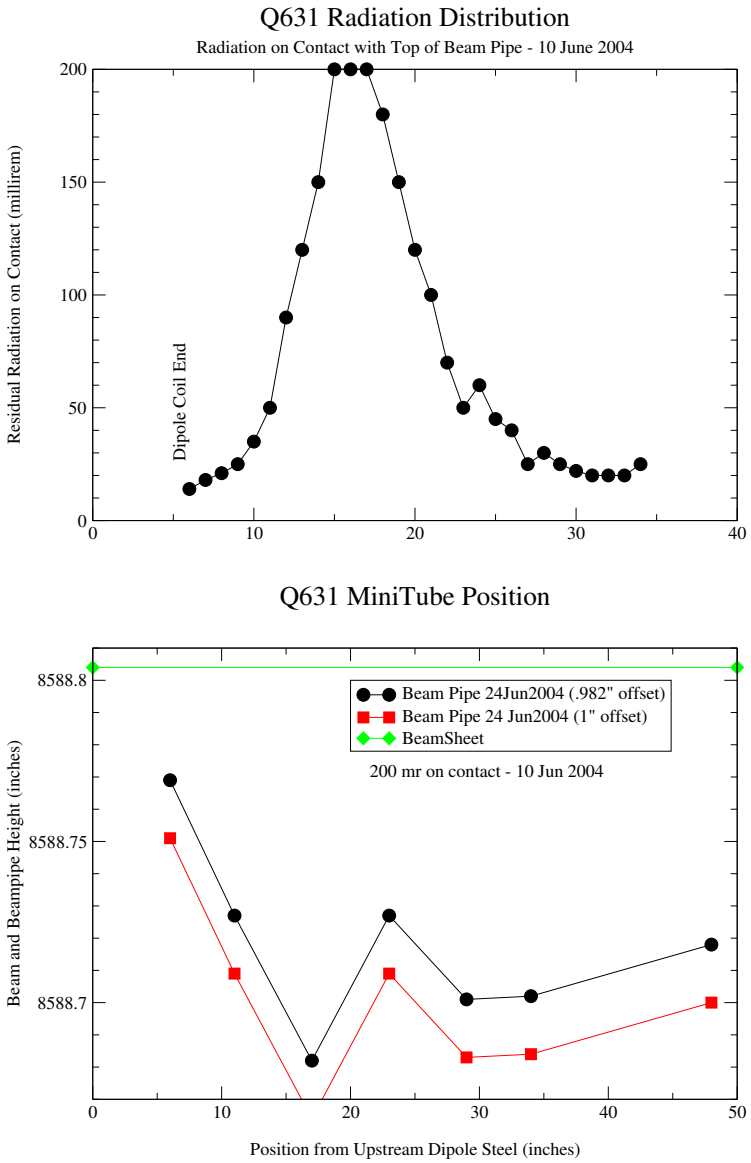
Figure 2: Upper Figure shows residual radiation pattern at Q631 as measured on contact with the top of the beam pipe. Lower Figure shows the elevations as surveyed at the top of the beam pipe but expressed as location of beam pipe center assuming a constant 1 inch or 0.982 inch offset from center to top of beampipe.

On June 11 the radiation survey was continued with an awareness of this pattern which appeared at D Quad (odd half cell) locations. The pattern was detailed at three locations by recording at one inch intervals the residual radiation measured on contact at the top of the beam pipe. This data is plotted in Figures 2, 3 and 4. It is sharply defined and local to the bare beam pipe.

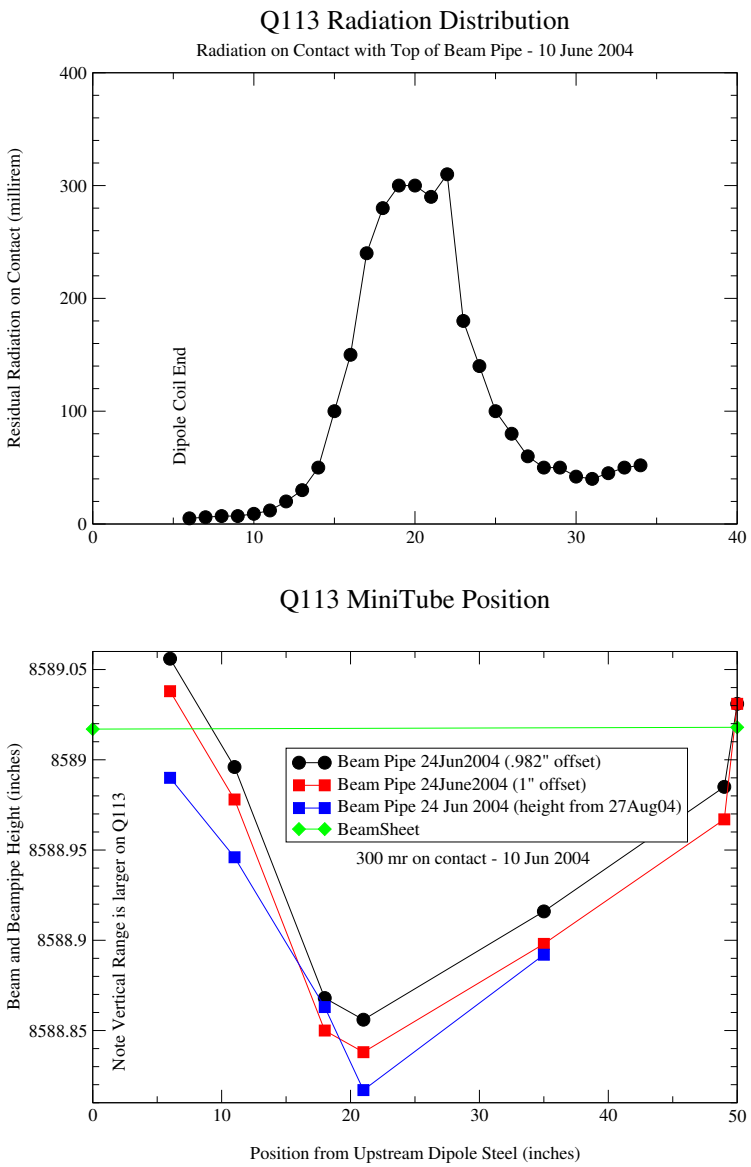
Figure 3: Upper Figure shows residual radiation pattern at Q113 as measured on contact with the top of the beam pipe. Lower Figure shows the elevations as surveyed at the top of the beam pipe but expressed as location of beam pipe center assuming a constant 1 inch (red squares), 0.982 inch offset (black circles) or as measured offset (blue squares) from center to top of beampipe.

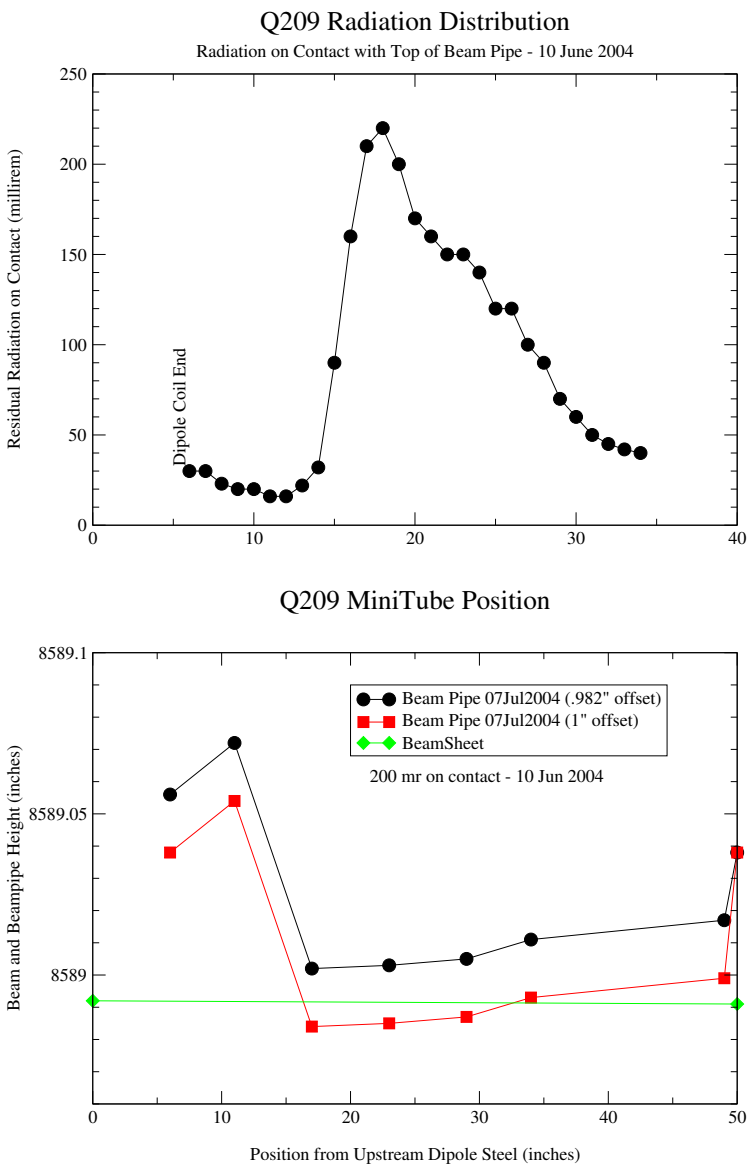
Figure 4: Upper Figure shows residual radiation pattern at Q209 as measured on contact with the top of the beam pipe. Lower Figure shows the elevations as surveyed at the top of the beam pipe but expressed as location of beam pipe center assuming a constant 1 inch or 0.982 inch offset from center to top of beampipe.

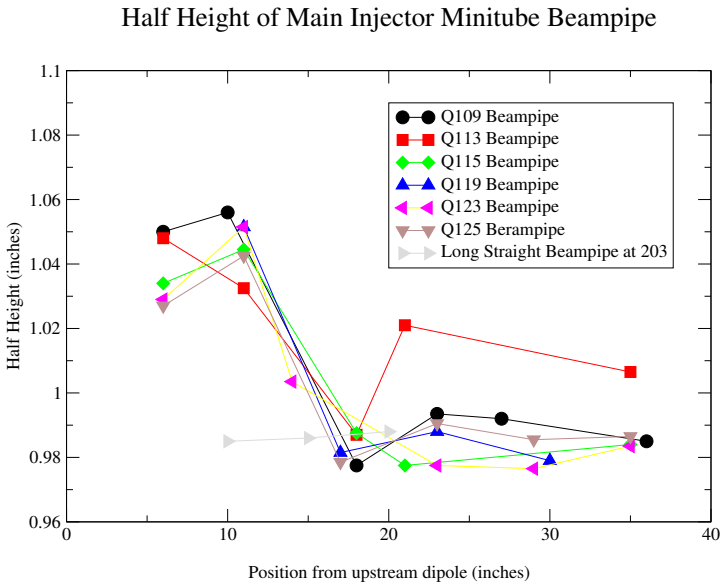
Figure 5: Minitube half heights (external) upstream of defocusing quadrupoles.

On August 27th, a digital caliper was employed to record the beam tube height at a number of the locations of interest[1]. In Figure 5 the data are plotted. We see that the initial assumption that the pipe would exhibit the two inch dipole gap was to simple. The beam pipe is more than $2.1''$ high in the region where the ion pump is attached (a port pointing to the aisle side) and maintains this height as it attaches to the bellows assembly which also has beam pipe about $2.1''$ high. Lengths of pipe unsupported and under vacuum are about $0.986''$ high (see right-pointing triangles in figure). The transition from the bellows support size to the size unsupported under vacuum occurs in about 6 inches and changes the beam pipe half height by about 0.05 - $0.07''$ (1.5 mm). Plots showing the survey analysis with the measured beam pipe height are shown in Appendix A.

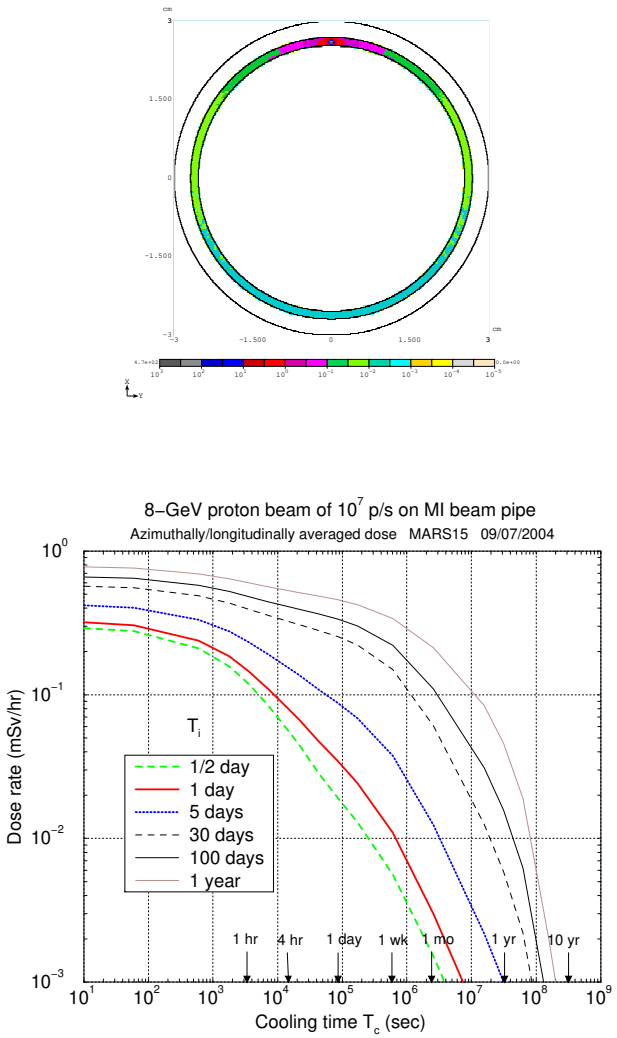
In order to find what level of localized beam loss would result in the observed residual radiation levels, a MARS calculation was performed[2] The beam pipe vertical profile reported above (approximate) was applied to a $2''$ diameter, 1.5 mm thick circular pipe. An 8 GeV beam was assumed to be pointlike (zero transverse size), impinging on the top of the pipe where the pipe was lowest. A geometry correction (reduction) factor of 3 for a 1.5-mm thick SS pipe which was determined in a previous calculation was applied. Results are shown in Figure 6. The dose longitudinal profile shows the same features reported above. The calculation predicted that for a rate of 3×10^7 protons/sec for thirty days of exposure and 1 day of cooldown, the residual radiation would measure 300 millirem on contact.

Figure 6: Upper Figure shows residual radiation pattern from MARS calculation of beam interacting at top of a beam pipe. Lower Figure shows the variation of residual radiation for various exposure and cooldown times

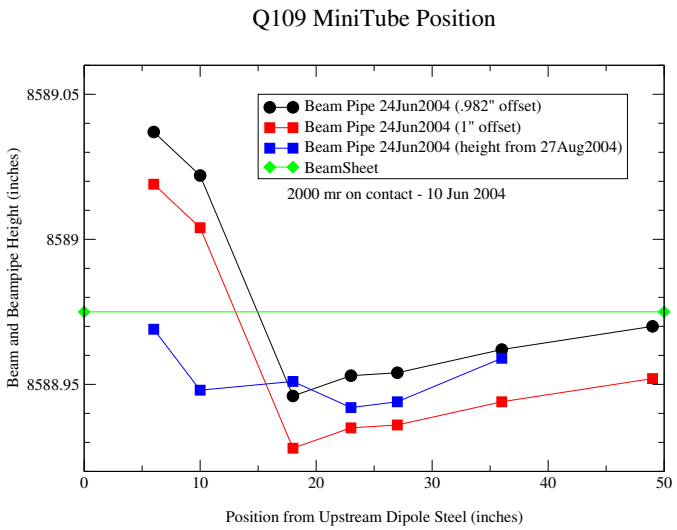
Figure 8: Alignment of Minitube upstream of Q109. Results assuming a constant pipe half height are shown in black and red. Results shown in blue use the measured beam tube half height. Expected Dipole and Quadrupole elevations from the Main Injector Beam Sheets are shown in green.

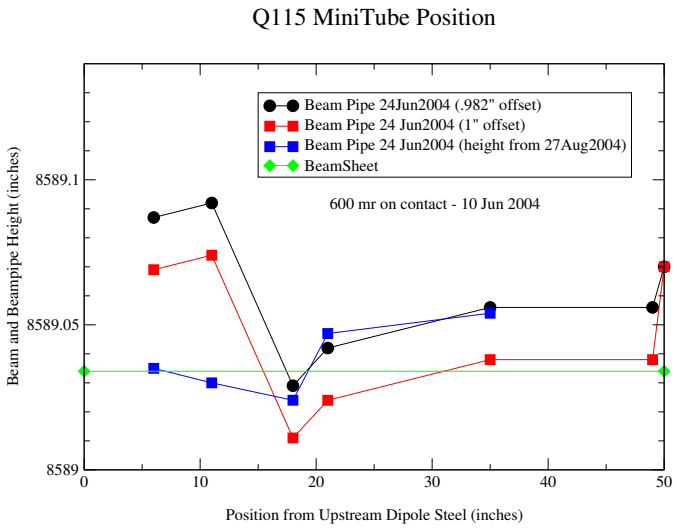
Figure 9: Alignment of Minitube upstream of Q115. Results assuming a constant pipe half height are shown in black and red. Results shown in blue use the measured beam tube half height. Expected Dipole and Quadrupole elevations from the Main Injector Beam Sheets are shown in green.

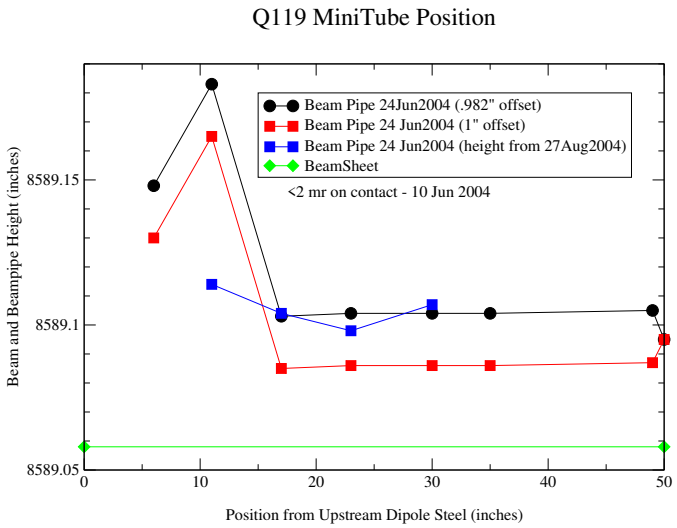
Figure 10: Alignment of Minitube upstream of Q119. Results assuming a constant pipe half height are shown in black and red. Results shown in blue use the measured beam tube half height. Expected Dipole and Quadrupole elevations from the Main Injector Beam Sheets are shown in green.

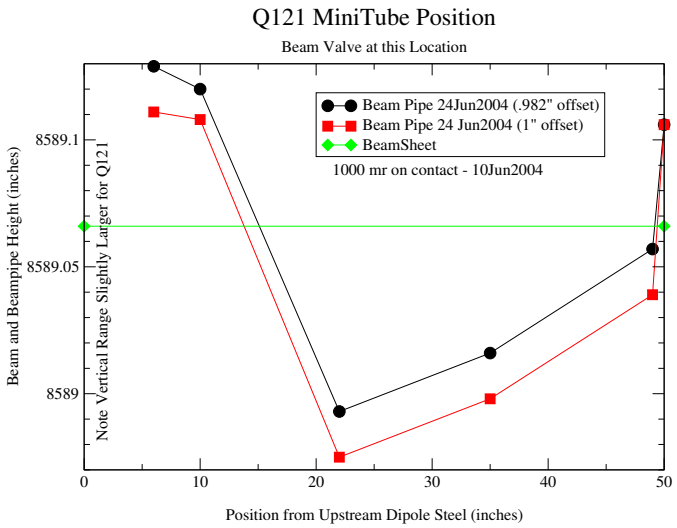
Figure 11: Alignment of Minitube upstream of Q121. Results assuming a constant pipe half height are shown in black and red. Expected Dipole and Quadrupole elevations from the Main Injector Beam Sheets are shown in green.

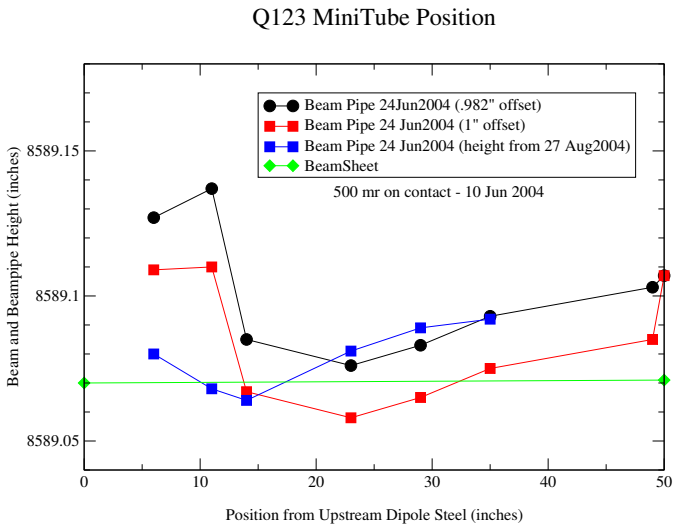
Figure 12: Alignment of Minitube upstream of Q123. Results assuming a constant pipe half height are shown in black and red. Results shown in blue use the measured beam tube half height. Expected Dipole and Quadrupole elevations from the Main Injector Beam Sheets are shown in green.

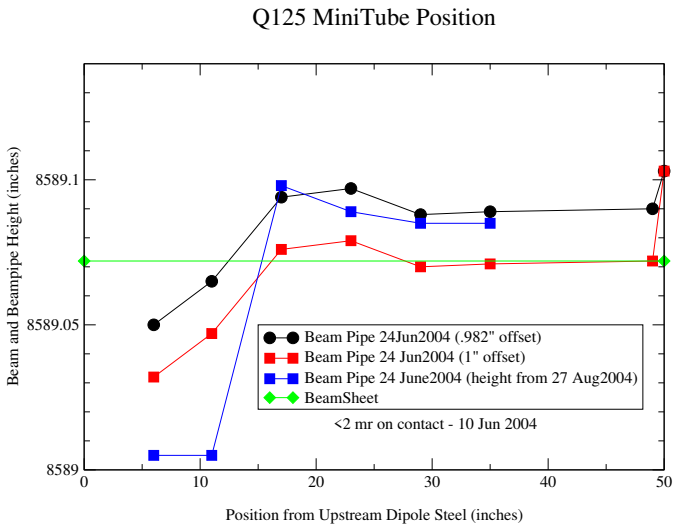
Figure 13: Alignment of Minitube upstream of Q125. Results assuming a constant pipe half height are shown in black and red. Results shown in blue use the measured beam tube half height. Expected Dipole and Quadrupole elevations from the Main Injector Beam Sheets are shown in green.

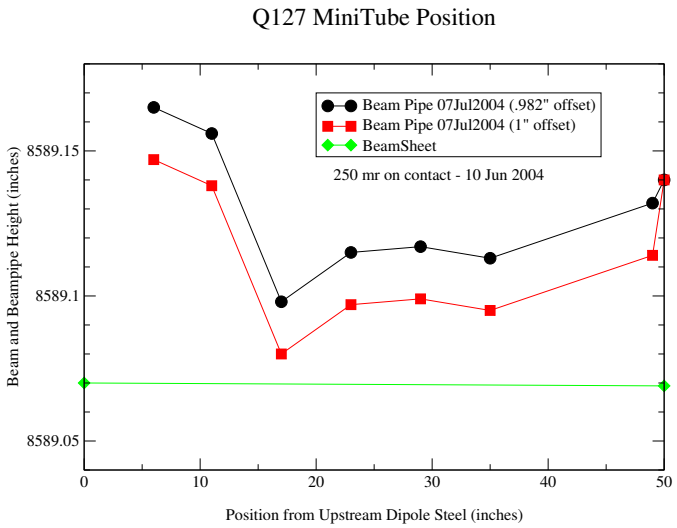
Figure 14: Alignment of Minitube upstream of Q127. Results assuming a constant pipe half height are shown in black and red. Expected Dipole and Quadrupole elevations from the Main Injector Beam Sheets are shown in green.

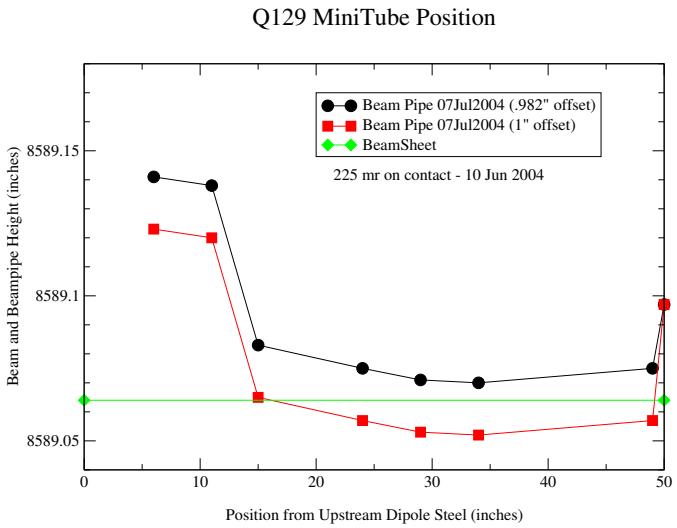
Figure 15: Alignment of Minitube upstream of Q129. Results assuming a constant pipe half height are shown in black and red. Expected Dipole and Quadrupole elevations from the Main Injector Beam Sheets are shown in green.

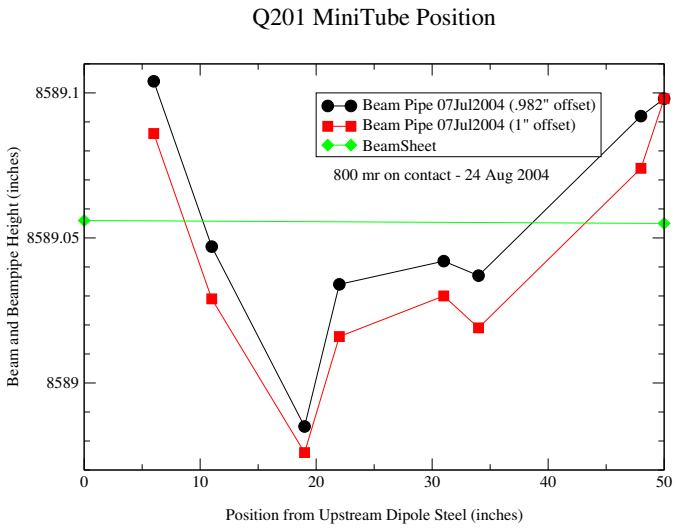
Figure 16: Alignment of Minitube upstream of Q201. Results assuming a constant pipe half height are shown in black and red. Expected Dipole and Quadrupole elevations from the Main Injector Beam Sheets are shown in green.

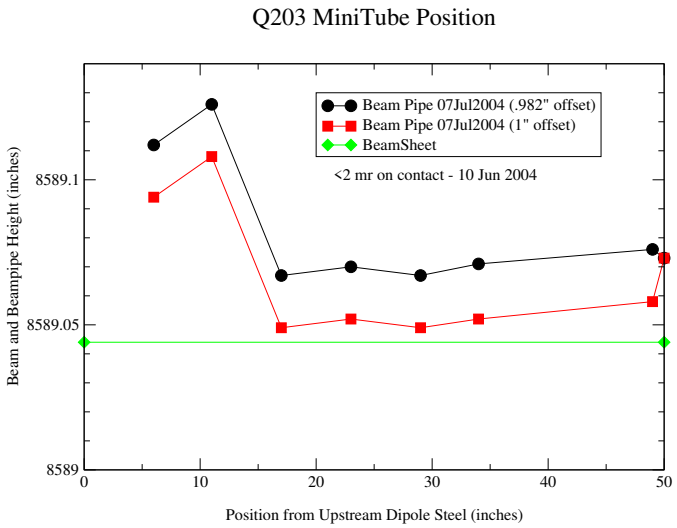
Figure 17: Alignment of Minitube upstream of Q203. Results assuming a constant pipe half height are shown in black and red. Expected Dipole and Quadrupole elevations from the Main Injector Beam Sheets are shown in green.

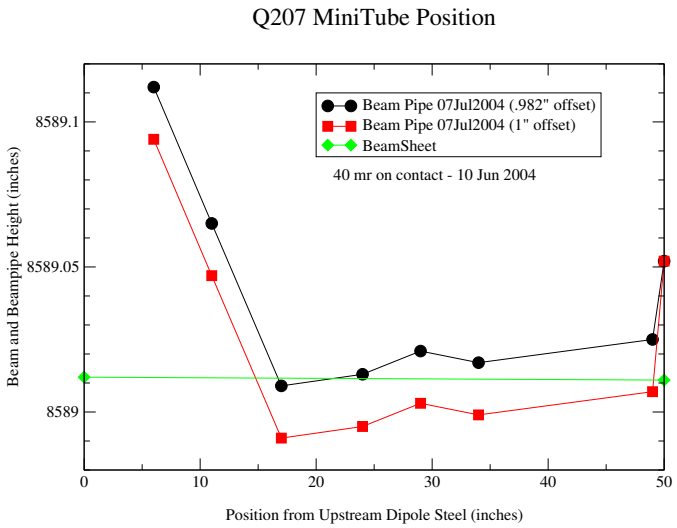
Figure 18: Alignment of Minitube upstream of Q207. Results assuming a constant pipe half height are shown in black and red. Expected Dipole and Quadrupole elevations from the Main Injector Beam Sheets are shown in green.

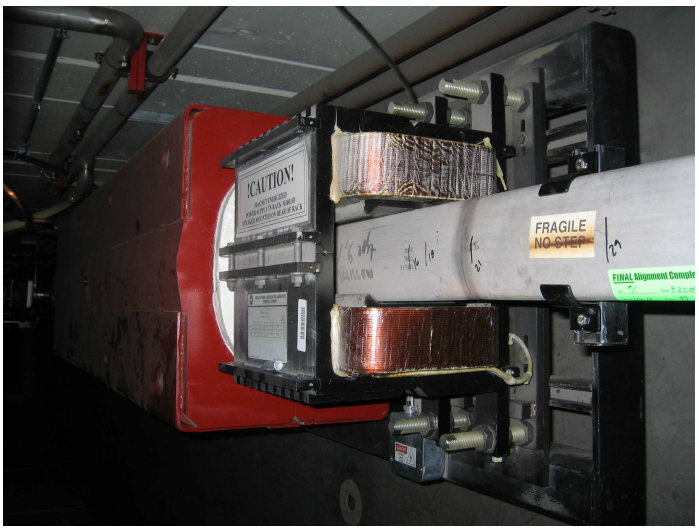
Figure 22: Image of upstream minitube at Q401 showing radiation damage to tape.

and these tags provide a visual representation of the beam loss. The are usually discolored where the radiation is high, not discolored where it is low and the image reveals a band indicating the limited horizontal extent of the beam. At Q321, the offset due to the requirement that the beam reach the off-centered field free region of the Lambertson is quite apparent (in the tunnel if not in the picture). Figures 19,20, 21 and 22 were photos taken in Summer 2004.
