# PERFORMANCE AND MAINTENANCE EXPERIENCES WITH A WIND TURBINE DURING 20 YEARS OF OPERATION

R. Nolan Clark  
Agricultural Engineer  
USDA – Agricultural Research Service  
PO Drawer 10  
Bushland, TX 79012  
[Nolan.Clark@ars.usda.gov](mailto:Nolan.Clark@ars.usda.gov)  
<http://www.cprl.ars.usda.gov>

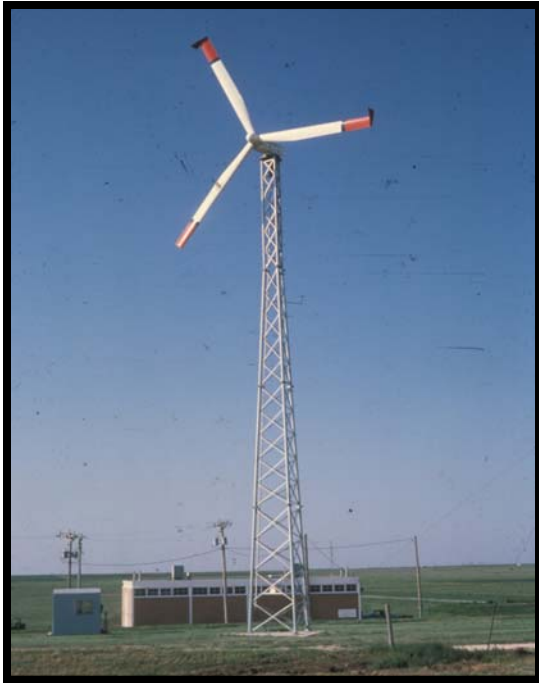
Fig. 1. The Enertech 44 was installed in 1982. The hub height was 25-m and the system supplied power to a 480 V irrigation pump connected to the utility grid.
