NMP EO-1

DELTA PRE-SHIP REVIEW

Hyperion

Grating Imaging Spectrometer

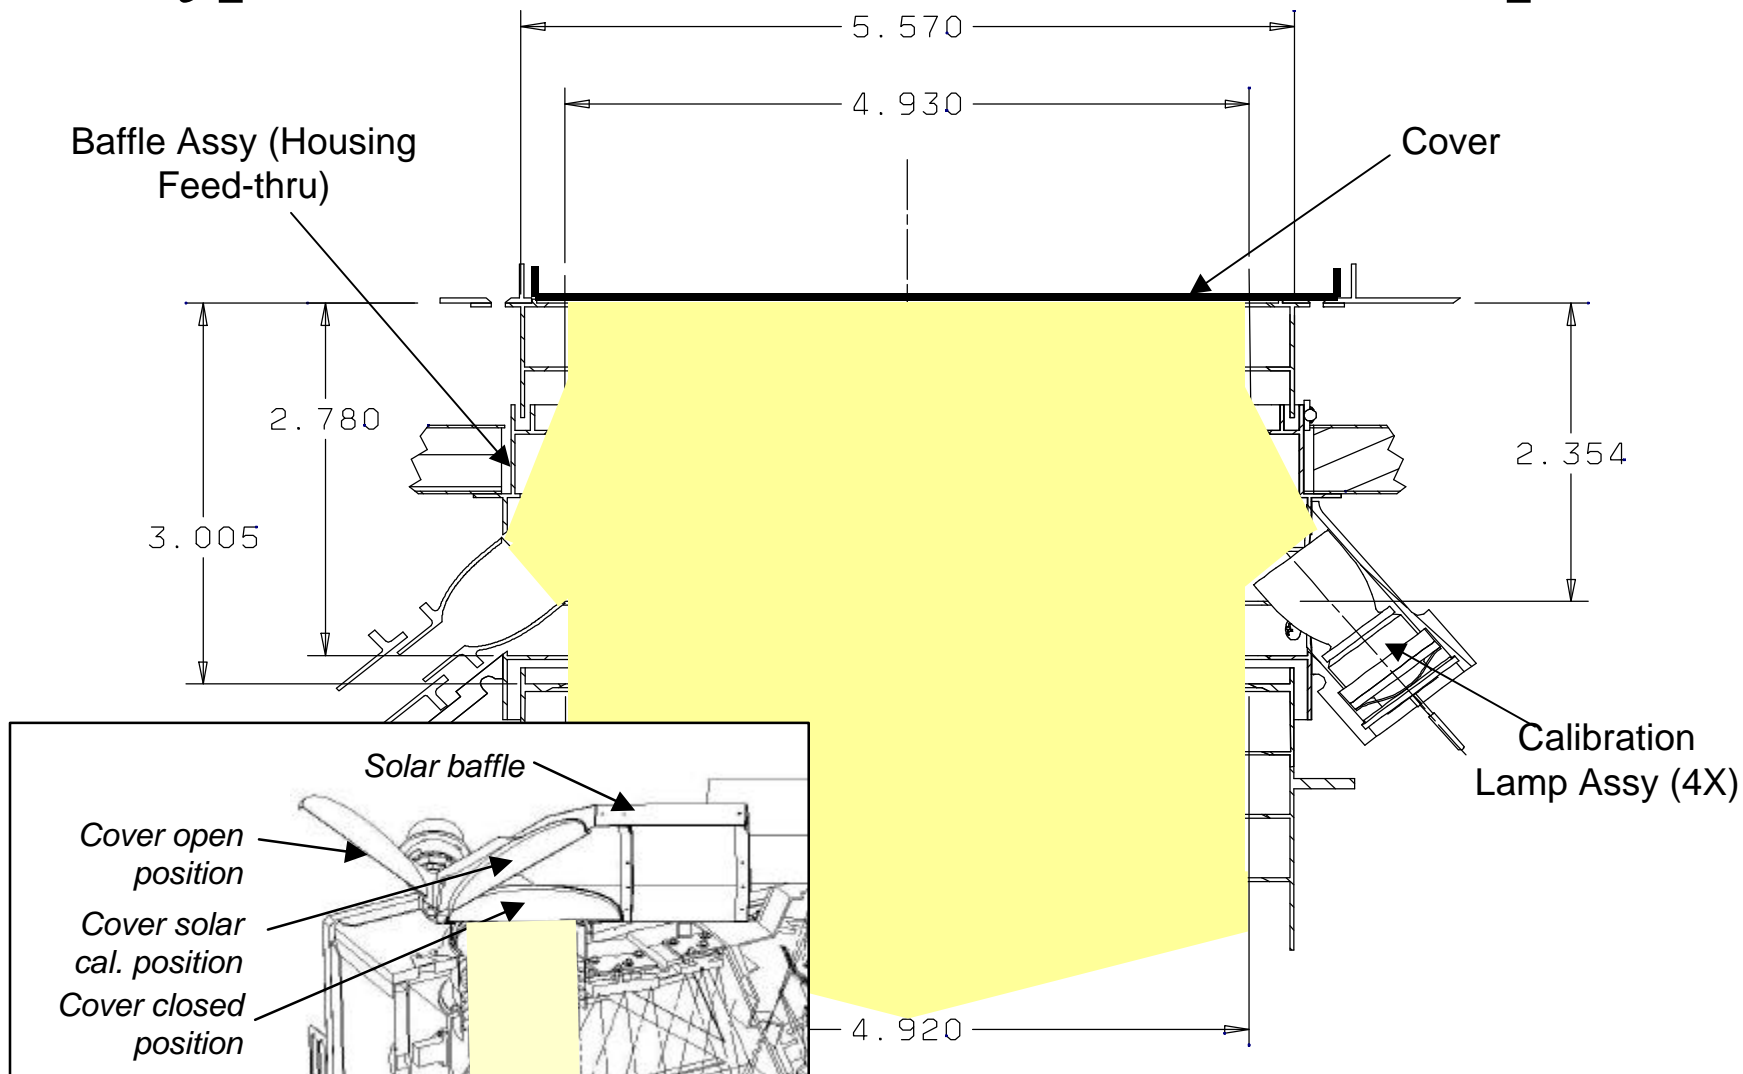
Hyperion Internal Calibration Lamps

- ◆ **Recent data from redundant internal cal lamps is higher than at TRW by 5%**
 - *Data acquired at GSFC is stable*
- ◆ **Lamps were not burned-in to stabilize properties before using them**
 - *Burn-in modifies tungsten filament grain structure, increasing output*

Inflight Calibration
Lamps installed in
the entrance
aperture baffle
*(view from inside
the HSA looking
out toward the
aperture cover)*

Possible cause	Investigation approach
1	Lamp envelope not getting warm enough to activate halogen cycle in short duration of operation, causing lamp to darken with tungsten deposits. (Primary lamp on time is 40 seconds, including a 5 second ramp of current; Secondary lamp on time is 75 seconds, including the 5 second ramp of current.)	Measure lamp envelope temperature vs. time. Inspect lamps for possible darkening. Measure bare lamp and, if possible, a flight spare lamp assembly.
2	Lamp filament undergoing changes as part of burn-in, which was not performed in advance.	Inspect lamps using digital microscope to see if filament shows any sign of change.
3	Lamp drive electronics problem in HEA (primary lamp was replaced when intermittent during TV at TRW)	Bench test electronics using Hyperion Instrument Test Set (HITS) and Instrument Simulator Unit, and test tools.

- ◆ ***Perform additional burn-in time on both lamps until response is repeatable***
 - *Accumulate on-time necessary to stabilize, at least 6.5 hours.*
 - *Primary lamp set has accumulated approximately 4 hours.*
 - *Secondary cal lamp has accumulated approximately 1 hour.*
- ◆ ***Increase lamp on time to 3 minutes after each DCE***
 - *Ensure glass envelope achieves sufficiently high temperature to activate the halogen cycle*
- ◆ ***Consider revised calibration sequence to utilize both lamps***
 - *Image (dark file)*
 - *Lamp 1 on 3 minutes, image lamp 1*
 - *Lamp 2 on 3 minutes, image (both lamps)*
 - *Lamp 1 off 3 minutes, image lamp 2*
 - *Lamp 2 off 3 minutes, image (dark file)*
