Yakima River Basin Phase II Fish Screen Evaluations, 2002

J. A. Carter
G. A. McMichael
M. A. Chamness

January 2003

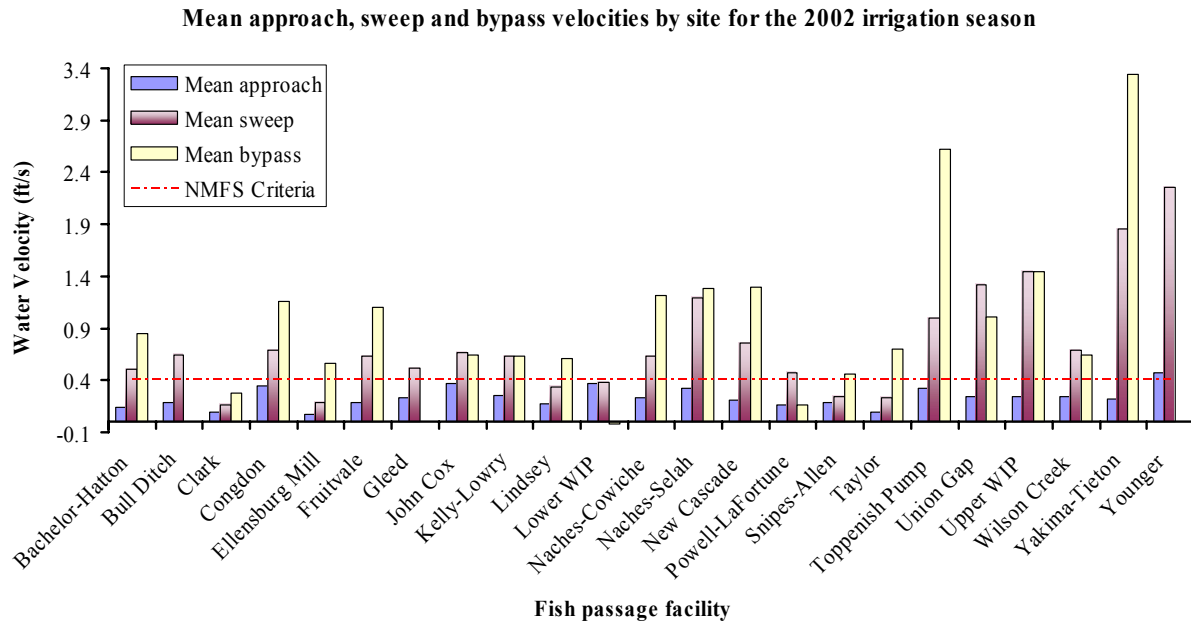
Figure 3. Mean Approach, Sweep, and Bypass Velocities at Phase II Fish Screen Facilities in the Yakima River Basin in 2002 Shown Against a Reference Line for the NMFS Approach Criteria (less than or equal to 0.4 ft/s)

Although velocities often fluctuated widely from site to site and over time, average sweep velocities for the year typically exceeded average approach velocities for the year (Table 2). Mean approach velocities were generally below the NMFS criteria of less than or equal to 0.4 ft/s (Table 3). However, many of the sites had bypass velocities that were slower than sweep velocities (Table 4, Figure 3).

Overall, 90% of all approach velocity measurements met the NMFS approach criteria of less than or equal to 0.4 ft/s (the same as was reported in 2000). This is much lower than the 97% reported in 2001; however, 2001 was an exceptionally low-water year, and many sites did not have enough water to meet other criteria, such as submergence and bypass flow. Areas of the screen (i.e., top, bottom, upstream, downstream) that exceeded these criteria were dependent on factors at the individual sites.

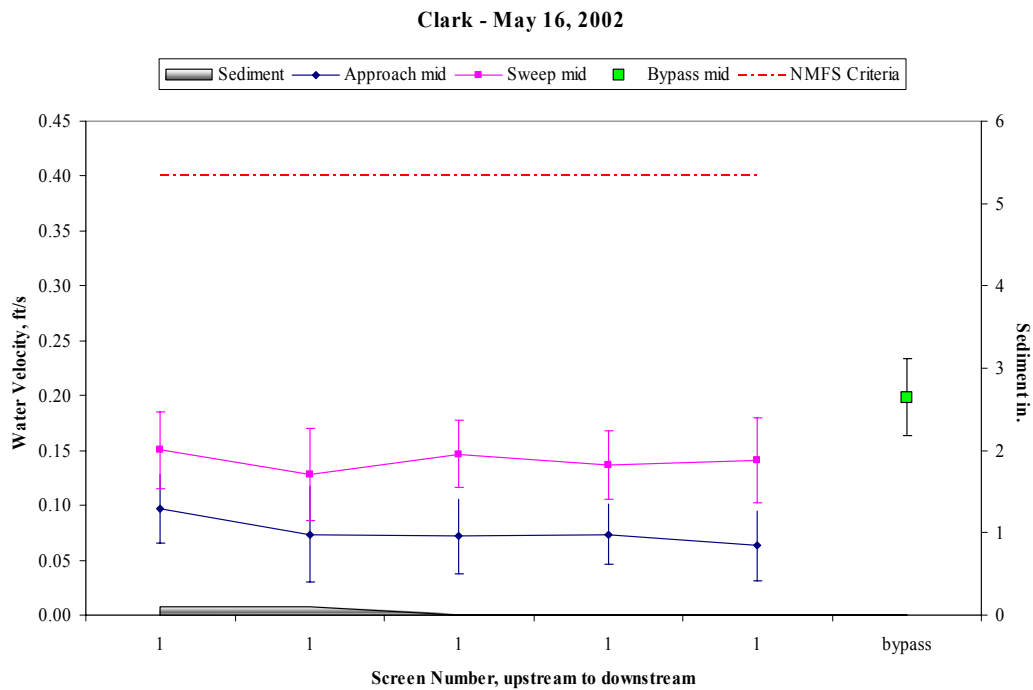
Figure 6. Water Velocities and Sediment Depths at Clark in May 2002. Error bars show turbulence (\pm the root-mean-squared [RMS]) at each point.

The Clark screening facility was visited on May 16, 2002; June 25, 2002; and September 19, 2002. Water velocities at this site complied with NMFS criteria during all surveys. All approach values were less than 0.4 ft/s, and sweep velocities were generally higher than approach velocities (Figures 6, 7, and 8). The water velocity in the bypass was always greater than the average sweep velocity, and in September, there was a clear increase in sweep velocity from upstream to downstream within the site. These conditions created a clear trajectory towards the bypass and would be expected to expedite fish passage through the site.

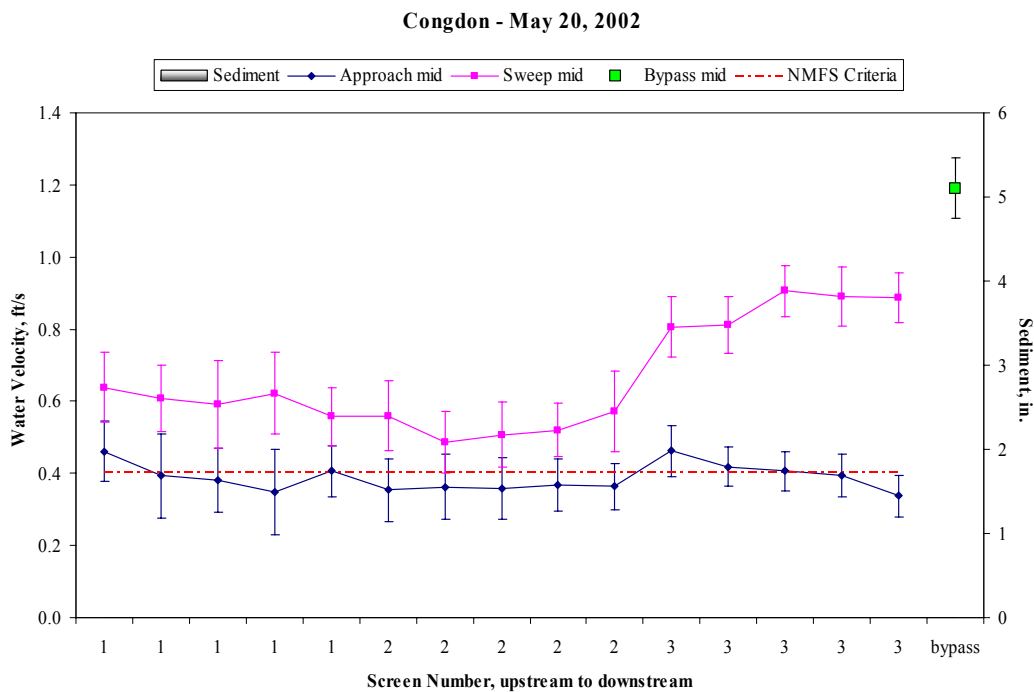
Figure 9. Water Velocities and Sediment Levels at Congdon in May 2002. Error bars show turbulence (\pm the root-mean-squared [RMS]) at each point.

The Congdon facility was evaluated on May 20, 2002; June 20, 2002; and September 17, 2002. During the May evaluation, 67% of approach velocities exceeded NMFS criteria. This figure had greatly improved by June, and all approach velocities met NMFS criteria in June and September (Figures 9, 10, and 11). Sweep velocities were always higher than approach velocities, and the velocity in the bypass was always higher still, creating a clear trajectory towards the bypass during all surveys.

The screen seals were in good condition. There was no sediment in front of the screens during any of the surveys. Submergence was at the high end of the criteria range throughout the survey period: 85% during May and June, and 83% in September. The depth of water flowing over the weir and through the outfall met NMFS criteria. Water ran freely through the bypass, though, as in previous years, water surged at the bypass outfall. This condition was not as severe as in 2001 when PNNL researchers observed water spraying at least a foot above the outfall pipe. A test conducted in 2000 concluded that the surging was not caused by an obstruction of the bypass. This surging water could be harmful to fish moving through the bypass; the PNNL researchers recommend the installation of an air pressure release tube to prevent the surges.

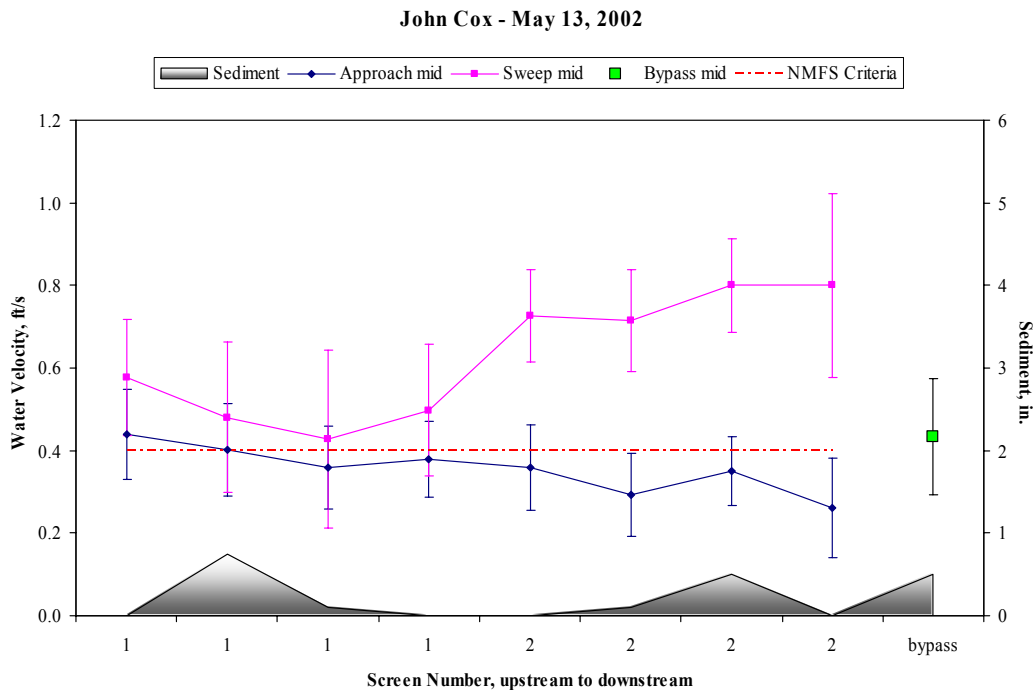
Figure 12. Water Velocities and Sediment Depths at John Cox in May 2002. Error bars show turbulence (\pm the root-mean-squared [RMS]) at each point.

The John Cox site was evaluated on May 13, 2002; June 17, 2002; and September 10, 2002, although the site was shut down for the season before the September survey. In May and June, 75 and 70% of approach velocities met NMFS criteria, respectively (Figures 12 and 13). However, there was a clear trend of decreasing approach velocity and increasing sweep velocity towards the downstream end of the site during both May and June. The bypass velocity was slower than the average sweep velocity in May, which led the PNNL researchers to believe that there was a blockage in the bypass. The PNNL researchers left a message for John Dyson (U.S. Bureau of Reclamation (USBR) concerning this issue on May 13, 2002. Tom Leonard (USBR) replied that there was no blockage. The PNNL researchers followed up on May 21, 2002, with a visit to the site. After passing a neutrally buoyant object through the bypass, the researchers concurred that the bypass was not blocked, but that it was backed up for some reason. This situation was remedied before the June survey, and in June, the bypass velocity was greater than the average sweep, and water ran freely over the weir and out the outfall.

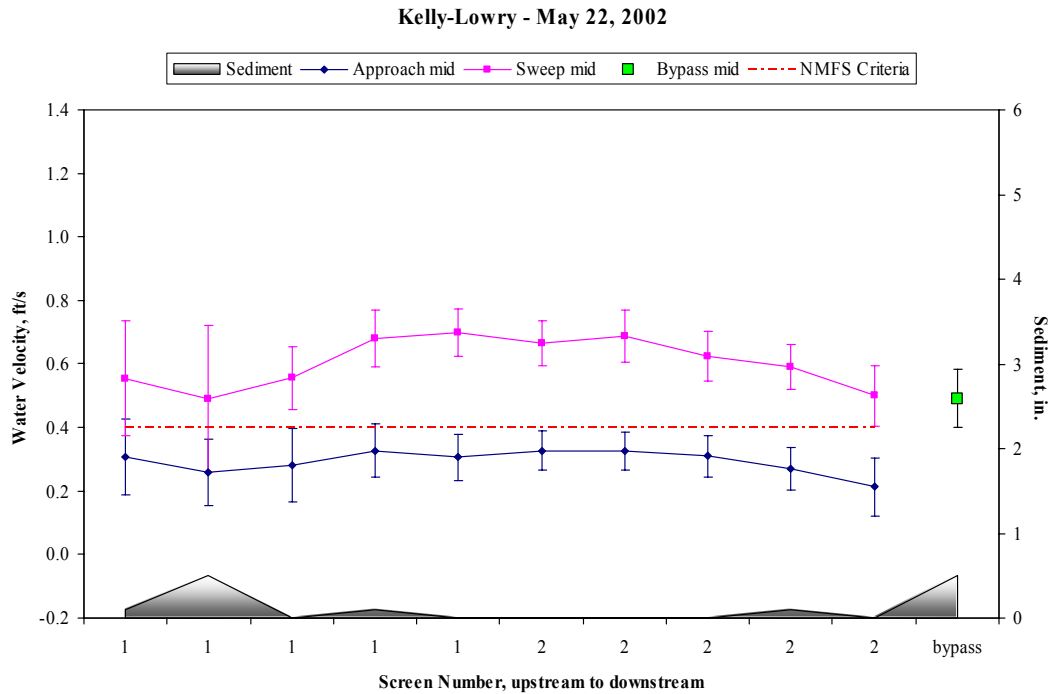
Figure 14. Water Velocities and Sediment Depths at Kelly-Lowry in May 2002. Error bars show turbulence (\pm the root-mean-squared [RMS]) at each point.

The Kelly-Lowry site was evaluated on May 22, 2002; June 20, 2002; and September 17, 2002. All approach velocities met NMFS criteria during all surveys (Figures 14, 15, and 16). Sweep velocities were always higher than approach velocities, though sweep velocities did not increase towards the bypass. The bypass velocity was slower than the average sweep velocity in May and faster in June and September.

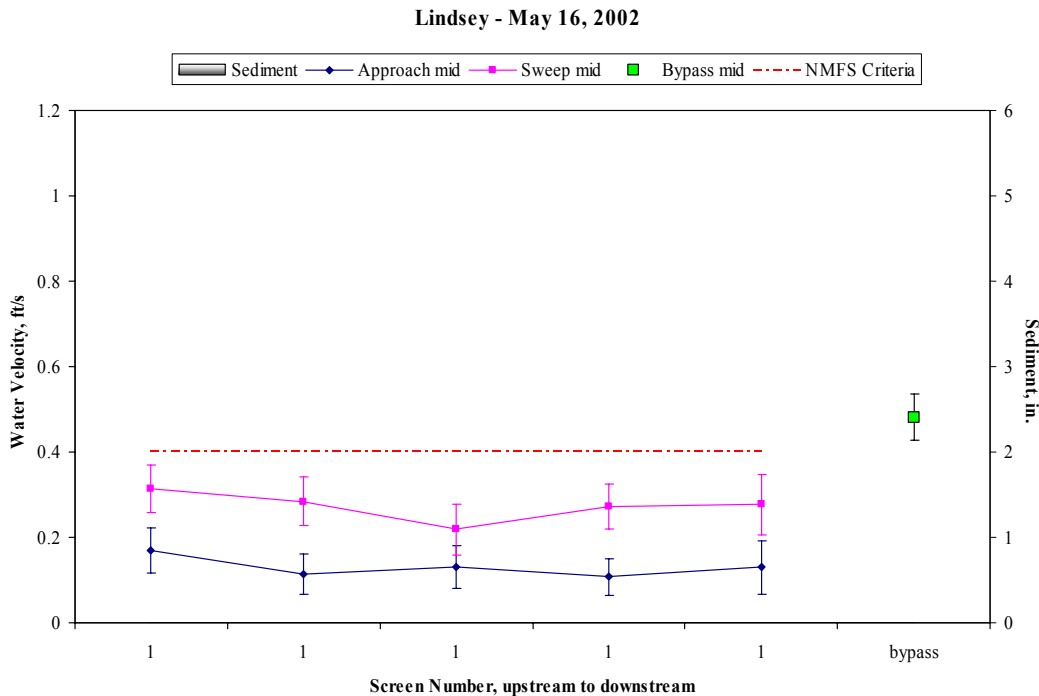
Figure 17. Water Velocities and Sediment Depths at Lindsey in May 2002. Error bars show turbulence (\pm the root-mean-squared [RMS]) at each point.

The Lindsey site was evaluated on May 16, 2002; June 25, 2002; and September 18, 2002. During all surveys, 100% of approach velocity values met NMFS criteria (Figures 17, 18, and 19). All sweep velocities were greater than approach velocities, and the bypass velocity was greater than the average sweep velocity, except in September. In June, sweep increased from the upstream end of the site towards the bypass.

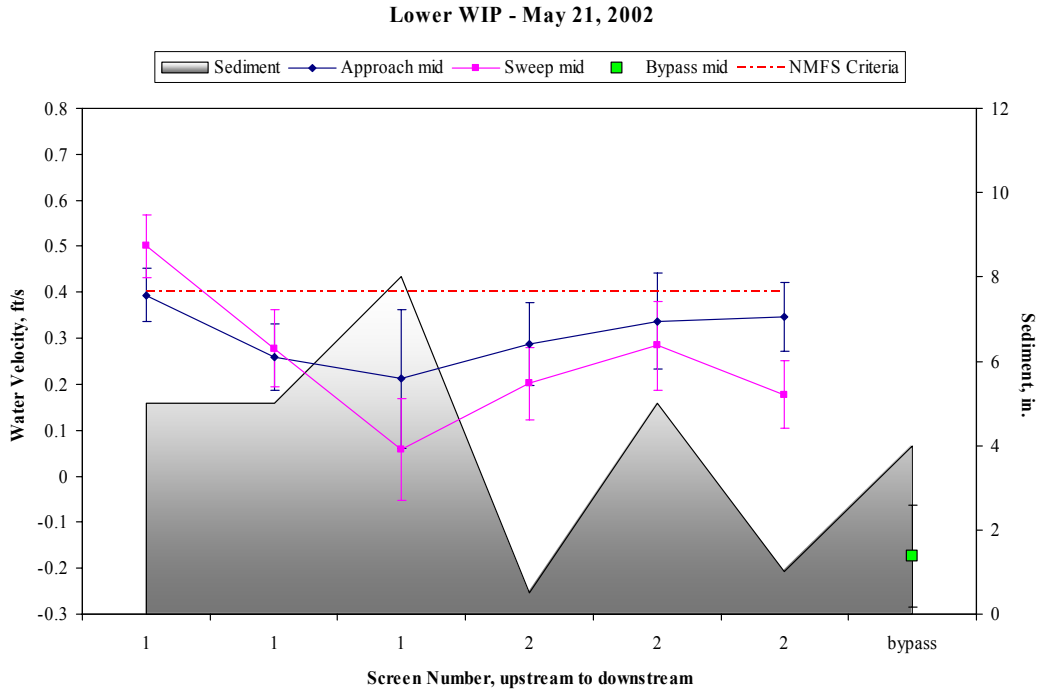
Figure 20. Water Velocities and Sediment Depths at Lower Wapato Irrigation Project (WIP) in May 2002. Error bars show turbulence (\pm the root-mean-squared [RMS]) at each point.

The Lower WIP site was visited on May 21, 2002; June 18, 2002; and September 10, 2002. In May, all approach velocities met NMFS criteria. That figure decreased to 67% in June and 17% in September. In May, approach velocities were greater than sweep velocities. Sweep velocities did not generally increase towards the downstream end of the site, and bypass velocities were slower than the average sweep velocity (Figures 20, 21, and 22). This set of conditions could lead to delay for migrating fish.

The USBR, which is responsible for the operation and maintenance of this site, was notified May 21, June 18, and September 10, 2002, concerning the non-compliance of the site to NMFS criteria and the other maintenance concerns mentioned earlier. The USBR did not respond to any of these notifications. Velocity and sediment conditions such as these could lead to injury or delay of migrating fish. The PNNL researchers recommend removal of sediment deposits from the screen site, as well as monitoring facility operations more closely in an attempt to meet NMFS criteria.

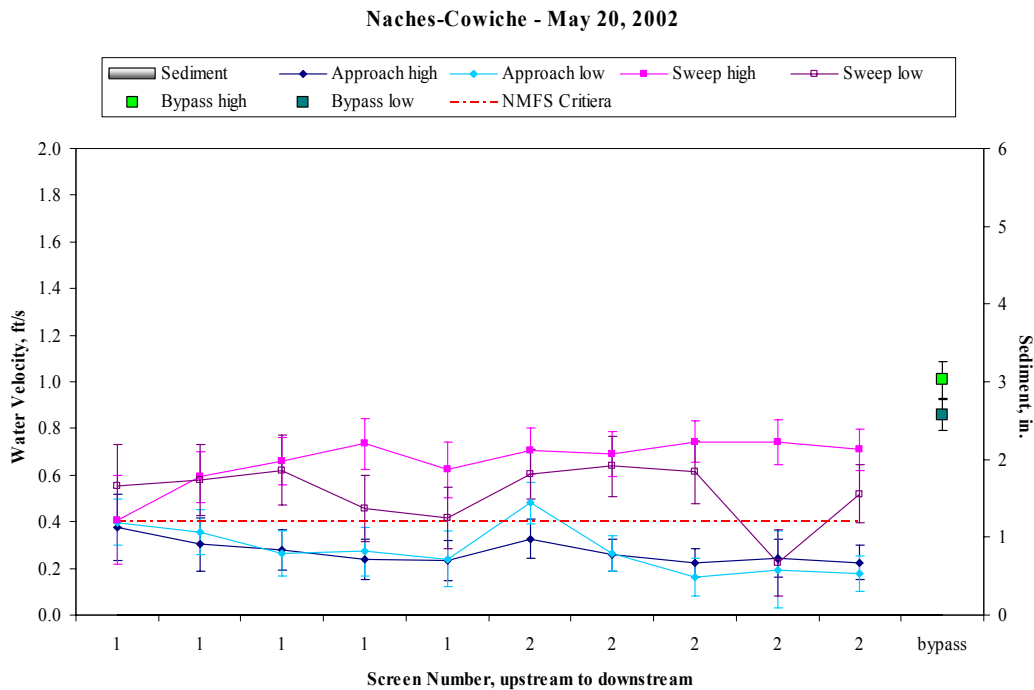
Figure 23. Water Velocities and Sediment Depths at Naches-Cowiche in May 2002. Error bars show turbulence (\pm the root-mean-squared [RMS]) at each point.

The Naches-Cowiche site was evaluated on May 20, 2002; June 19, 2002; and September 11, 2002. In May, 95% of all approach values met NMFS criteria (Figure 23). This figure increased to 100% for June and September (Figures 24 and 25). Sweep velocities were generally higher than approach velocities but did not increase towards the bypass in May or June. The average bypass velocity was faster than the average sweep velocity during all surveys.

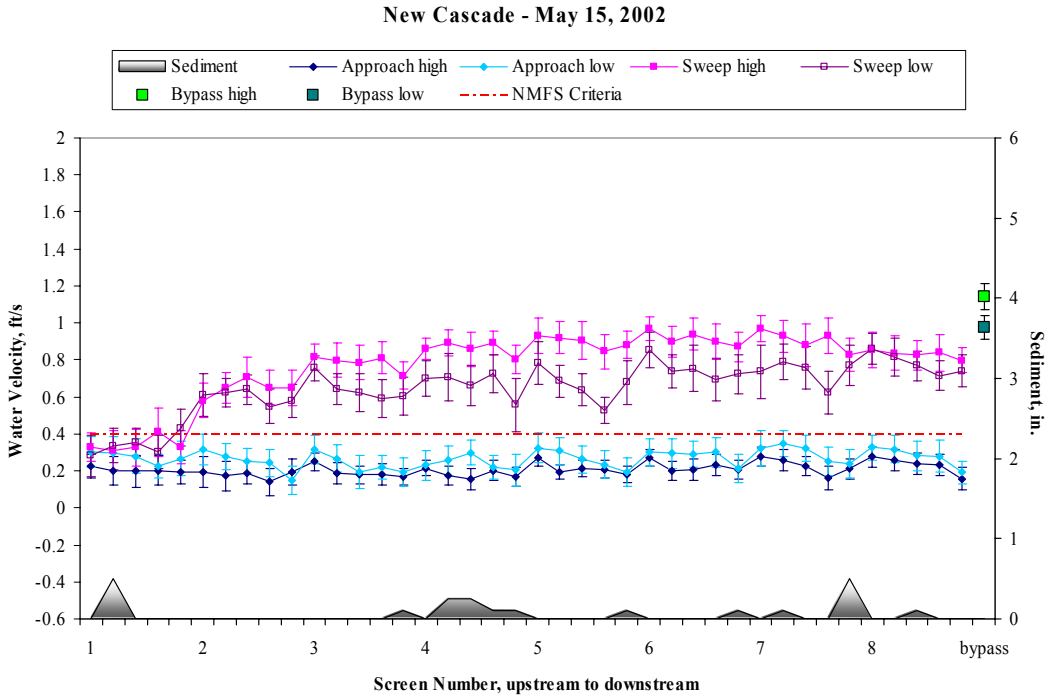
Figure 27. Water Velocities and Sediment Depths at New Cascade in May 2002. Error bars show turbulence (\pm the root-mean-squared [RMS]) at each point.

The New Cascade site was evaluated on May 15, 2002; July 1, 2002; and September 16, 2002. Growth of aquatic plants in the forebay in September forced researchers to use the Marsh-McBirney flow meter, so turbulence values are not available for that survey. In May, July, and September 100, 93, and 100% of approach velocities met NMFS criteria, respectively (Figures 27, 28, and 29). Sweep velocities were generally faster than approach velocities, and sweep velocities increased slightly towards the bypass. Bypass velocities were faster than the average sweep velocity during all surveys.

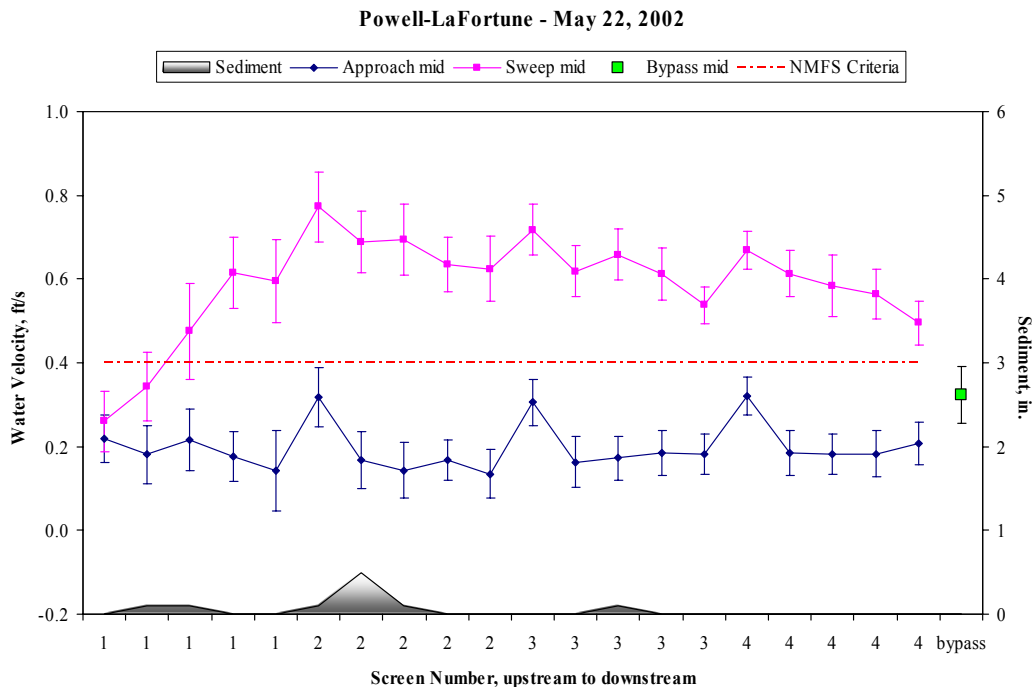
Figure 31. Water Velocities and Sediment Depths at Powell-LaFortune in May 2002. Error bars show turbulence (\pm the root-mean-squared [RMS] at each point).

Powell-LaFortune was evaluated on May 22, 2002; June 20, 2002; and September 17, 2002. Approach velocities met NMFS criteria 100% of the time. Sweep velocities were generally higher than approach velocities but did not increase towards the bypass (Figures 31, 32, and 33). Bypass velocities were slower than the average sweep velocity. Percent submergence fell below NMFS criteria in May and September at 63 and 50%, respectively. Submergence was 72% in June.

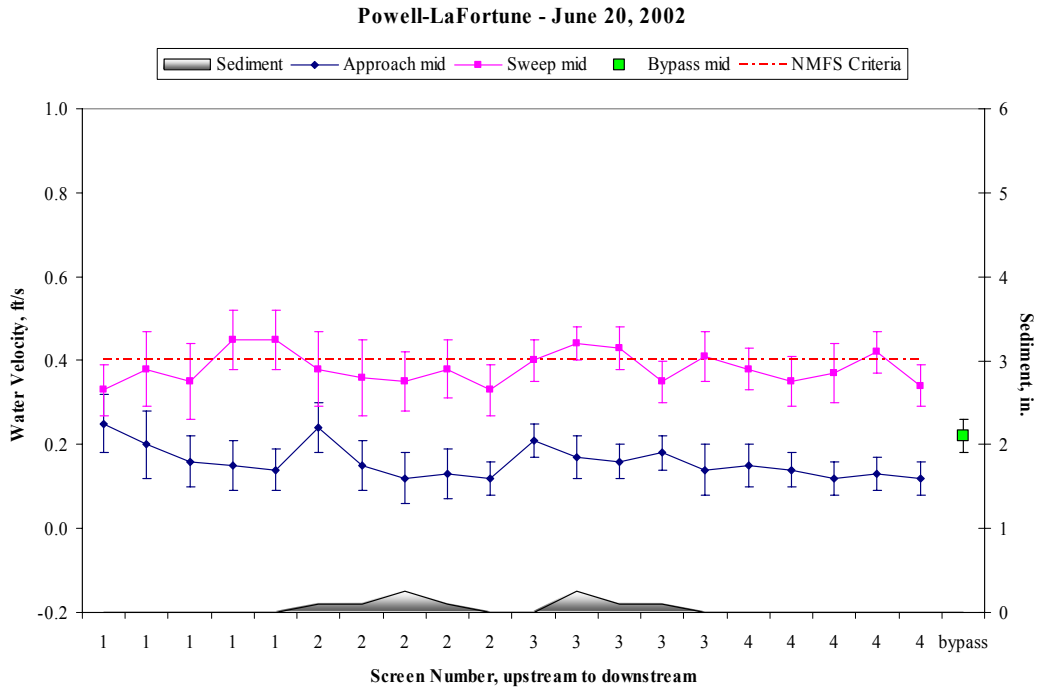
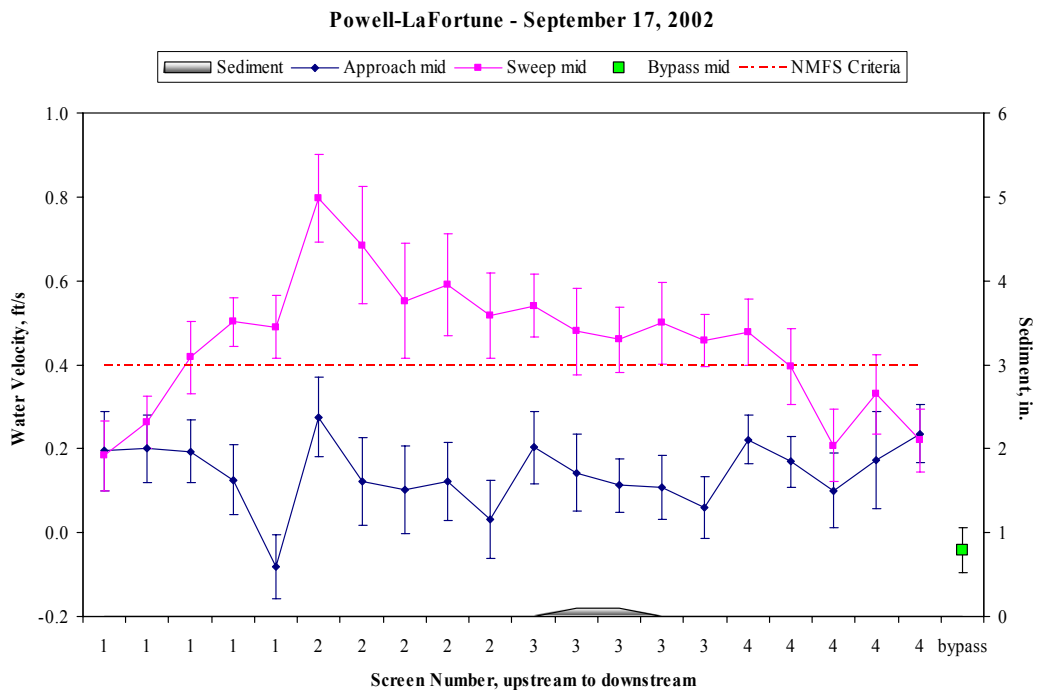
Figure 32. Water Velocities and Sediment Depths at Powell-LaFortune in June 2002. Error bars show turbulence (\pm the root-mean-squared [RMS]) at each point.

Some small 2- to 3-in. fish were seen in the forebay and the bypass entrance in May and June, and four 4- to 6-in. fish were seen in front of the screens and in the bypass in September. All visible seals were in good condition, as was the screen material. An accumulation of sediment covered some of the bottom seals in May, and a log was jammed underneath the open bypass ramp. Also in May, the video survey revealed what appeared to be a seed or rock trapped between the screen and bottom seal creating a small gap. After a few seconds, the obstruction was rolled out by the movement of the screen.

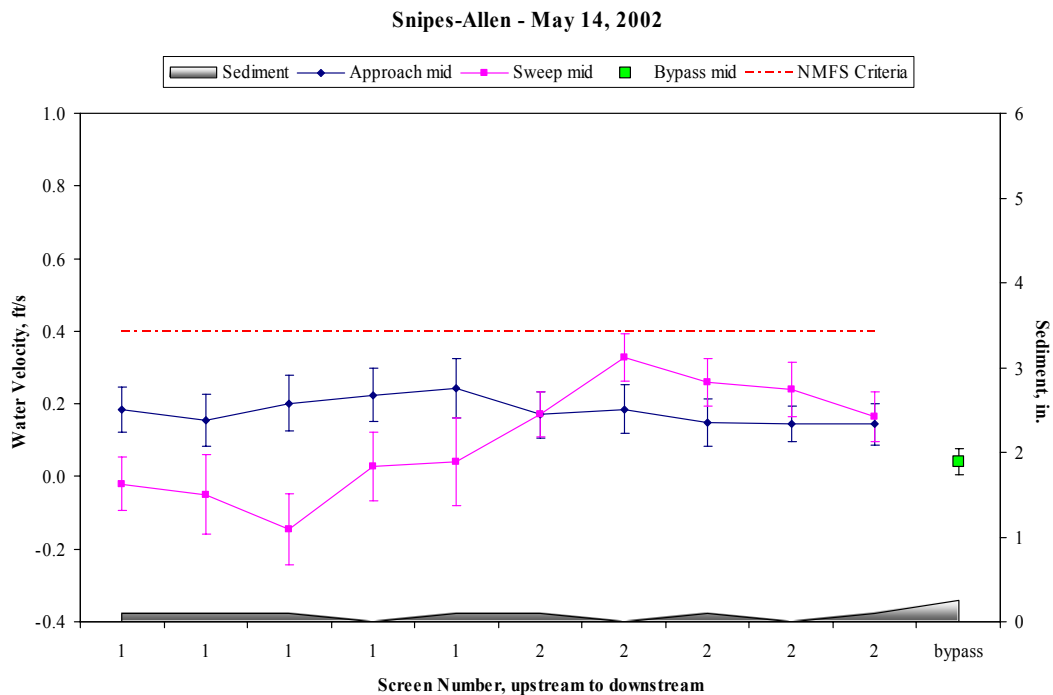
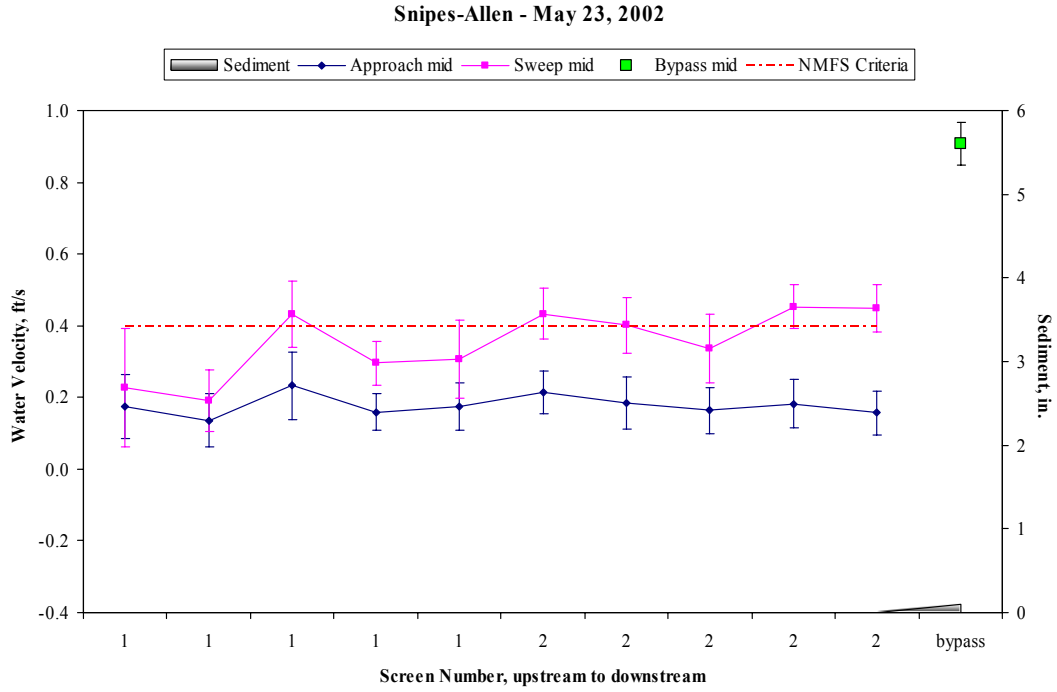
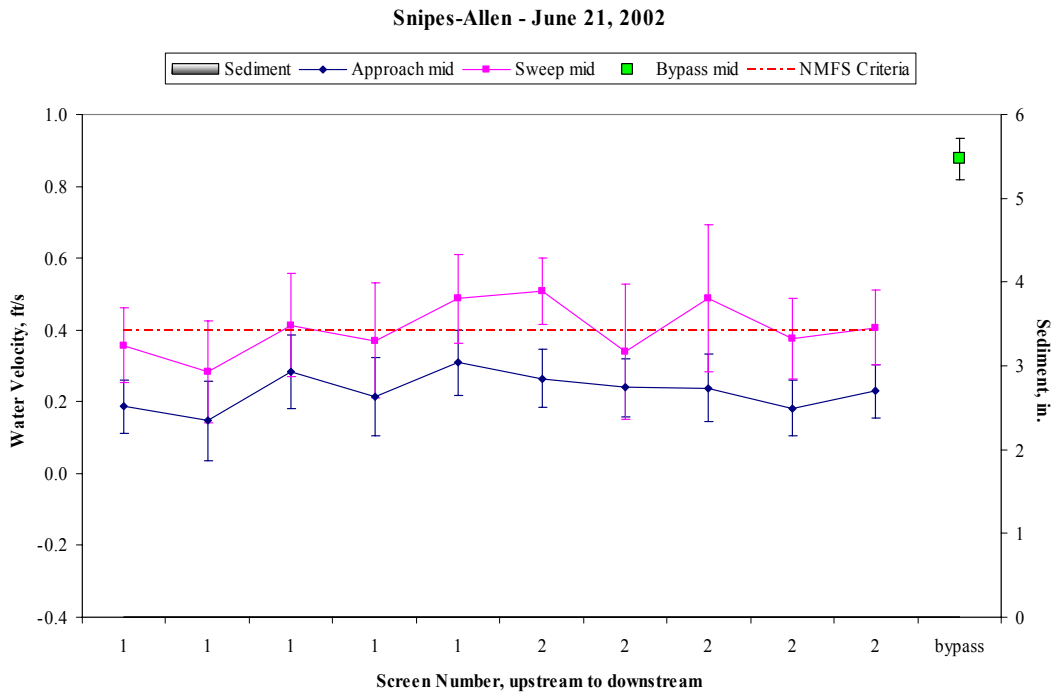
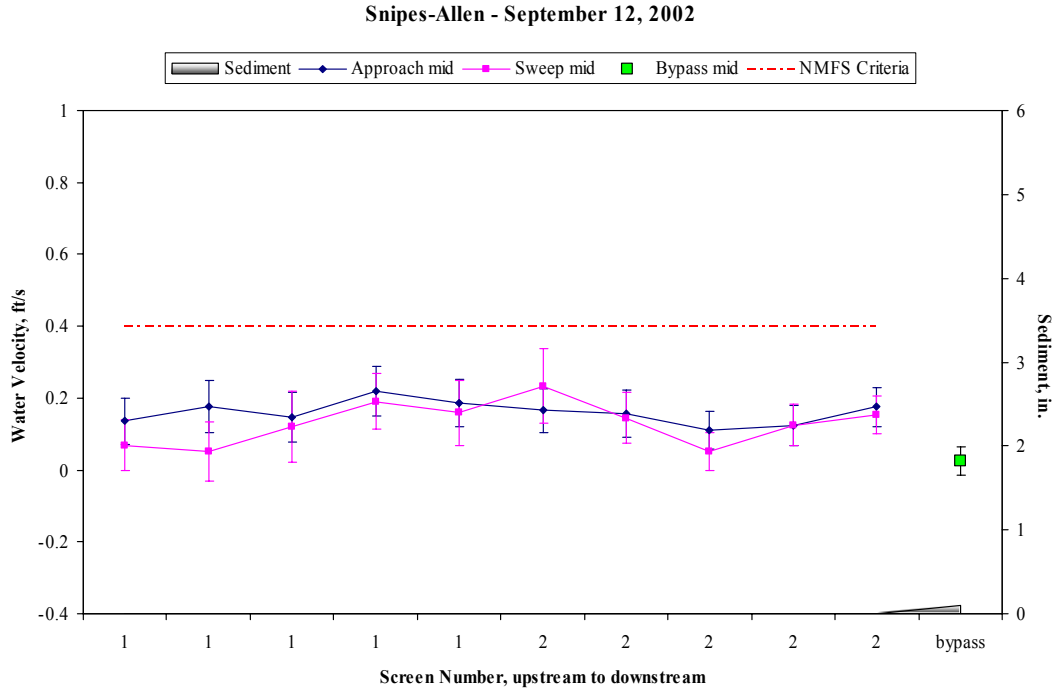
Screen submergence at Snipes-Allen met NMFS criteria during all surveys except in early May when the submergence was slightly higher (86%). In the past, this site has had many problems with debris catching on the trashracks, and while this problem was not as severe in 2002, there was still an accumulation of debris in the space behind the trashrack that could have provided cover for predator species or disrupted water flow through the site. In June and September, growth of aquatic plants in the forebay was noted. These plants also could provide shelter for predator species. The PNNL researchers recommend the site be regularly cleared of debris and vegetation to prevent harm to migrating fish.

buoyant object through the bypass pipe in June. It passed with no problems. Notes in the site operator's logbook mention additional problems with bypass blockage in August, and during the September survey, PNNL researchers noticed that the downwell was full of sticks, the bypass pipe was half full of debris, and less than 1 in. of water flowed over the weir. PNNL researchers notified Ray Gilmour (WDFW) of the blockage on September 13, 2002. He cleared out the bypass on September 17, 2002. The PNNL researchers followed up on September 19, 2002, and found submergence to be back up to 80%, and 6 in. of water flowed over the weir.

The screens and screen seals at this site were in good condition during all surveys. A 7-in. salmonid was seen in the forebay in early May, along with some other small fish. Some fish were noted in the forebay in May that were possibly chiselmouth or redbreast shiners. In September, several larger fish were seen in the bypass, and small fish were observed upstream of the trashracks and just below the outfall pipe.

Figure 34. Water Velocities and Sediment Depths at Snipes-Allen, May 14, 2002. Error bars show turbulence (\pm the root-mean-squared [RMS]) at each point.

Figure 35. Water Velocities and Sediment Depths at Snipes-Allen, May 23, 2002. Error bars show turbulence (\pm the root-mean-squared [RMS]) at each point.

Figure 36. Water Velocities and Sediment Depths at Snipes-Allen in June 2002. Error bars show turbulence (\pm the root-mean-squared [RMS]) at each point.

Figure 37. Water Velocities and Sediment Depths at Snipes-Allen in September 2002. Error bars show turbulence (\pm the root-mean-squared [RMS]) at each point.

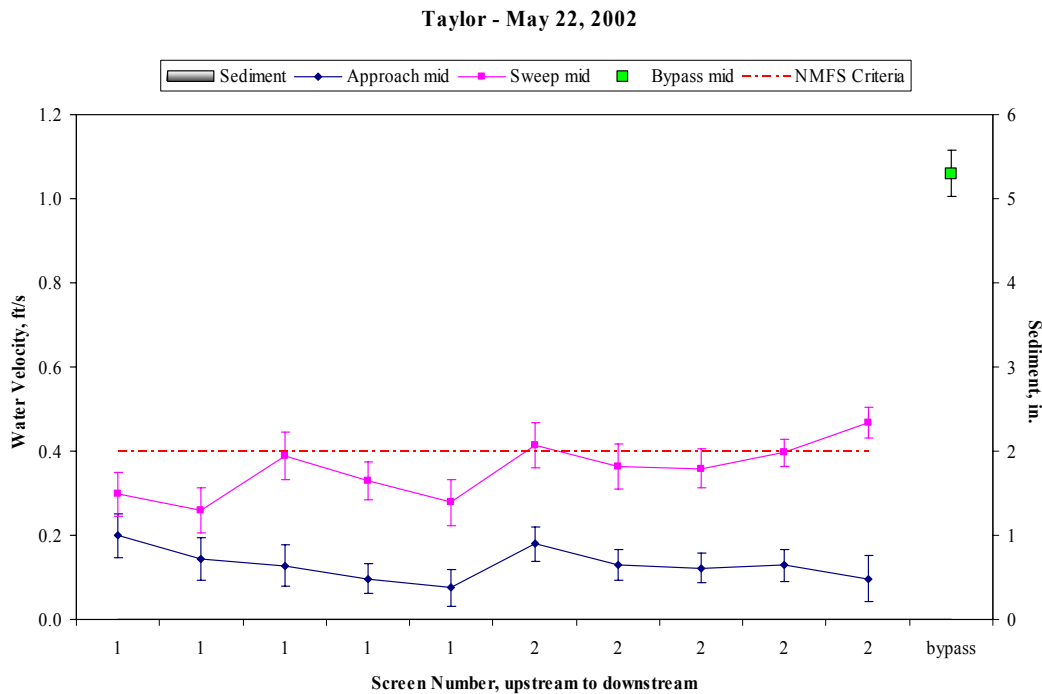
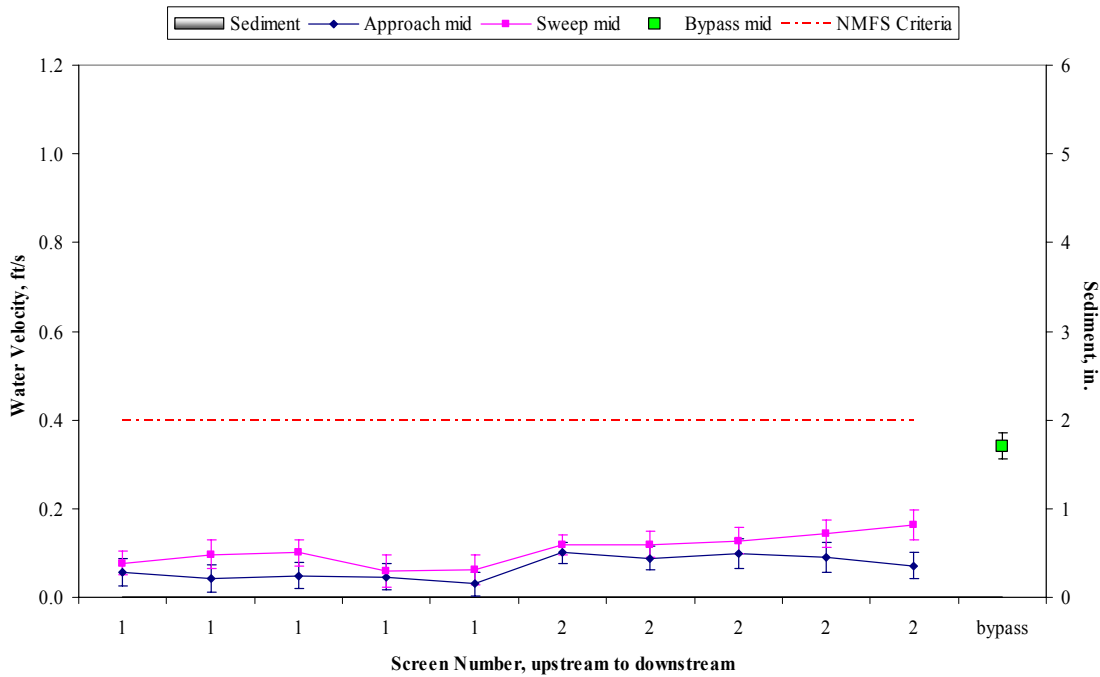
The Taylor site was evaluated on May 22, 2002; June 25, 2002; and September 17, 2002. All approach velocities met NMFS criteria in May and June, and the site was effectively shut down for the season before the September evaluation (Figures 38 and 39). Sweep velocities were always greater than approach velocities, and the bypass velocity was always greater than the average sweep velocity. Percent submergence met criteria during the surveys in May and June.

Screen and seal condition appeared to be fine, and the gaps between the metal frame of the screens and the cement walls were filled with expanding foam insulation. In May, water flowed freely under the bypass ramp, which was lifted completely up, and through the weir into the downwell. In June, the ramp was closed, and water flowed freely over the weir. Outfall conditions were within all criteria limits in May and could not be evaluated in June because the area was overgrown.

In September, there was only 6 in. of water in the forebay, and the first drum screen was turned off. The bypass was blocked off by checkboards that were installed in front of the ramp on September 4, 2002. There was no flow through the bypass, and the point of discharge at the outfall appeared to be less than 12 in. deep, though the researchers could not get to it to measure it because the area was too overgrown. Notes in the site operator's logbook show that this site had difficulties maintaining submergence to within criteria and that flows have been very inconsistent throughout the irrigation season. Submergence was below criteria for most of September.

Figure 38. Water Velocities and Sediment Depths at Taylor in May 2002. Error bars show turbulence (\pm the root-mean-squared [RMS]) at each point.

Figure 39. Water Velocities and Sediment Depths at Taylor in June 2002. Error bars show turbulence (\pm the root-mean-squared [RMS]) at each point.

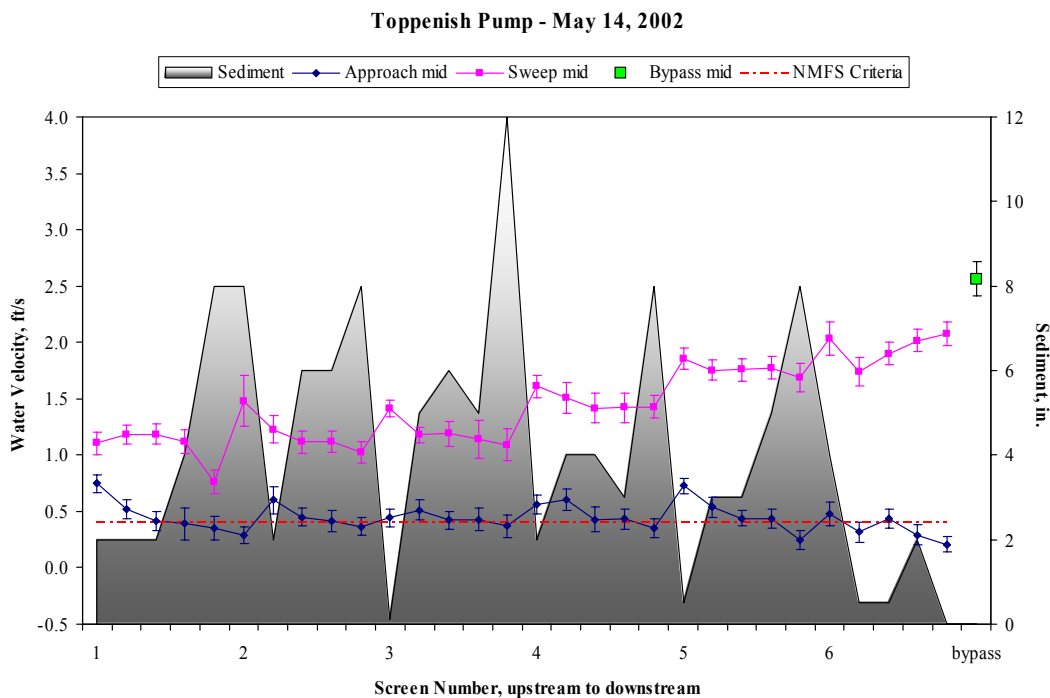
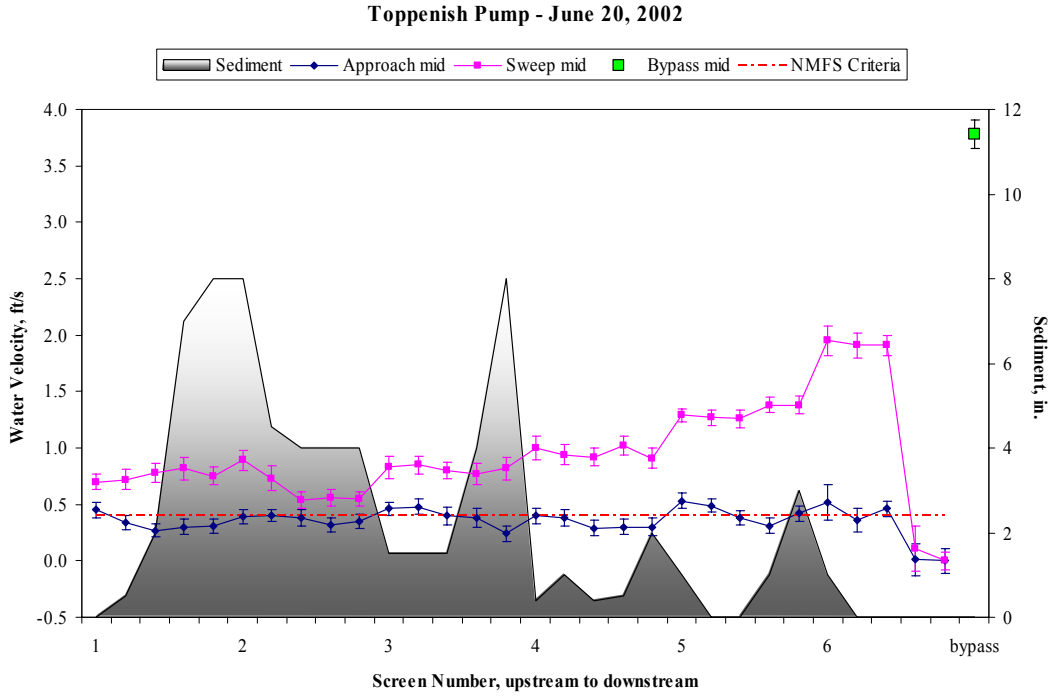
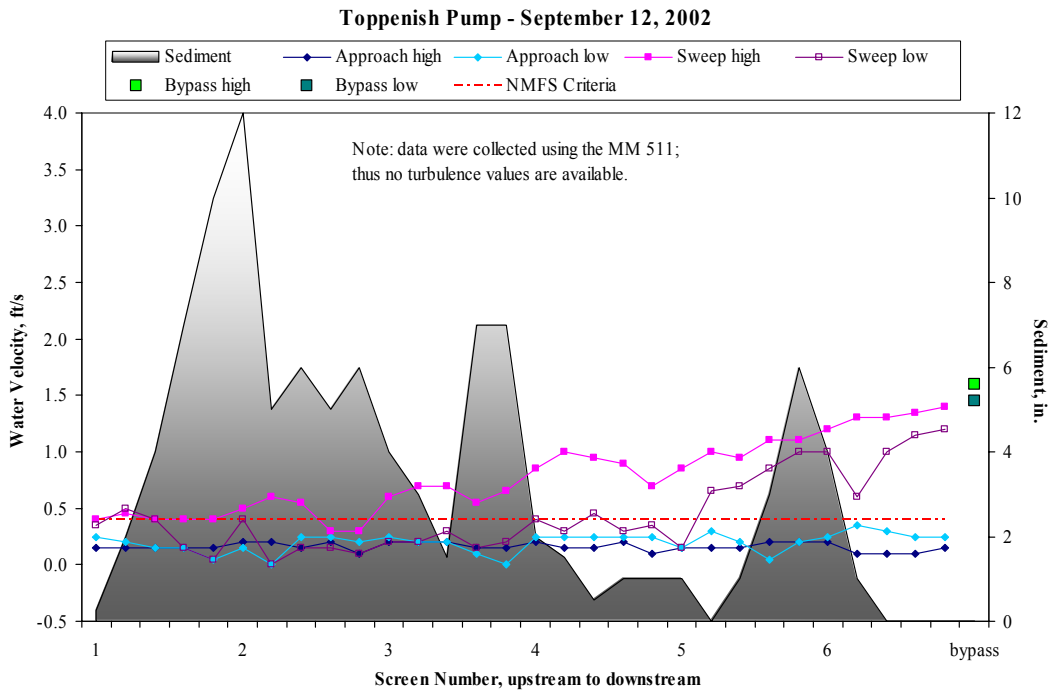
The Toppenish Pump site was visited on May 14, 2002; June 20, 2002; and September 12, 2002. In May, June, and September, 33, 73, and 100% of approach velocities met NMFS criteria, respectively. Sweep velocities were generally higher than approach velocities (Figures 40, 41, and 42). Sweep velocities generally increased towards the bypass, and bypass velocities were higher than sweep velocities. Submergence was calculated to be slightly low in May at 60% and met criteria in June and September. A major cleanout of the main channel and installation of checkboards upstream of the trashracks was happening during the May evaluation, and water levels continued to rise, which may account for the slightly low submergence.

Figure 40. Water Velocities and Sediment Depths at Toppenish Pump in May 2002. Error bars show turbulence (\pm the root-mean-squared [RMS] at each point).

Figure 41. Water Velocities and Sediment Depths at Toppenish Pump in June 2002. Error bars show turbulence (\pm the root-mean-squared [RMS]) at each point.

Figure 42. Water Velocities and Sediment Depths at Toppenish Pump in September 2002

The USBR, which is responsible for the operation and maintenance of the Toppenish Pump facility, was notified on May 21, 2002, concerning the high approach velocities noted during the May survey. Tom Leonard (USBR) estimated that it would be a couple of weeks or more before this would be fixed. On May 23, 2002, the PNNL researchers left a message asking to be notified when something was done about this. The USBR never responded.

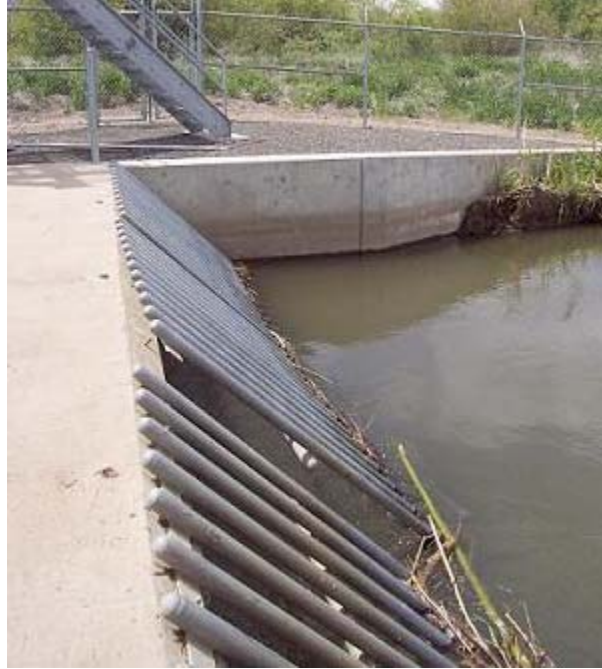
Visible seals appeared to be in good condition during all surveys. In May, some debris was observed on the trashrack, and the middle section of the trashrack had separated approximately 1 ft from the concrete wall (Figure 43). During all surveys, sediment and debris covered nearly all of the bottom seals.

Figure 43. The Trashrack at Toppenish Pump was Partially Separated from the Concrete Wall in May 2002

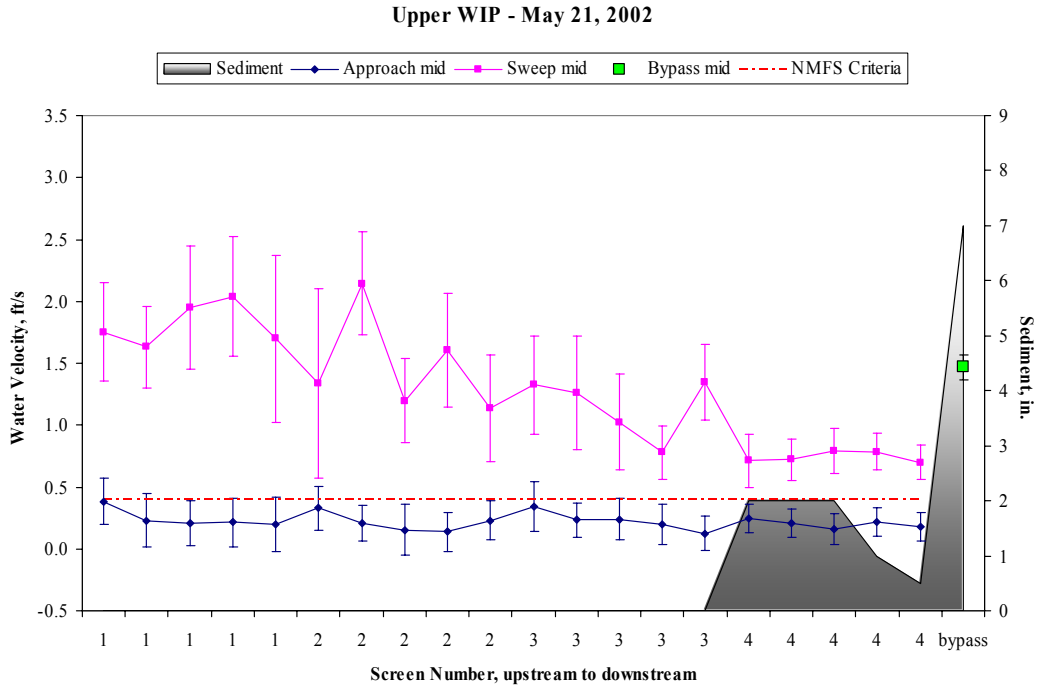
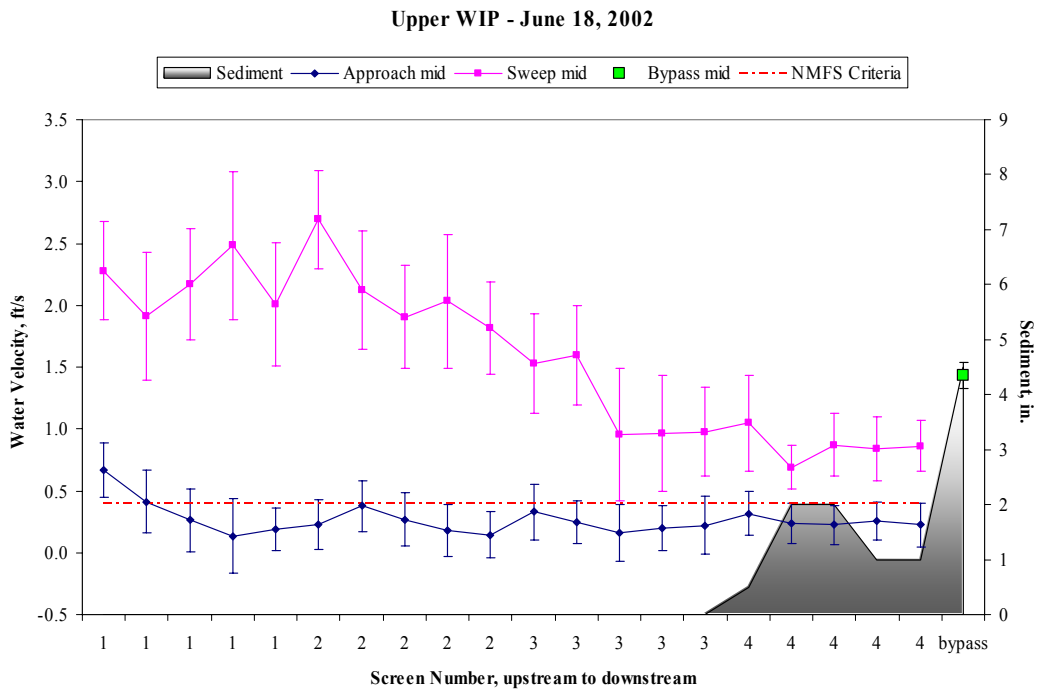
The Upper WIP site was visited on May 21, 2002; June 18, 2002; and September 10, 2002. The site was shut down for the season before the survey in September. All approach velocities met NMFS criteria in May, while only 90% of approach velocities met NMFS criteria in June (Figures 44 and 45). Those points that exceeded 0.4 ft/s were located at the upstream end of the site. During both surveys, sweep velocities were much more turbulent than approach velocities. Sweep velocities did not increase towards the bypass, and in June, the bypass velocity was less than the average sweep velocity.

In May, debris buildup on the trashracks caused approximately 1 in. of head loss across the racks. This did not appear to affect screen submergence, which met NMFS criteria at 80% submergence in May and June. The screens seals were replaced in 2001 and appeared to be in good condition in 2002. Water ran freely behind the weir and out the outfall. The water depth at the point of discharge was greater than 12 in. in May and June, which satisfied NMFS criteria and should be expected to provide sufficient water to allow for safe fish passage.

Figure 44. Water Velocities and Sediment Depths at Upper Wapato Irrigation Project (WIP) in May 2002. Error bars show turbulence (\pm the root-mean-squared [RMS]) at each point.

Figure 45. Water Velocities and Sediment Depths at Upper Wapato Irrigation Project (WIP) in June 2002. Error bars show turbulence (\pm the root-mean-squared [RMS]) at each point.

The gaps between the metal frames of the drums and the cement walls of the forebay were not caulked. The PNNL researchers recommend that these be filled with expanding foam insulation to prevent harm to migrating fish.
