Yakima River Basin Phase II Fish Screen Evaluations, 2002

J. A. Carter
G. A. McMichael
M. A. Chamness

January 2003

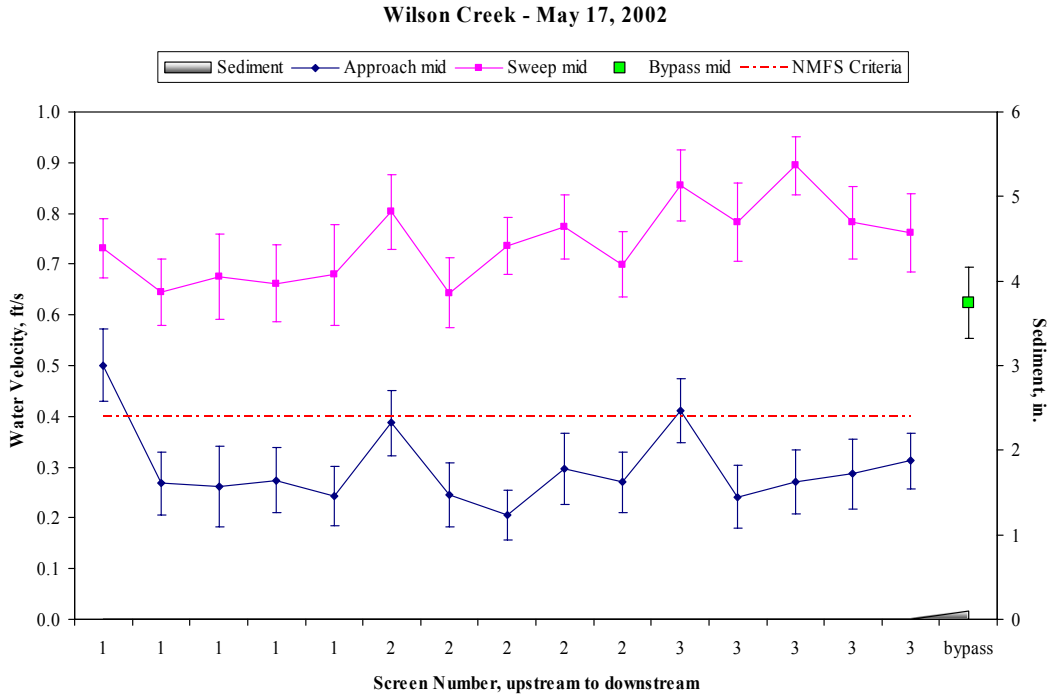
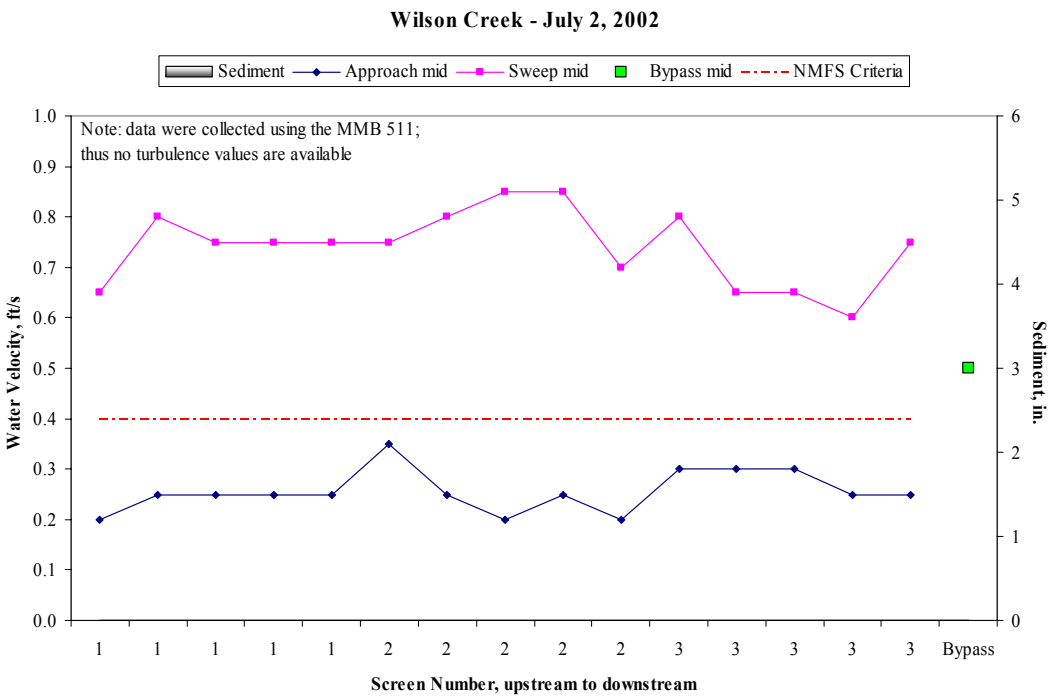
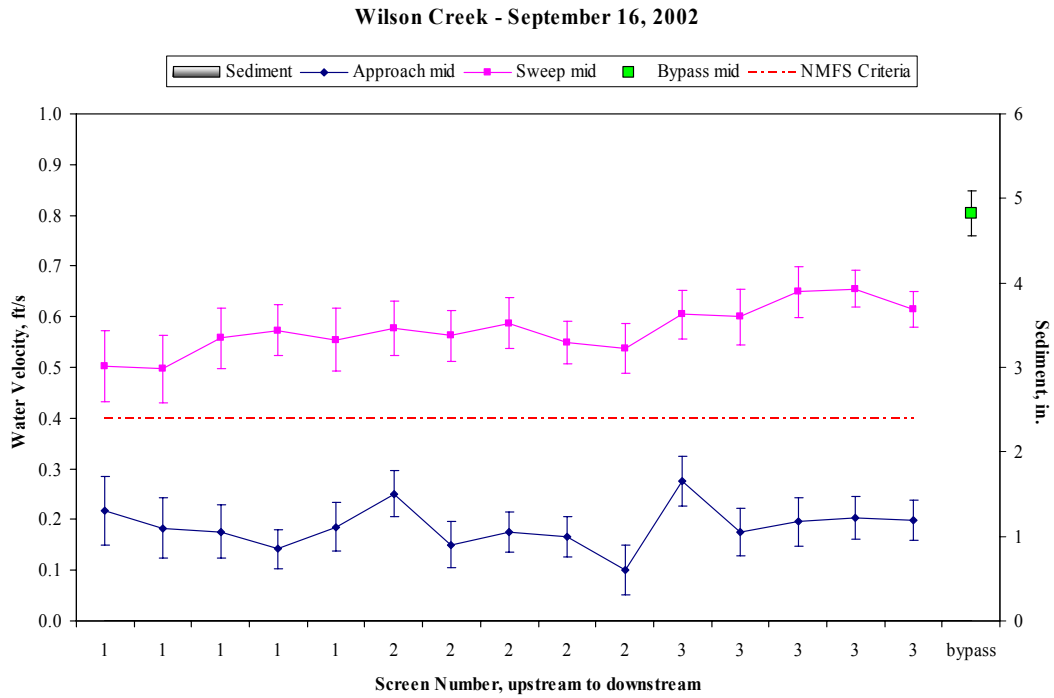
The Wilson Creek site was visited on May 17, 2002; July 2, 2002; and September 16, 2002. Because of excessive growth of aquatic plants in the forebay in July, the Marsh-McBirney 511® velocity meter was used, so no turbulence values are available. In May, July, and September, 87, 100 and 100% of approach velocities met NMFS criteria, respectively (Figures 46, 47, and 48). Sweep velocities were always greater than approach velocities. Sweep velocities did not increase towards the bypass, and the average bypass velocity was slower than the average sweep velocity in May and July.

Submergence met criteria during all surveys. There was 3 in. of head loss over the screens in May and 1.5 in. in June. This was probably due to growth of algae on the screens, which tends to partially or fully plug the screen holes. The screen material was in good condition during all surveys, as were all seals. In June, there were small gaps between the bottom seal and both screens (for example Figure 49). These gaps were likely caused by debris that was rolled into that space by the turning of the drum, as was observed at Powell-LaFortune in May. This problem probably took care of itself shortly as no gaps were observed in September. The gaps between the metal frames of the drums and the concrete walls of the forebay were filled with expanding foam insulation to prevent harm to migrating fish.

Drums turned freely and evenly during all surveys and rolled leaf matter into the aftbay. Water flowed freely over the weir and out the outfall in May and July. In September, the outfall pipe surged, which may have been caused by a partial plug in the downwell or in the bypass pipe. Ray Gilmour (WDFW) believes that this may have been caused by taking too much water into the site. The outfall pipe was submerged during all surveys and the depth at the point of discharge was greater than 1 ft.

Figure 46. Water Velocities and Sediment Depths at Wilson Creek in May 2002. Error bars show turbulence (\pm the root-mean-squared [RMS]) at each point.

Figure 47. Water Velocities and Sediment Depths at Wilson Creek in July 2002

Figure 48. Water Velocities and Sediment Depths at Wilson Creek in September 2002. Error bars show turbulence (\pm the root-mean-squared [RMS]) at each point.

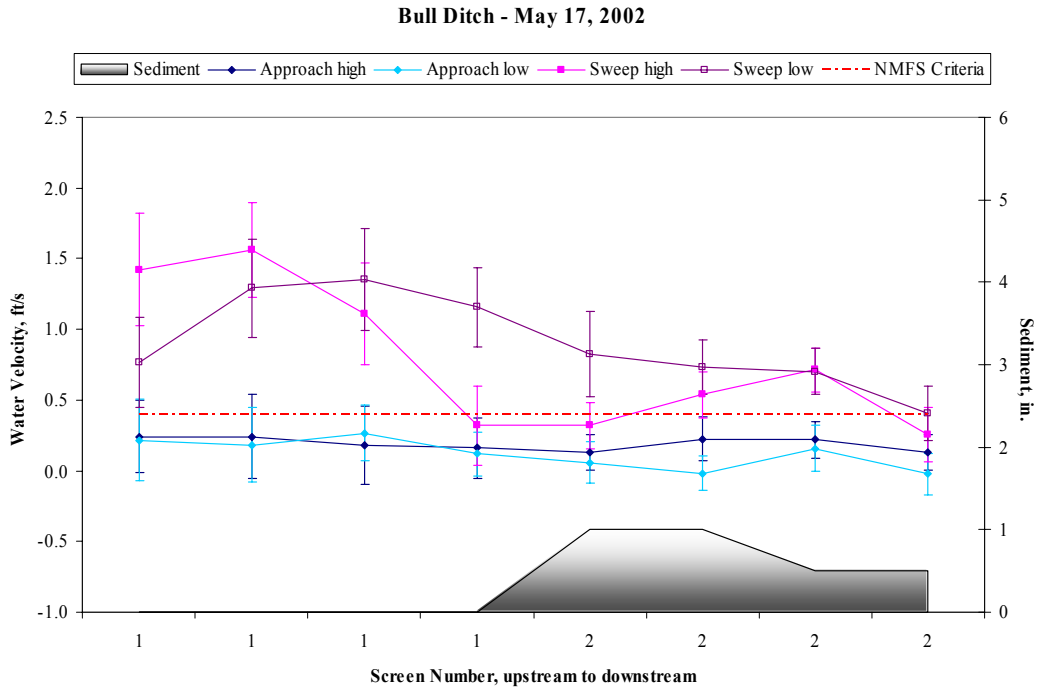
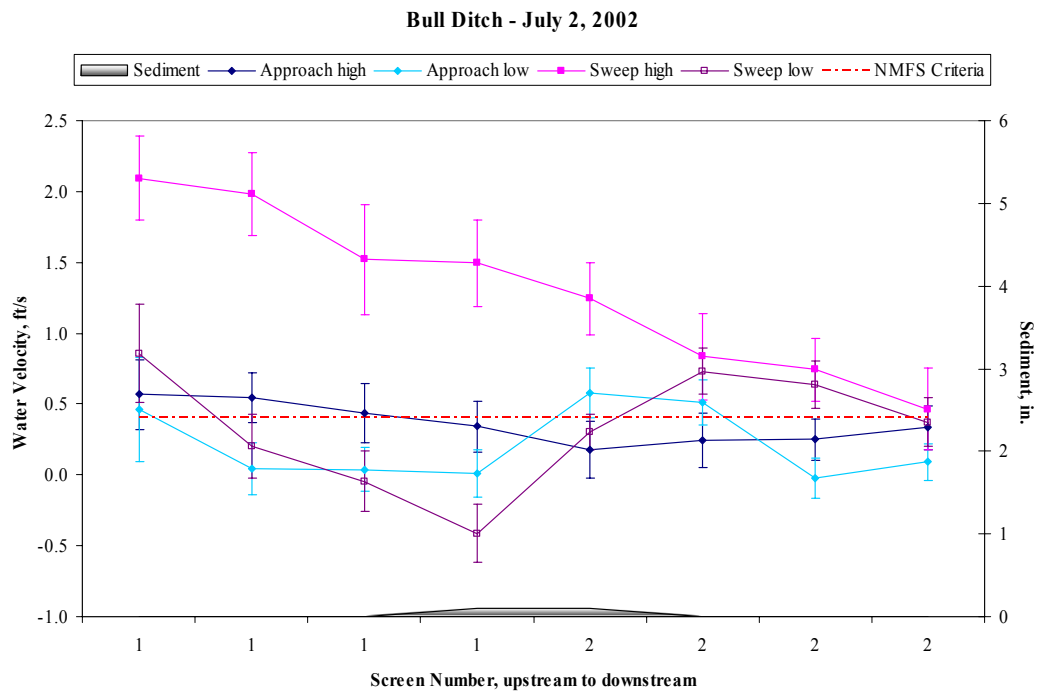
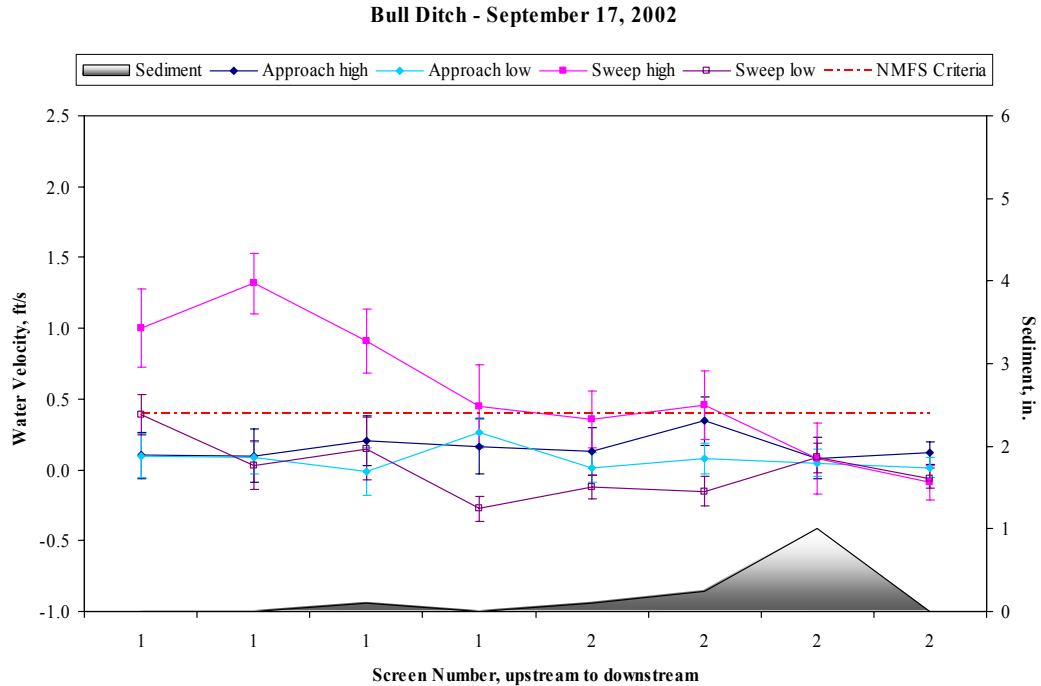
The Bull Ditch site was evaluated on May 17, 2002; July 2, 2002; and September 17, 2002. Sweep velocities were generally higher than approach velocities in May but not in July or September (Figures 50, 51, and 52). Approach velocities met NMFS criteria 100, 63, and 100% of the time in May, July, and September, respectively. Sweep velocities tended to decrease over the length of the site, and in September, both sweep and approach velocities at the downstream end of the site were approximately zero.

All screens and seals appeared to be in good condition during the surveys. The debris noted at the downstream end of the site in 2001 was cleaned out in 2002, and there was little debris present during any of the surveys in 2002. A log was installed upstream of the upstream trashrack to prevent further accumulation of sediment. The downstream brush that had broken because of this debris was fixed, and the brushes operated effectively to remove debris from the screen face.

In May and July, leafy branches were caught on the upstream trashrack, and in September, some debris was observed underneath the metal plates that cover the parallel trashracks. A large Northern pikeminnow was observed in this foliage in May. Several juvenile salmonids were observed in the forebay in May and September.

Low sweeping velocities at the downstream end of the site combined with the presence of predator habitat may result in the delay of and predation on migrating salmonids. The slower water may also cause sediment accumulation at the downstream end of the site. The PNNL researchers recommend that procedures be evaluated to increase sweep velocities and minimize predator habitat growth and sediment accumulation.

Figure 50. Water Velocities and Sediment Depths at Bull Ditch in May 2002. Error bars show turbulence (\pm the root-mean-squared [RMS]) at each point.

Figure 51. Water Velocities and Sediment Depths at Bull Ditch in July 2002. Error bars show turbulence (\pm the root-mean-squared [RMS]) at each point.

Figure 52. Water Velocities and Sediment Depths at Bull Ditch in September 2002. Error bars show turbulence (\pm the root-mean-squared [RMS]) at each point.

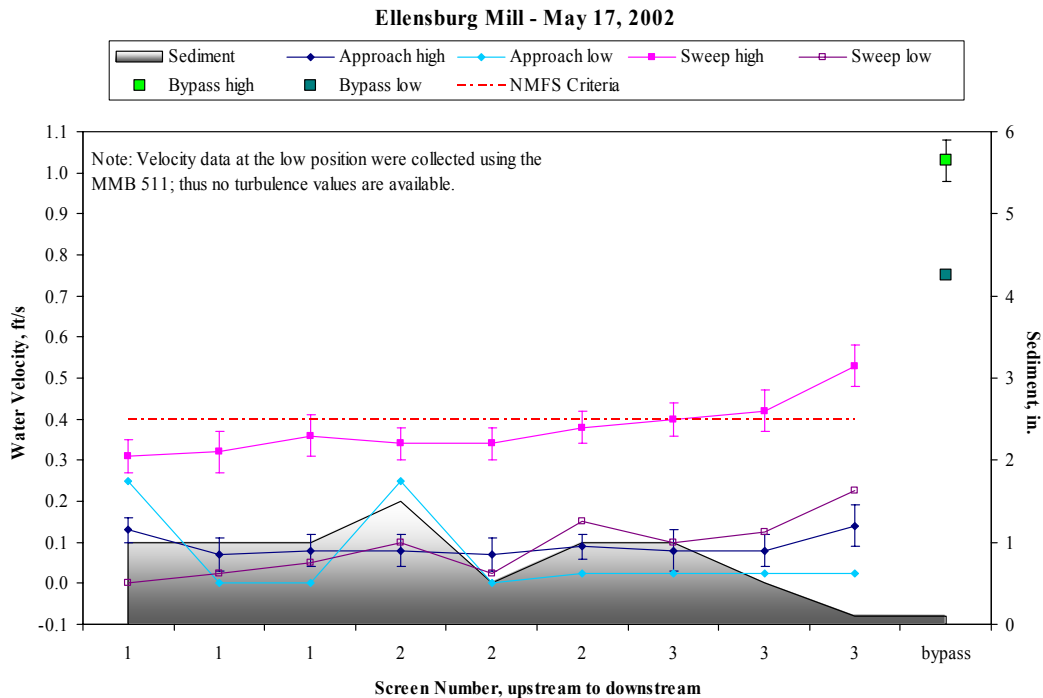
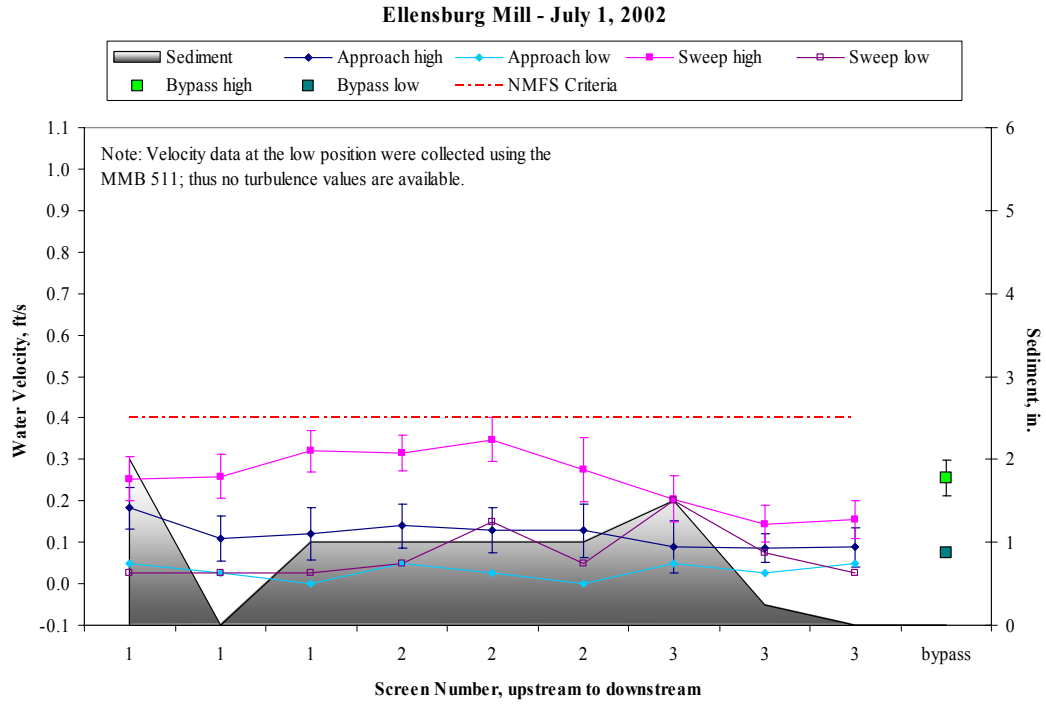
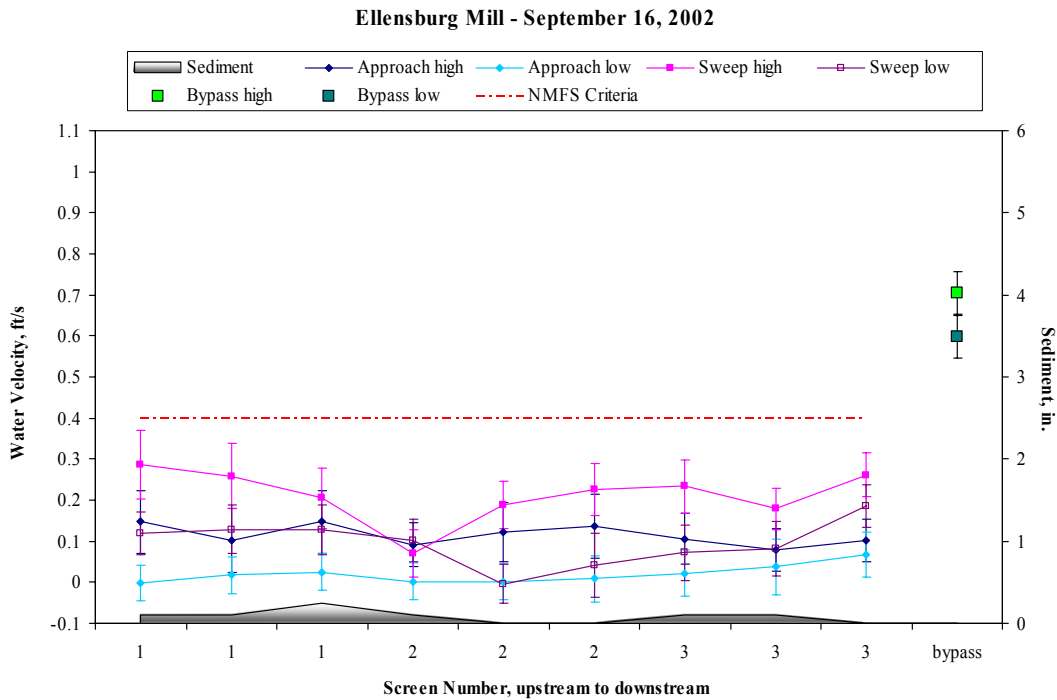
The Ellensburg Mill site was visited on May 17, 2002; July 1, 2002; and September 16, 2002. Because of aquatic vegetation growth in the forebay, the Marsh-McBirney 511® flow meter was used to measure velocity at the low position in May and June, so turbulence values are not available for those measurements. All approach velocities met NMFS criteria during all surveys (Figures 53, 54, and 55). Sweep velocities were not always higher than approach velocities, especially at the low position. This was probably due to the presence of aquatic plants in the forebay and near the screen surfaces. Sweep velocities did not increase towards the bypass, although the bypass velocity was greater than the average sweep velocity in May and September.

The screens appeared to be in good condition during all surveys, but the seals between the screens were partially missing and may need to be replaced. In May and July, bottom seals were not evaluated due to growth of aquatic plants in the forebay. The September video survey revealed that the bottom seals may also need to be replaced as the caulking is missing in places. The mechanical brushes effectively removed algae and debris from most of the screen surfaces, though there were patches, especially towards the bottoms of the screens, that remained covered with algae.

In May, the bypass might have been partially blocked. In July, PNNL researchers tested the bypass by attempting to pass a neutrally buoyant object through it and determined that it was blocked. The researchers notified Ray Gilmour (WDFW) of the blockage on July 2, 2002. The researchers were informed on July 11, 2002 that the blockage was no longer present. Outfall conditions were good for safe fish passage during all surveys.

Figure 53. Water Velocities and Sediment Depths at Ellensburg Mill in May 2002. Error bars show turbulence (\pm the root-mean-squared [RMS]) at each point.

Figure 54. Water Velocities and Sediment Depths at Ellensburg Mill in July 2002. Error bars show turbulence (\pm the root-mean-squared [RMS]) at each point.

Figure 55. Water Velocities and Sediment Depths at Ellensburg Mill in September 2002. Error bars show turbulence (\pm the root-mean-squared [RMS]) at each point.

Notes in the site operator's logbook show that the bypass was cleaned, and milfoil was removed from the forebay on July 31, 2002. The next day, silt was removed from the forebay. In the future, the researchers recommend a more aggressive cleaning schedule that allows silt and plants to be removed before they begin to affect the operation of the site.

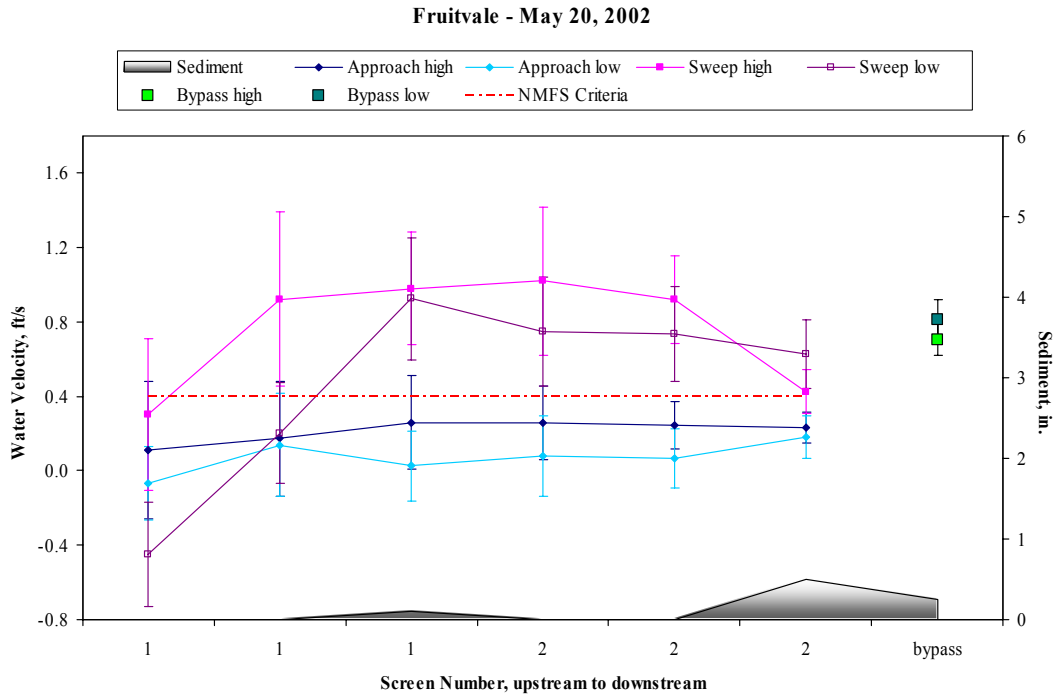
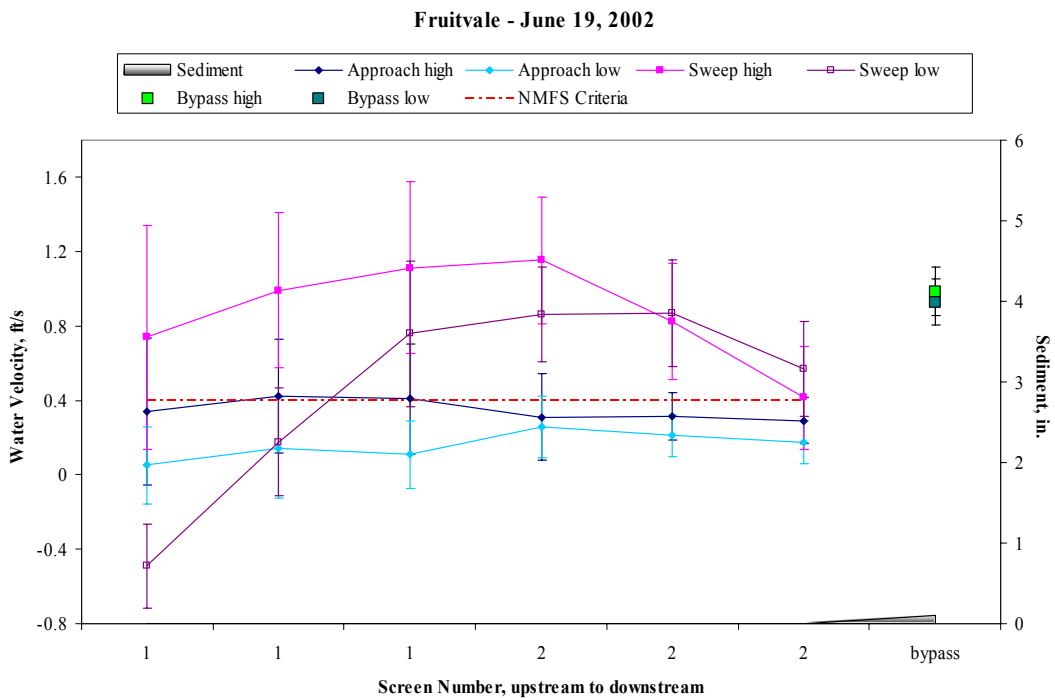
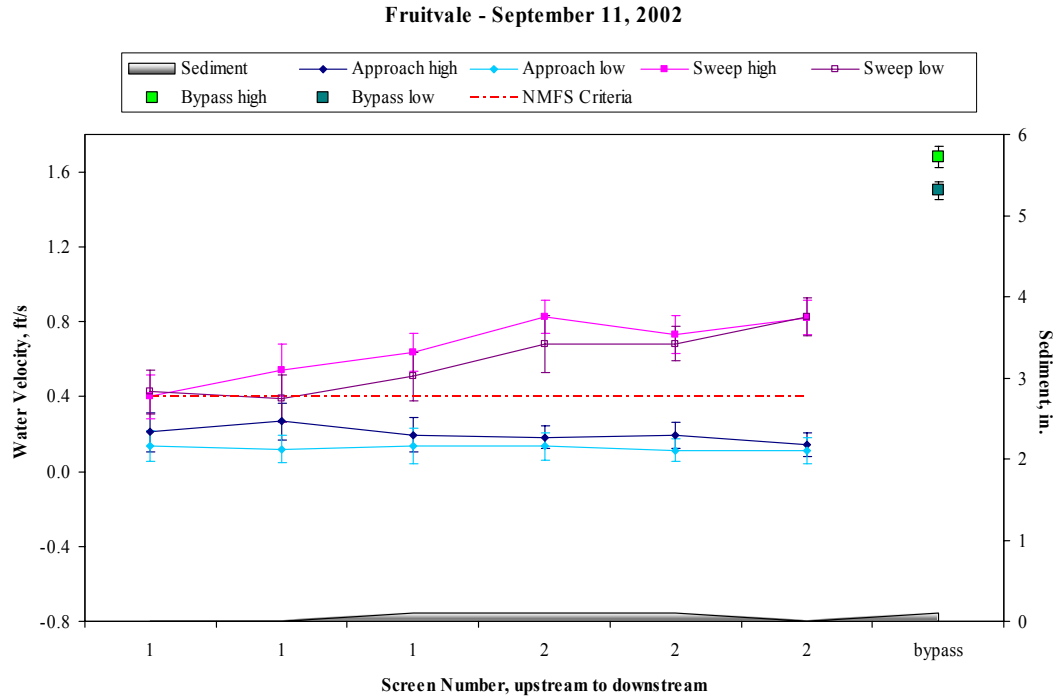
The Fruitvale site was visited on May 20, 2002; June 19, 2002; and September 11, 2002. In May, June, and September, 100, 83, and 100% of approach velocities met NMFS criteria, respectively (Figures 56, 57, and 58). Sweep velocities were not always higher than approach velocities and did not increase towards the bypass. Bypass velocities were higher than the average sweep velocity during all surveys.

Notes in the logbook indicated low flow and no bypass or fishway flow from late July through early September. This is similar to what happened in 2001, when the bypass was shut off completely for almost a month. Because smolts are not expected to migrate during this period, as long as there was enough water movement to maintain oxygen levels in the water, the flow conditions would not be expected to be a problem. However, if the bypass were to become blocked during a smolt migration period, it could kill any smolts that were trapped in the forebay. The PNNL researchers recommend that operational procedures be evaluated to minimize these conditions, especially during smolt migration periods.

The mechanical brushes operated effectively to remove debris from the screens during all surveys. The screens appeared to be in good condition, with the exception of a spot marked in red near the surface of screen 1 where the screen material pulled loose from the frame. This was fixed sometime before the September survey. It is unlikely that this portion of the screen was submerged during this time and should not have caused a problem for fish. The seals on the upper parts of the screens appeared somewhat weathered, and the video survey revealed that the caulking along the bottom of the screens was loose or missing in places.

Figure 56. Water Velocities and Sediment Depths at Fruitvale in May 2002. Error bars show turbulence (\pm the root-mean-squared [RMS]) at each point.

Figure 57. Water Velocities and Sediment Depths at Fruitvale in June 2002. Error bars show turbulence (\pm the root-mean-squared [RMS]) at each point.

Figure 58. Water Velocities and Sediment Depths at Fruitvale in September 2002. Error bars show turbulence (\pm the root-mean-squared [RMS]) at each point.

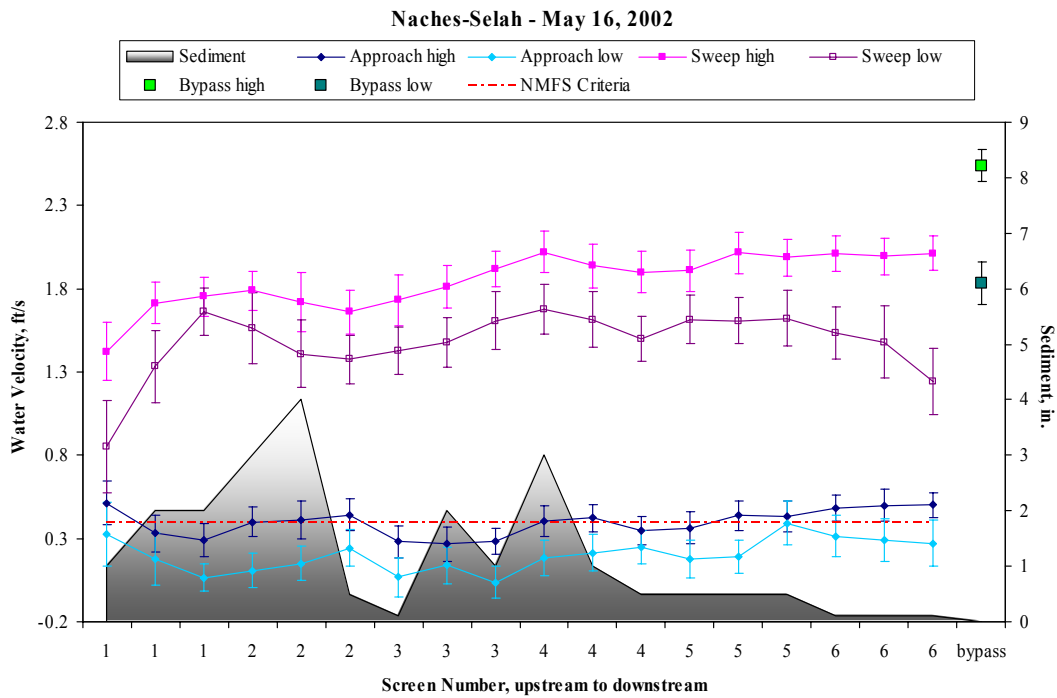
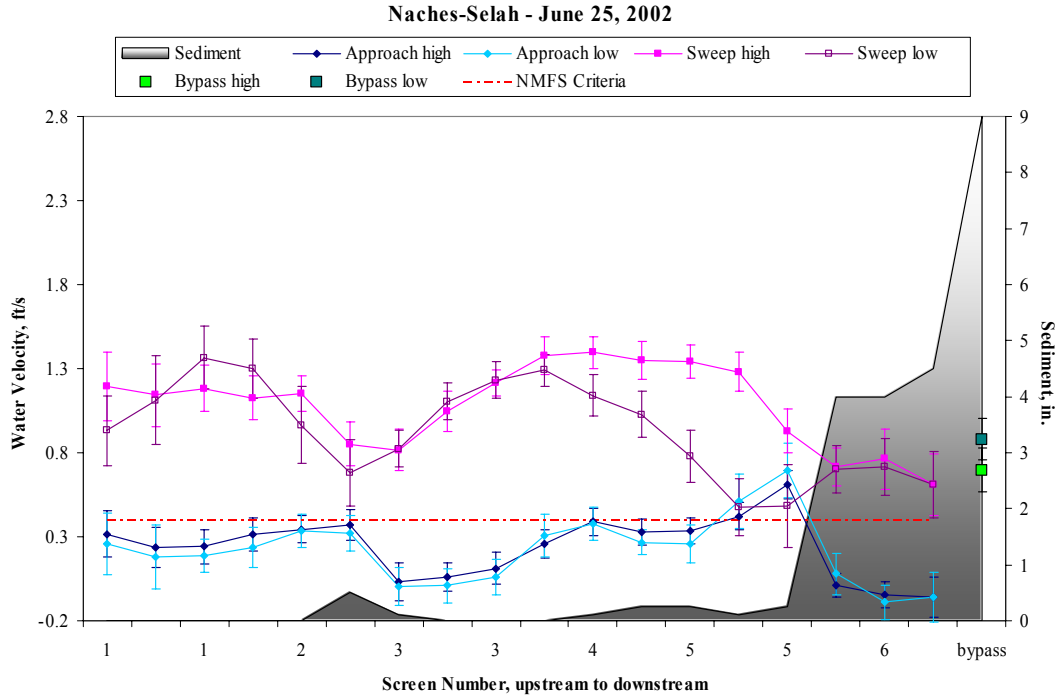
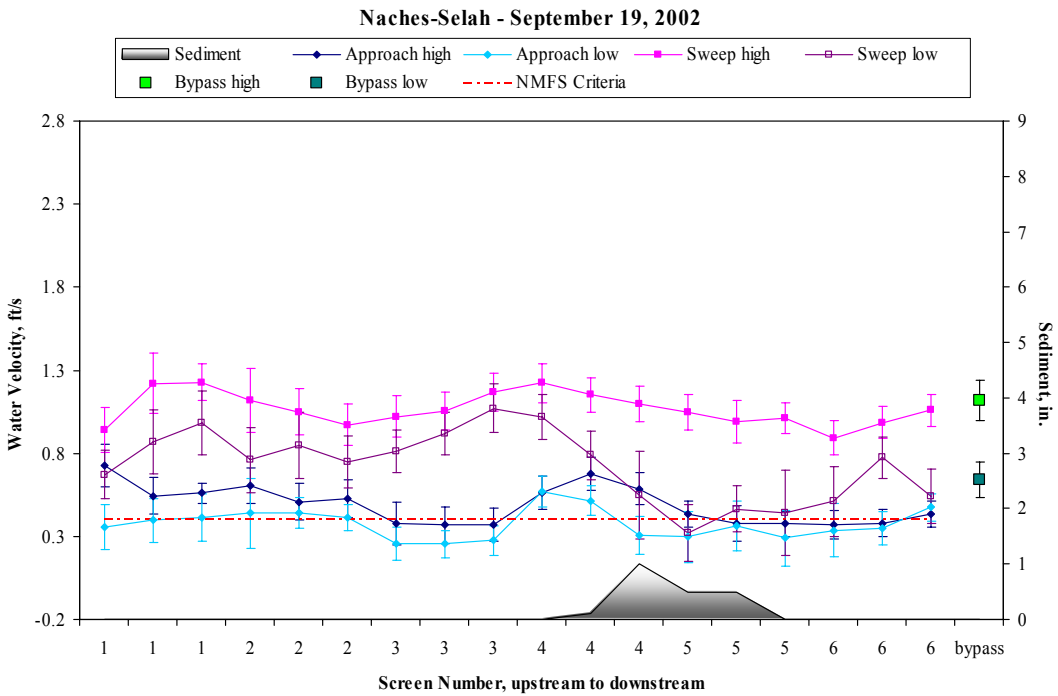
The Naches-Selah site was visited on May 16, 2002; June 25, 2002; and September 19, 2002. In May, June, and September, 72, 89, and 50% of approach velocities met NMFS criteria, respectively (Figures 59, 60, and 61). Sweeping velocities were greater than approach velocities and increased towards the bypass only in May. The average bypass velocity was greater than the average sweep velocity in May. In June and September, sweep velocities were usually greater than approach velocities but did not increase towards the bypass, and bypass velocities were slower than the average sweep velocity. This site has one of the worst records as far as meeting NMFS velocity criteria (Table 4). The PNNL researchers recommend that site operating procedures be evaluated to attempt to protect migrating fish from injury as they pass through this site.

Figure 59. Water Velocities and Sediment Depths at Naches-Selah in May 2002. Error bars show turbulence (\pm the root-mean-squared [RMS]) at each point.

Figure 60. Water Velocities and Sediment Depths at Naches-Selah in June 2002. Error bars show turbulence (\pm the root-mean-squared [RMS]) at each point.

Figure 61. Water Velocity and Sediment Depths at Naches-Selah in September 2002. Error bars show turbulence (\pm the root-mean-squared [RMS]) at each point.

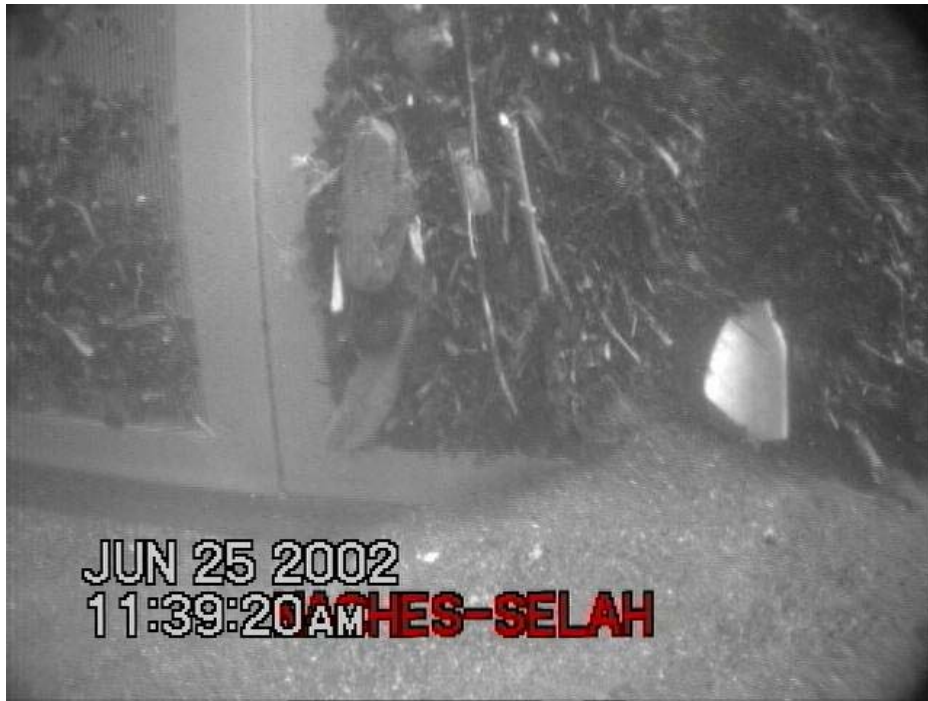
The screens were patched in places, but they appeared to be in good condition during all surveys. The caulking between the screens and under the screens was missing in places. In May, the bypass was approximately half filled with sand underneath the ramp. In June, sand and debris had built up near screen 6 to the point that it covered all of the bottom seal and prevented the brush from cleaning the screen (Figure 62), and the bypass ramp was completely plugged with sand and debris. The PNNL researchers notified Bill Werst (WDFW) on June 25, 2002. The problems were fixed on June 26, 2002.

Figure 62. Sediment Accumulation and Debris on Screen 6 at Naches-Selah in June 2002

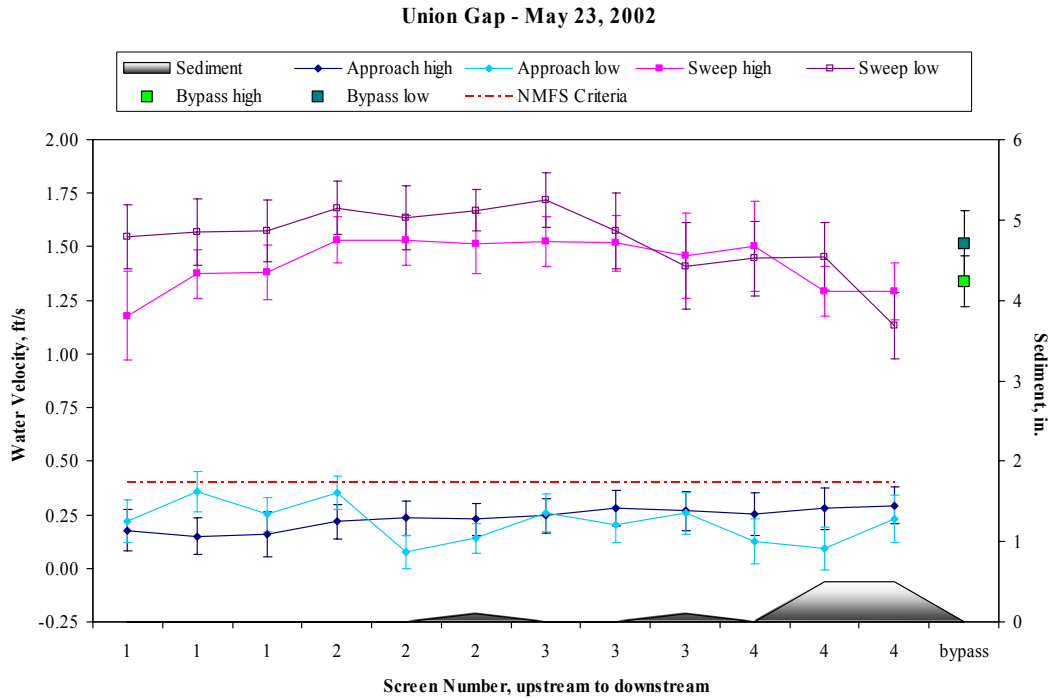
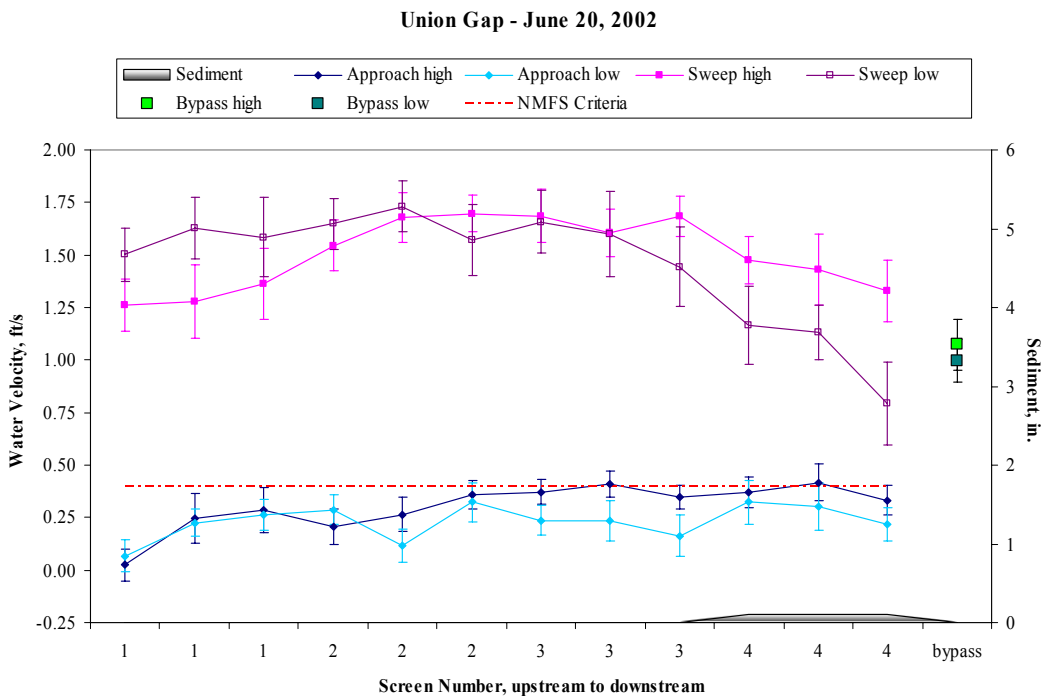
The Union Gap site was evaluated on May 23, 2002; June 19, 2002; and September 11, 2002. In May, June, and September, 100, 92, and 100% of approach velocities met NMFS criteria, respectively (Figures 63, 64, and 65). Sweep velocities were almost always higher than approach velocities. Sweep velocities did not increase towards the bypass, and the average bypass velocity was slower than the average sweep velocity.

The screen material was in good condition during all surveys. The seals on all screens were missing in places, as they have been for the past several years. No algae or aquatic plant growth was observed in the forebay during 2002.

Water ran freely behind the weir and through the outfall pipe in May and September. In June, the bypass was filled with sticks underneath the ramp and water appeared to be backed up in the downwell, though conditions at the outfall pipe were still good. Based on the problem-tracking protocol, the PNNL researchers notified Bill Werst (WDFW) of the conditions on June 19, 2002, and he cleaned out the bypass the same day. When the researchers returned to the site on June 20, 2002, the situation was greatly improved. The bypass velocity was greater (though still slower than the average sweep velocity), the water dropped into the downwell, and the depth of water in the outfall pipe was greater.

Figure 63. Water Velocities and Sediment Depths at Union Gap in May 2002. Error bars show turbulence (\pm the root-mean-squared [RMS]) at each point.

Figure 64. Water Velocities and Sediment Depths at Union Gap in June 2002. Error bars show turbulence (\pm the root-mean-squared [RMS]) at each point.

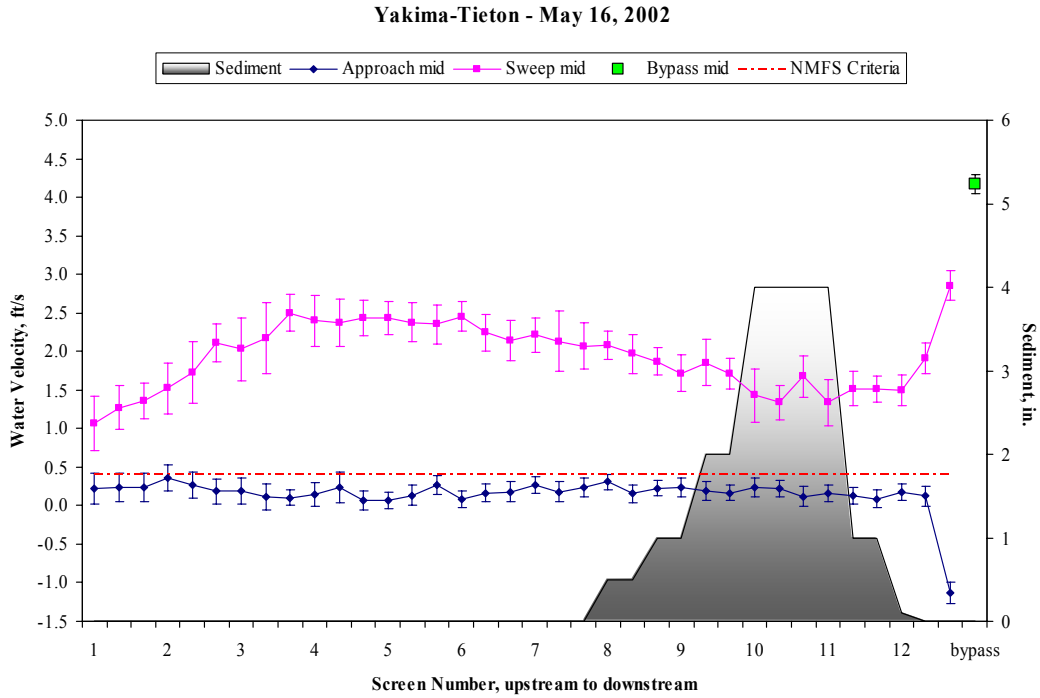
Figure 66. Water Velocities and Sediment Depths at Yakima-Tieton in May 2002. Error bars show turbulence (\pm the root-mean-squared [RMS]) at each point.

The Yakima-Tieton site was evaluated on May 16, 2002; June 26, 2002; and September 18, 2002. In May, June, and September, 100, 57, and 100% of approach velocities met NMFS criteria, respectively (Figures 66, 67, and 68). Sweep velocities were always higher than approach velocities. Sweep velocities did not increase towards the bypass, and the average bypass velocity was always higher than the average sweep velocity.

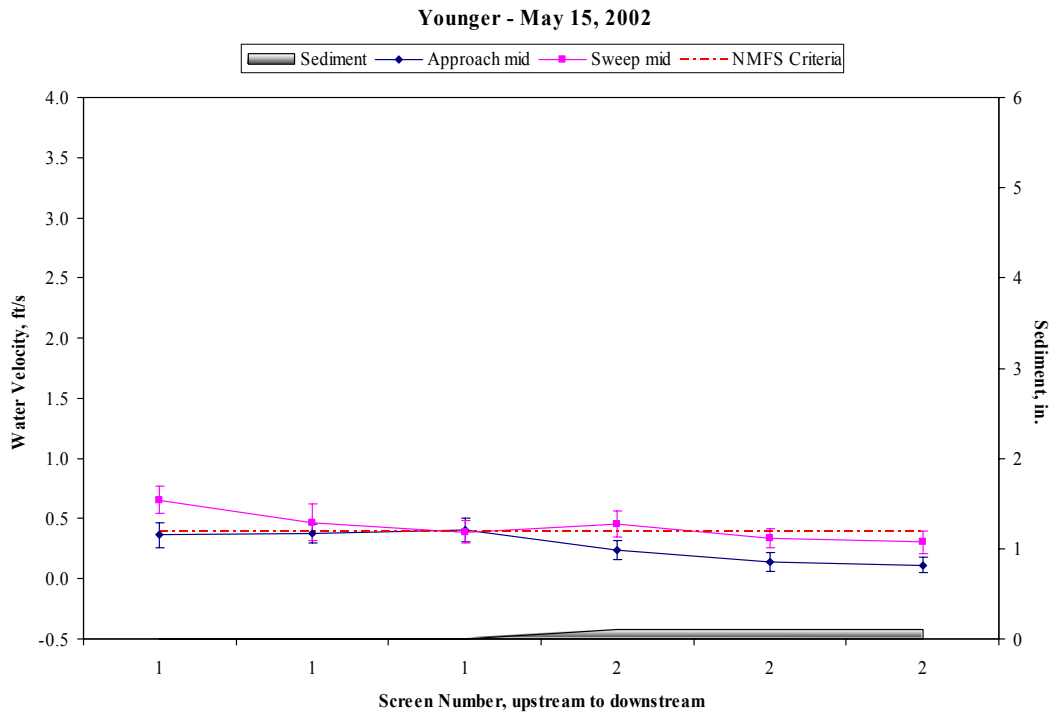
Figure 69. Water Velocities and Sediment Depths at Younger in May 2002. Error bars show turbulence (\pm the root-mean-squared [RMS]) at each point.

The Younger site was visited on May 15, 2002; July 1, 2002; August 1, 2002; and September 16, 2002. In May, July, and August, 83, 0 and 50% of approach values met NMFS criteria, respectively (Figures 69, 70, and 71). The site was shut down before the September survey. Sweep velocities were generally higher than approach velocities, though they did not increase towards the downstream end of the site. Because none of the approach values met NMFS criteria in July, Jose Molano (WDFW) was notified on July 1, 2002, and Ray Gilmour (WDFW) was notified on July 2, 2002. Molano said that he would check the site on July 2, 2002, and fix it the week of July 8, 2002. The researchers followed up with Molano on July 11, 2002, and he said that it had been fixed. The researchers revisited the site on August 1, 2002, and found that while approach velocities were still high in places, the site average was below 0.4 ft/s.

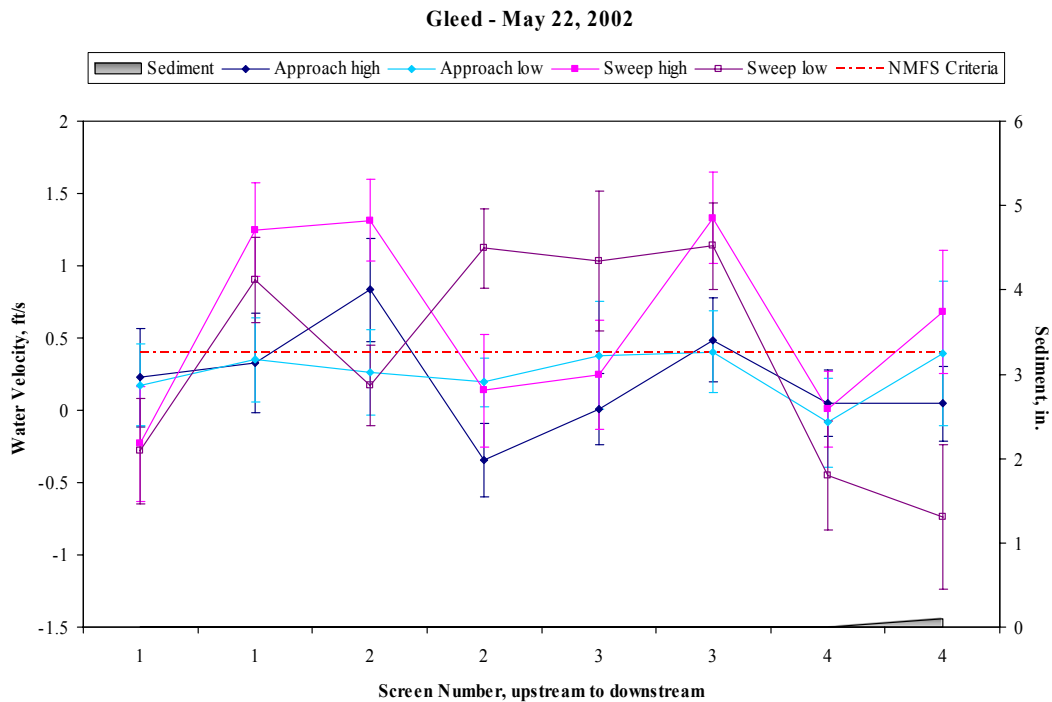
Figure 72. Water Velocities and Sediment Depths at Glead in May 2002. Error bars show turbulence (\pm the root-mean-squared [RMS]) at each point.

The Glead site was evaluated on May 22, 2002; June 25, 2002; and September 19, 2002. In May, June, and September, 81, 79, and 88% of approach values met NMFS criteria of less than or equal to 0.4 ft/s, respectively (Figures 72, 73, and 74). Aside from fast water, fish encountering this site also had to deal with highly turbulent water, without a clear trajectory. Sweep velocities were not always greater than approach velocities and did not increase towards the downstream end of the site.
