Yakima River Basin Phase II Fish Screen Evaluations, 2003

J. A. Vucelick
G. A. McMichael
M. A. Chamness

May 2004

Prepared for the U.S. Department of Energy
Bonneville Power Administration
under Project 1982-06200

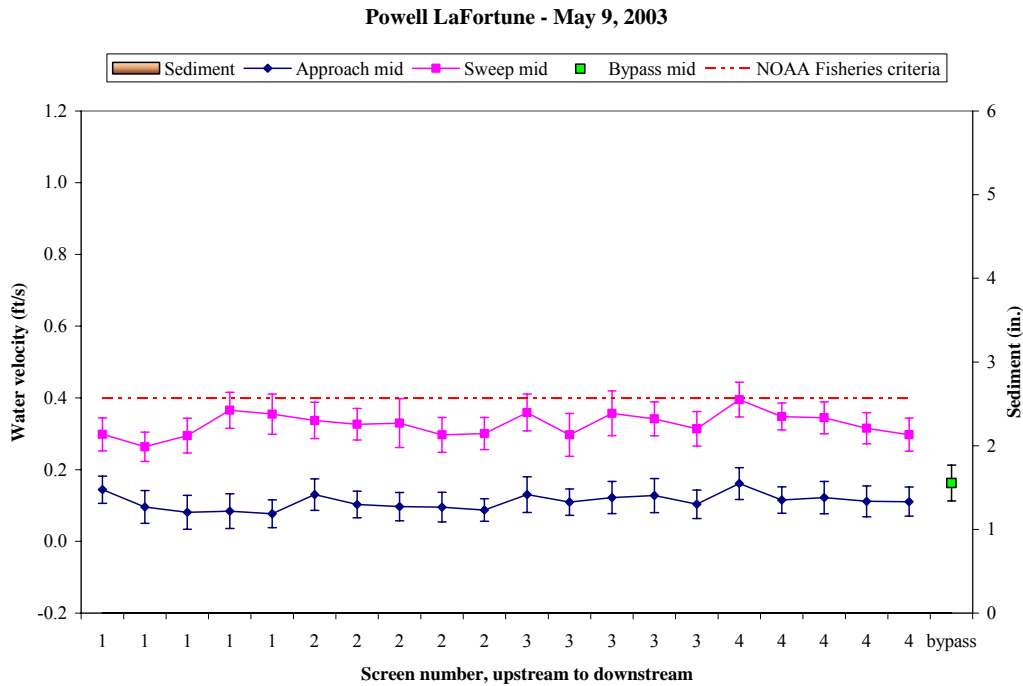
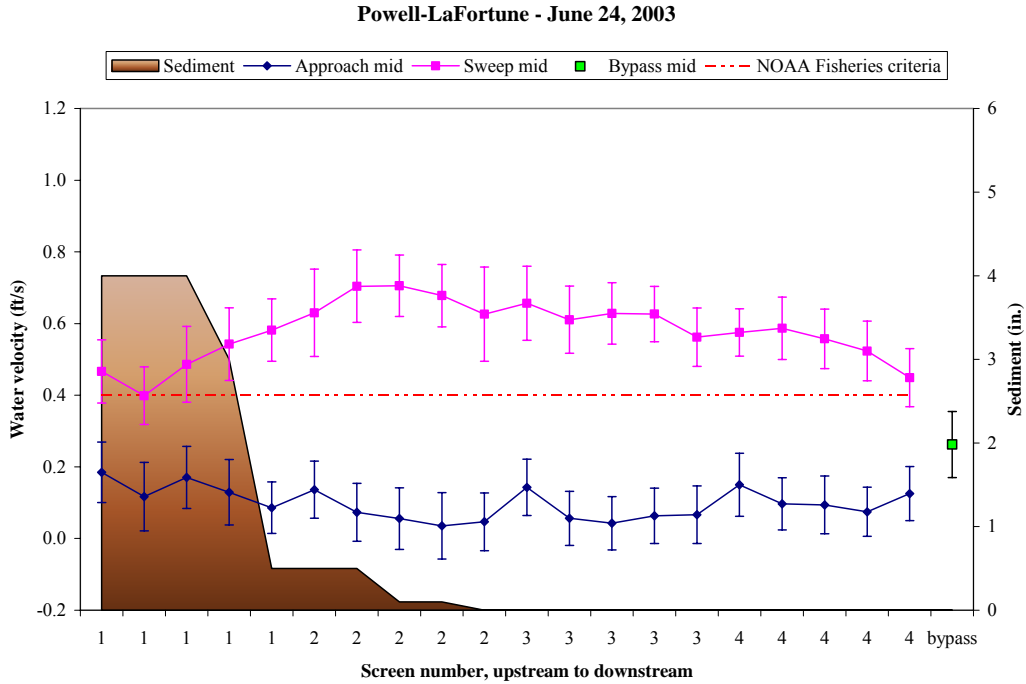
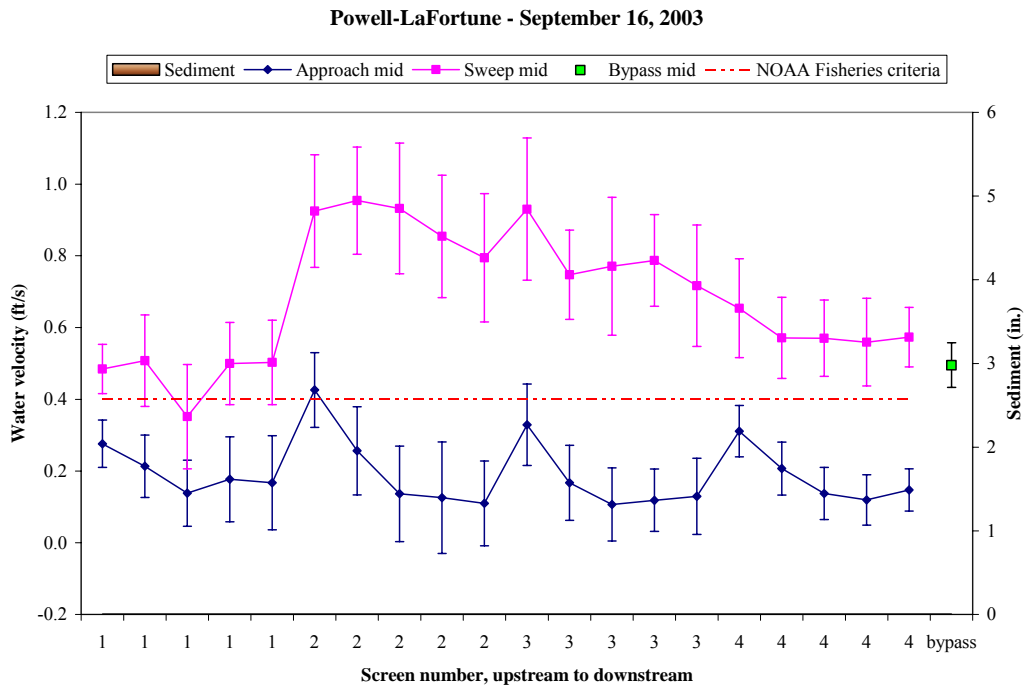
The Powell-LaFortune site was evaluated on May 9, 2003; June 26, 2003; and September 16, 2003. In May and June, 100% of approach velocities met NOAA Fisheries criteria. In September, 95% of approach velocities met NOAA Fisheries criteria. Sweep velocities were always higher than approach velocities but did not generally increase towards the bypass (Figures 31, 32, and 33). Bypass velocities were slower than the average sweep velocity. Percent submergence met the NOAA Fisheries criteria in May, June, and September at 77%, 80%, and 72% respectively.

Figure 31. Water Velocities and Sediment Depths at Powell-LaFortune in May 2003. Error bars show turbulence (\pm the root-mean-squared [RMS]) at each point.

Figure 32. Water Velocities and Sediment Depths at Powell-LaFortune in June 2003. Error bars show turbulence (\pm the root-mean-squared [RMS]) at each point.

Figure 33. Water Velocities and Sediment Depths at Powell-LaFortune in September 2003. Error bars show turbulence (\pm the root-mean-squared [RMS]) at each point.

All visible seals were in good condition, as was the screen material. An accumulation of sediment and/or debris covered some of the bottom seals during all surveys. Bypass conditions appeared to be conducive to safe fish passage. The downwell at this site is unusually deep, and the water level in it is relatively shallow. To mitigate for these conditions, the WDFW installed boards in the downwell on April 7 to create a pool for fish to fall into safely. During all surveys, water flowed freely over the weir and through the outfall, and water depth in the outfall pipe met NOAA Fisheries criteria, though the water depth at the point of discharge (over the outfall apron) was slightly less than 1 ft during all surveys. The depth of water in the river just beyond the apron was always greater than 1 ft.

In the past, this site has had problems meeting NOAA Fisheries criteria for submergence, and while submergence was within criteria during our visits in 2003, these problems continued throughout the 2003 irrigation season. Notes in the site operator's logbook state that submergence was low (10% to 60%) almost every time the site was visited by WDFW staff May through mid-July, when a wing dam was installed in the river. After that point, submergence was generally at the high end of the criteria range to above criteria (between 82% and 100%). The Powell-LaFortune site has two trash racks: one on the canal leading to the site and the other at the head gates, farther upstream. The trash racks at the head gate often plug with excessive debris and are not cleaned regularly. Notes in the site operator's logbook state that on May 17, enough debris had built up on the head-end trash rack to cause more than 13 in. of head loss across the debris, and PNNL observed similar conditions during the September inspection. The PNNL researchers recommend that the upper trash rack be cleared of debris by the water users as a part of their daily operations procedures.

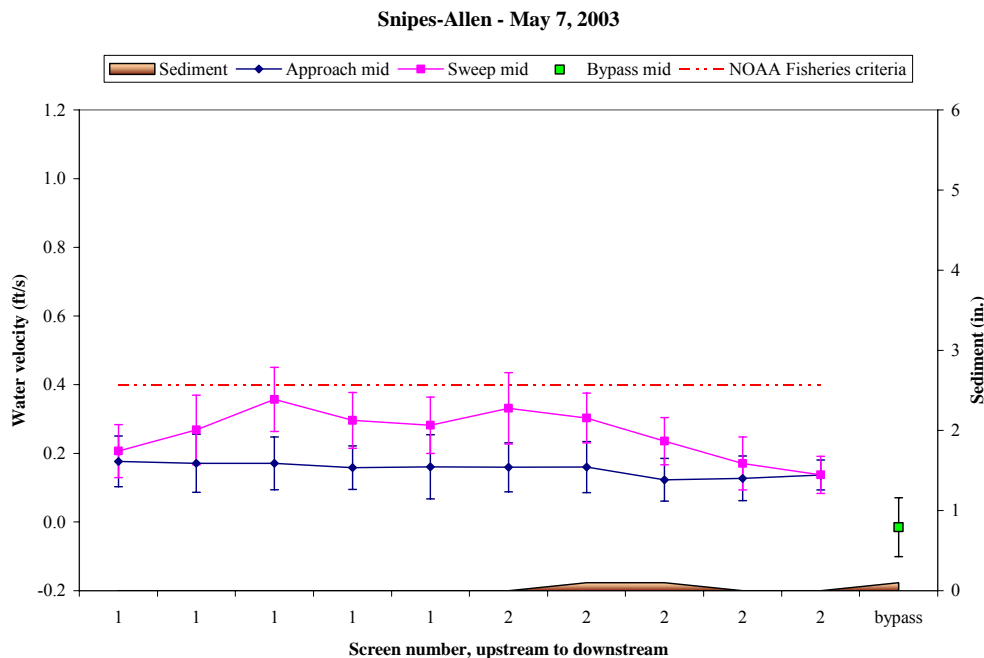
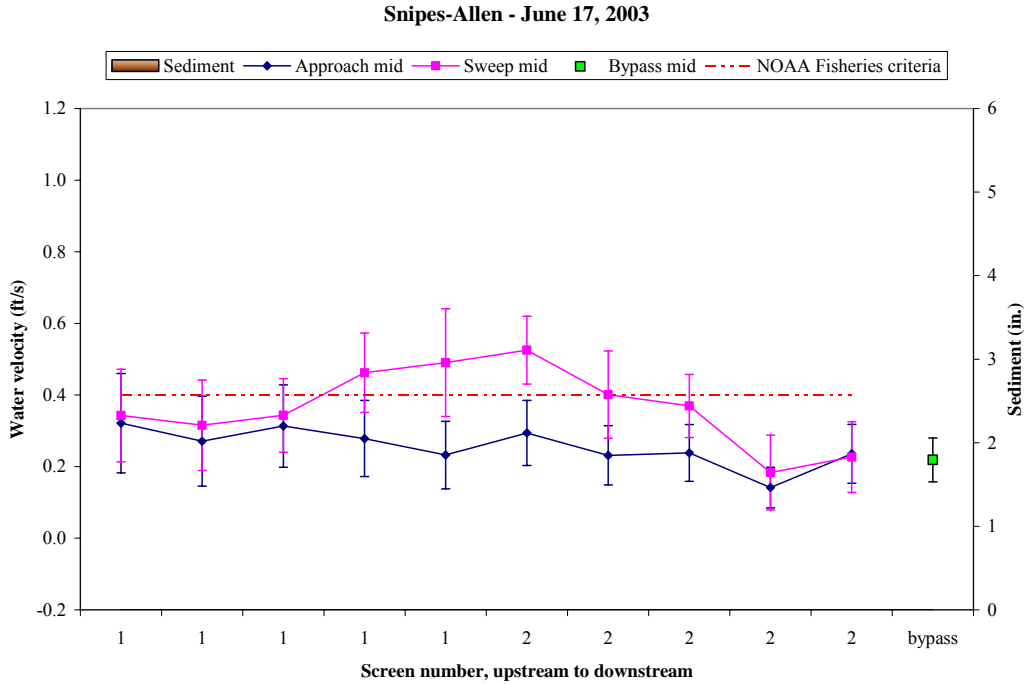
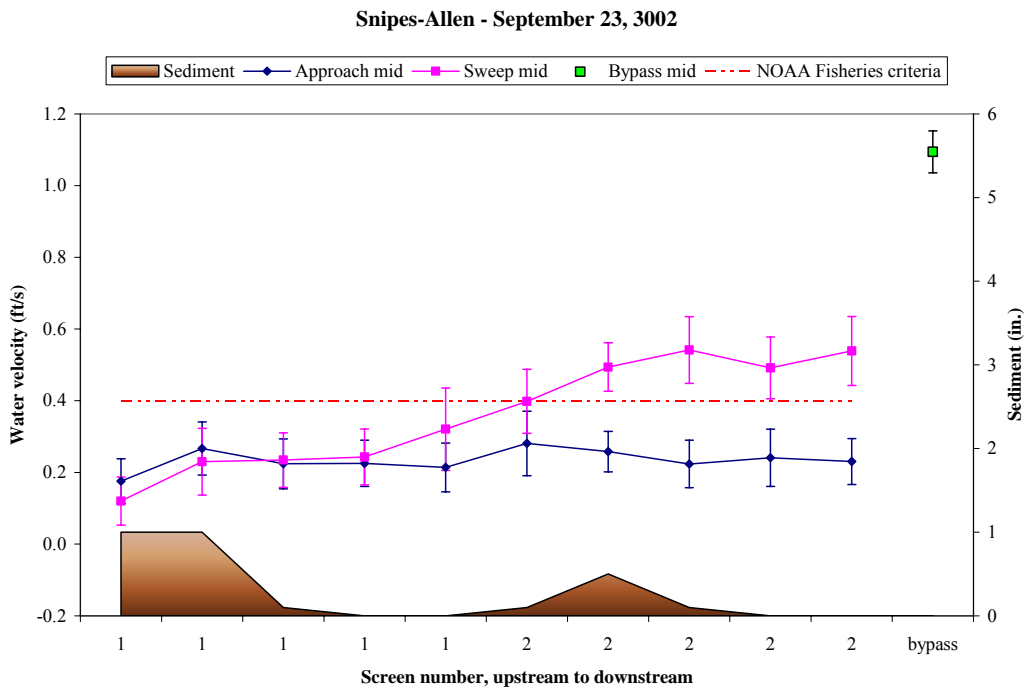
The Snipes-Allen site was evaluated on May 7, 2003; June 17, 2003; and September 23, 2003. All approach velocities met NOAA Fisheries criteria during all surveys (Figures 34, 35, and 36). Sweep velocities were generally higher than approach velocities during all surveys (Figures 34, 35, and 36). Sweep velocities did not increase towards the bypass except in September, and the average bypass velocity was slower than the average sweep velocity in May and June.

The screens and screen seals at this site were in good condition during all surveys. Screen submergence at met NOAA Fisheries criteria during all surveys. However, past problems with debris catching on the trash racks continued in 2003, and notes in the logbook state that submergence was often below criteria, and that at times there was no bypass flow. The accumulation of debris in the space behind the trash rack that was noted in 2002 was removed before the 2003 irrigation season.

Figure 34. Water Velocities and Sediment Depths at Snipes-Allen in May 2003. Error bars show turbulence (\pm the root-mean-squared [RMS]) at each point.

Figure 35. Water Velocities and Sediment Depths at Snipes-Allen in June 2003. Error bars show turbulence (\pm the root-mean-squared [RMS]) at each point.

Figure 36. Water Velocities and Sediment Depths at Snipes-Allen in September 2003. Error bars show turbulence (\pm the root-mean-squared [RMS]) at each point.

Bypass conditions were generally safe for fish passage during all three evaluations. In the past, this site has had many problems with bypass obstructions, and it appeared that these problems had been resolved for 2003. During our evaluations, water ran freely behind the weir and out the outfall, and water depth at the point of discharge was always greater than 1 ft. However, it is apparent from notes in the logbook that there was not always enough flow through the headgates to produce bypass flow. Construction of the diversion dam has diverted all water (except leakage) through the site. Accumulation of debris on the trash rack may be to blame for problems with low submergence and bypass flow. We would recommend that the trash rack be cleaned as a part of daily ditch operations.

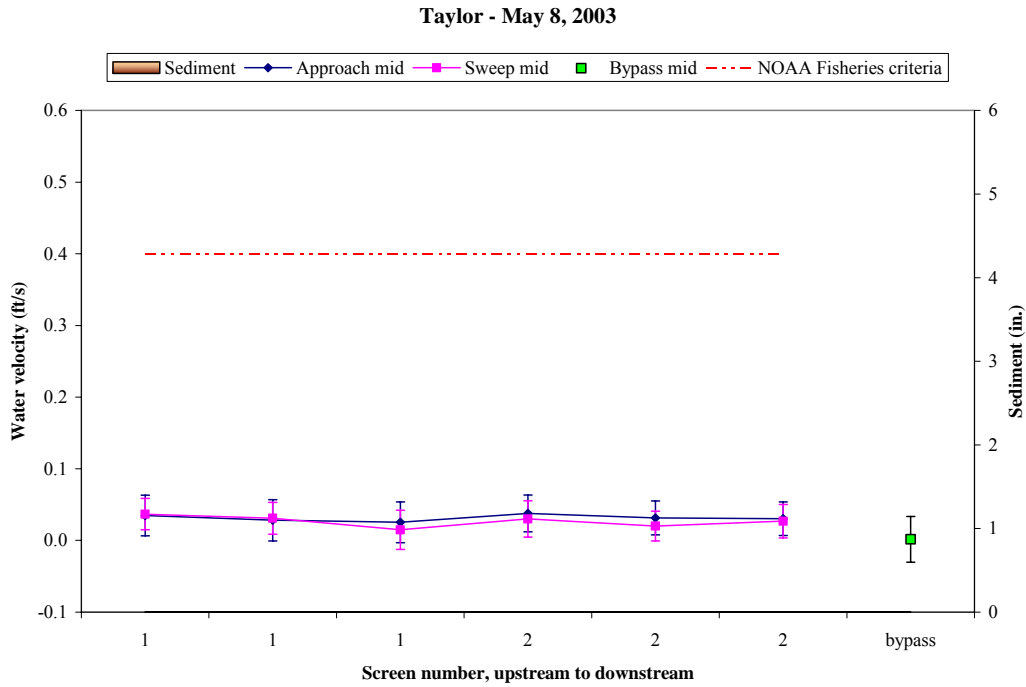
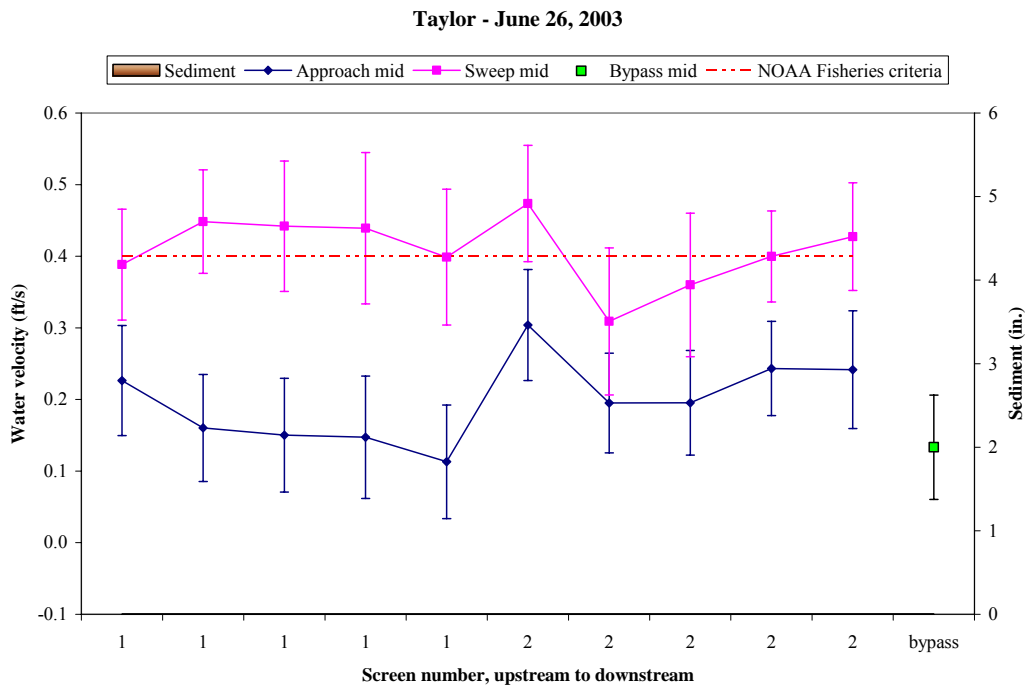
The Taylor site was evaluated on May 8, 2003; June 26, 2003; and September 16, 2003, although the site was essentially shut down for the season before our September survey. All approach velocities met NOAA Fisheries criteria in May and June (Figures 37 and 38). Sweep velocities were greater than approach velocities in June, but the bypass velocity was always less than the average sweep velocity. Percent submergence was below criteria during the survey in May at 35%. In June, submergence met criteria with 72%.

This site has had many problems meeting submergence and flow criteria over the past several years. Flows in the stream tend to be inconsistent within the irrigation season, and the main channel has shifted away from the screen site, making it even more difficult to divert water to the site, especially when flows are low. Notes in the site logbook indicate that submergence fluctuated between 20% and greater than 100% (screens were overtopped on June 8) between our May and June evaluations. Ray Gilmore was notified on May 12, 2003 of the low submergence, although there was nothing he could do about it because the stream level was low.

Figure 37. Water Velocities and Sediment Depths at Taylor in May 2003. Error bars show turbulence (\pm the root-mean-squared [RMS]) at each point.

Figure 38. Water Velocities and Sediment Depths at Taylor in June 2003. Error bars show turbulence (\pm the root-mean-squared [RMS]) at each point.

Because of the history of problems at this site and the change in stream conditions, we strongly recommend that the design of this site and its diversion be reevaluated and that changes be made to put the site into compliance with the NOAA Fisheries criteria.

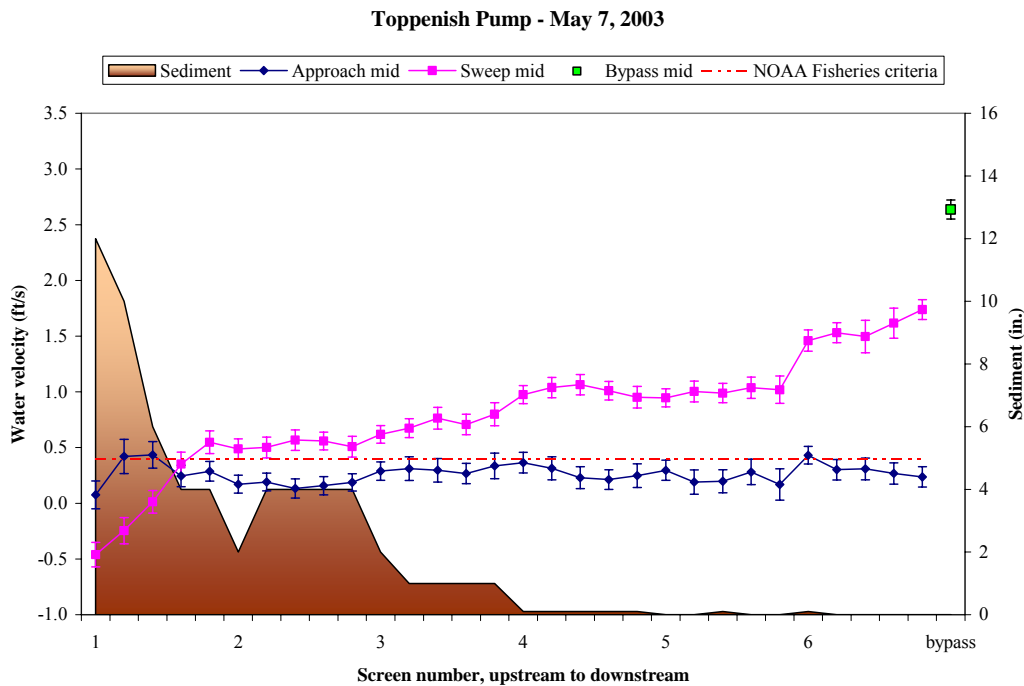
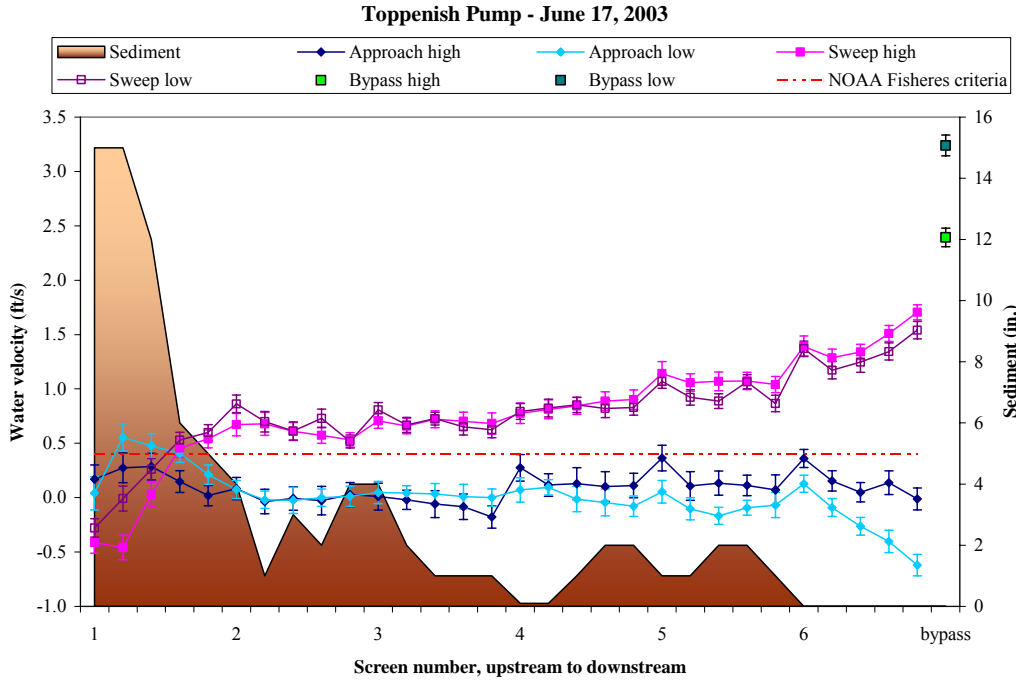
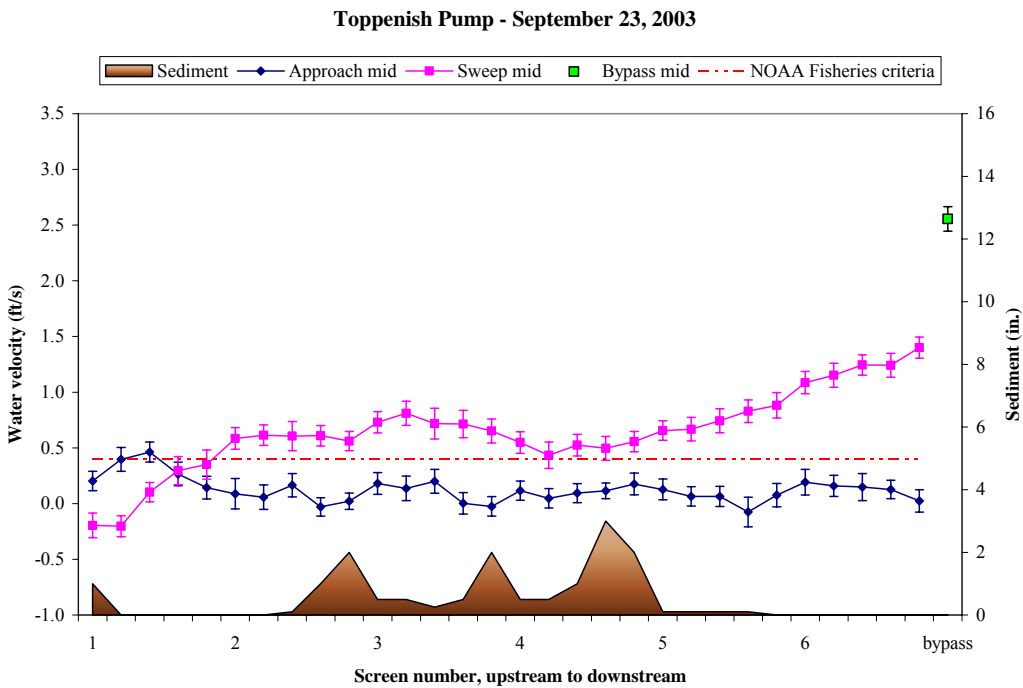
The Toppenish Pump site was visited on May 7, 2003; June 17, 2003; and September 23, 2003. In May, June, and September, 90%, 95%, and 97% of approach velocities met NOAA Fisheries criteria, respectively. This was a great improvement over 2002, when an average of 31% of approach velocities were >0.4 ft/s. Sweep velocities were generally higher than approach velocities, except in front of screen 1 (Figures 39, 40, and 41). Sweep velocities generally increased towards the bypass, and bypass velocities were always higher than sweep velocities. Submergence was calculated to be slightly low in May at 64% and met criteria in June and September at 79% and 72%, respectively.

Visible seals appeared to be in good condition during all surveys, with the exception of one or more warps in the upstream side seal on screen 5. During all surveys, sediment and debris covered some to nearly all of the bottom seals. The gaps between the metal frames of the drums and the cement walls of the site were not caulked. Bypass conditions were favorable during all surveys, though there was a small amount of debris floating on the water surface at the outfall.

Figure 39. Water Velocities and Sediment Depths at Toppenish Pump in May 2003. Error bars show turbulence (\pm the root-mean-squared [RMS]) at each point.

Figure 40. Water Velocities and Sediment Depths at Toppenish Pump in June 2003. Error bars show turbulence (\pm the root-mean-squared [RMS]) at each point.

Figure 41. Water Velocities and Sediment Depths at Toppenish Pump in September 2003. Error bars show turbulence (\pm the root-mean-squared [RMS]) at each point.

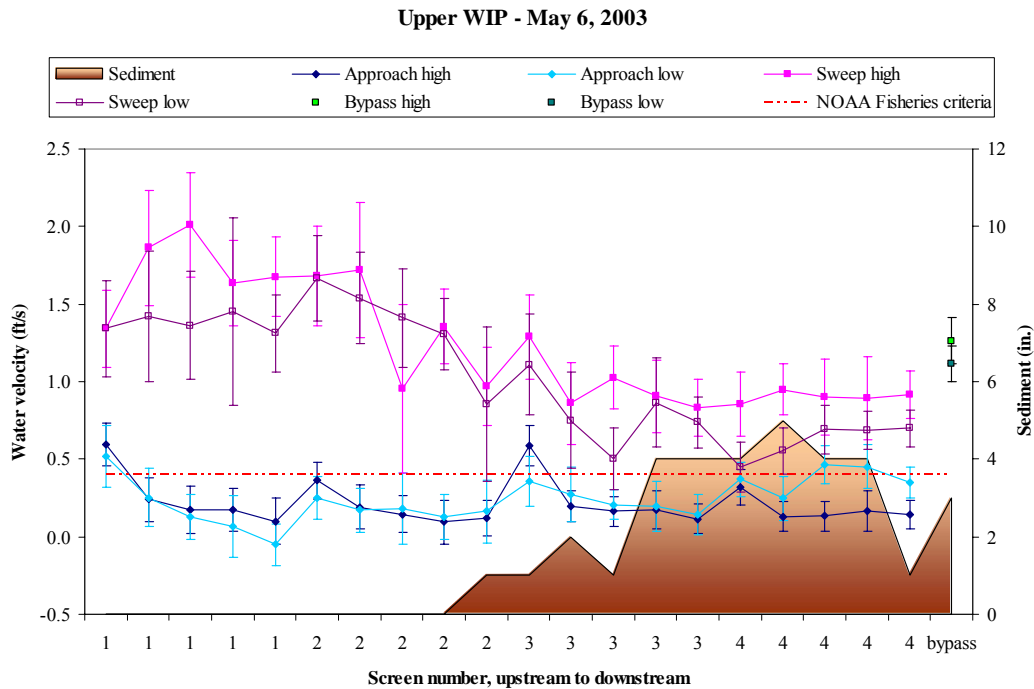
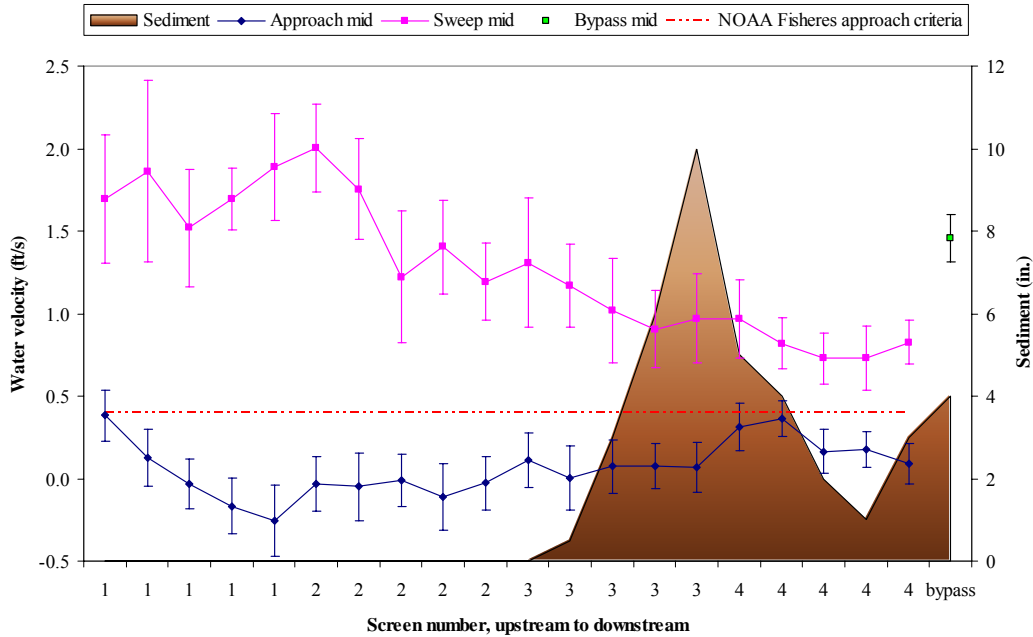
The Upper WIP site was visited on May 6, 2003; June 18, 2003; and September 19, 2003. The site was shut down for the season before the survey in September. Eighty-eight percent of approach velocities met NOAA Fisheries criteria in May, and 100% of approach velocities met NOAA Fisheries criteria in June (Figures 42 and 43). During both surveys, sweep velocities were much more turbulent than approach velocities. Sweep velocities did not increase towards the bypass, and the bypass velocity was only slightly greater than the average sweep velocity.

Screen submergence exceeded NOAA Fisheries criteria at 96% submergence in May and met criteria in June with 84% submergence. The screens seals were replaced in 2001 and have already begun to show some wear. There were two small warps in the downstream side seal on screen 2. Bypass conditions were generally good in May and June, although in June there was a large log in the forebay that had branches poking into the bypass and another in the downwell. Water ran freely behind the weir and out the outfall. The water depth at the point of discharge was greater than 12 in. in May and June, which satisfied NOAA Fisheries criteria and should be expected to provide sufficient water to allow for safe fish passage.

Figure 42. Water Velocities and Sediment Depths at Upper Wapato Irrigation Project (WIP) in May 2003. Error bars show turbulence (\pm the root-mean-squared [RMS]) at each point.

Figure 43. Water Velocities and Sediment Depths at Upper Wapato Irrigation Project (WIP) in June 2003. Error bars show turbulence (\pm the root-mean-squared [RMS]) at each point.

The gaps between the metal frames of the drums and the cement walls of the forebay were not caulked. The PNNL researchers recommend that these be filled with expanding foam insulation to prevent harm to migrating fish.

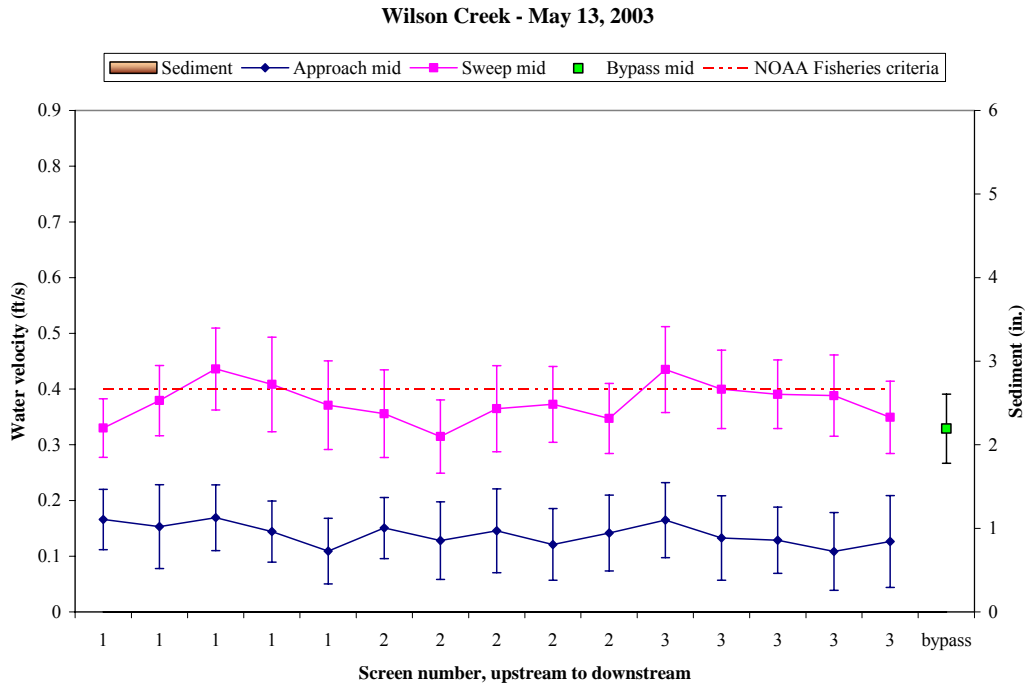
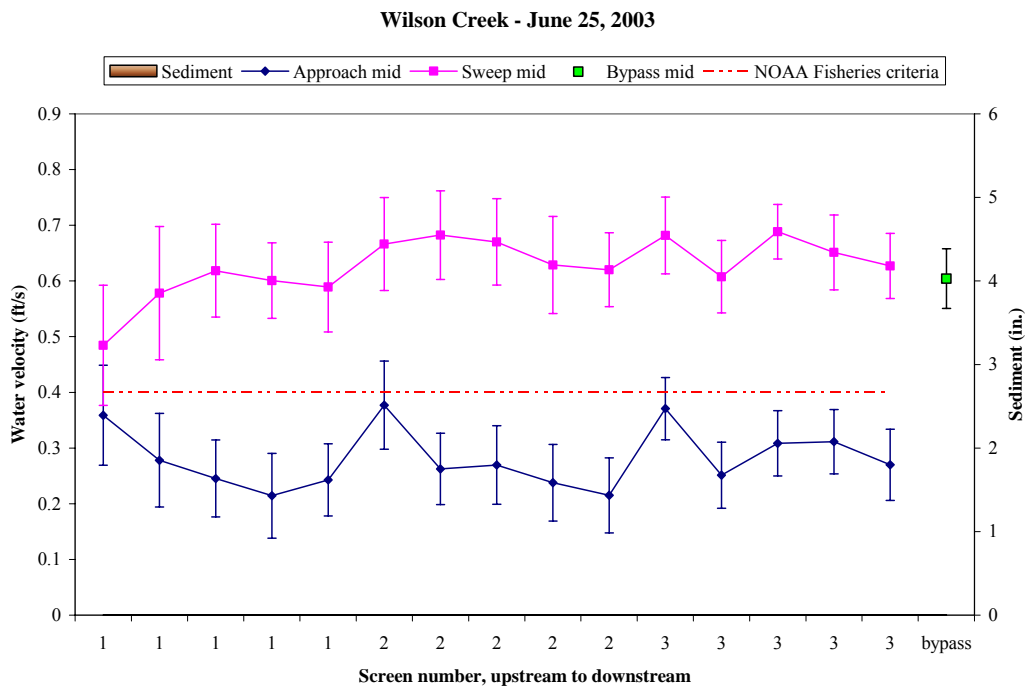
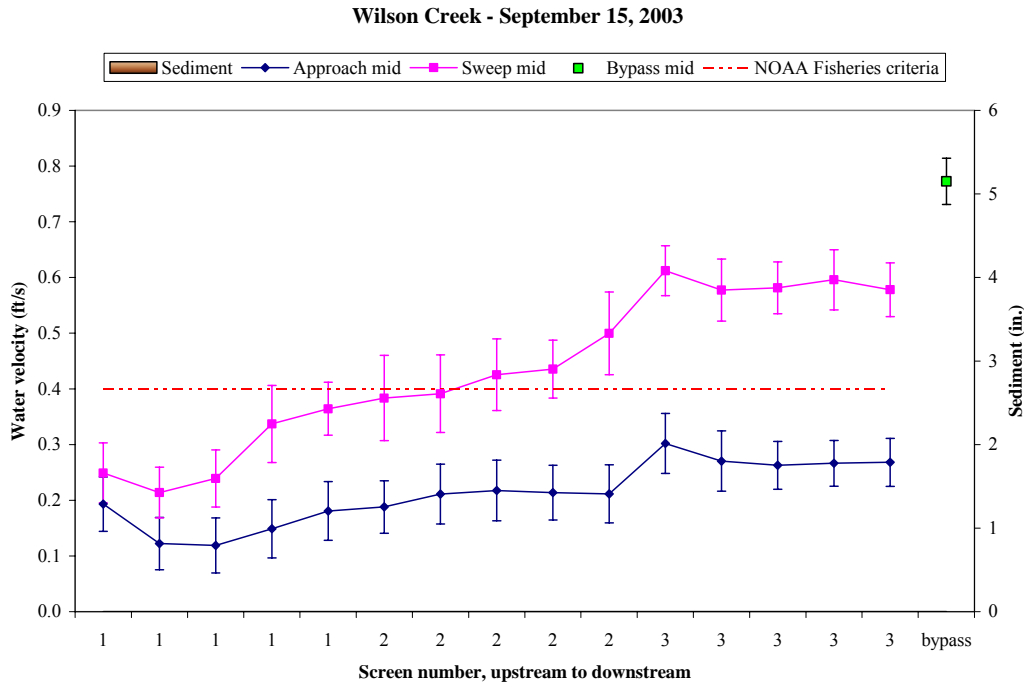
The Wilson Creek site was visited on May 13, 2003; June 25, 2003; and September 15, 2003. All measured approach velocities met NOAA Fisheries criteria during all surveys (Figures 44, 45, and 46). Sweep velocities were always greater than approach velocities. Sweep velocities did not increase towards the bypass except in September, and the average bypass velocity was slower than the average sweep velocity in May and June.

Submergence met criteria during all surveys. There was 2 in. of head loss over the screens in May. This was probably due to growth of algae on and inside of the screens, which tends to partially or fully plug the screen holes. The screen material was in good condition during all surveys, as were all seals. The gaps between the metal frames of the drums and the concrete walls of the forebay were filled with expanding foam insulation to prevent harm to migrating fish.

Figure 44. Water Velocities and Sediment Depths at Wilson Creek in May 2003. Error bars show turbulence (\pm the root-mean-squared [RMS]) at each point.

Figure 45. Water Velocities and Sediment Depths at Wilson Creek in June 2003. Error bars show turbulence (\pm the root-mean-squared [RMS]) at each point.

Figure 46. Water Velocities and Sediment Depths at Wilson Creek in September 2003. Error bars show turbulence (\pm the root-mean-squared [RMS]) at each point.

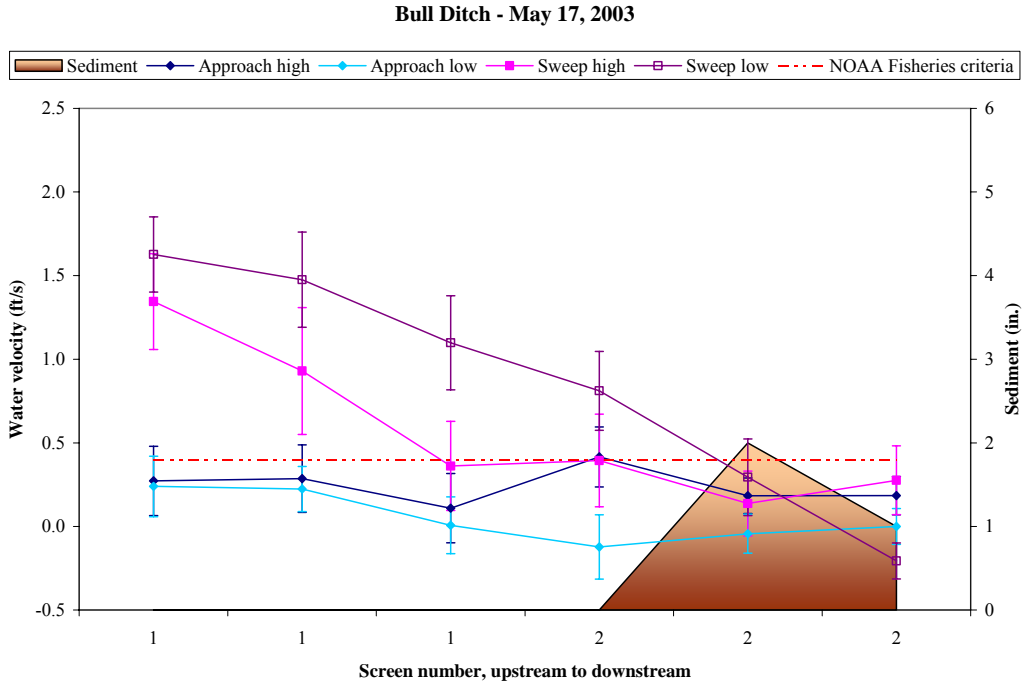
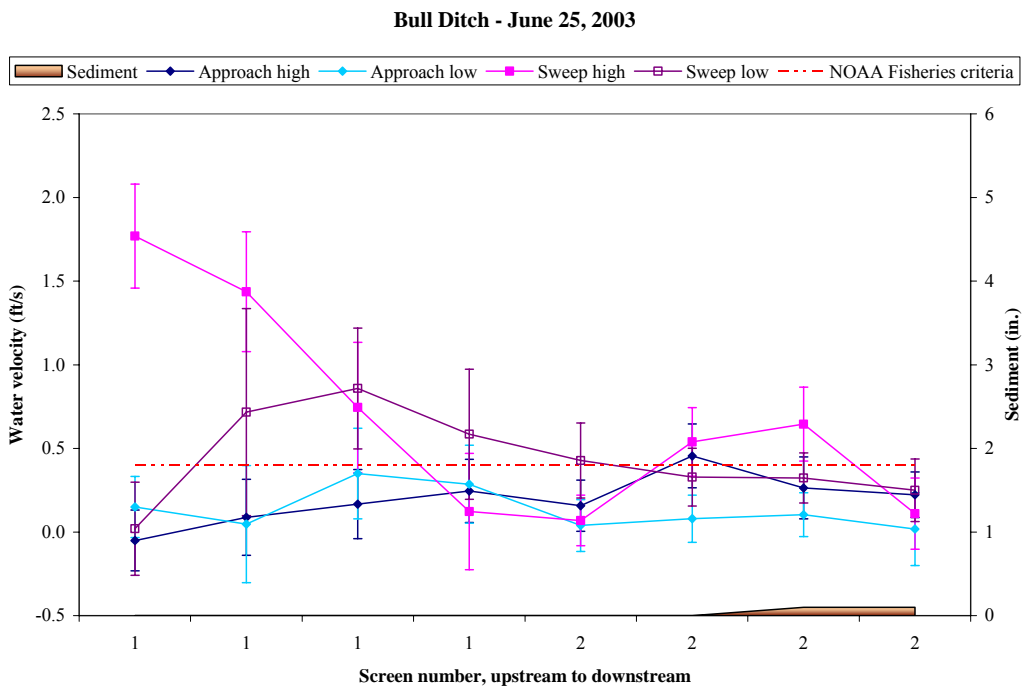
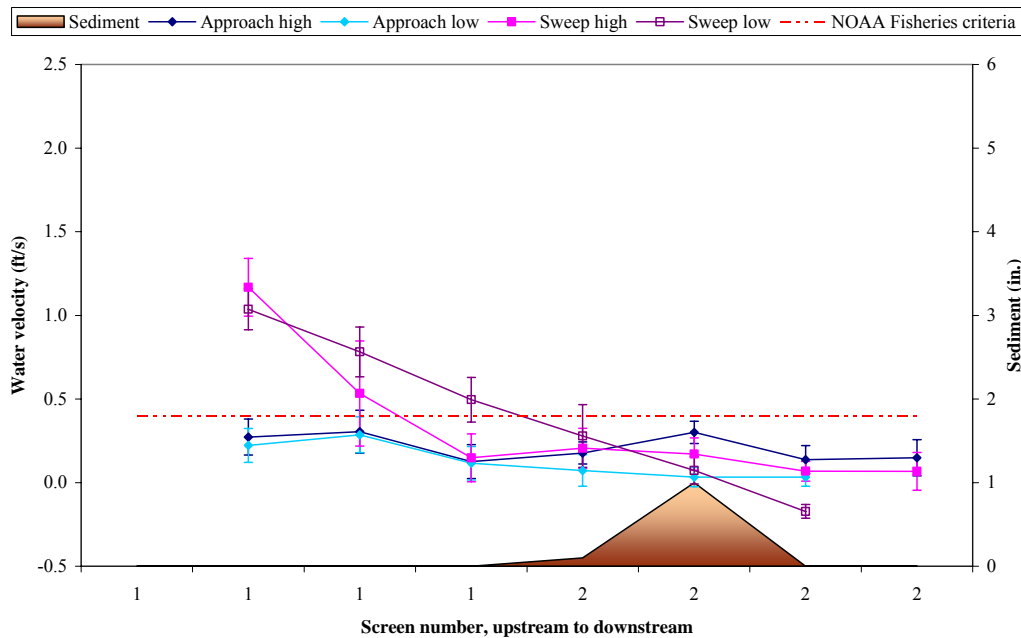
The Bull Ditch site was evaluated on May 12, 2003; June 25, 2003; and September 16, 2003. Sweep velocities were generally higher than approach velocities in May but not in June or September (Figures 47, 48, and 49). Approach velocities met NOAA Fisheries criteria 92%, 94%, and 100% of the time in May, June, and September, respectively. Sweep velocities tended to decrease over the length of the site, and in September, both sweep and approach velocities at the downstream end of the site were approximately zero.

Low-sweeping velocities at the downstream end of the site combined with the presence of predator habitat may result in the delay of and predation on migrating salmonids. Low-sweeping velocities are controlled in part by the metal plates placed between the screens and the channel, and changes in their position may help increase sweep velocities. The slower water may also cause sediment accumulation at

Figure 47. Water Velocities and Sediment Depths at Bull Ditch in May 2003. Error bars show turbulence (\pm the root-mean-squared [RMS]) at each point.

Figure 48. Water Velocities and Sediment Depths at Bull Ditch in June 2003. Error bars show turbulence (\pm the root-mean-squared [RMS]) at each point.

Figure 49. Water Velocities and Sediment Depths at Bull Ditch in September 2003. Error bars show turbulence (\pm the root-mean-squared [RMS]) at each point.

the downstream end of the site. This site has been tentatively scheduled for removal during the 2003 winter. If it continues to be used, the PNNL researchers recommend that procedures be evaluated to increase sweep velocities and minimize predator habitat growth and sediment accumulation.

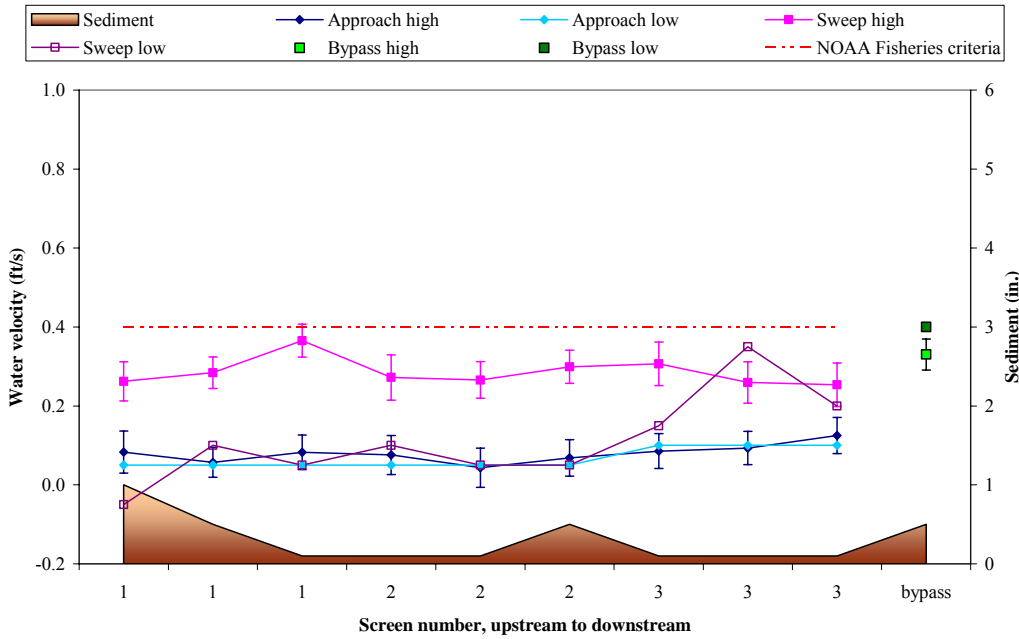
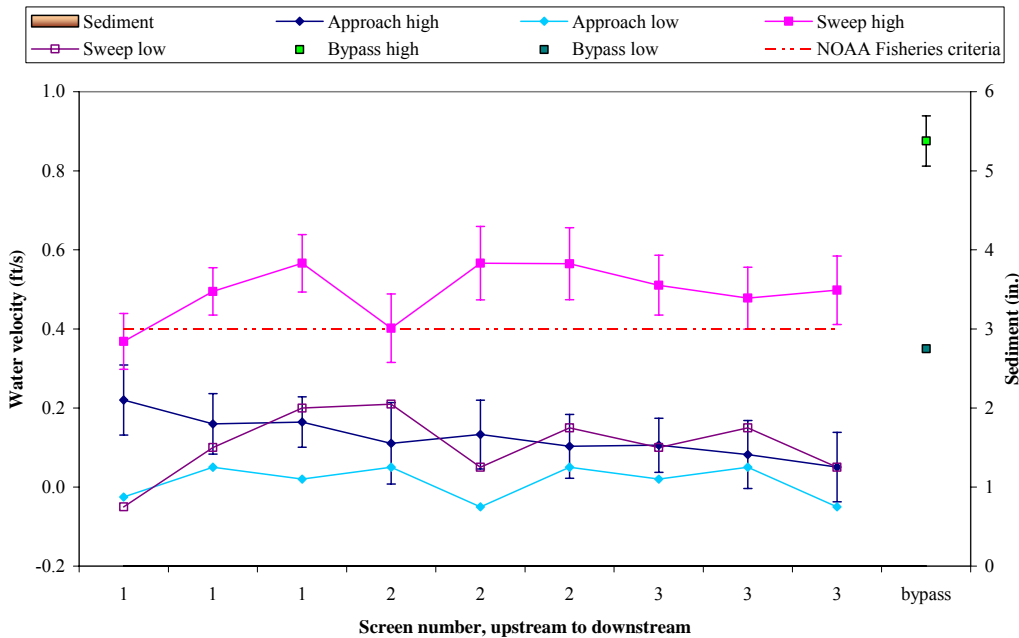
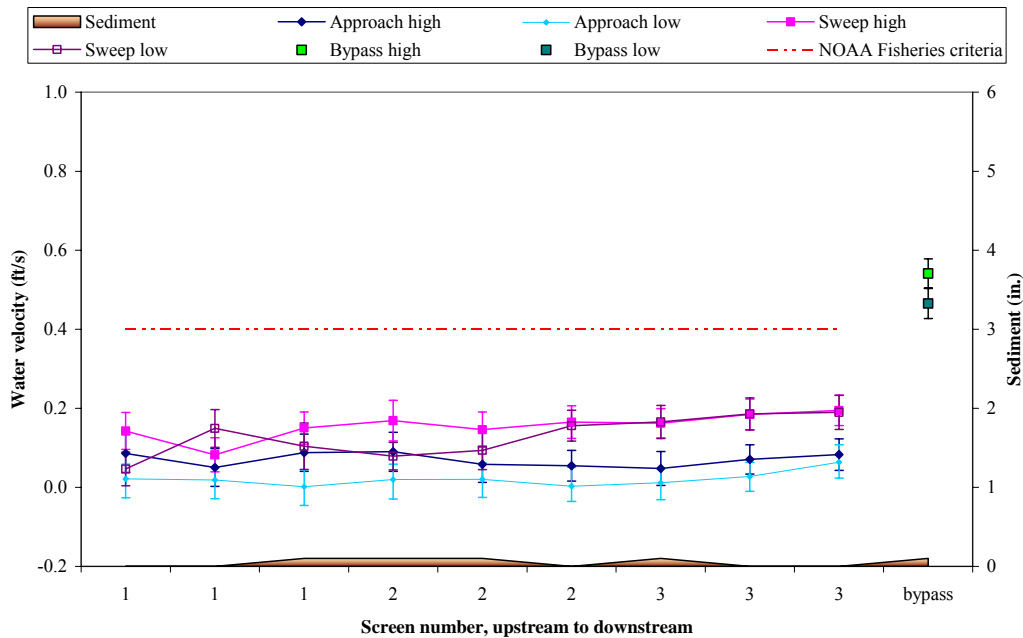
The Ellensburg Mill site was visited on May 12, 2003; June 25, 2003; and September 15, 2003. Because of aquatic vegetation growth in the forebay, the Marsh-McBirney 511[®] flow meter was used to measure velocity at the low position in May and June; consequently, turbulence values are not available for those measurements. All approach velocities met NOAA Fisheries criteria during all surveys (Figures 50, 51, and 52). Sweep velocities were generally higher than approach velocities. Sweep velocities did not increase towards the bypass, although the bypass velocity was greater than the average sweep velocity during all surveys.

The screens appeared to be in good condition during all surveys, but the seals between the screens were partially missing and may need to be replaced. In May and June, bottom seals were not evaluated due to growth of aquatic plants in the forebay. While this is not generally a concern at flat-plate screen sites, the September video survey revealed that the bottom seals may also need to be replaced as the caulking is missing in places. The mechanical brushes effectively removed algae and debris from most of the screen surfaces, though there were patches, especially towards the bottoms of the screens that remained covered with algae.

Figure 50. Water Velocities and Sediment Depths at Ellensburg Mill in May 2003. Error bars show turbulence (\pm the root-mean-squared [RMS]) at each point.

Figure 51. Water Velocities and Sediment Depths at Ellensburg Mill in June 2003. Error bars show turbulence (\pm the root-mean-squared [RMS]) at each point.

Figure 52. Water Velocities and Sediment Depths at Ellensburg Mill in September 2003. Error bars show turbulence (\pm the root-mean-squared [RMS]) at each point.

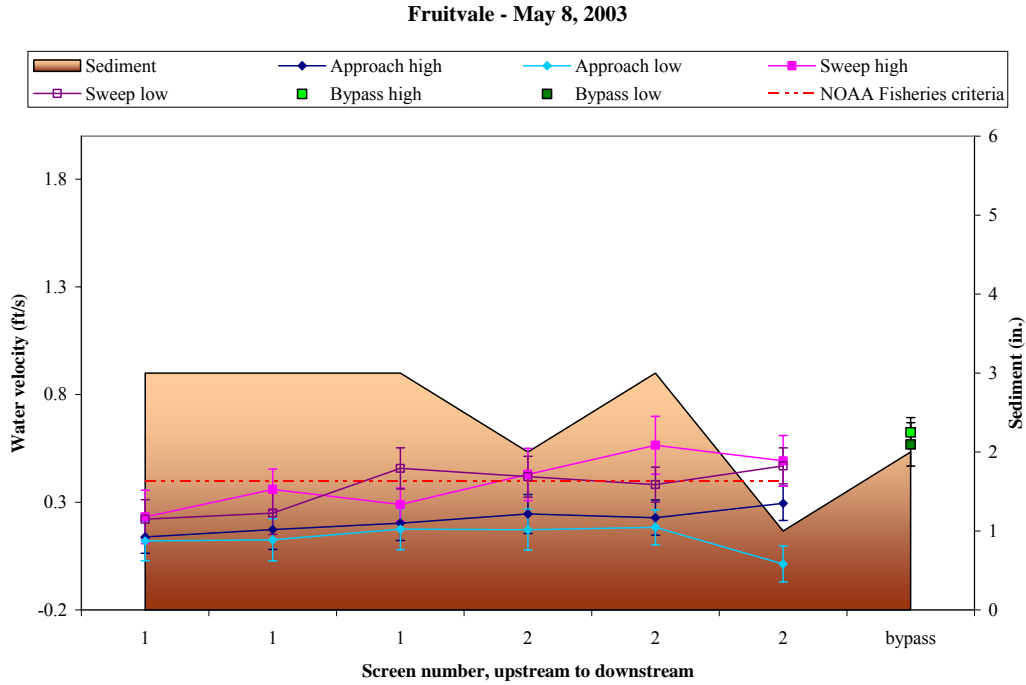
The Fruitvale site was visited on May 8, 2003; June 26, 2003; and September 16, 2003. During all surveys, 100% of approach velocities met NOAA Fisheries criteria (Figures 53, 54, and 55). Sweep velocities were generally higher than approach velocities and increased towards the bypass in September. Bypass velocities were higher than the average sweep velocity in May and September.

Figure 53. Water Velocities and Sediment Depths at Fruitvale in May 2003. Error bars show turbulence (\pm the root-mean-squared [RMS]) at each point.

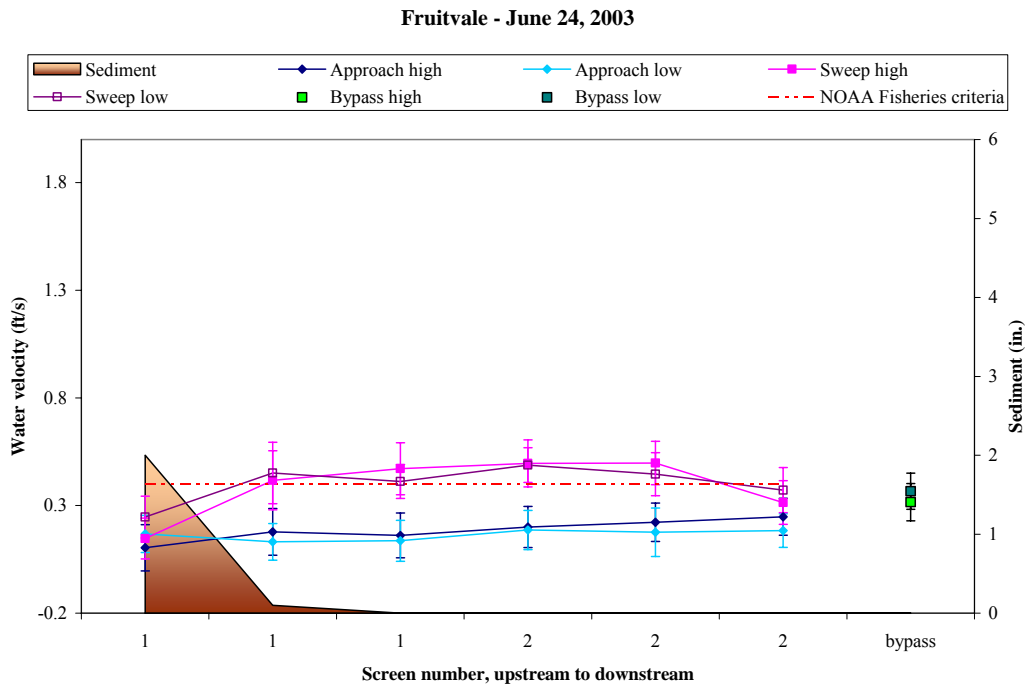
Figure 54. Water Velocities and Sediment Depths at Fruitvale in June 2003. Error bars show turbulence (\pm the root-mean-squared [RMS]) at each point.

The level of sediment accumulation in the forebay was reasonable during all surveys, however in June we observed a gigantic pile of sediment in the aftbay that came within 2 to 3 in. of the surface of the water. Generally this would not be a concern, but the pile of sediment infiltrated the screen louvers, many of which could not have been moved while the sediment was present. While maintenance and care of the forebay is generally sufficient, any problem in the aftbay that affects the operation of the site, like this giant pile of sediment, needs to be addressed as well.

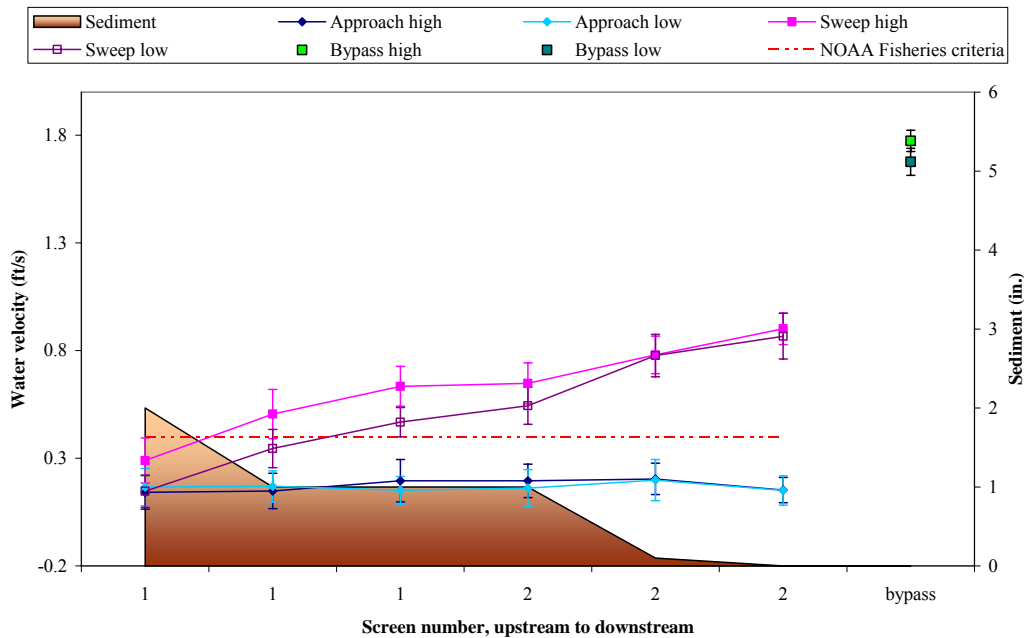
Fruitvale - September 16, 2003

Figure 55. Water Velocities and Sediment Depths at Fruitvale in September 2003. Error bars show turbulence (\pm the root-mean-squared [RMS]) at each point.
