Yakima River Basin Phase II Fish Screen Evaluations, 2003

J. A. Vucelick
G. A. McMichael
M. A. Chamness

May 2004

Prepared for the U.S. Department of Energy
Bonneville Power Administration
under Project 1982-06200

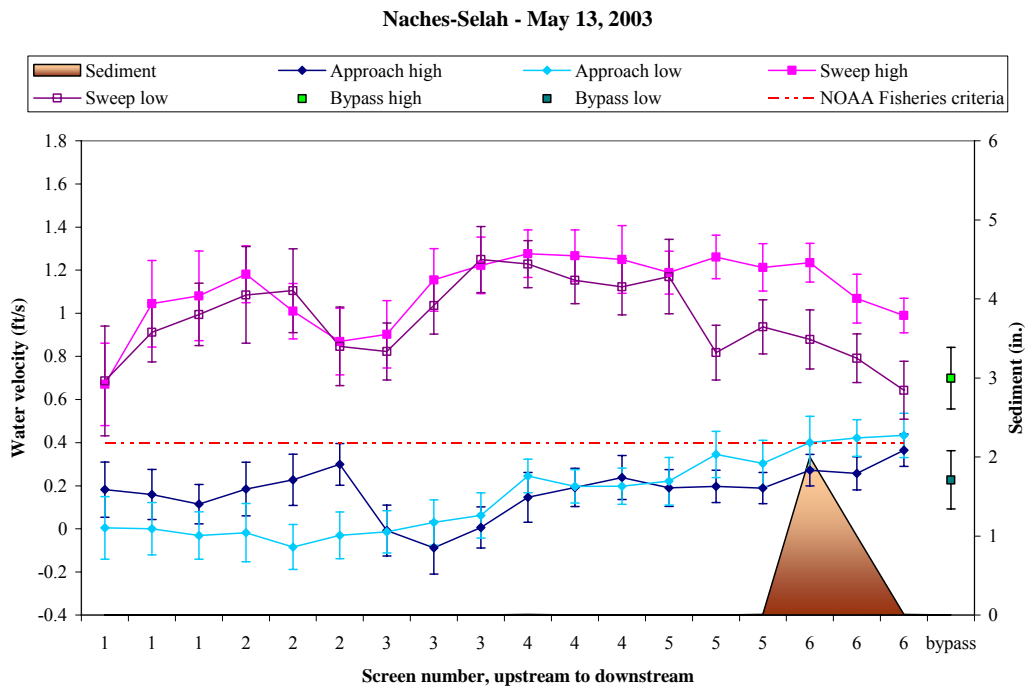
The Naches-Selah site was visited on May 13, 2003; June 24, 2003; and September 16, 2003. In May, June, and September, 92%, 72%, and 75% of approach velocities met NOAA Fisheries criteria, respectively (Figures 56, 57, and 58). Sweep velocities were always greater than approach velocities but did not increase towards the bypass. The average bypass velocity was slower than the average sweep velocity during all surveys. Ray Gilmore was notified of the high approach velocities on June 26. Dave Floyd made changes to the operating conditions on July 2, but the changes did not put the site in compliance with the NOAA Fisheries criteria, and in September the approach velocities were still high. Ray Gilmore was notified again on September 17, although there was not much he could do. This site has

Figure 56. Water Velocities and Sediment Depths at Naches-Selah in May 2003. Error bars show turbulence (\pm the root-mean-squared [RMS]) at each point.

one of the worst records as far as meeting NOAA Fisheries velocity criteria, and while the numbers for 2003 are an improvement over 2002, they are still low (Table 4). The PNNL researchers recommend that site operating procedures and/or site structure be modified to protect migrating fish from injury as they pass through this site.

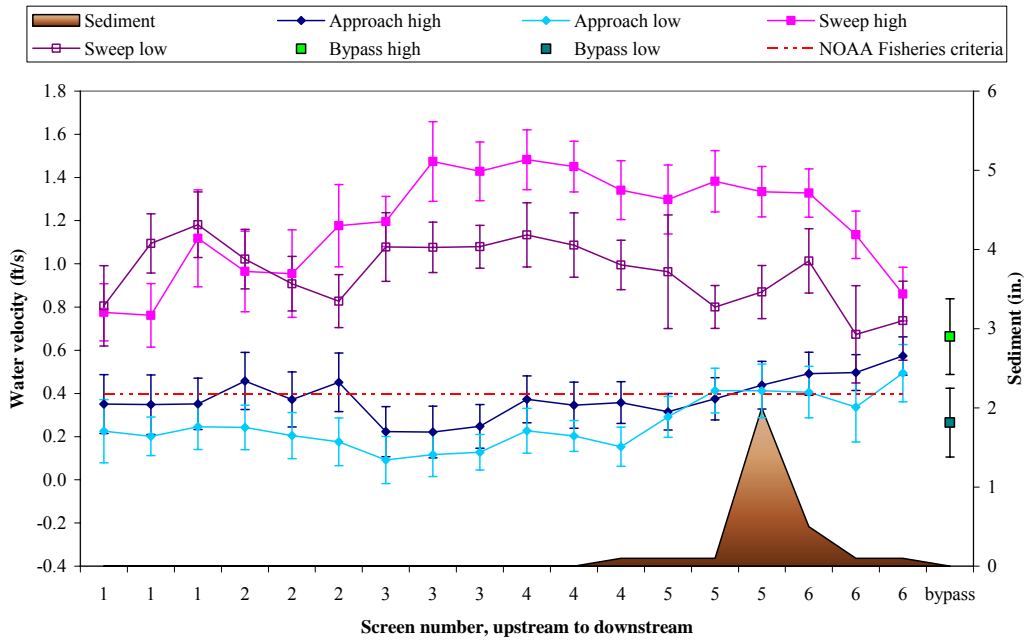
Naches-Selah - June 24, 2003

Figure 57. Water Velocities and Sediment Depths at Naches-Selah in June 2003. Error bars show turbulence (\pm the root-mean-squared [RMS]) at each point.

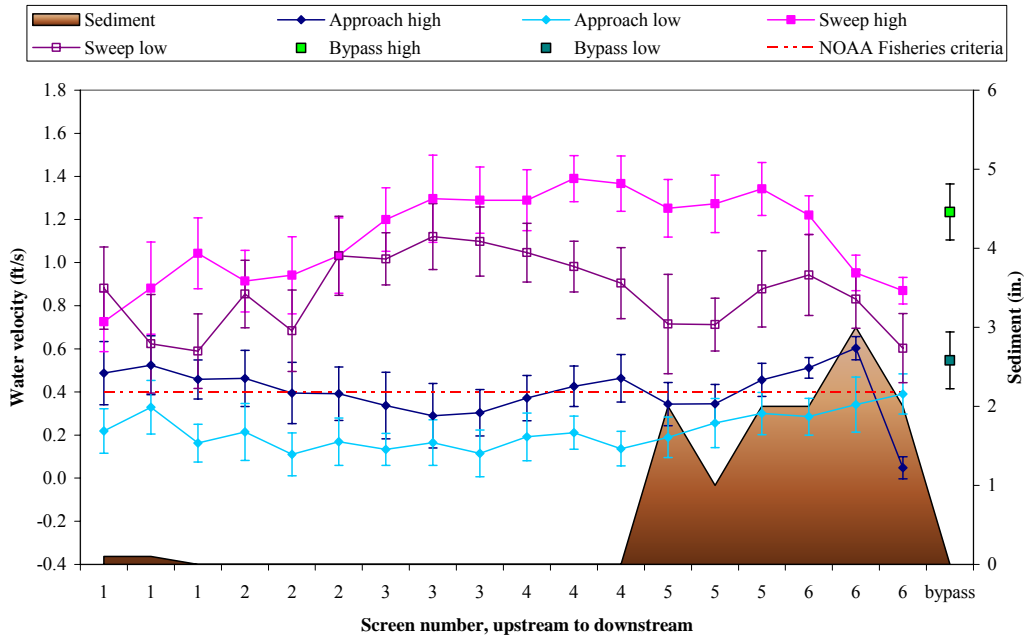
Naches-Selah - September 16, 2003

Figure 58. Water Velocity and Sediment Depths at Naches-Selah in September 2003. Error bars show turbulence (\pm the root-mean-squared [RMS]) at each point.

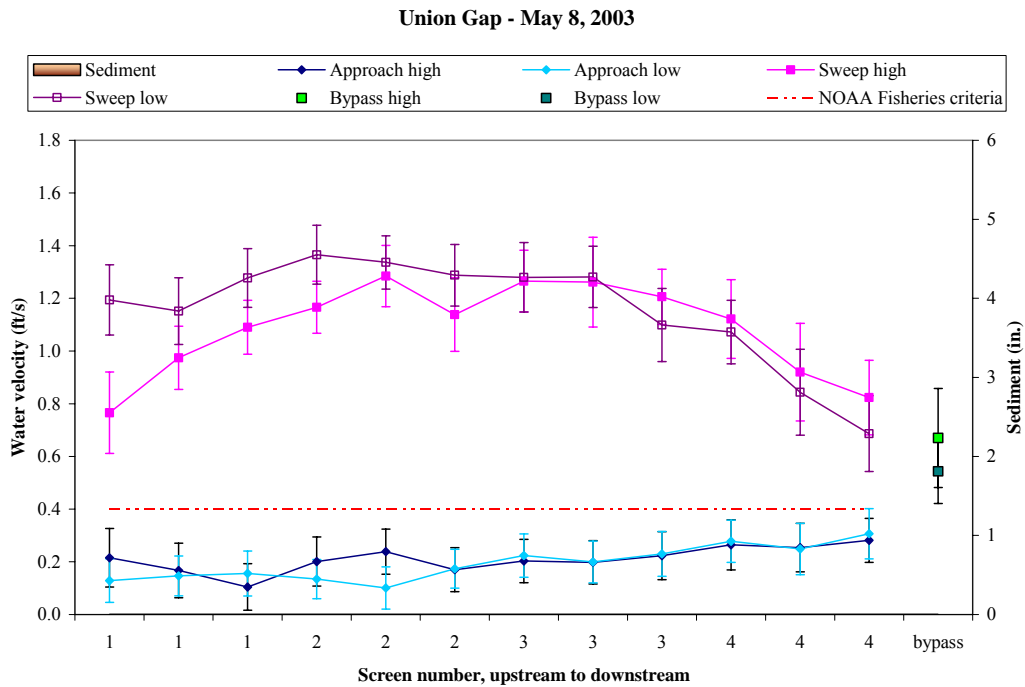
The Union Gap site was evaluated on May 8, 2003; June 24, 2003; and September 16, 2003. In May, June, and September, 100%, 71%, and 100% of approach velocities met NOAA Fisheries criteria, respectively (Figures 59, 60, and 61). Sweep velocities were always higher than approach velocities, but did not increase toward the bypass. The average bypass velocity was slower than the average sweep velocity. Ray Gilmore was notified on June 24 that greater than 10% of the approach velocity measurements exceeded 0.4 ft/s. Follow-up measurements taken on June 26 after changes in operating conditions showed that velocities were still high. PNNL followed up again on July 2, and approach velocity conditions met the NOAA Fisheries criteria.

Figure 59. Water Velocities and Sediment Depths at Union Gap in May 2003. Error bars show turbulence (\pm the root-mean-squared [RMS]) at each point.

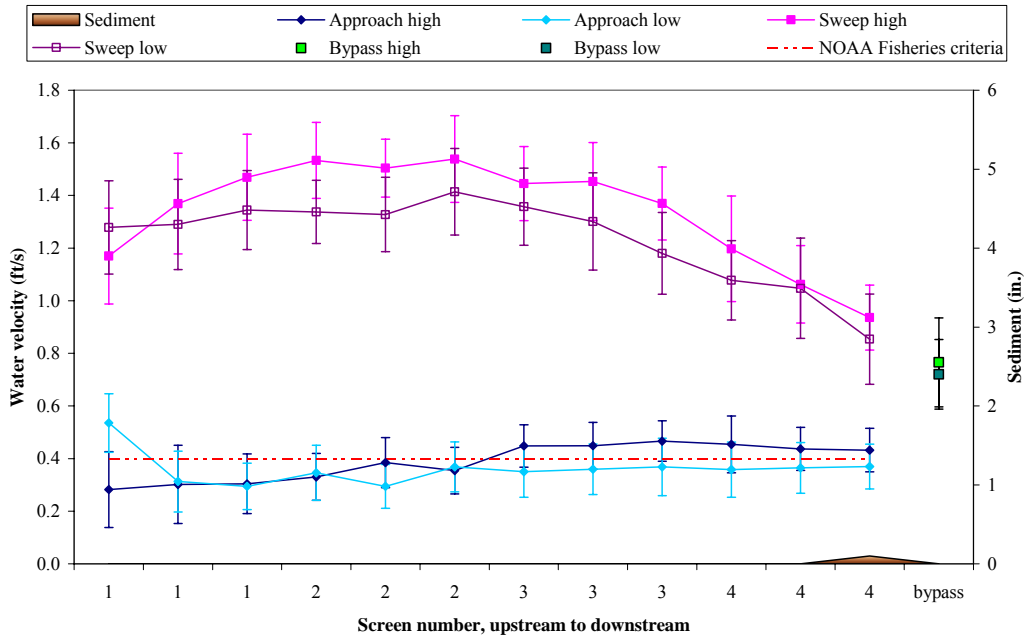
Union Gap - June 24, 2003

Figure 60. Water Velocities and Sediment Depths at Union Gap in June 2003. Error bars show turbulence (\pm the root-mean-squared [RMS]) at each point.

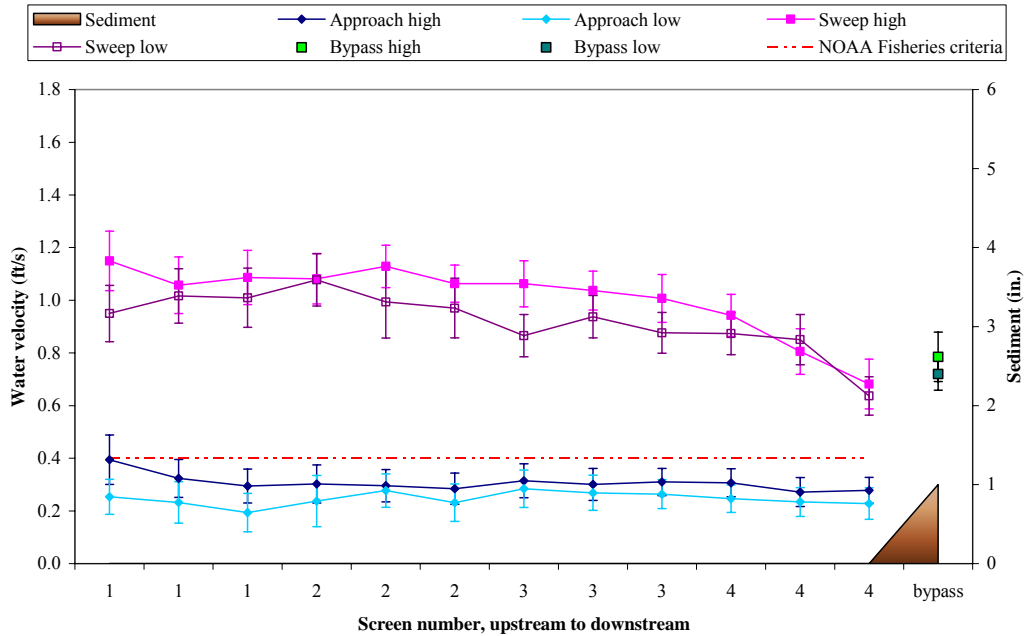
Union Gap - September 16, 2003

Figure 61. Water Velocities and Sediment Depths at Union Gap in September 2003. Error bars show turbulence (\pm the root-mean-squared [RMS]) at each point.

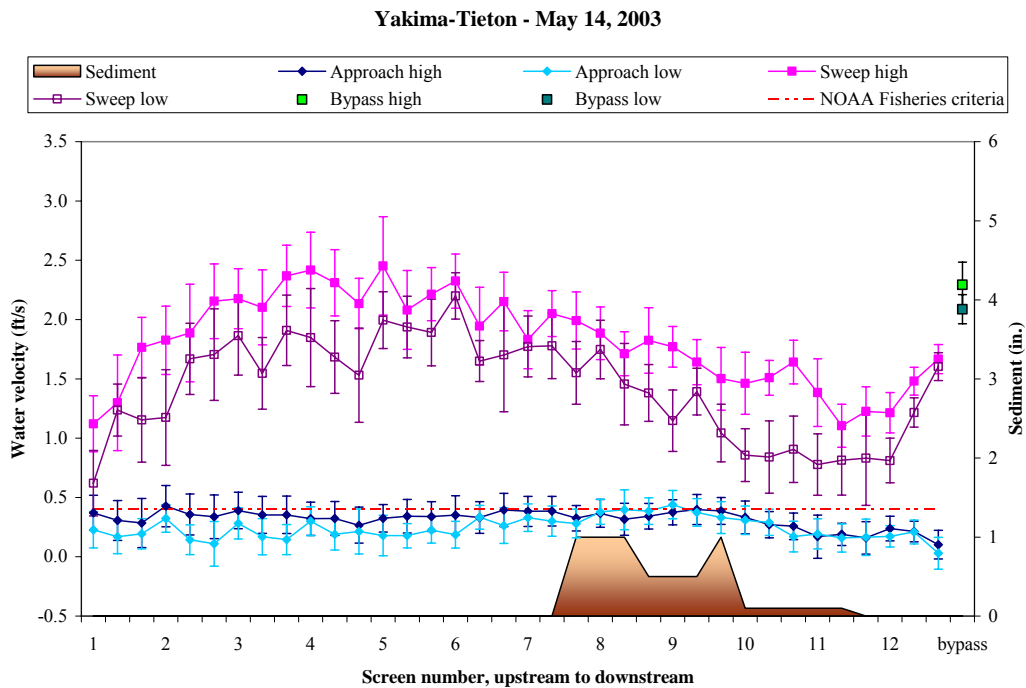
The Yakima-Tieton site was evaluated on May 14, 2003; June 19, 2003; and September 17, 2003. In May, June, and September, 97%, 94%, and 100% of approach velocities met NOAA Fisheries criteria, respectively (Figures 62, 63, and 64). Sweep velocities were always higher than approach velocities. Sweep velocities did not increase towards the bypass, and the average bypass velocity was always higher than the average sweep velocity.

Figure 62. Water Velocities and Sediment Depths at Yakima-Tieton in May 2003. Error bars show turbulence (\pm the root-mean-squared [RMS]) at each point.

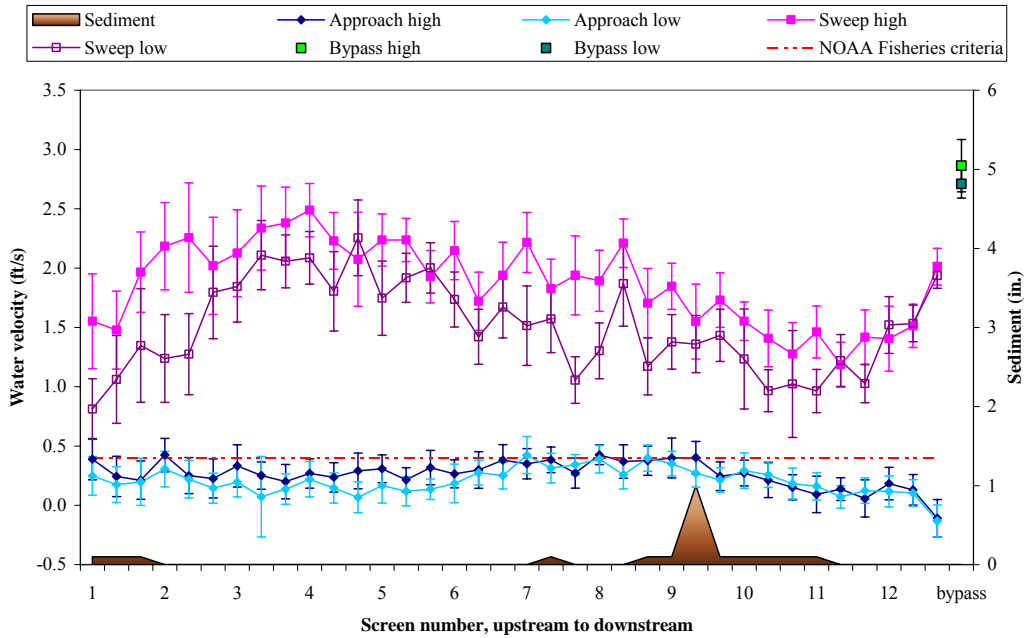
Yakima-Tieton - June 19, 2003

Figure 63. Water Velocities and Sediment Depths at Yakima-Tieton in June 2003. Error bars show turbulence (\pm the root-mean-squared [RMS]) at each point.

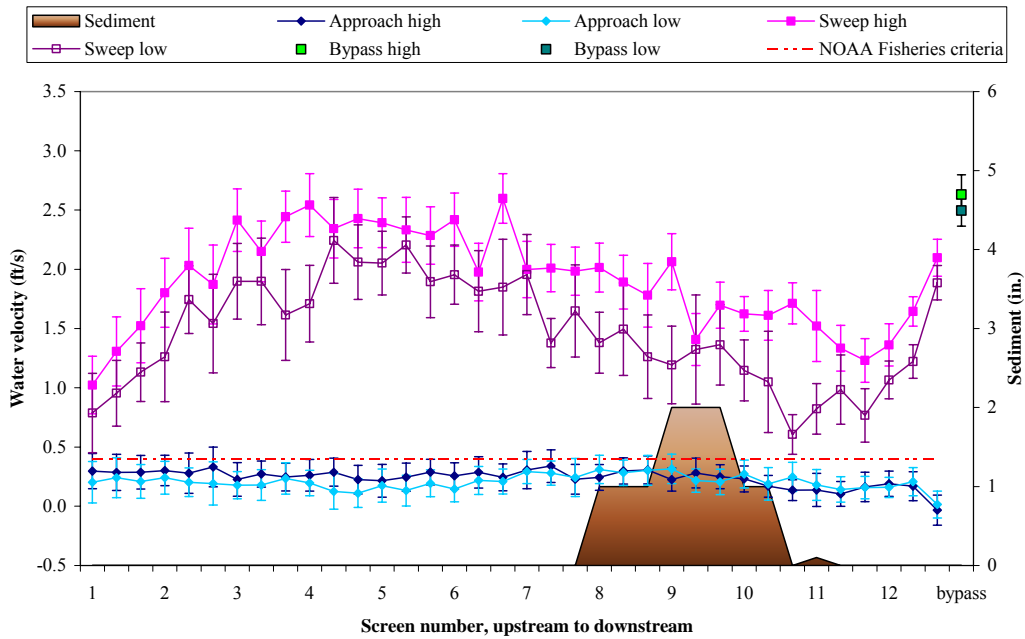
Yakima-Tieton - September 17, 2003

Figure 64. Water Velocities and Sediment Depths at Yakima-Tieton in September 2003. Error bars show turbulence (\pm the root-mean-squared [RMS]) at each point.

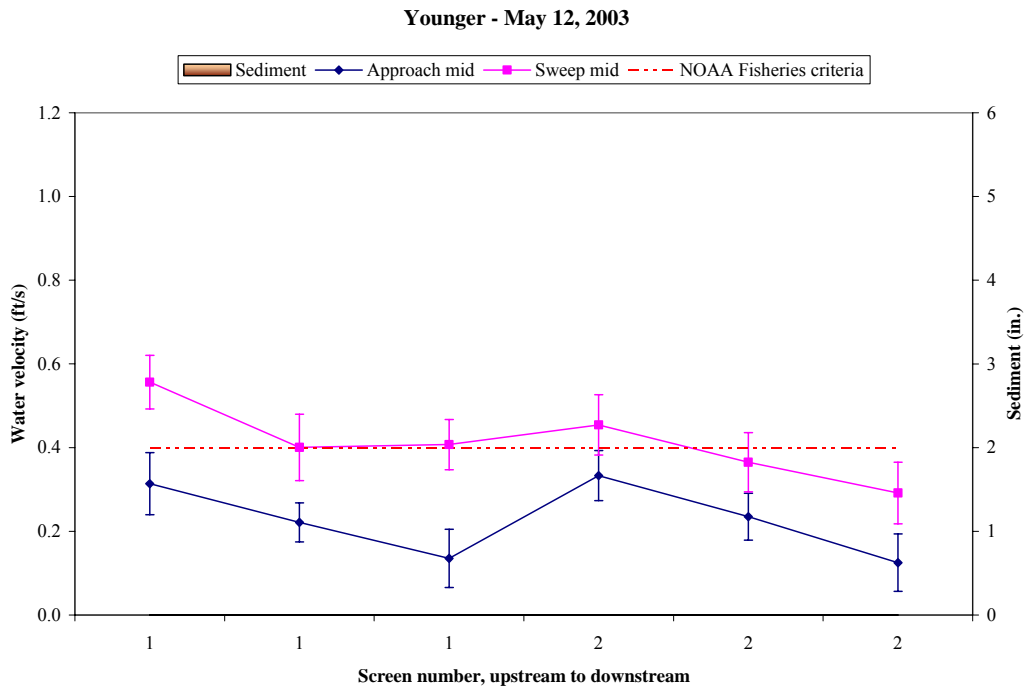
The Younger site was visited on May 12, 2003; June 25, 2003; and September 15, 2003. All approach velocities met NOAA Fisheries criteria during all surveys (Figures 65, 66, and 67). Sweep velocities were generally higher than approach velocities, though they did not increase towards the downstream end of the site.

In May, there was no flow over the checkboards in the forebay, effectively blocking passage through the site. A large trout was present at the time. Ray Gilmour was notified about the blockage on May 12, 2003, and he fixed the problem the same day.

Figure 65. Water Velocities and Sediment Depths at Younger in May 2003. Error bars show turbulence (\pm the root-mean-squared [RMS]) at each point.

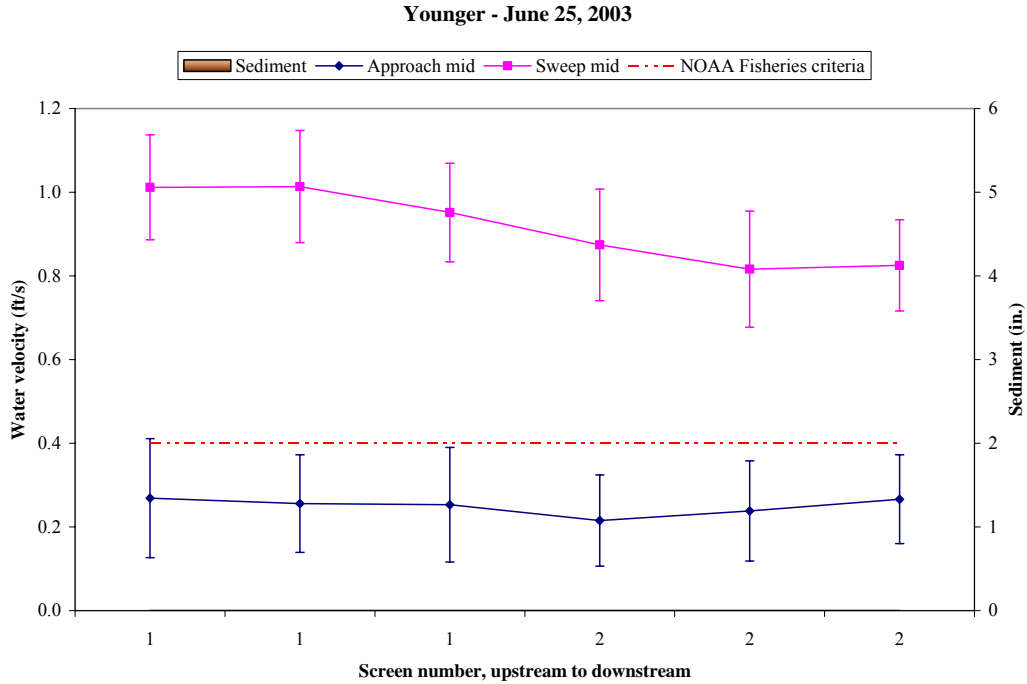
Figure 66. Water Velocities at Younger in June 2003. Error bars show turbulence (\pm the root-mean-squared [RMS]) at each point.

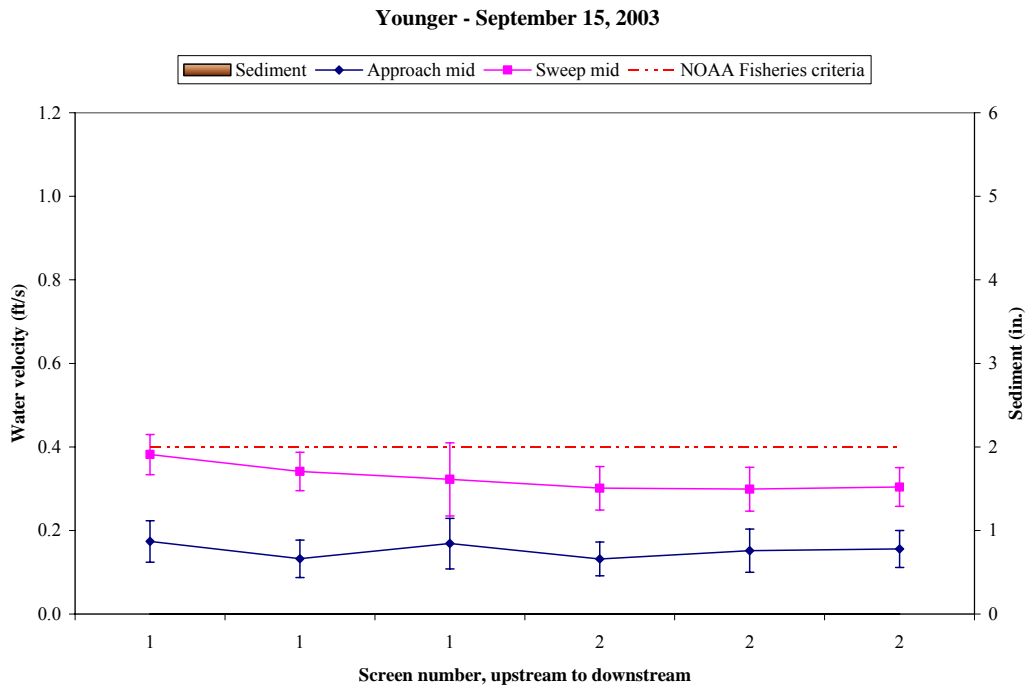
Figure 67. Water Velocities at Younger in September 2003. Error bars show turbulence (\pm the root-mean-squared [RMS]) at each point.
