<i>Title:</i> <b>ET Tiger Team Report – Part I : Interim</b>	<i>Revision:</i> Rev C	<i>Date:</i> 07 Oct 05	<i>Page:</i> 1 of 80
---	---------------------------	---------------------------	-------------------------

As a result of foam loss on STS-114, an ET Tiger Team was chartered by the Headquarters Mission Director for Space Operations (MDSO) and NASA's Chief Officer for Safety and Mission Assurance (COSMA), to review unexpected External Tank (ET) Thermal Protection System (TPS) foam loss. Foam losses of significance occurred in five areas of ET foam, including the Protuberance Air Load (PAL) ramp, the left bi-pod fitting closeout, several locations on the ice/frost ramps covering the re-pressurization line attachment brackets, two locations on the liquid hydrogen (LH<sub>2</sub>) tank-to-intertank flange, and two locations in the LH<sub>2</sub> tank acreage. The largest piece, approximately one pound, was from the PAL ramp. The ET Tiger Team reviewed foam performance to determine most likely root causes, to determine whether these were unique to STS-114/ET-121, and to make both near- and long-term recommendations to minimize likelihood of recurrence.

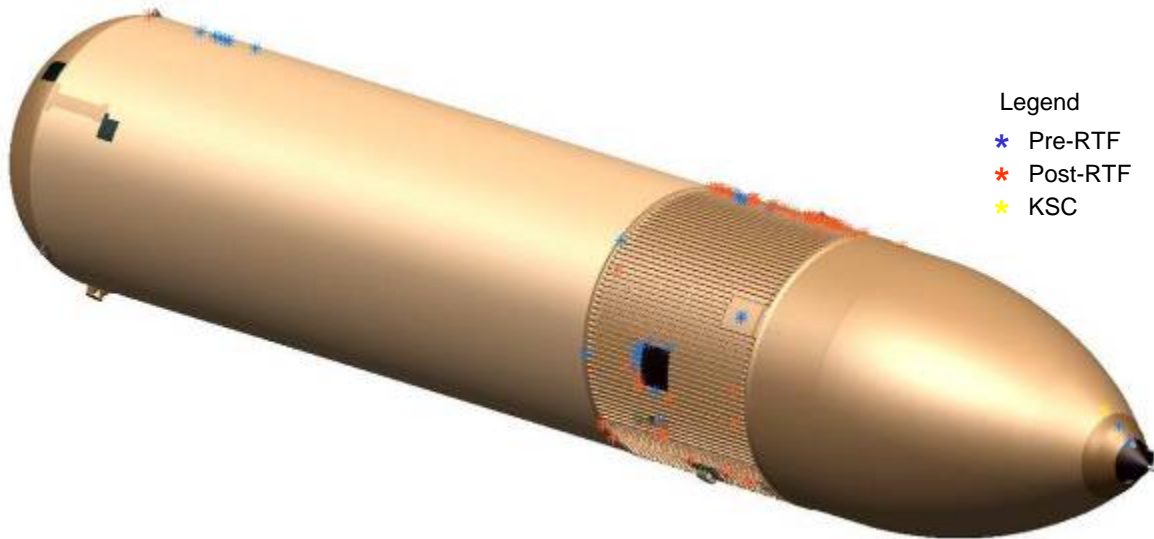
**Figure 5.2-2. ET-121 Nonconformances Documented on the -Z Side of the Tank**

While ground-handling loads were judged inconsequential, the occurrence of collateral damage during ground processing appears significant with numerous cuts, scratches, crushed foam and other damage documented during ET-121 processing. The rework of ET-121 and subsequent tanks, and the performance of that work after installation of the LH<sub>2</sub> PAL ramp, represents a significant departure from the normal processing flow. A high correlation was noted between areas of the tank with the highest levels of processing traffic (those adjacent to work platforms, mats, etc.), the locations of documented repairs known as nonconformance documents, or NCDs, and the locations from which foam was lost on STS-114 (Figure 5.2-1). Comparison to the -Z side of the tank, which sees relatively little processing activity, illustrates the point (Figures 5.2-2 and 5.2-3). Data collected for ET-119 and ET-115 shows a similar pattern: foam loss typically occurs in locations that have seen the highest levels of processing traffic (Appendix A). This suggests the possibility that undetected collateral damage may be a direct or contributing cause of some foam loss.

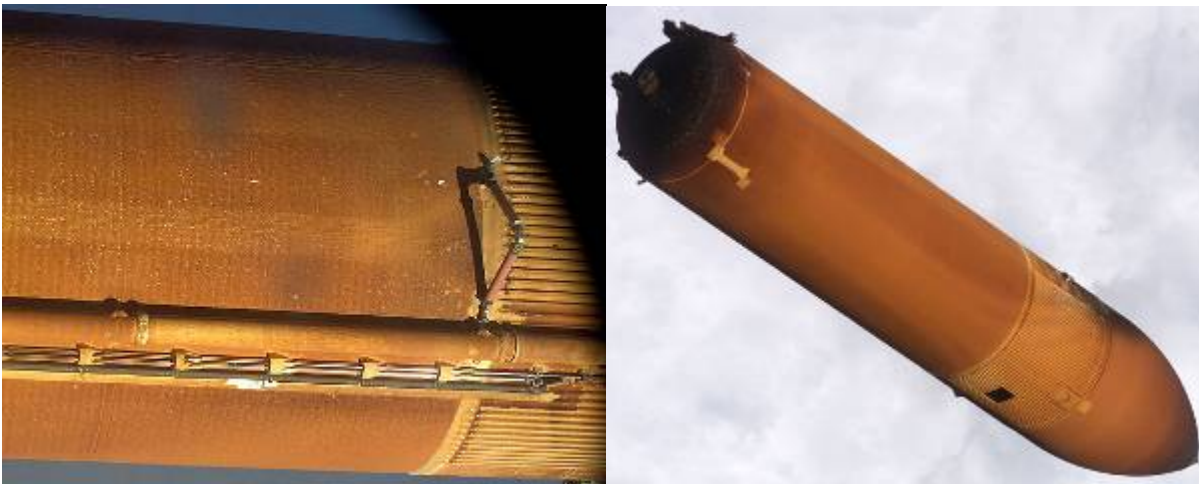
**Figure 5.2-3. ET-121 On-Orbit +Z / -Z Comparison**

On-orbit photographs of ET-121 clearly show a higher level of foam loss in the acreage on the +Z (near) side of the tank as compared to the -Z (back) side (refer to Figure 5.2-3 and Appendix B). This is the side of the tank that sees the highest level of traffic during processing, again raising the possibility that undetected collateral damage to the acreage TPS may be a contributor to foam loss.

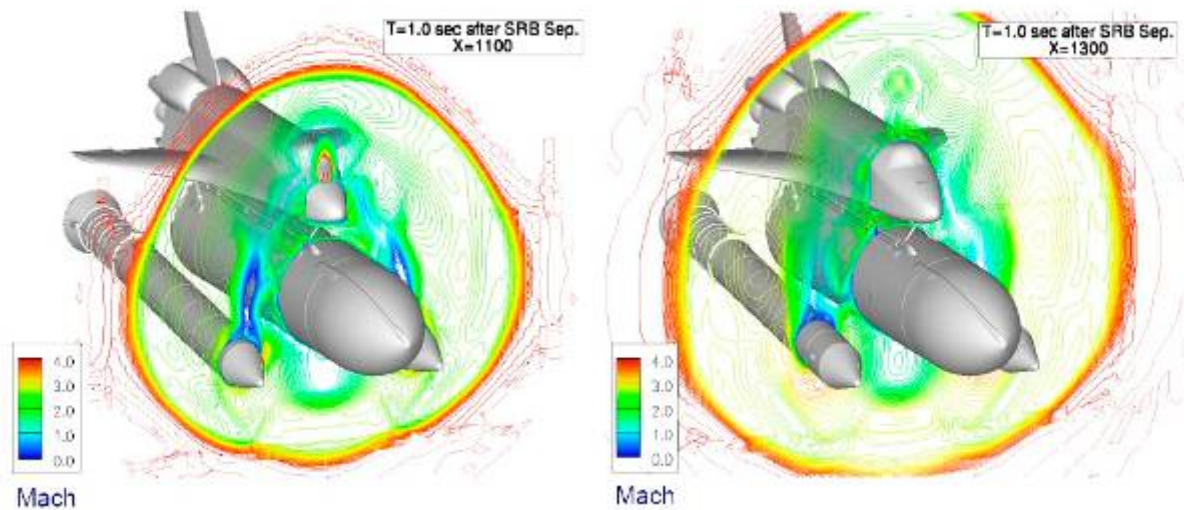
**Figure 6.0-2. Shock Impingement at SRB Separation**

The loads transfer associated with SRB separation was also assessed (ref. 10). At the time of separation, SRB thrust is significantly reduced and the Space Shuttle Main Engine (SSME) thrust load is the largest amplitude forcing function through the LH<sub>2</sub> tank barrel structure. To assess the transient loads at the LH<sub>2</sub> PAL ramp during SRB separation, an analysis was performed to generate a comparison of the maximum design shell compression loads for both the pre-staging and post-staging load conditions. The results of the analysis show that SSME-induced compression loading does increase from pre- to post-staging, but the overall tank shell loading remains in tension (i.e., there is insufficient loading to overcome internal pressure-induced shell loading). The absence of net compression eliminates the potential for localized shell buckling as a contributor to the PAL ramp foam loss event. Because the LH<sub>2</sub> tank shell is a stiff, pressure-stabilized structure and the loads transfer is somewhat gradual as the SRB thrust drops off, the effect of the loads transfer on the PAL ramp is negligible.

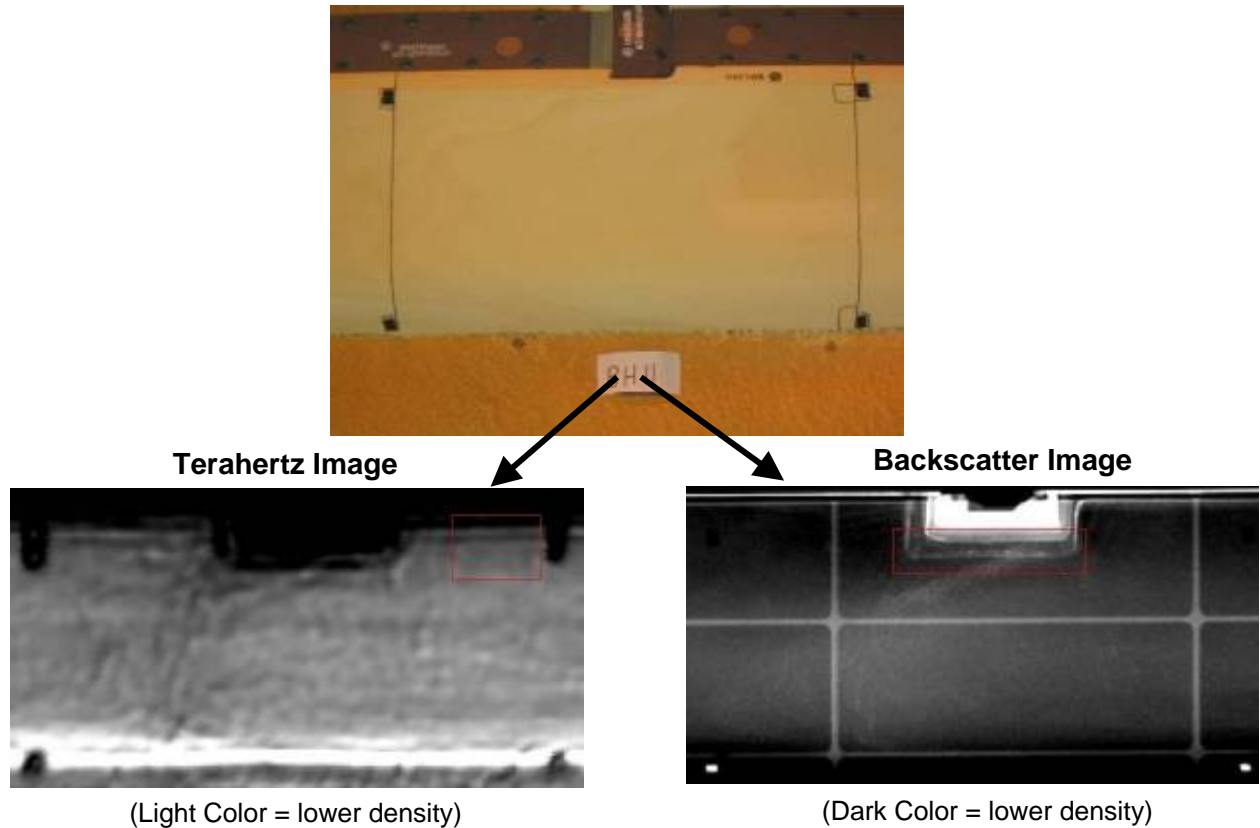
**Figure 6.0-4. Terahertz and Backscatter Indications in the ET-121 Foam Loss Area**

Note NDE was performed before the PAL ramp crushed foam was documented and the sand-and-blend rework performed. No post-RTF rework NDE exists.

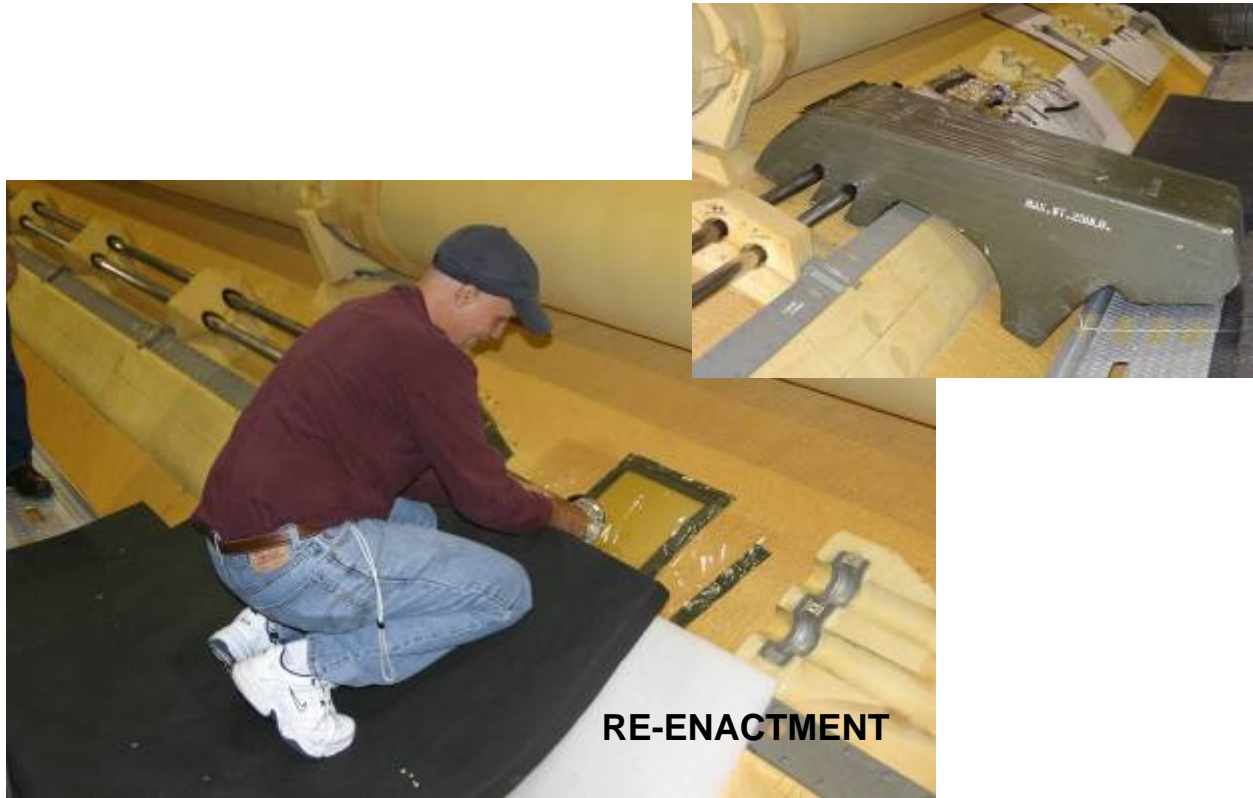
**Figure 6.0-5. Re-enacted Image Demonstrating Tank Re-Work over the PAL Ramp**

The PAL ramps ordinarily are the last major TPS component installed, yet RTF modifications drove extensive work in the immediate vicinity of the lost foam. At least one instance of collateral damage occurred per the NCD noted earlier. Protective mats and bridges were used for access over the LH<sub>2</sub> PAL ramp when the work was done, imparting unknown loads into the BX-265 material (Figure 6.0-5). The ET Tiger Team noted that these protective covers are not configuration-controlled and have not been subjected to rigorous engineering analysis. The PAL Ramp IFA Resolution Team has additional testing planned to better characterize the response of BX-265 and NCFI to loads imparted during processing (Appendix C).

*Mats were used to provide hardware protection during ET-121 RTF rework. Bridge shown in the upper right is a shop-aid used to provide access across the PAL ramp and re-pressurization lines for work on the LO<sub>2</sub> feedline.*

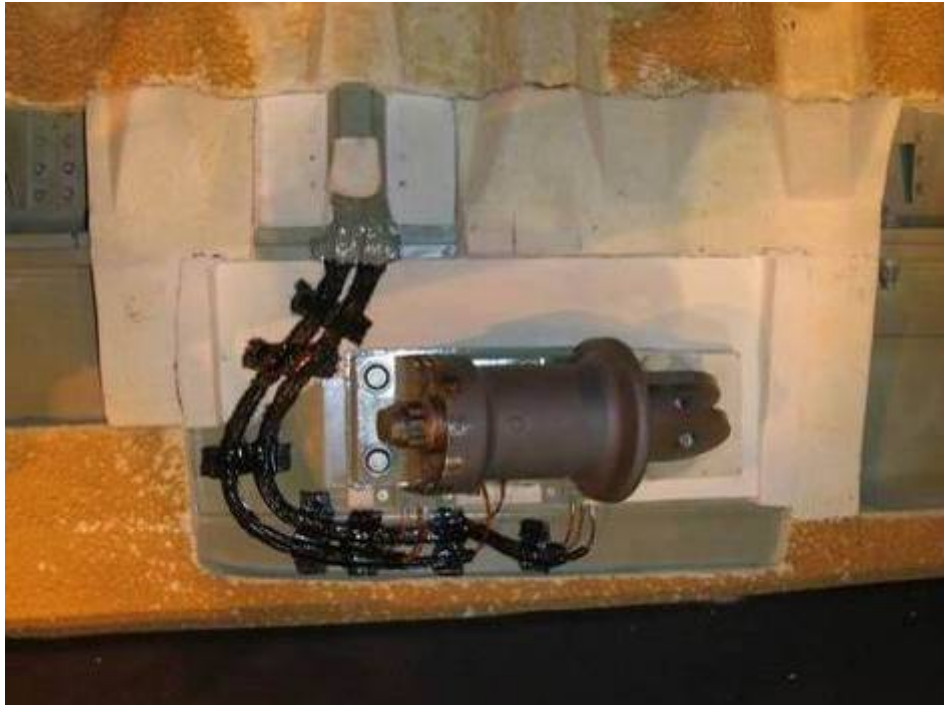
**Figure 7.0-4. Bi-Pod Heater Wire Routing**

A newly-designed ET bi-pod area closeout was implemented on ET-121 and flown for the first time on STS-114. The bi-pod aerodynamic ramps were removed in conjunction with the new design and heaters installed to prevent ice formation during tanking. Wiring for the heaters was routed from each bi-pod spindle along the tank skin, into a stringer, and into the intertank above the flange (Figure 7.0-4). The wiring was secured with an epoxy overcoat and sprayed with BX-265 closeout foam. During thermal/vacuum testing of high-fidelity 3' x 5' bipod test panels required for certification of the redesigned closeout, one to two cracks were noted in the BX-265 during each of 14 cryogenic cycles (ref. 24). The cracks varied from 1/4 inch to 2 inches in length and formed during simulated de-tanking (warm-up) periods. Despite the cracking, no divots were formed during either of two simulated ascent cycles. The cracks were thought to be caused by high thermally-induced TPS stress levels generated as a result of CTE differences between the aluminum substrate, TPS, and other dissimilar materials including primer, adhesives, and wiring. No cracking was observed on ET-121 during either the scrubbed or actual launch attempts. It is worth noting that during the warm-up period of the first tanking test of STS-114 with ET-120, cracks similar to those seen on the test panels were observed.

Two NCDs were recorded. One NCD associated with the final closeout addressed two relatively small surface voids (0.1 in x 0.05 in x 0.05 in deep and 0.5 in x 0.2 in x 0.2 in deep) in the forward cavity, one of which required a repair with a Polymer Development Laboratories (PDL) foam material. The second NCD was associated with the PDL spindle pour trim done prior to final closeout and addressed an area on the forward top surface of the spindle pour that was trimmed 0.1 inch – 0.2 inch too thin. The ET Project’s disposition was to use as-is.

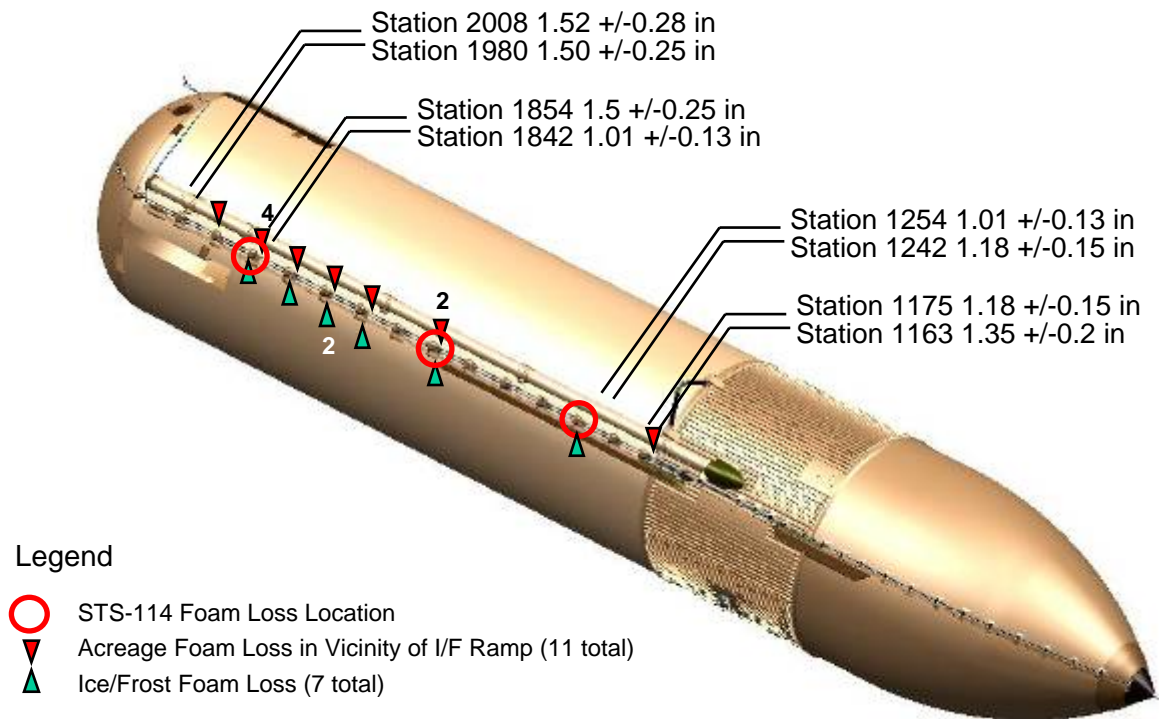
**Figure 9.0-3. Acreage and Ice/Frost Ramp Foam Loss History**

observation that the bi-pod and ice/frost ramp areas of the tank are subjected to a relatively high level of processing traffic; thus, there is high potential for collateral damage. Foam loss at the 1839 location is of special interest in this regard. The ET Tiger Team noted that acreage foam has been lost adjacent to ice/frost ramps a number of times in the past, including at least four times in the immediate vicinity of the 1839 ramp (Figure 9.0-3). Acreage foam in this area decreases from 1.5 to 1.01 inches in thickness, a change which may exacerbate the potential for collateral damage during ice/frost ramp fabrication.

*Acreage foam thickness variations up to 1/2-inch occur in vicinity of the 1851 and 1270 ice/frost ramps.*

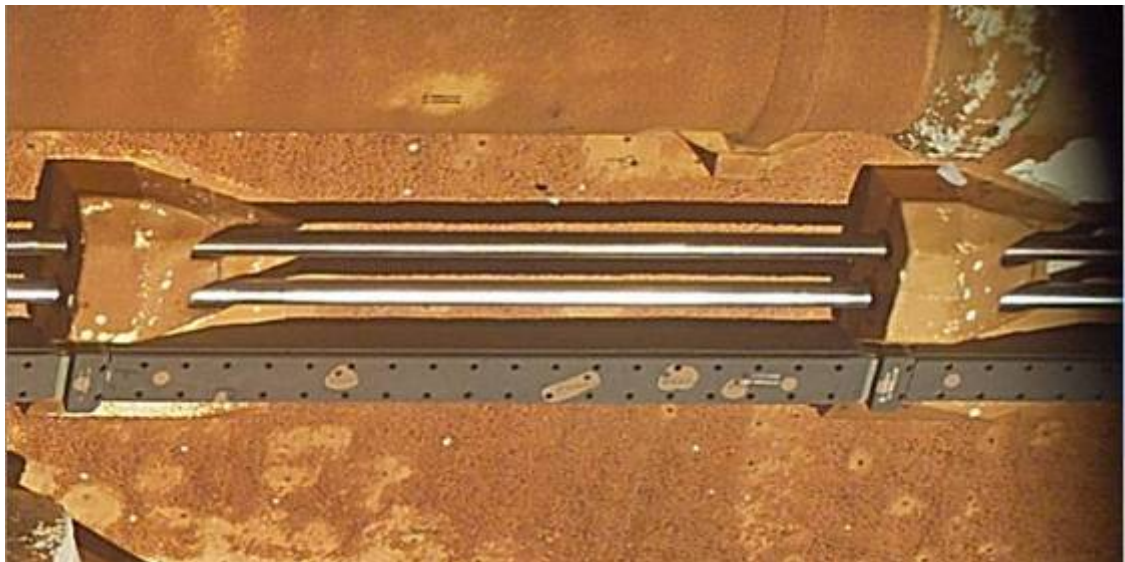
**Figure 9.0-5. STS-114 Acreage Foam Loss in Vicinity of 1851 Ice/Frost Ramp (upper right-hand corner of photo)**

The molds typically leave a visible line where the seal contacts the acreage (Figure 9.0-4). The ET Tiger Team also noted that the STS-114 location 1839 acreage failure has a sharp line coincident with the 1851 ramp (Figure 9.0-5). Variabilities in the molds were also noted, including contact area thicknesses, curvature radius, etc. Molds are not tracked by serial number but by part number, making it difficult – if not impossible – to determine which mold was used to fabricate any specific ramp. The IFA Resolution Teams have testing planned to better characterize the material properties of NCFI and to ascertain what role, if any, damage induced by ice/frost ramp fabrication may play in acreage foam loss (refer to Appendix C).

*Sharp separation line appears to be consistent with ice/frost ramp mold line. Note mold line visible on acreage adjacent to the next aft (1916) ramp.*
