Chandra Flight Note

FLIGHT NOTE NO.	439
SUBJECT	2003:319 Attitude Disturbance
DATE	29 June 2004
AUTHOR	S. Bucher / E. Martin

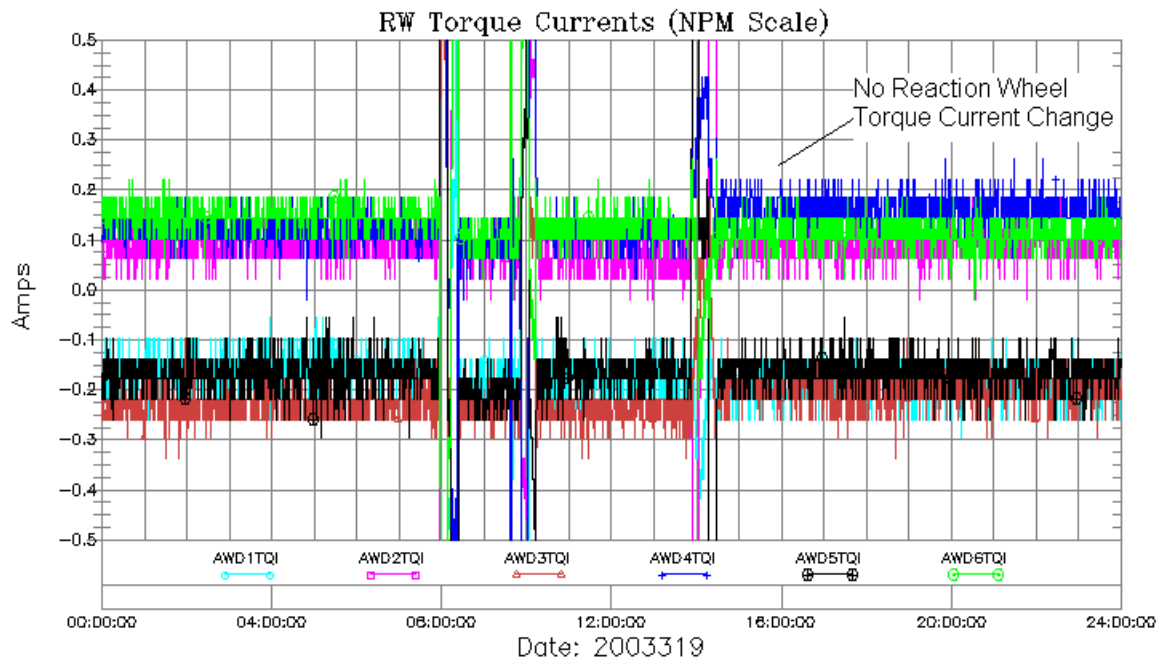
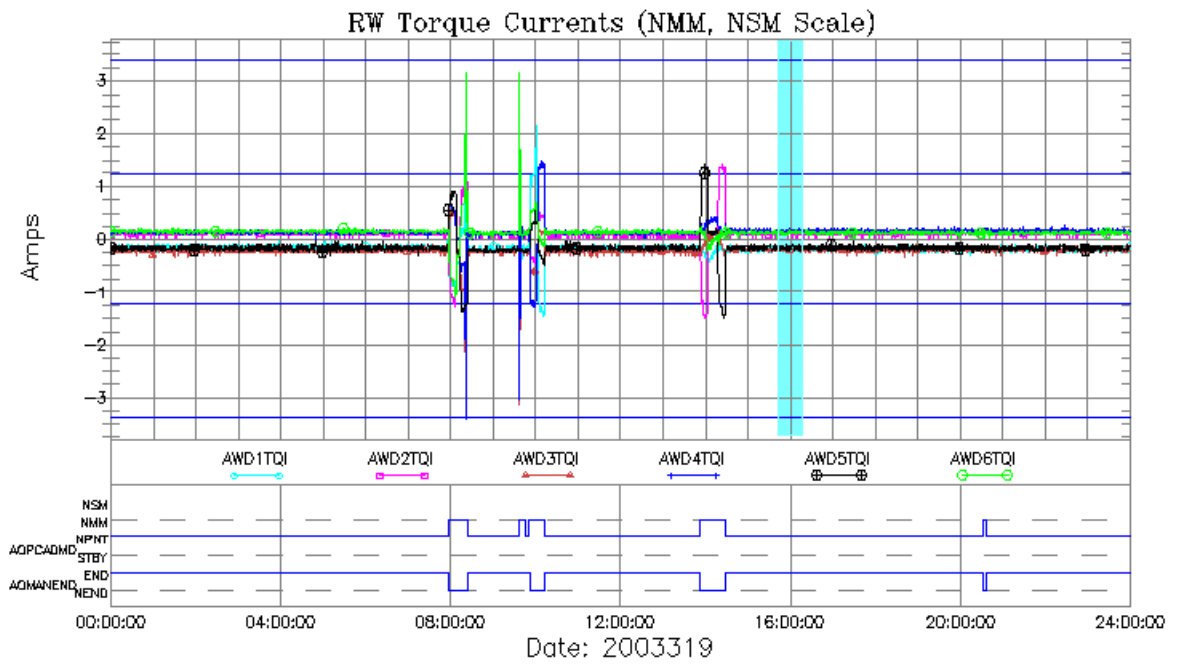
Figure 7: Reaction Wheel Torque Currents

A problem with a reaction wheel would cause degraded pointing performance. The reaction wheel state of health plots showed no problems. Additionally, all of the reaction wheel safing actions (SCSs 17-22) were inactive, not disabled as they would be if one had executed. Finally, the reaction wheel safing actions take a wheel offline and disable the reaction wheel bias, but neither of these actions had taken place.

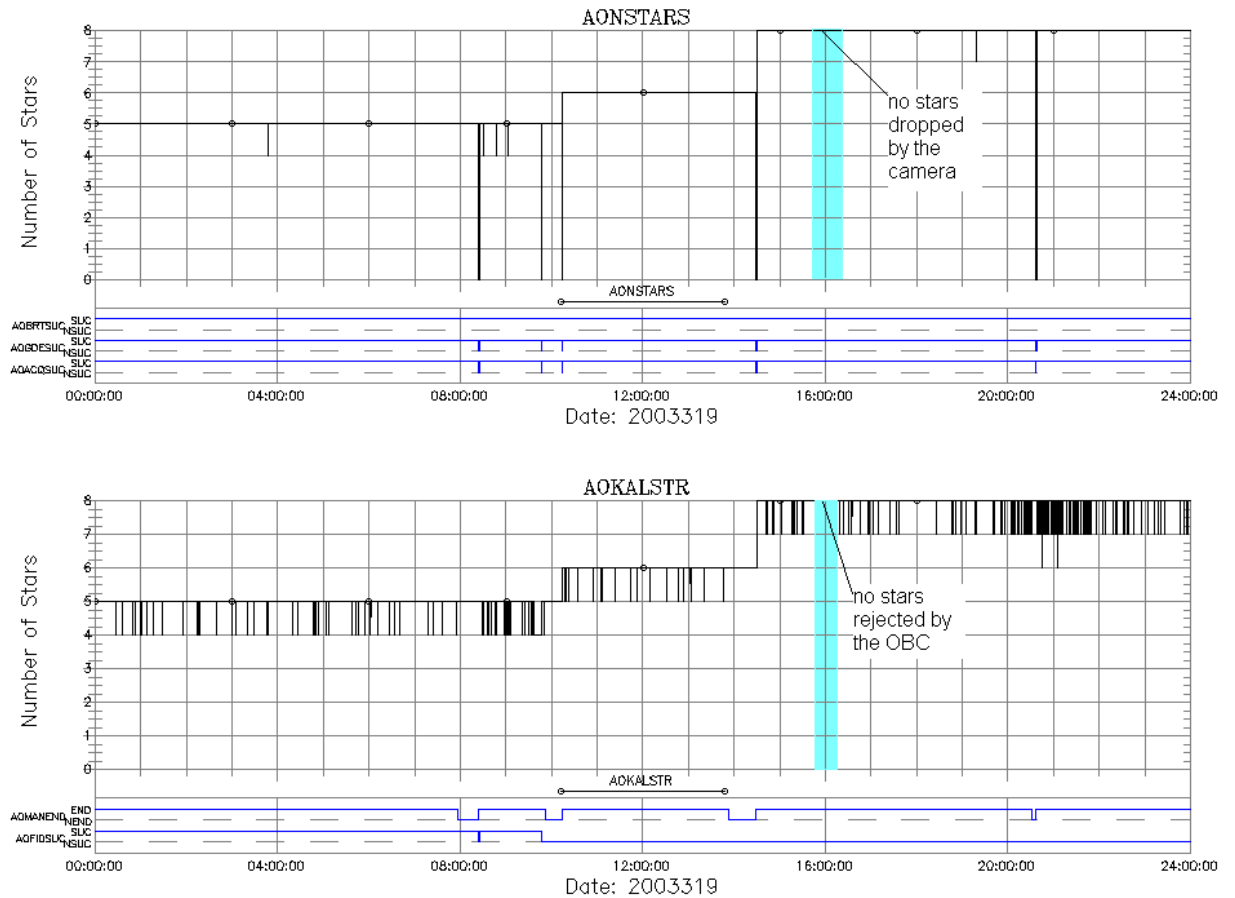
Figure 8: Number of Stars (Camera and OBC)

Stray light in the Aspect Camera can cause an error in the aspect solution, which in turn can cause a spike in the on-board attitude error calculation. This would produce a disturbance in the pointing stability plot. Plots of star positions were used to determine the source of any possible error (**Figure 12**). Due to the nature of the disturbance, if it were caused by stray light in the camera, the source would have to be instantaneous, such as a cosmic ray. A cosmic ray would shift the centroid of only one star. If the attitude were perturbed (exonerating the camera), all of the stars would instantaneously shift in the same direction. The data supported the latter characterization of the event.

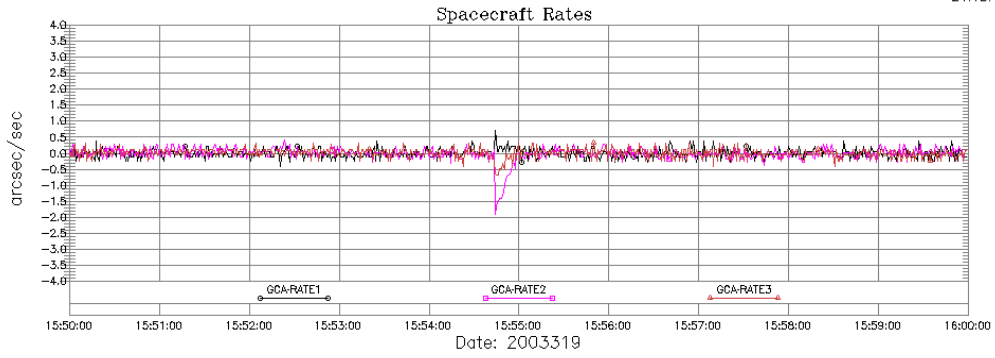
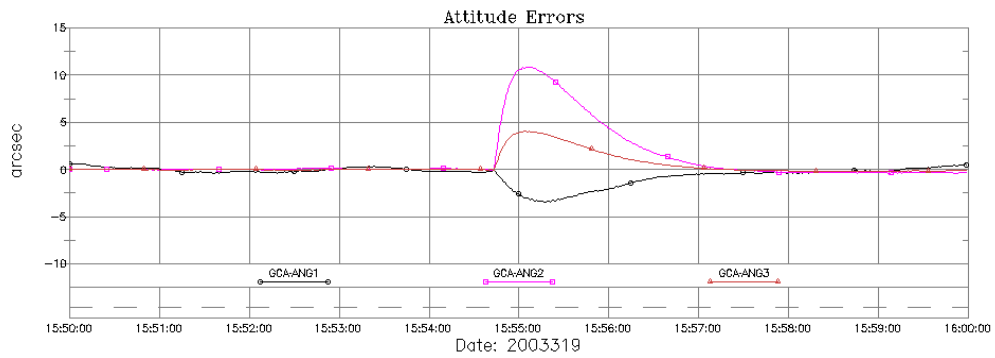
Figure 9: Spacecraft Rates and Attitude Error

Once the daily plots were checked and the usual explanations (in terms of anticipated or unanticipated spacecraft commanding) were ruled out, a more thorough investigation of the telemetry was required. First, the top level PCAD health and status GRETA display (EHS_A_1NOC.dec) was played back for the time period and checked for any unusual behavior. None was found. A plot of the spacecraft rates and attitude errors was used to establish a time and size for the observed disturbance (**Figure 9**). The disturbance occurred at 2003:319:15:54:43 and had a magnitude of approximately 13 arcsec. Along with the rate, the disturbance torque, which is the input to the spacecraft momentum monitor that compares the expected change in momentum from thruster firings to the observed change in the momentum, was checked (**Figure 10**). The disturbance was noticeable, but far too small to trip the spacecraft momentum monitor.
