Engineering Analysis Report

Smoke Detector Operability Survey

Engineering Laboratory Analysis

**Julie I. Shapiro
U.S. Consumer Product Safety Commission
Directorate for Engineering Sciences
Division of Engineering Laboratory**

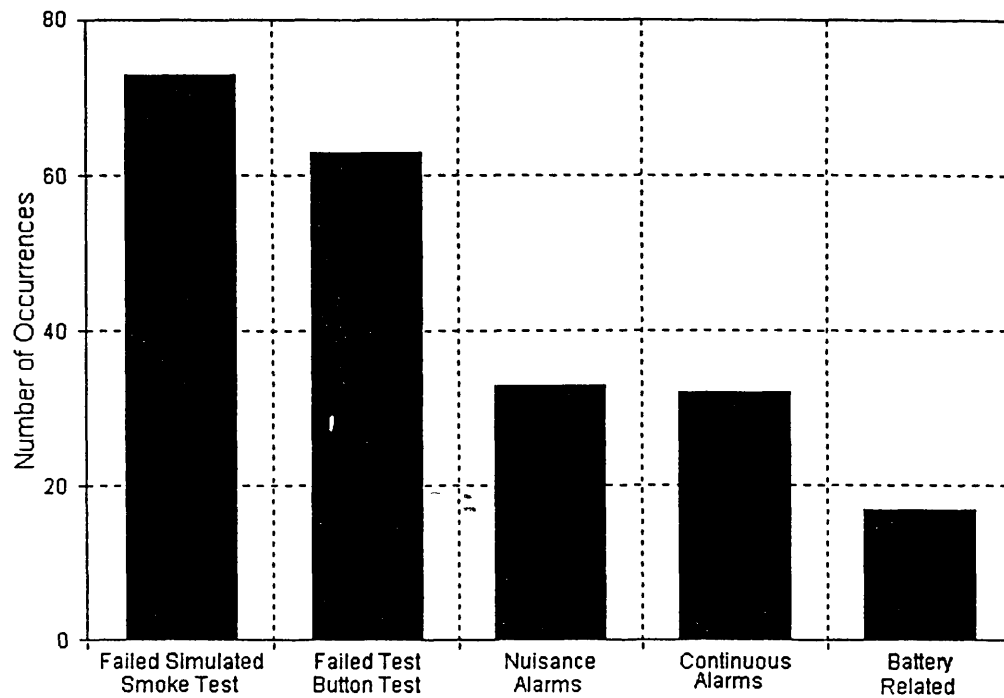
Four samples did not fit in the necessary profile and were excluded from the analysis, bringing the total number of samples for evaluation to 155. In Figure 1, the various reasons for sample collection are shown. Units collected during the field assessment for more than one reason are tallied in multiple categories. For instance, if the smoke detector failed the Simulated Smoke Test and the Test Button Test in the field, and the consumer complained of excess nuisance alarms, the detector would appear in three different categories in Figure 1.

Figure 1. The Reasons for Sample Collection by the Field Interviewer (n=155).
(Smoke Detectors were collected for multiple reasons causing the total to be greater than 155.)

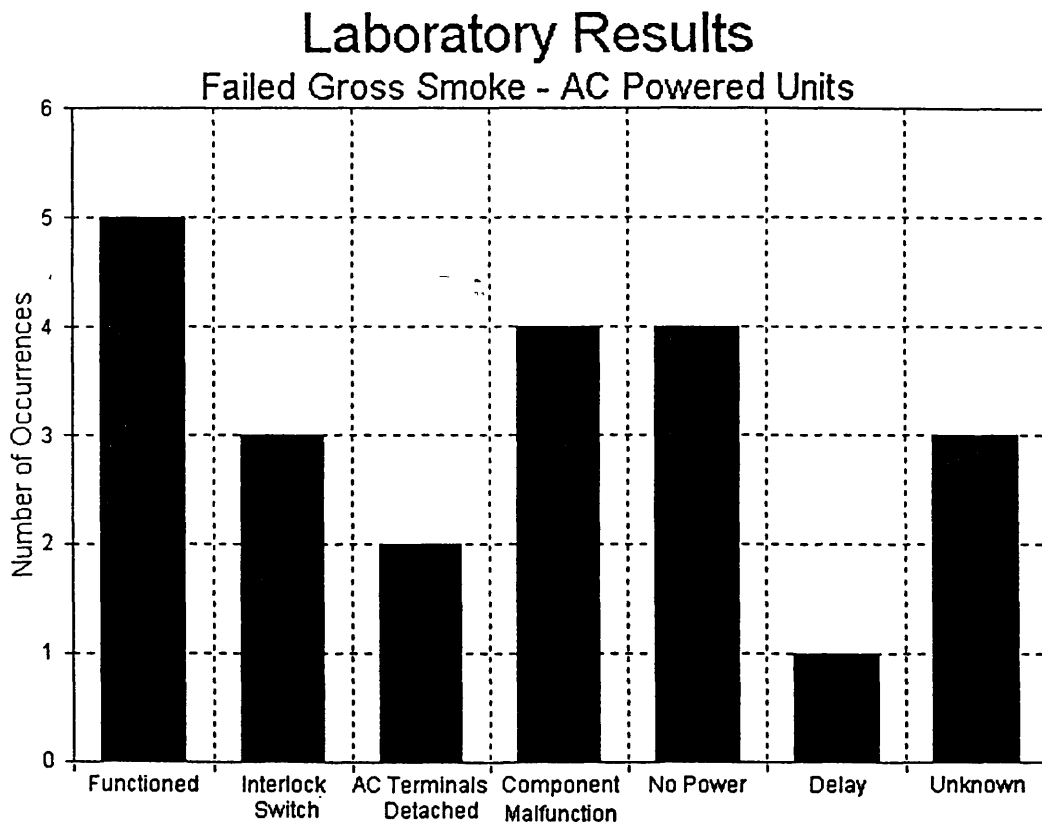
The reasons for Gross Smoke Test failure (see Figure 2) discovered by the Engineering Laboratory are:

- Three units were missing covers, which made them inoperative because of an interlock switch that activated the detector when its cover was in place.
In the laboratory, using the appropriate covers, one detector was operable and two sounded continuously. After a thorough cleaning of the detectors that sound continuously, one behaved appropriately, and one continued to alarm. Further investigation of the latter sample is required.
- Two units' AC input terminals were intentionally detached from the circuit board.
Both detectors functioned properly and passed all tests satisfactorily after reconnecting the input wires.

Figure 2. Laboratory Results for AC Powered Detectors Collected for Simulated Smoke Test Failure (n=22).

- Four units had defective components.

In another smoke detector, the power dropping resistor failed and overheated. The heat generated by the resistor melted the solder connection for the resistor and it became detached from the circuit board causing the unit to fail the Gross Smoke Test.

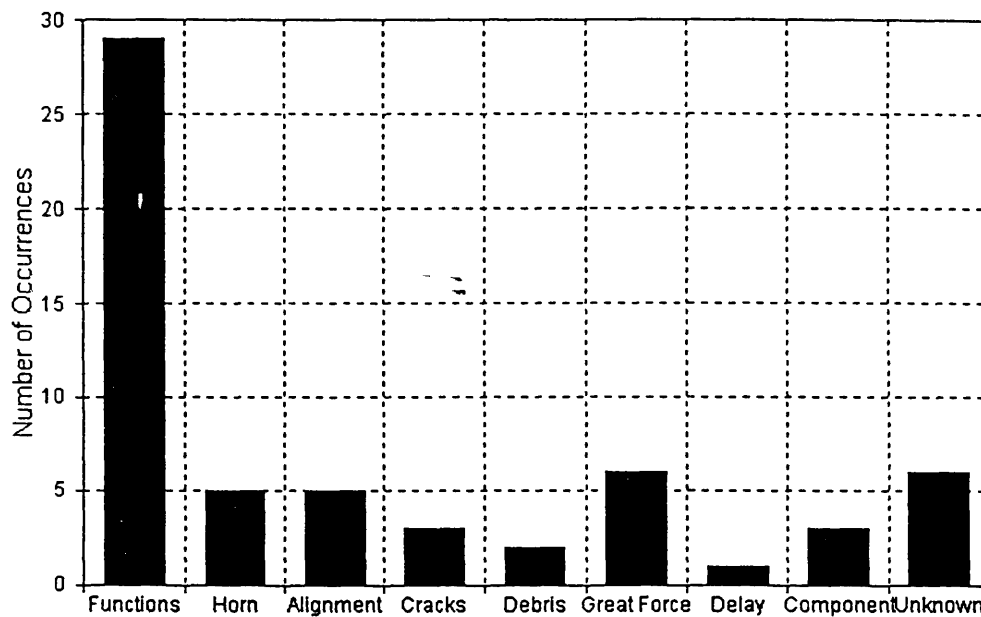
Sixty-three smoke detectors were collected for failing the Test Button Test in field testing. Three detectors did not have a test button and were improperly collected for failing the Test Button Test. Twenty-nine of the 60 smoke detectors evaluated for failing the Test Button Test functioned properly when tested in the Engineering Laboratory. Ten smoke detectors that functioned properly in the Laboratory had insects and debris in the unit and the sensing chamber of the smoke detector that may have caused failure during field testing. Debris, which may have caused failure in the field, could have been dislodged during shipment, resulting in a fully functional test button.

Figure 4. Laboratory Results for Detectors Collected for Test Button Test Failure (n=60).

The remaining 31 cases divide into eight categories involving horn contact deterioration, electrical component failure, physical flaws, test button contact difficulty, and other complications. The reasons for failure of the Test Button Test are summarized in Figure 4 and described below.

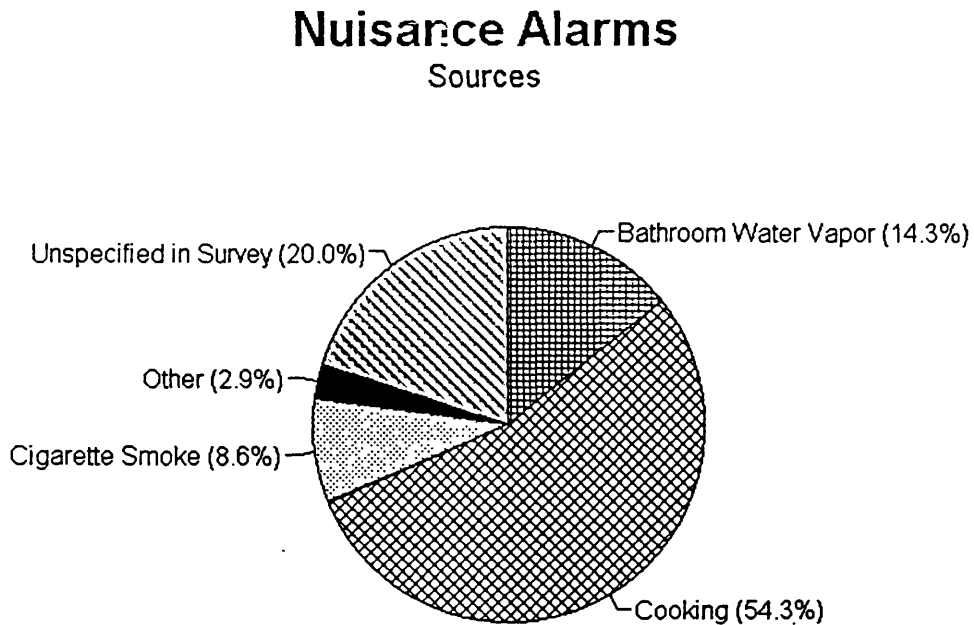
The Smoke Detector Operability Survey showed that many of the detectors in consumers' homes sounded due to cooking smoke, bathroom water vapors, tobacco smoke and other non-threatening sources of air-suspended particulate. Thirty-three detectors were collected and sent to the Laboratory for examination because the consumer believed there was a problem with the detector. In 32 of the detectors collected, the power had been disconnected by the consumer because of nuisance alarms. Figure 5 shows a breakdown of the sources of nuisance in the respondents' homes.

Figure 5. Sources of Nuisance Alarms from Collected Samples (n=33).

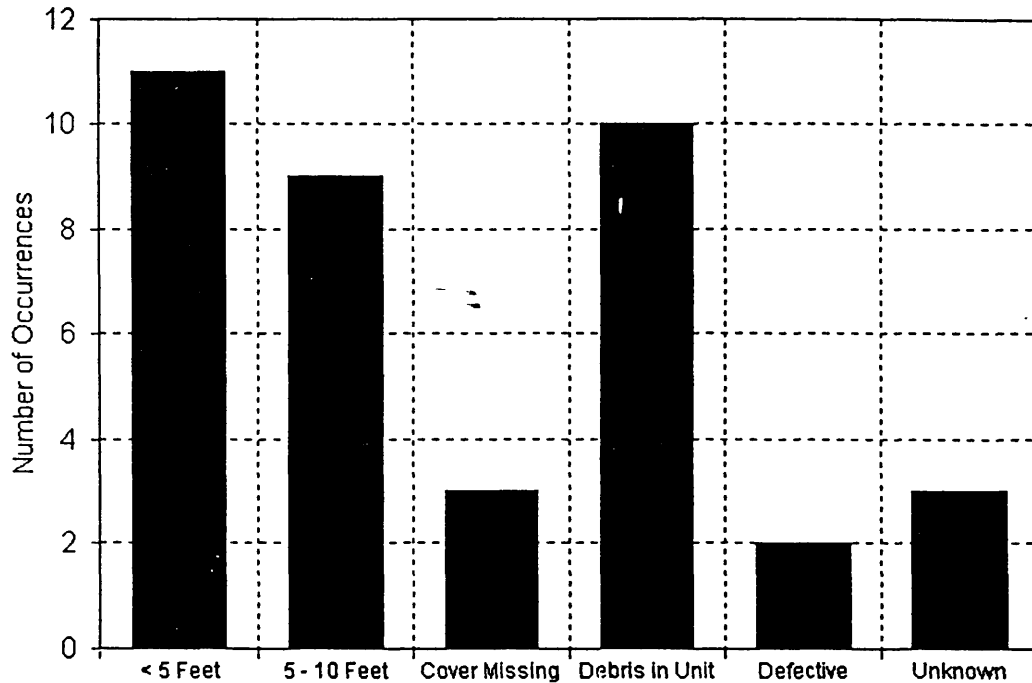
In Figure 6, the causes for frequent nuisance alarming were divided into categories determined by evaluating the smoke detectors in the Laboratory. The evaluation included reviewing the questionnaire survey responses, making visual observations of the units and testing the smoke detectors in the UL 217 Sensitivity Testing Chamber. Some units fell into more than one category. For example, one detector in which the "toaster set it off every morning," was located in the kitchen three feet from the toaster. The Sensitivity Test showed that this detector was highly sensitive, 0.66% ob/ft (2.15% ob/m). A combination of the location and the extreme sensitivity of the detector contributed to the frequent occurrence of nuisance alarms.

Figure 6. Reasons for Nuisance Alarms for Samples Collected (n=33).
 (Smoke Detectors were collected for multiple reasons causing the total to be greater than 33.)

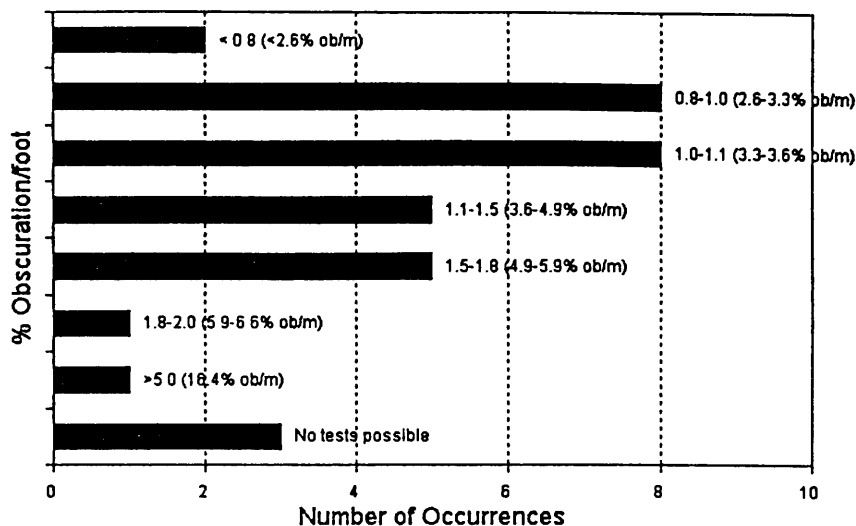
The detectors collected in the Survey were placed in the UL 217 Sensitivity Test Chamber to determine at what smoke obscuration level the detector responded. Three units collected for excessive nuisance alarming could not be tested in the UL 217 Sensitivity Test Chamber because of various malfunctions in the detector. The remaining 30 smoke detectors' sensitivity values are displayed in Figure 8. Further discussion on the sensitivity issue appears in the "Discussion" section of this report.

Figure 8. Sensitivity Levels of Smoke Detectors collected for Nuisance Alarming (n=33).

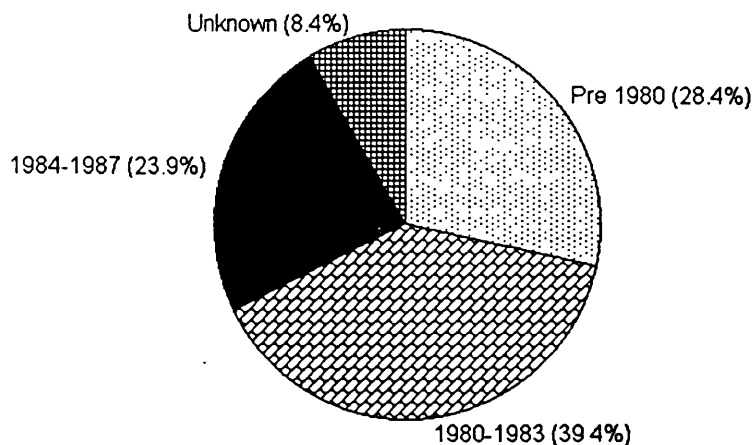
Figure 10 shows that detectors collected in the Survey have UL Release Dates prior to 1987. This information suggests that newly manufactured smoke detectors are much less likely to malfunction or have excessive nuisance alarms. Over time the detector's components can malfunction and their sensitivity can be altered by the household environment.

Figure 10. UL Release Date of Detectors Collected as Inoperable (n=155).
