MEMS reliability in shock environments

Danelle M. Tanner, Jeremy A. Walraven, Karen Helgesen, Lloyd W. Irwin,
Fredrick Brown, Norman F. Smith, and Nathan Masters

Sandia National Laboratories, P.O. Box 5800, MS 1081, Albuquerque, NM 87185-1081
http://www.mems.sandia.gov
email: tannerdm@sandia.gov

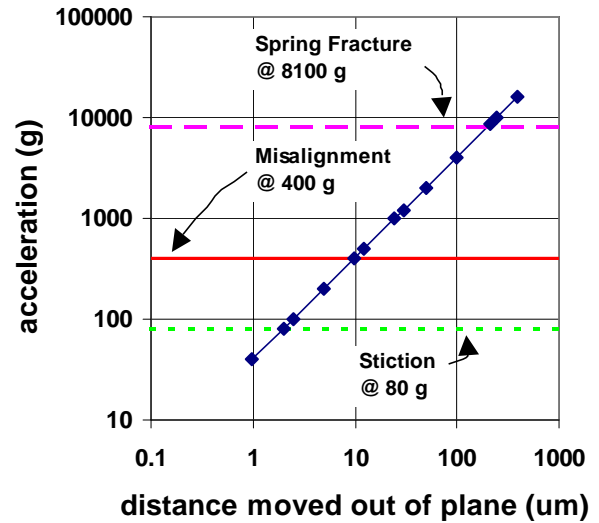
A large shock from the top could allow the massive shuttle and combs to rise in relation to the substrate. The springs are free to bend giving rise to misalignment and with a large enough shock could produce a spring fracture. Misalignment can occur when the combs and shuttle move away from the substrate by roughly 10 μm from a shock of 400g. Using equation (6), a force of 21 μN would break an individual spring beam. Because we have four springs, the force is distributed implying that we may see spring fracture at 84 μN or 8100g.

A shock from the bottom could push the shuttle, combs and springs down into the substrate. For stiction to occur, the beams must flex only 2 μm towards the substrate, which could be achieved by a shock of 80g. A plot of the deflection equation (3) is shown in Figure 3 for accelerations of interest. Also shown on the plot are possible failure modes.

Figure 3. The plot shows where the problem accelerations may arise. Air-damping effects were ignored.
