# **Critique of Electric Shock Incident at X1**

**September 10, 2004**

**Nicholas F. Gmür and W. Robert Casey**

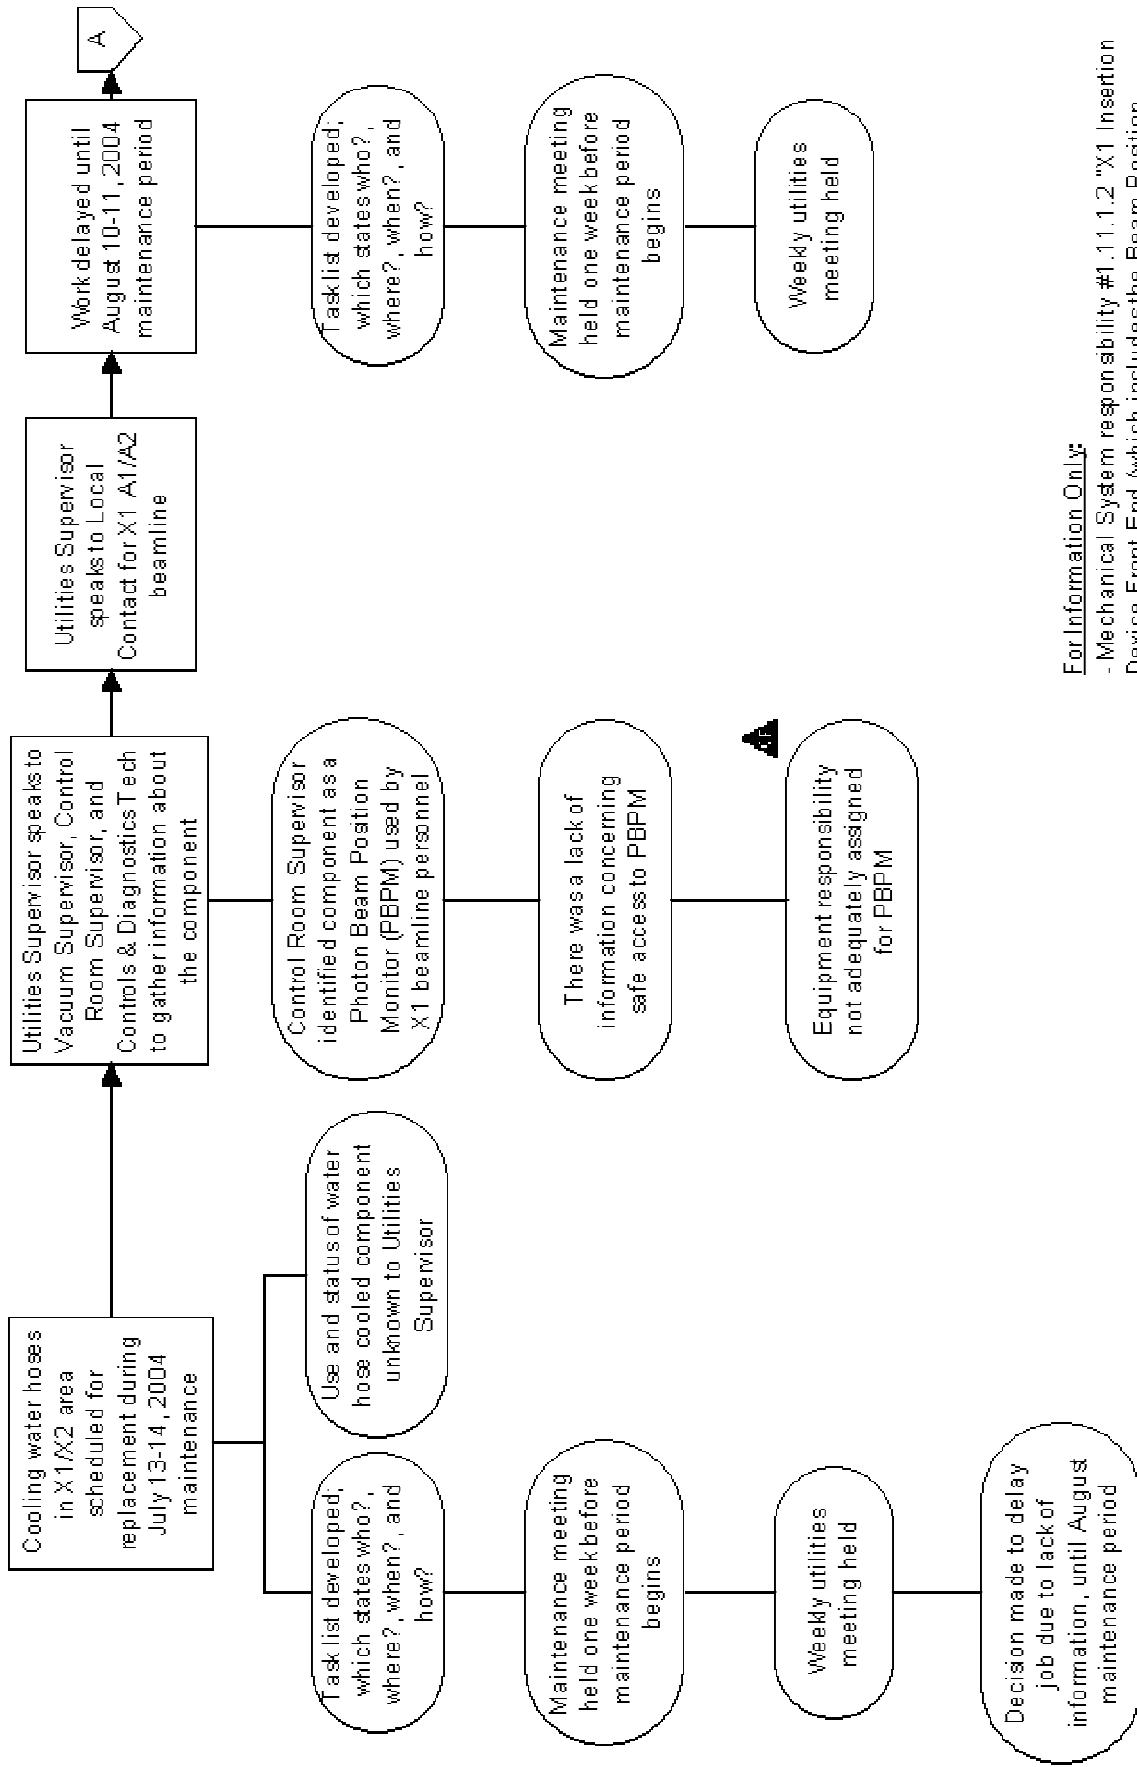
## X1 Electrical Shock Incident at NSLS

- Mechanical System responsibility #1.1.1.2 "X1 Insertion Device Front End (which includes the Beam Position Monitor)" lacks engineer/technician name.
- PBP/M not listed in any other Responsibilities List.
- Stony Brook label on power supply.

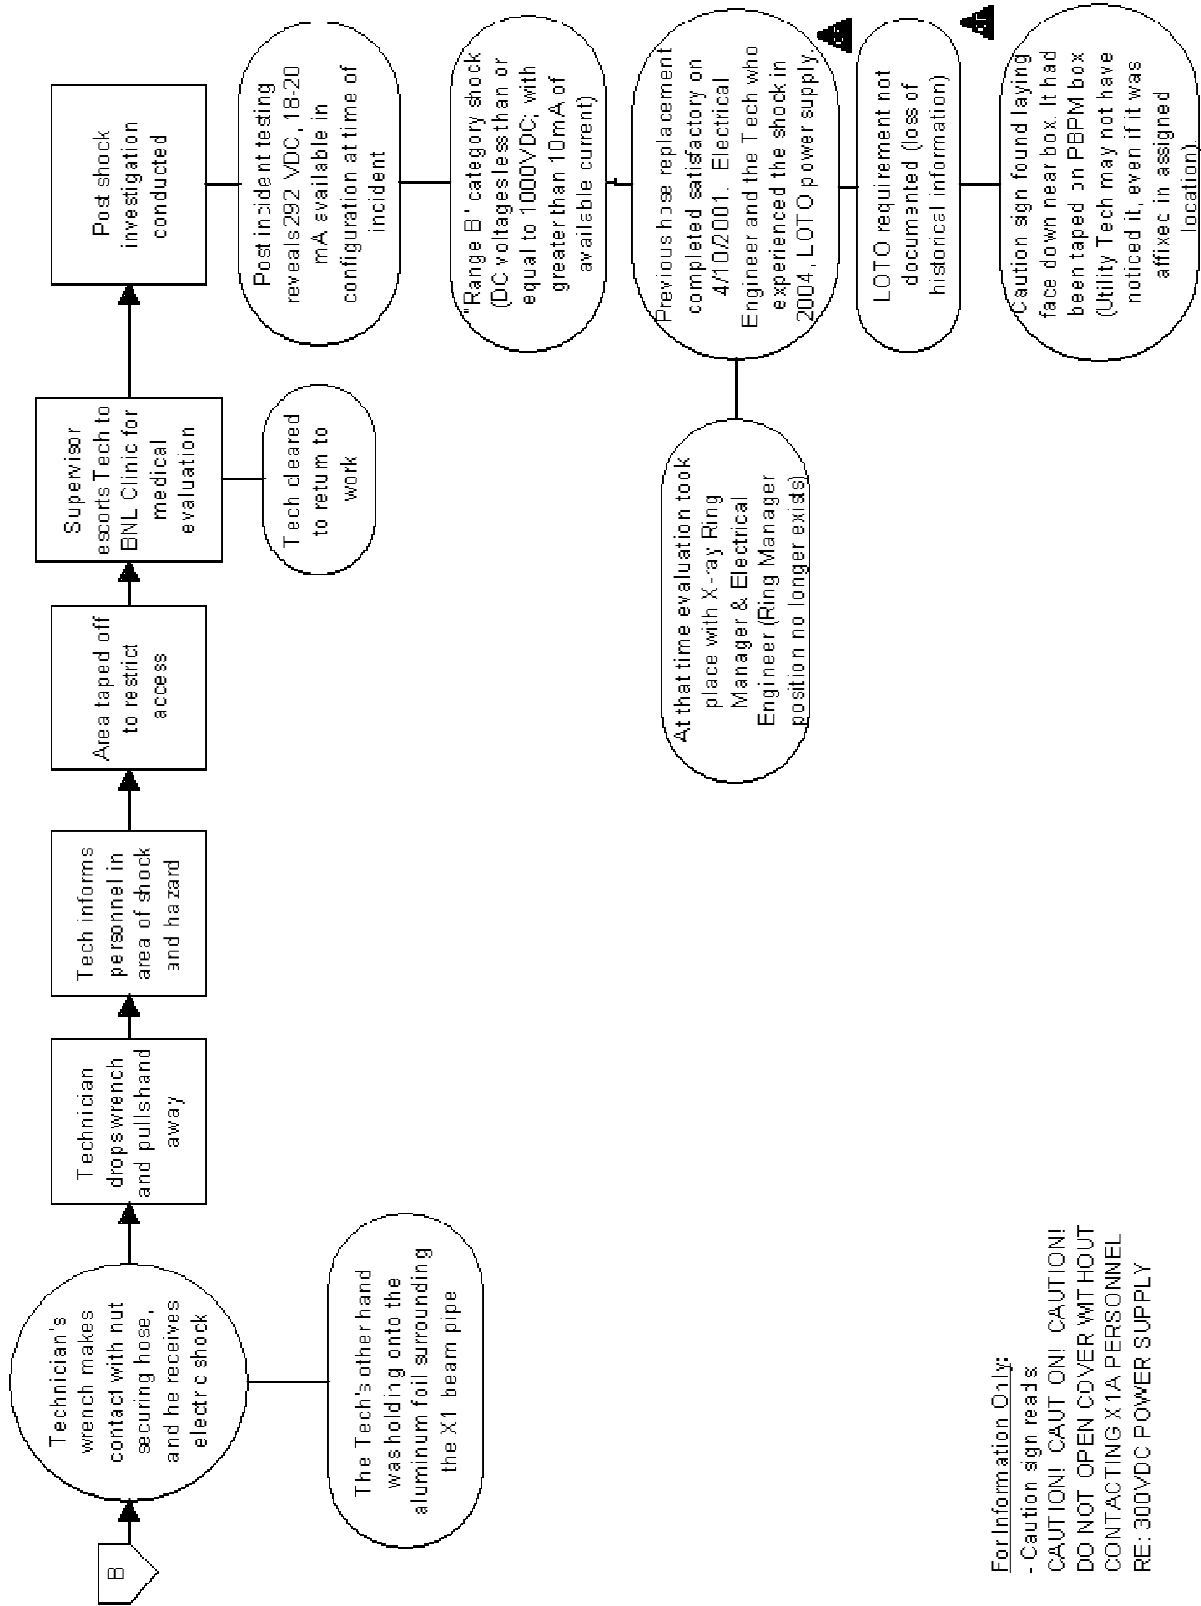
For Information Only:  
 - Caution sign reads:  
 CAUTION! CAUTION! CAUTION!  
 DO NOT OPEN COVER WITHOUT  
 CONTACTING X1A PERSONNEL  
 RE: 300VDC POWER SUPPLY
