7.4.6 Coaxial Transfer Switch Fails

7.4.7 Failure to Establish UHF Link Between the Lander and Mars Global Surveyor

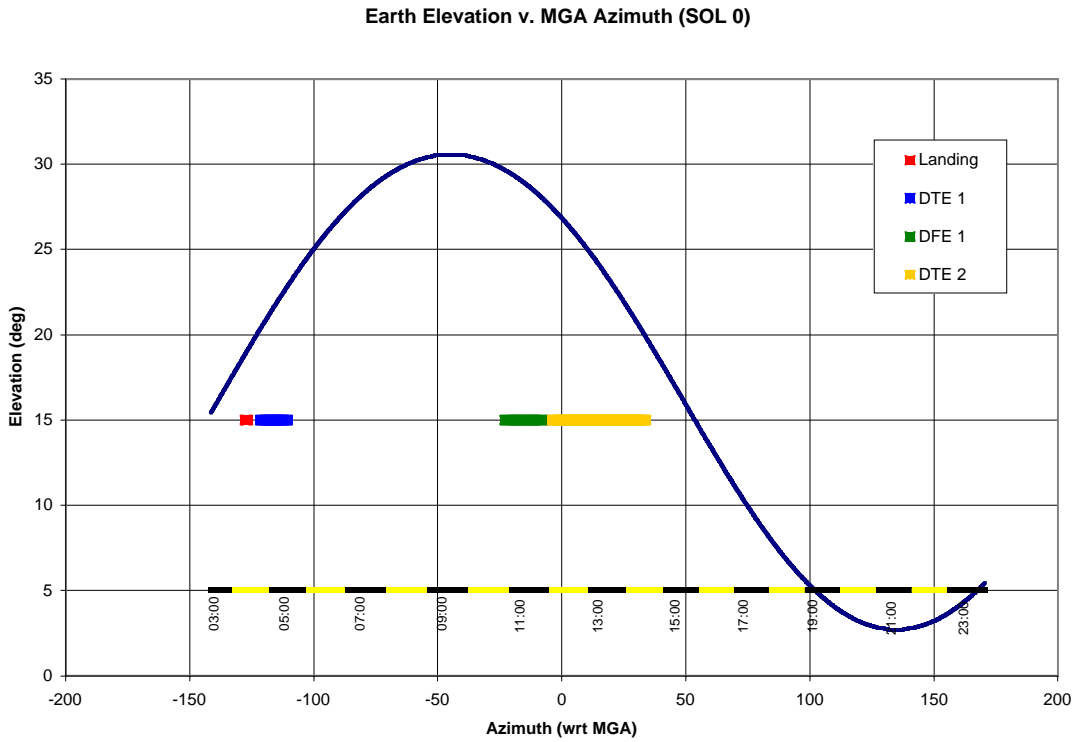
Figure 7-5. Earth Geometry for the Nominal Landing Orientation and Site on Sol 0

The LGA is fixed and pointed at the approximate center of the nominal Earth azimuth range. In elevation, the LGA boresight is pointed approximately 43 degrees above the lander deck and the nominal horizon line. The mean Earth elevation angle is approximately 17 degrees above the horizon. In the worst-case azimuth orientation (180-degree error), the mean Earth would be 120 degrees off boresight. At 7.8125 bps, an uplink can be received by the spacecraft at up to 135 degrees off boresight. So there is at least a chance of getting an uplink into the spacecraft in the worst-case azimuth orientation. However, since Earth is frequently at lower than mean elevation, it is probably more realistic to consider a region of ± 16 degrees (elevation error) around the worst-case landing azimuth error to be a “command blind” zone.

There is a landed orientation in which an X-band uplink cannot be established through the MGA or the LGA. Precluding the establishment of an uplink path requires either a malfunction of the gyro compassing function or a severe rotation of the lander at touchdown.
