# Operating Experience Summary

U.S. Department of Energy  
Office of Environment, Safety and Health  
OE Summary 2006-10  
August 25, 2006

### Equipment Labeling Error and Inadequate Zero-Energy Check Result in Electrical Arc Flash

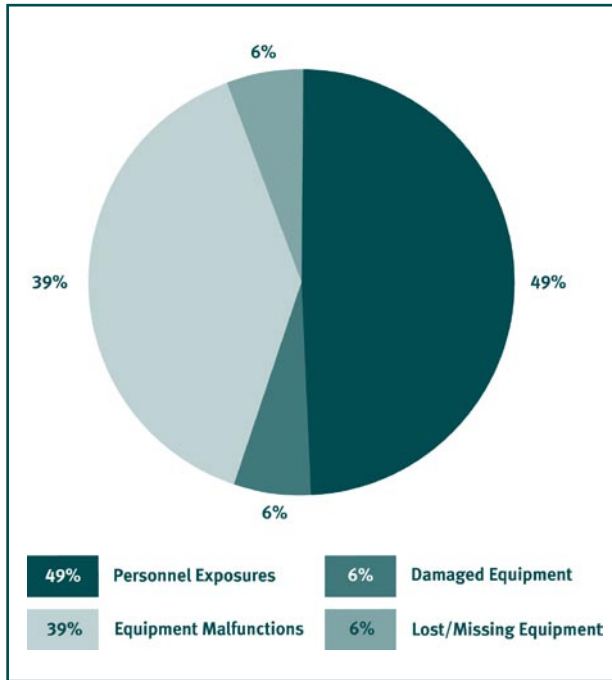
Figure 2-2. NRC-reported radiography events (2006)

A review of the NRC event notification database showed 18 reported events involving radiography so far in 2006 (Figure 2-2). Almost half of these events resulted in personnel exposures, followed closely by events involving radiographic equipment malfunctions.

- Crank cable housing came loose while moving the device;
- Source stuck in extended position and failed to retract;
- Disconnected source pigtail; and
- Crimped source tube.

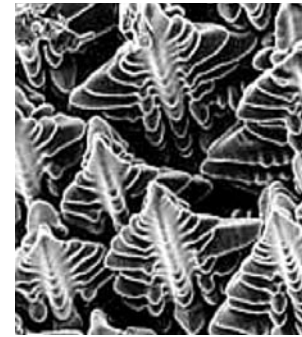
**Figure 3-4. Dendrites**

Metal whiskers differ from the more commonly known dendrites (from the Greek word for "tree"), not only by their shape and orientation, as shown in Figure 3-4, but also by the mechanism that forms them.

Dendrites form in damp environments when metal ions dissolve and are then redistributed in the presence of an electromagnetic field. Although the precise mechanism for metal whisker formation remains unknown, it is known that whisker formation requires neither metal dissolution nor the presence of an electromagnetic field.
