Egyptian Delegation Presentation

# Flight MS 990 Accident

April 28, 2000

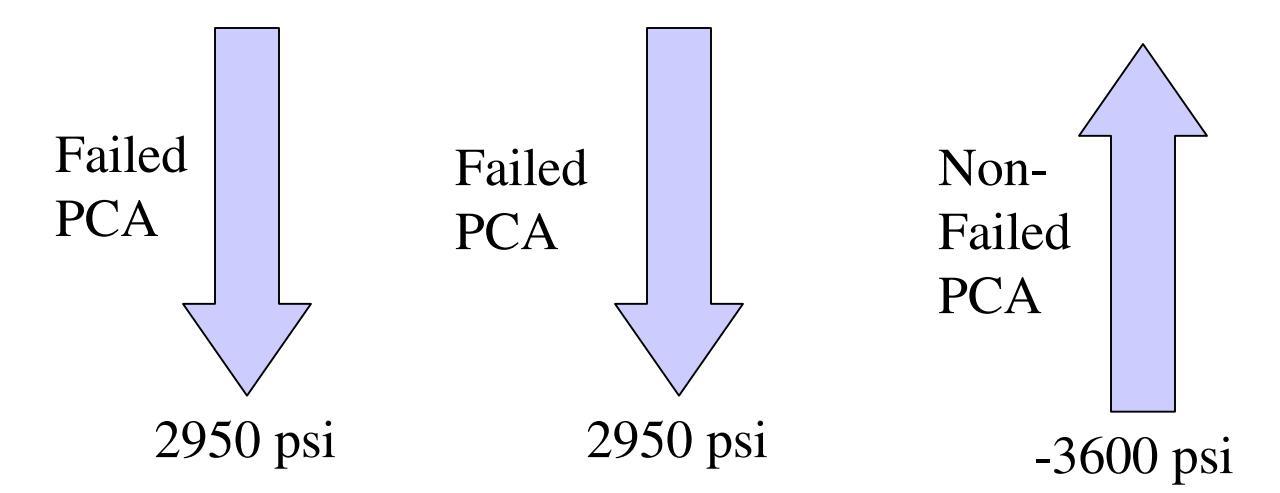
In all cases of dual PCA failure on one side(either jamming, disconnect or combined jam and disconnect), the two failed PCA's will be fighting against the non failed PCA Normal system press is 3000 psi, system return press 50 psi, non failed PCA relief press is 3600 psi

The effective force acting on the elevator is (2950 psi + 2950 psi - 3600 psi) \* PCA area = 2300 psi \* area = 0.77 PCA

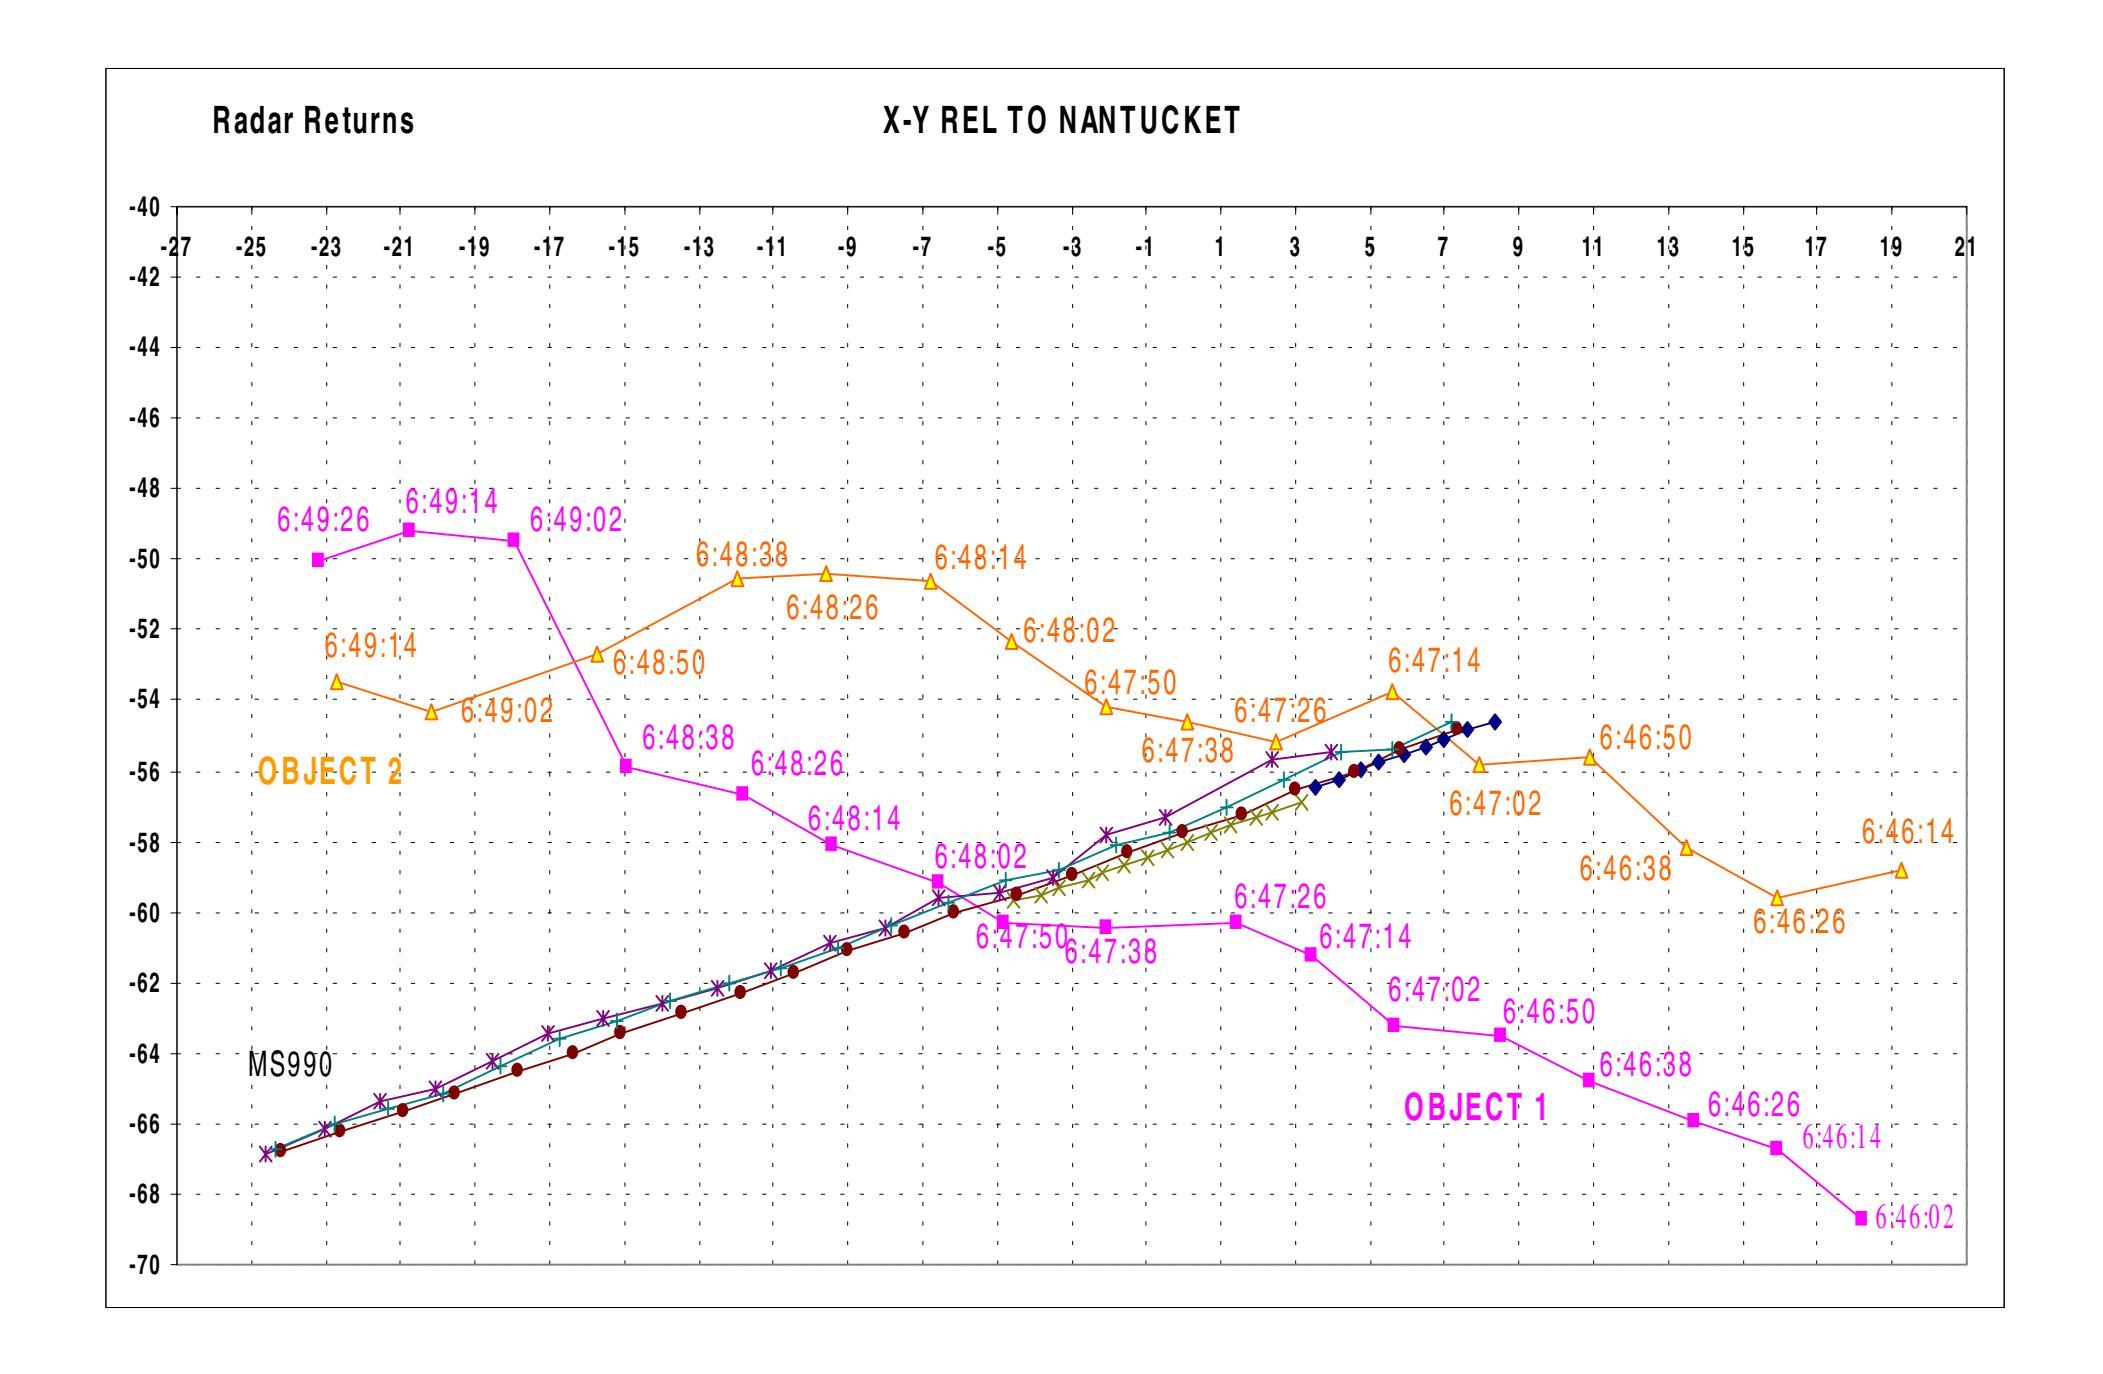
Radar Returns

- Returns data have been obtained from four radar's stations:
  - ARSR-4 AT Riverhead, NY (RIV)
  - ARSR-4 at Gigsboro, NJ (GIB)
  - ARSR-4 AT North Truro,MA (NOR)
  - ASR9 at Nantucket, MA (ACK)
- Radar data provides two types of returns:
  - Beacon (supported by airplane transponder)
  - Primary (not supported by airplane transponder)

- Many of the unidentified returns formed continuous flight paths. These targets were travelling generally from East to West at a high ground speed.
- The altitude of the targets is not identified
- The continuous flight paths of the unidentified returns crossed the path of MS990 several times
- At this time, the only explanation for these returns are :
  - 1- They are caused by an unknown phenomenon that is unique to that location over the ocean

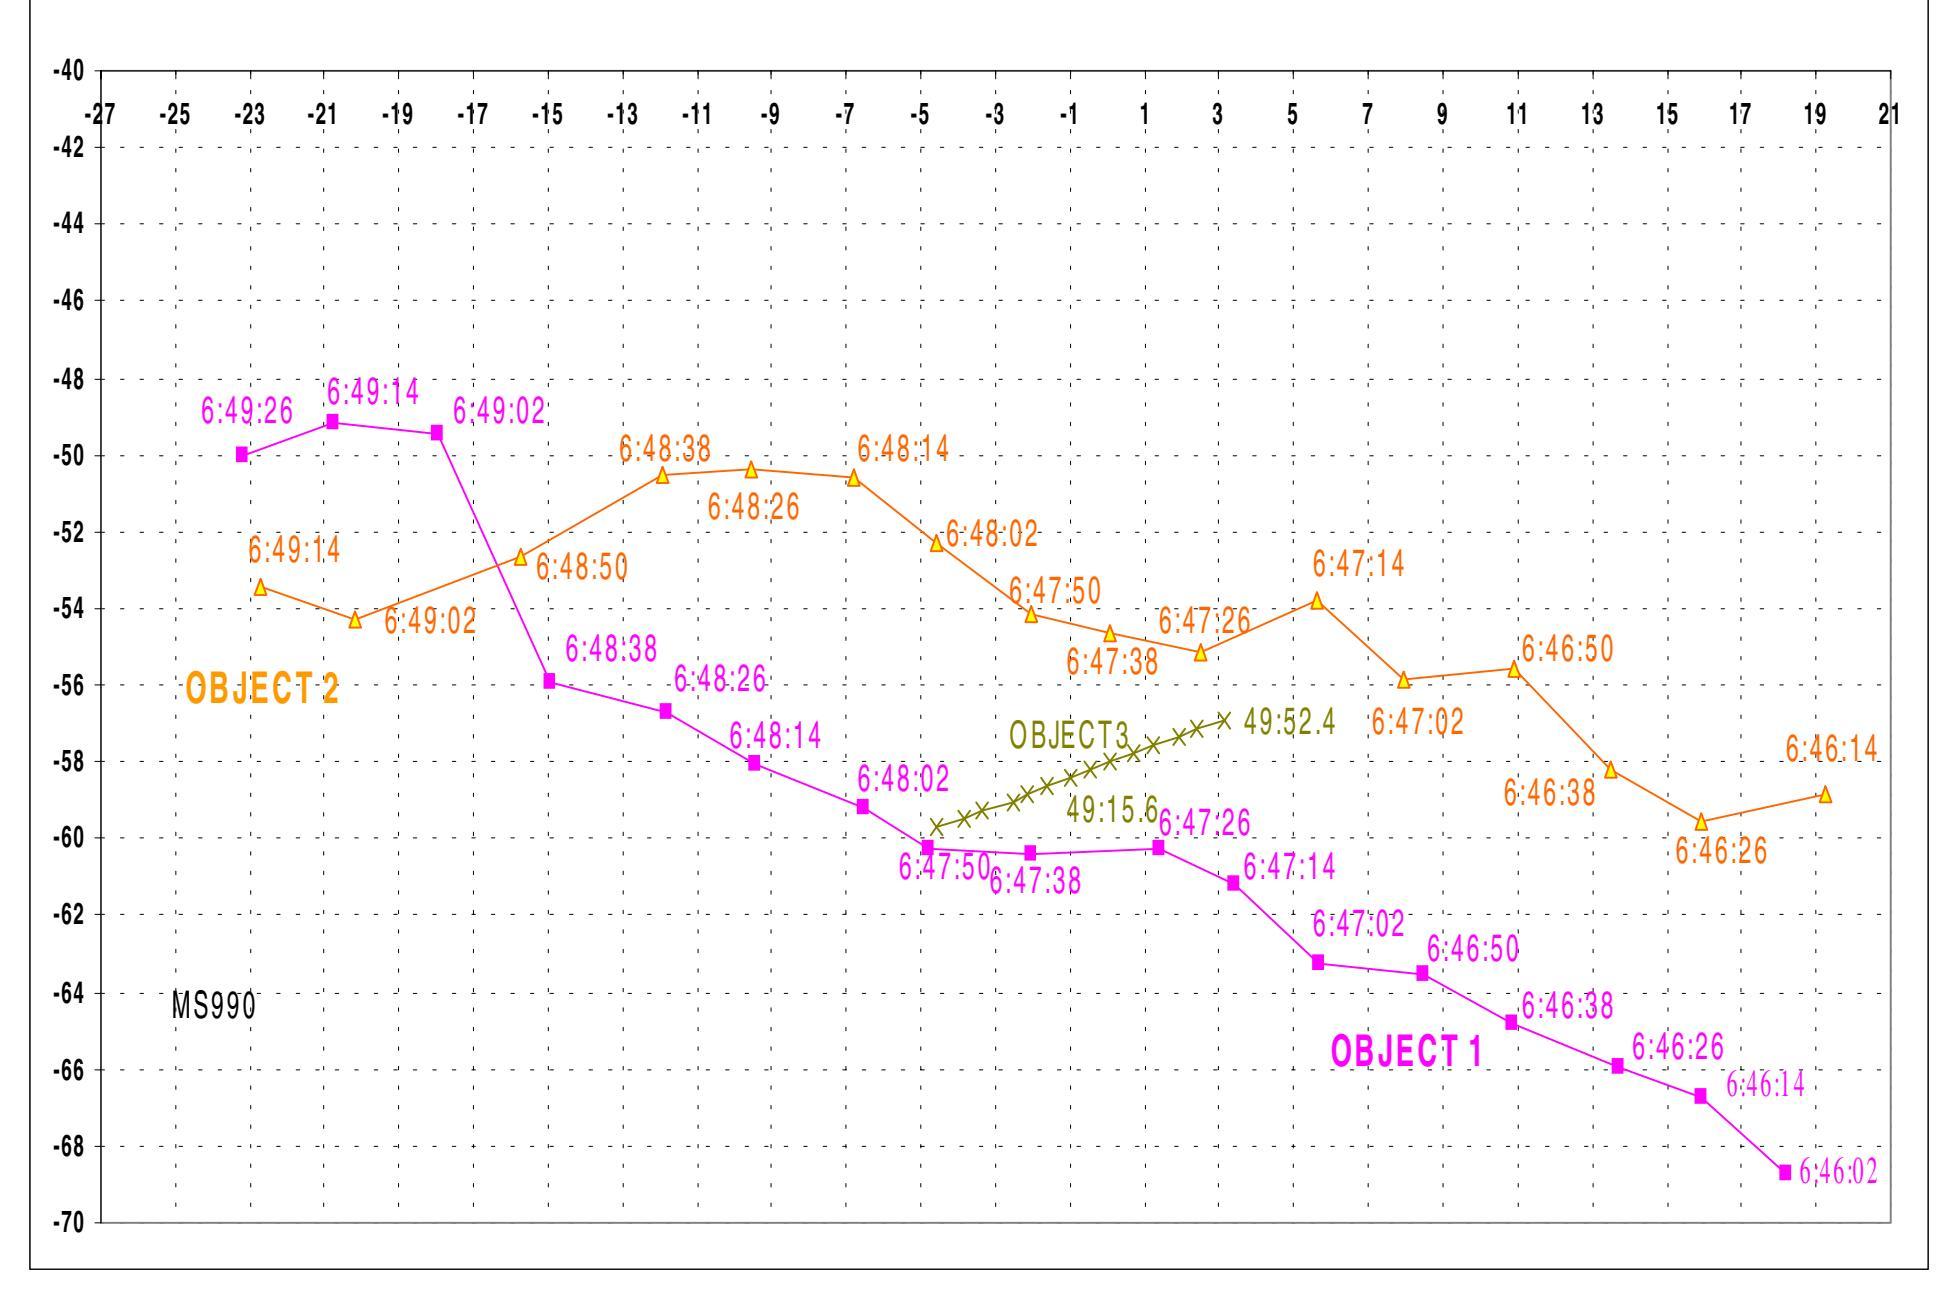
Egypt Air 990 Track Plots

- 2- They were caused by real airborne objects
- Further information is requested from NTSB to continue the analysis.
