OCT 15 2004

**Type B  
Accident Investigation Board Report  
On the August 25, 2004  
Head Injury to Miner  
Waste Isolation Pilot Plant  
Carlsbad, New Mexico**

**Type B  
Accident Investigation Board Report  
of the August 25, 2004  
Head Injury to Miner  
at the  
Waste Isolation Pilot Plant  
Carlsbad, New Mexico**

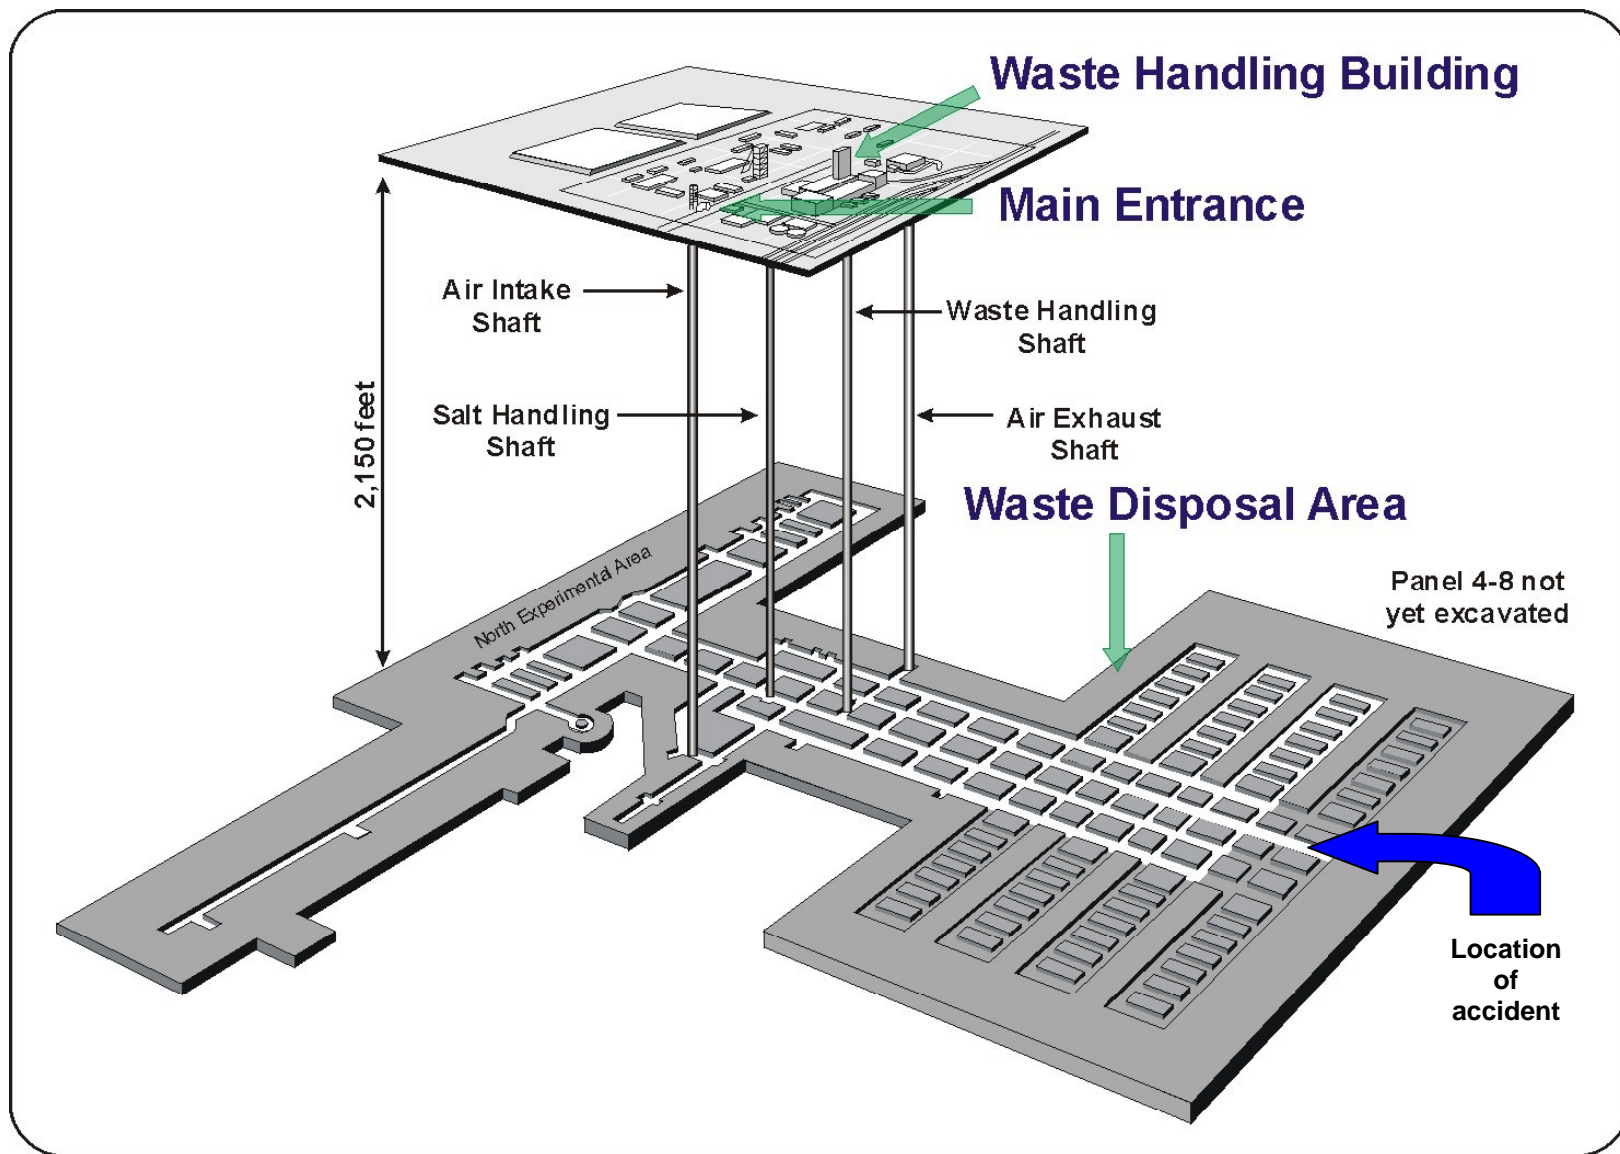
Figure 1: Location of the accident scene

Vertical shafts, including the waste shaft, the salt handling shaft, the exhaust shaft, and the air intake shaft, extend from the surface to the underground horizon as shown in Figure 1. These shafts are lined from the shaft collar to the top of the salt formation, approximately 850' (259m) below the surface, and are unlined through the salt formation.

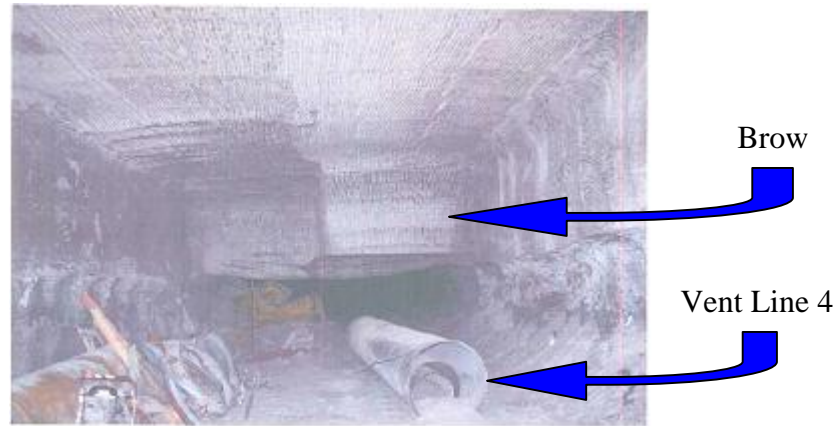
**Figure 2: Looking South in Drift E-140**

On August 23<sup>rd</sup>, members of the MRT and underground operations personnel performed a walk down of the work area. The area under the brow, the point where the mine ceiling steps down to the lower level (Figure 2), where abandoned materials and equipment were located was not entered during the walk down.

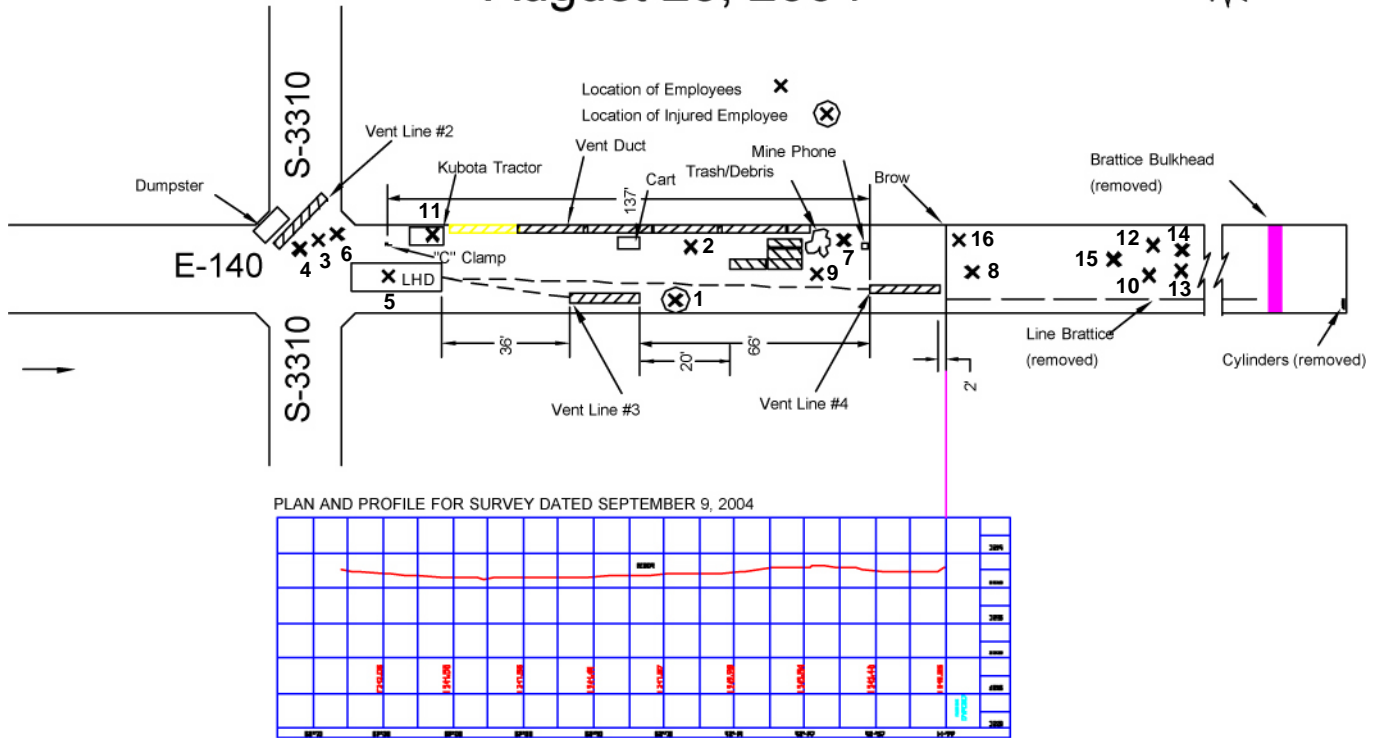
**Figure 3: Schematic of Drift and Elevation Map**

Figure 3 depicts the work site where the accident occurred. It illustrates the various objects present at the site, and shows the number identifying each worker at the work site and their positions at the time of the accident.

# E-140 Drift S-3310 to S3650 August 25, 2004

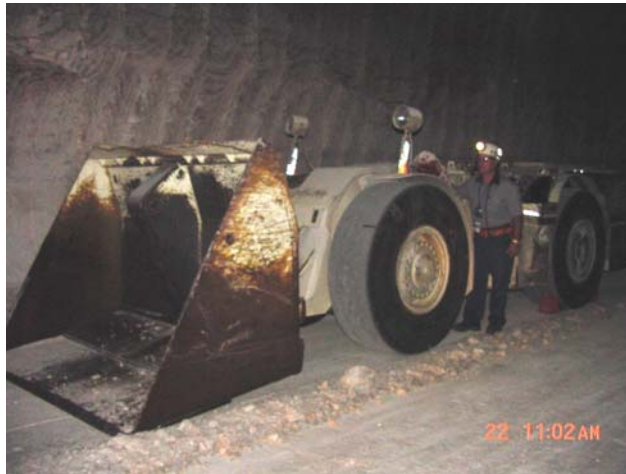
**Figure 8: Example of an LHD**

At approximately 8:15 am, MGC-1 directed E5, to bring a Load Haul Dump (LHD), Figure 8, for moving nested metal vent line sections. Employee 8 (E8) and MGC-1 discussed using C-clamps as handles rather than pipe wrenches, but this was not communicated to MRT members under the brow. When the ordered LHD had not arrived by 8:30 am, MGC-1 left the worksite to check on its status. It was unclear to workers not under the brow, who was in charge when MGC-1 left the worksite area.

Vent Line 3 reached the brow, and the Kubota tractor being used to pull it lost traction and bogged down. It was decided that the tractor was unable to pull the vent line further. The LHD (Figure 8), operated by E5, which was much heavier and more

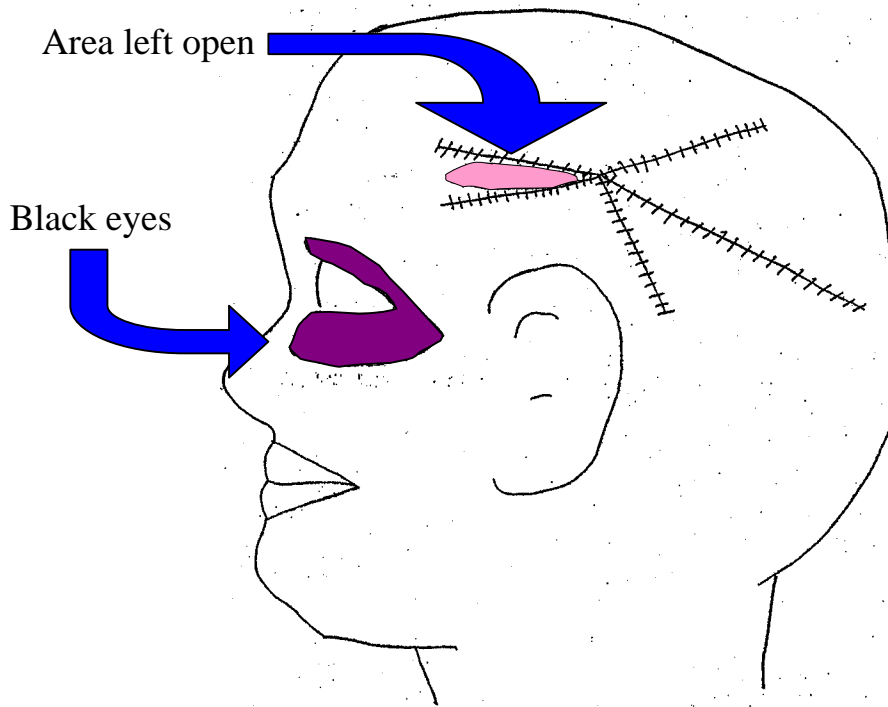
**Figure 13: Closure of Wound**

Upon arrival at the surface, E1 was assessed by the Site Occupational Nurse, assisted by EMT and EST personnel. E1 was found to be alert, reasonably oriented, and asking for a cigarette repeatedly. E1 had no idea of what had hit him, how badly he was hurt or how long it had been since the accident. However, his overall mental state seemed within normal limits, as far as event recall before and after the accident. The nurse performed a brief secondary survey and found no other indication of injury other than his head. Trauma protocols were applied and E1 was loaded in the ambulance. The emergency dressing applied by responders underground, which was a tee shirt supplied by a coworker, was removed. The wound was a full thickness starburst laceration encompassing the entire left side of the head. The T-shaped wound (top of T) extended from the left temple to approximately 5cm from midline on the back of the head. The top of the T was full thickness, rolled into a flap towards the top of his head. The posterior section of the wound was flayed into 4 or 5 "fingers" of flapped flesh rolled towards the back of the head. Each "finger" was rolled either up or down as it deflected towards the back. Approximately 10-12 cm of skull was plainly visible (Figure 12 prior to medical treatment, Figure 13 post treatment). There appeared to be no indication of fractures; however, the skull was discolored near the front leading edge of the wound. Bleeding was moderate at that time. The nurse and EMT irrigated the wound with sterile normal saline, approximated the wound edges as well as possible and applied sterile dressings. His vital signs and level of consciousness were stable at this time.
