Marine Accident Report

Collision Between the U.S. Coast Guard Patrol Boat *CG242513* and the U.S. Small Passenger Vessel *Bayside Blaster*, Biscayne Bay, Florida January 12, 2002

**NTSB/MAR-02/05
PB2002-916405
Notation 7454A
Adopted December 17, 2002**

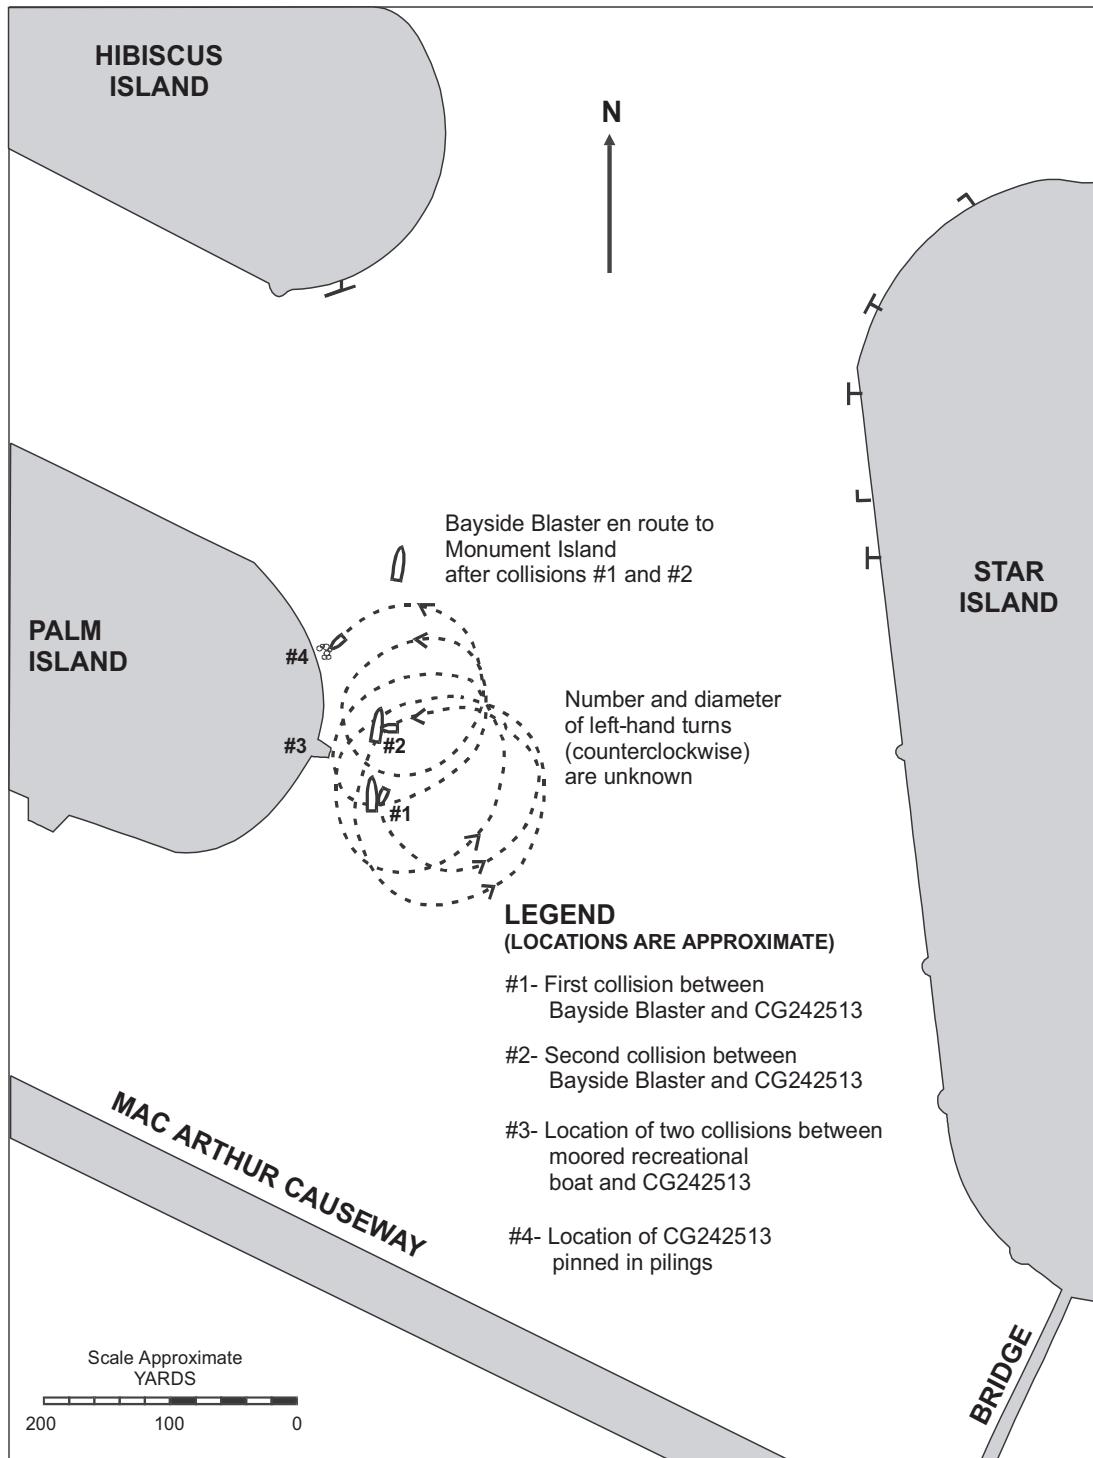
Meanwhile, the Coast Guard patrol boat continued turning in counterclockwise circles toward the east side of Palm Island. Twice, the Coast Guard patrol boat struck a 46-foot recreational boat moored bow-out at a dock on Palm Island. The Coast Guard patrol boat's T-top struck the bow pulpit of the recreational vessel during the first collision. The T-top was knocked over and dragged on the port side of the Coast Guard patrol boat. According to witnesses on shore, the patrol boat began making very small left-hand circles with the T-top dragging (attached to the boat by engine control cables and electrical wiring) in the water. At 2035, about 20 minutes after it first collided with the *Bayside Blaster*, the Coast Guard patrol boat hit pilings on the northeast side of Palm Island. It was wedged into the pilings by a Florida Fish & Wildlife Conservation Commission (FWC) boat and a Miami Beach Police Department boat that had responded to the emergency (see figure 5). The officers managed to shut down the patrol boat's engines (figure 6 shows the patrol boat after the accident). See "Emergency Response" section for further details.

Figure 5. Possible track of the Coast Guard patrol boat from the time it collided with the *Bayside Blaster* to the time it was secured to pilings on Palm Island (for illustrative purposes only).

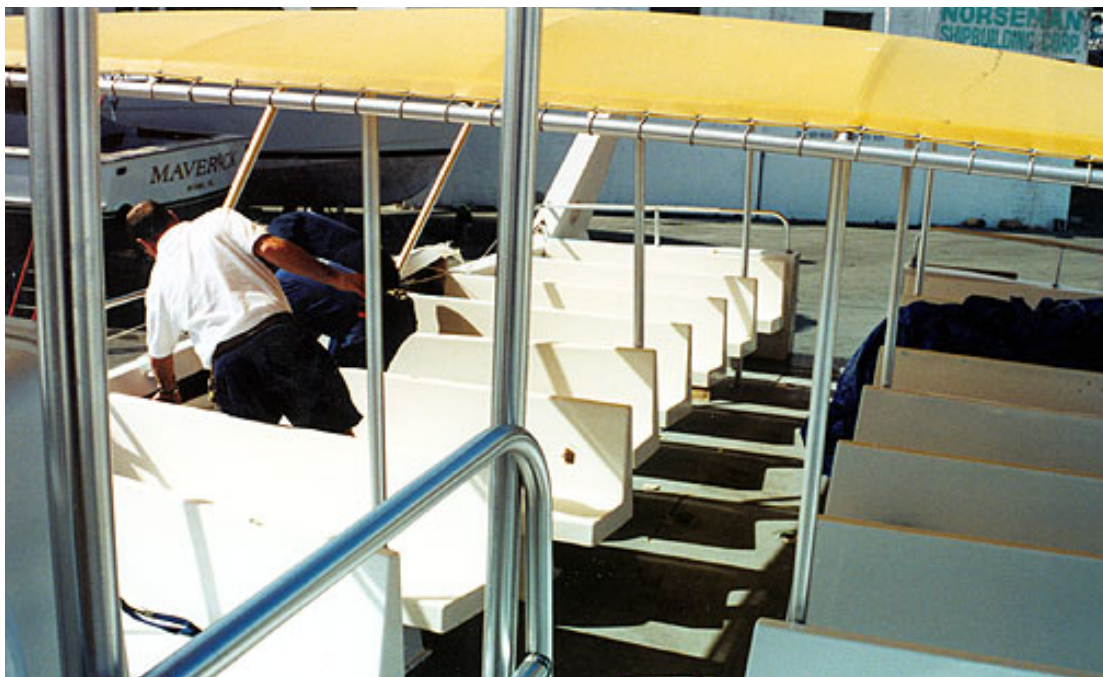
Figure 11. *Bayside Blaster* seating, looking aft from steering station.

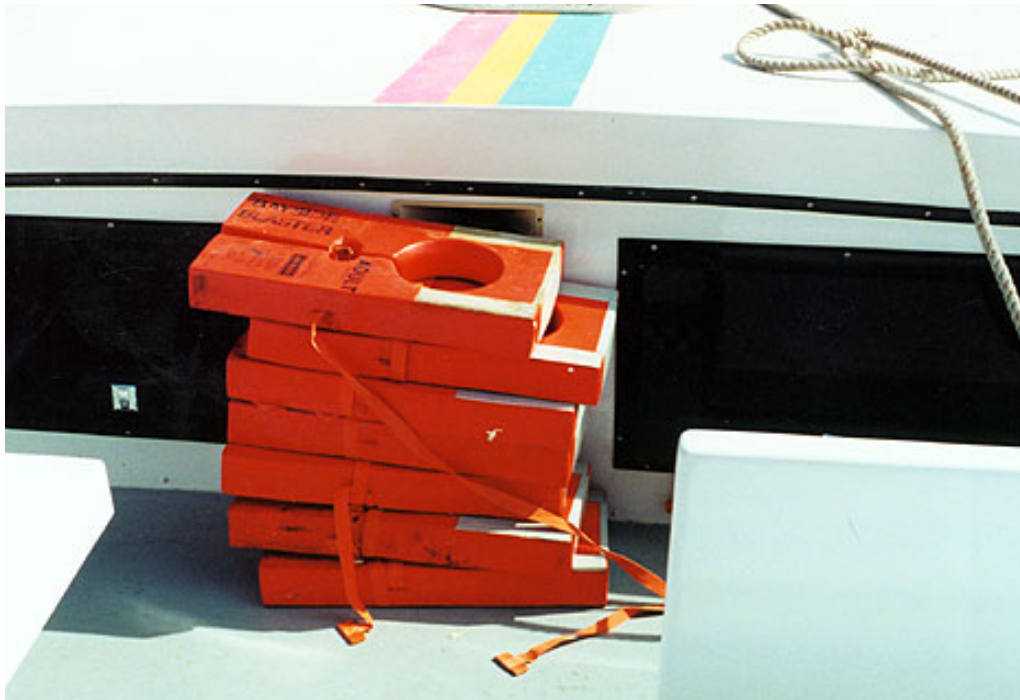
Bayside Blaster. The *Bayside Blaster* was equipped with 90 Coast Guard-approved adult-size lifejackets stowed in lockers at the bow (see figure 12). The lifejackets could be reached through two vertical hatches at the forward edge of the forward passenger seating area. The hatches were not labeled. The owner reported that the signs had been removed during ongoing refinishing of the decks and bulkheads. Fourteen Coast Guard-approved child-size lifejackets were stored in a compartment at the operator's station. The compartment was labeled "Childs Lifejackets," but the locker's opening mechanism was broken. Safety Board investigators observed that opening the compartment required prying the latch with a knife or similar object.

Small passenger vessels such as the *Bayside Blaster* that carry 150 or fewer passengers or have overnight accommodations for 49 or fewer passengers are required by 46 CFR part 180.78 to have lifejackets "stored in convenient places distributed throughout accommodation spaces."¹¹ The CFR further requires that "each life jacket kept in a storage container must be readily available." Federal regulations (46 CFR part 185.604(f)) also require that each container for lifejackets be marked with the number and identification of the items stowed inside. The Coast Guard last inspected the *Bayside Blaster* on August 20, 2001, and found no deficiencies in lifejacket stowage, although the inspection required

Figure 12. *Bayside Blaster's* forward lifejacket stowage lockers.
