Type B Investigation Board Report
Worker Fall from Shoring/Scaffolding Structure
at the
Savannah River Site
Tritium Extraction Facility -
Construction Site
April 2, 2002

SAVANNAH RIVER SITE OFFICE
MAY 2002

May 13, 2002

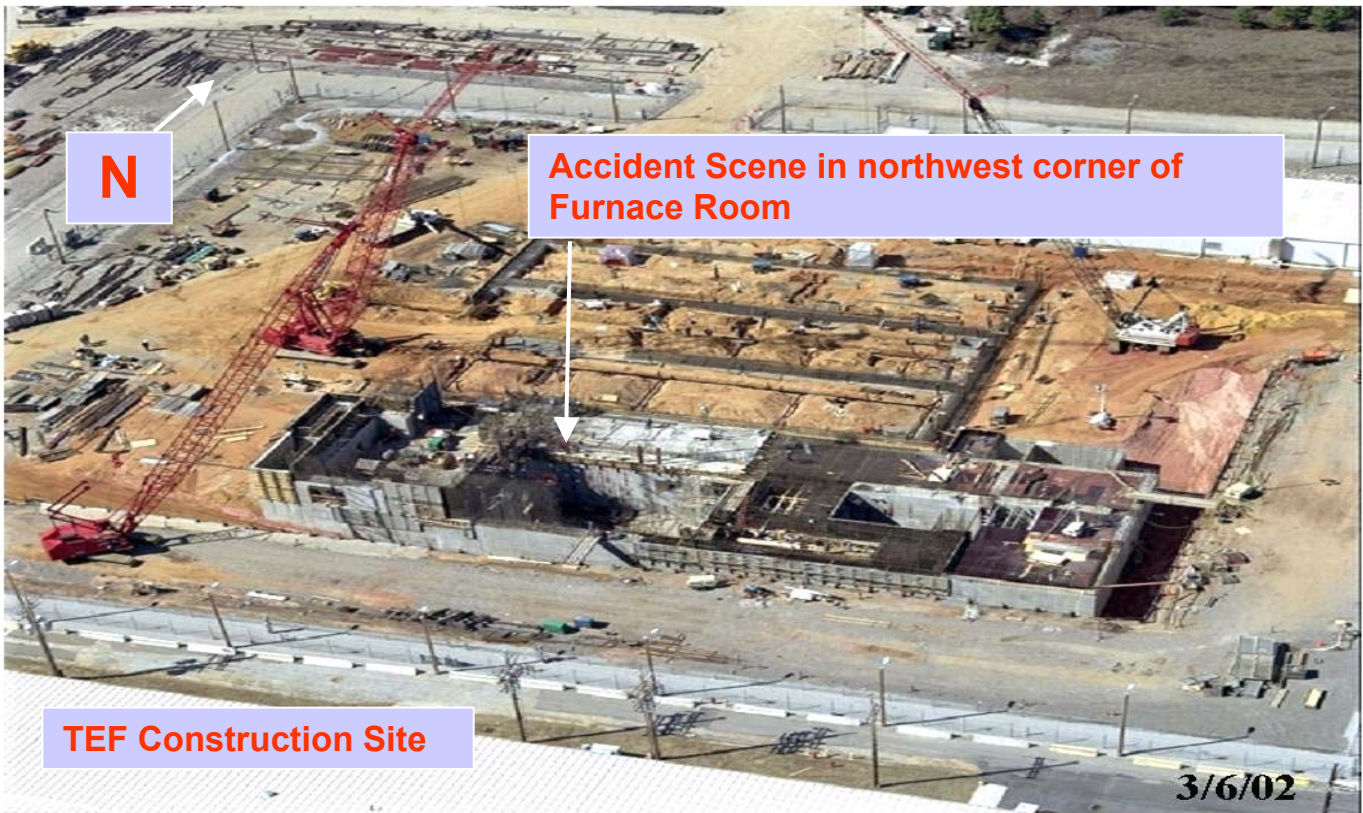
The RHB will be a shielded concrete structure approximately 70' wide by 200' long and approximately 90' tall, with about 30' underground. The RHB will include a truck receiving area, cask decontamination area, TPBAR and waste preparation area, furnaces, hot maintenance areas, and associated extraction pumps and tanks. The RHB will also include overhead cranes and remote handling equipment. The underground portion of this facility will house, in part, furnaces to heat the TPBARs under a vacuum to drive off the tritium-containing gases. The shoring/scaffolding structure where the carpenter fell was located in the Furnace Room. (See Figure 1)

Figure 1 - TEF Construction Site

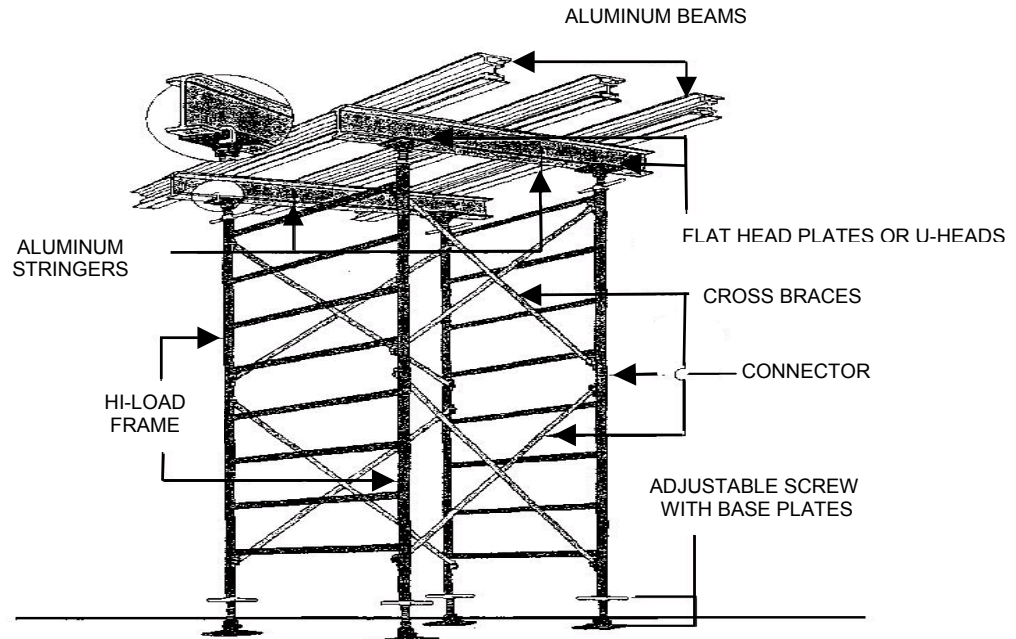
Two carpenters (C1 and C2) had been working in the Furnace Room for about one week prior to the accident erecting shoring/scaffolding to support form work for concrete placement for the floor above the Furnace Room. Erection was proceeding in accordance with the Safeway Formwork Systems Shoring Plan drawing numbers S11 and S14 and instructions. The shoring had been erected to an approximate height of about 20'. The shoring system in this area would eventually reach over 60'. The shoring construction consisted of connecting 4' x 5' and 4' x 6' sections (known as bucks) with cross bracing, forming tower assemblies that would be tied together to construct the specified array. The shoring when completed supported aluminum beams, which in turn supported flat forms for a concrete roof placement. Adjustable screw jacks with base plates were at the bottom and adjustable screw jacks with flat plates or "U" heads at the top of the array adjusted the structure to the precise height needed. (See Figure 2) The primary purpose of the structure was to support the construction of the floor above, but Bell also intended to occasionally use the structure as a scaffold for other work. The Safeway Formworks plan only identified the structure as shoring.

Figure 2 - Shoring Drawing

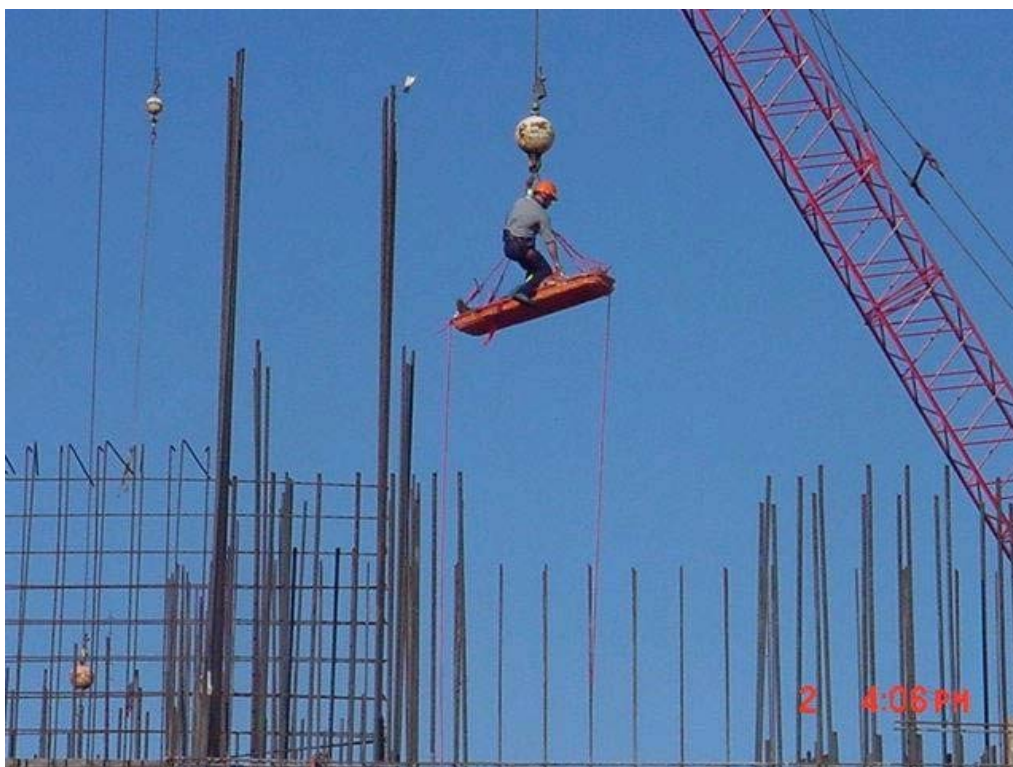
The tight maze of scaffolding, shoring, rebar and walls required that a crane be used to lower a Stokes rescue basket into the Furnace Room and to lift out C1. (See Figure 4) One of the EMTs put on a rescue harness and safety line and attached himself and the basket to the crane hook. The EMT rode up with C1 to help steady the rescue basket during C1's extraction.

Figure 4 - Crane lifting injured carpenter and EMT out of construction site

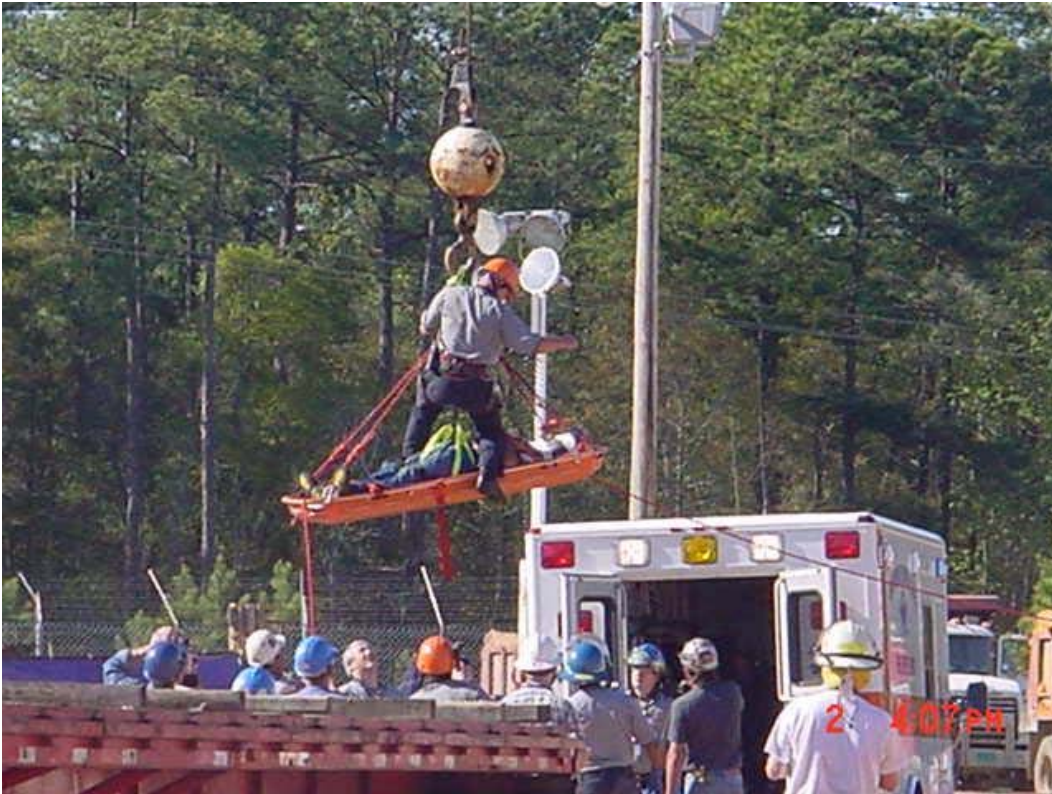
While the extraction progressed, emergency responders cleared a landing zone and a Wackenhut Services, Inc. helicopter landed approximately 1/8 mile from the accident scene. The crane operator set the basket down near an ambulance that transported C1 to the helicopter. (See Figure 5) The helicopter transported C1 to the Medical College of Georgia (MCG) Trauma Center.

Figure 5 - Injured being transferred to ambulance to be taken to helicopter for evacuation to MCG Trauma Center
