ISS Fiber Optic Failure Investigation

Root Cause Report

August 1, 2000

**ISS Fiber Root Cause Investigation Team
Lead organization NASA GSFC
Sponsored by: NASA JSC and the Boeing Company**

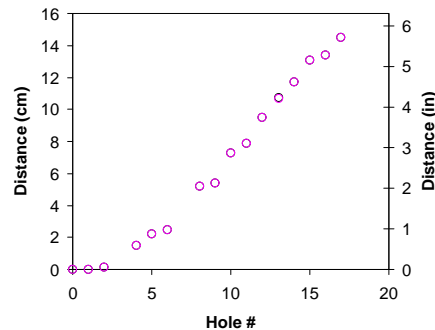
Figure 14 Distribution of Features Along a 6” Sample of CD0588XD Fiber

The arrangement of the bubbles and depressions were found to be in a fairly straight line and parallel with the longitudinal axis of the fiber. Figure 14 is a plot of the distribution of the features along the length of one of the “588” samples.

Aeolian motion may be occurring with the fiber in the draw tower. Using equations (4) and (5), one can predict the periodicity of defects which may be coincident with the resonant frequencies of the fiber in tension. The draw speed being known, we can determine that the defects spaced as shown in Figure 14 move past a fixed point at a frequency of 33 to 83 Hz.

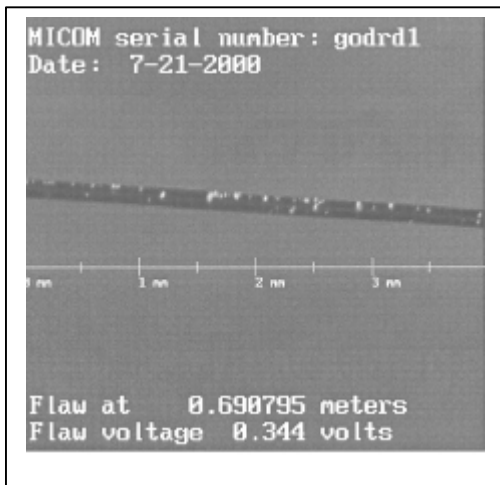
Figure 17 Debris-Laden Fiber

A fiber inspection system, built by the US Army Aviation & Missile Command for their own internal use, was used to try to inspect for 10 μm sized features in the polyimide surface that might indicate the presence of the bubble feature that has been consistently associated with "rocket engine" defects and low strength breaks. The system uses an infrared detector and looks for signal scatter off of the surface at feature locations. The feature is described with respect to the voltage of the returned scattered signal. When a feature is found that corresponds to a minimum signal voltage, the system takes a picture of the corresponding location. The inspection system is very sensitive to any surface feature, especially contamination such as lint and dust (Figure 17). A lint free dust capture stage was arranged around the fiber and the inspection was continued. Figure 18 shows the image of a debris-free fiber with polyimide surface features.

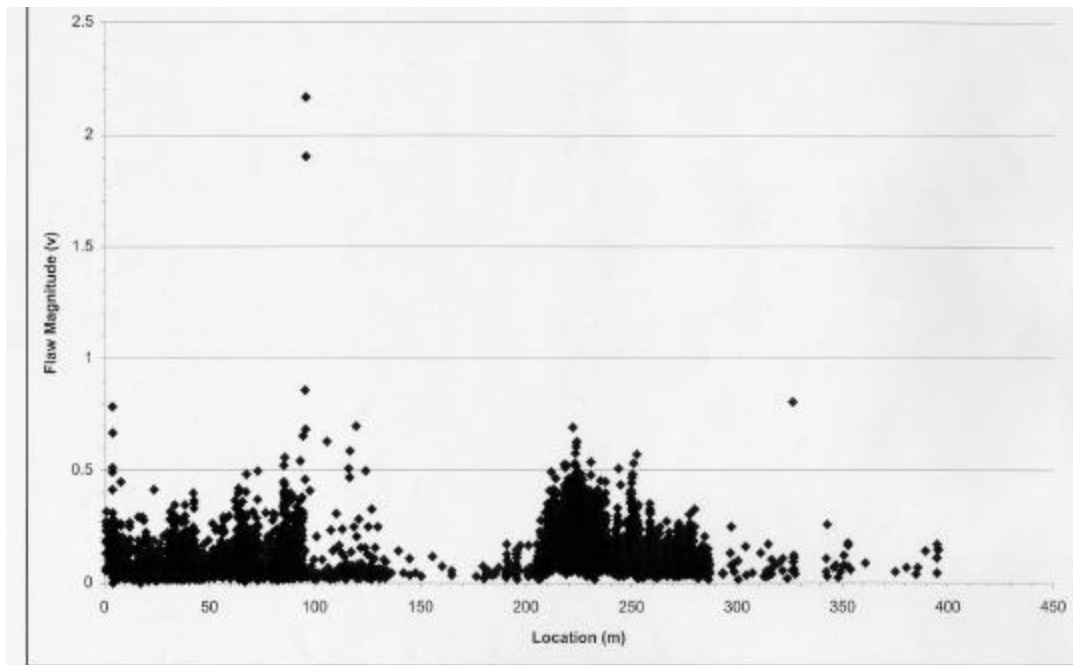
Figure 19 Feature Statistics for CD0588XD

To see if, using a more typical inspections speed, 0.5 m/sec, the machine could provide useful statistics which would differentiate the two reels. Figure 19 and Figure 20 show the results of running approximately 400 m through the machine, looking for a 0.1V feature size or greater. Additional work is required to understand the usefulness of a system such as this to identify defects in the polyimide coating.

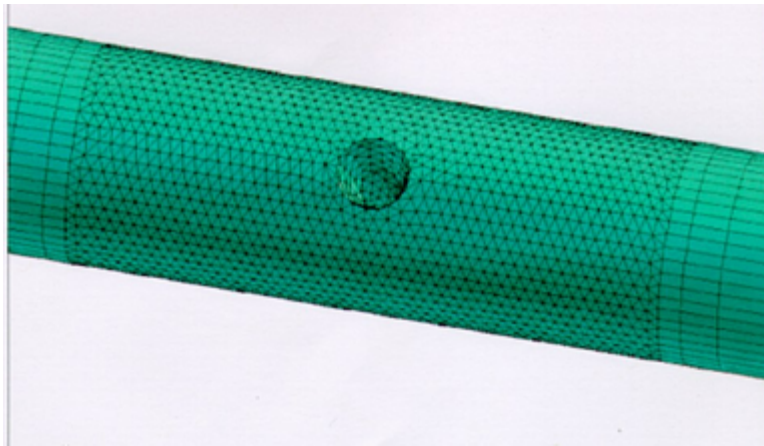
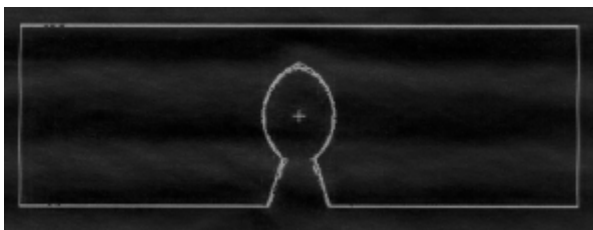
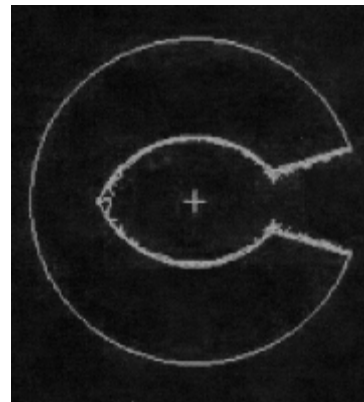
Figure 24 Model of “Rocket Engine” Defect

The shape of the cup in the cladding area reflects the speed at which the reaction occurs in the pure silica material and its increasing speed in the Ge rich material. A FEA model was constructed for the BF04515 fiber to understand the internal stresses in the glass with a “rocket engine” defect when the fiber is under a 25% strain (Figure 24a through c). Figure 25a through c shows that the internal stress in the fiber in this case rises by a factor of three over a section, which is experiencing the same amount of strain with no “rocket-engine” defect.

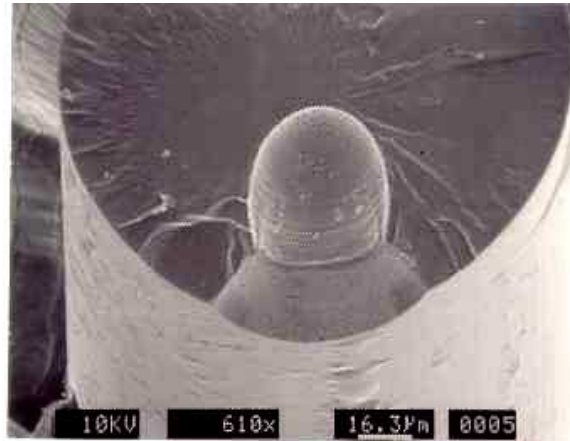
Figure 26 Etch Pit Resulting From Experimentation

Lucent Technologies experimented with BF04515 fiber from a cable with “glows”. The polyimide coating was stripped and the grounded, carbon coated fiber was exposed to a 1 kV source (wire electrode). An arc discharged through the air between the wire and the fiber. The sample was then exposed to both aqueous and vapor HF (in a humid environment) [ref-16]. HeNe light was transmitted through the fiber during the test and when light began to leak out of the side, the test was stopped. Figure 26 shows the resulting defect with the characteristic bulb pattern and ringed structure seen in the Boeing photographs (Figures 9). The sample was rinsed to drive off the highly corrosive HF, so it is not known whether there were any GeO₂ crystals or SiO₂ balls resulting from the experiment.

Lucent observed that the Ge-doped core etches considerably faster than the cladding. If the etch time is too long, then the entire core can be removed, leaving a silica tube with a pinhole in it. This indicates that the amount of HF present at the site is the limiting factor in the degree of etching.

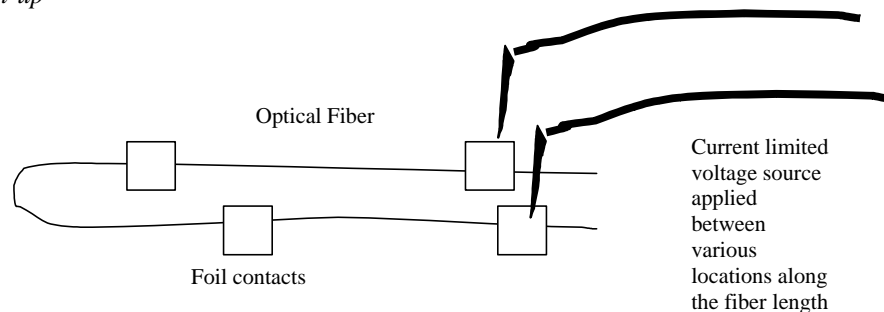
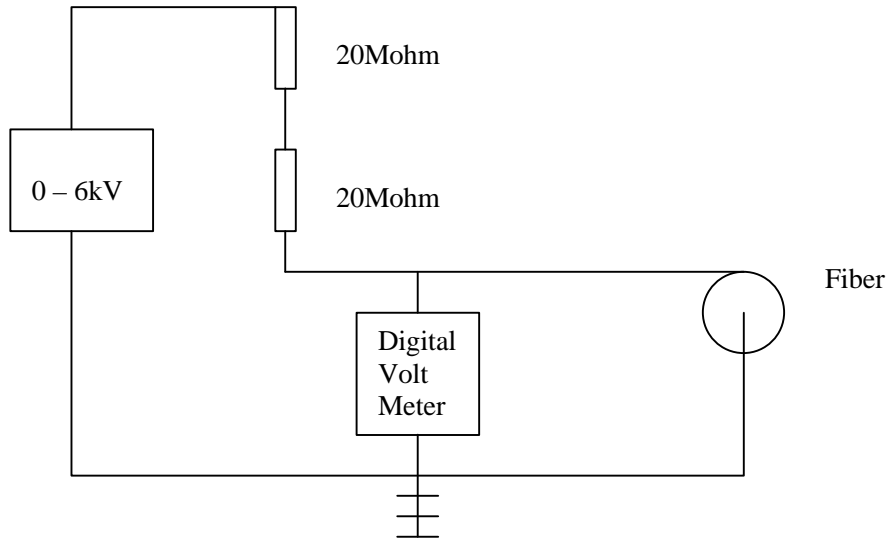
Figure 27 Experimentally Produced ESD Damage

NASA GSFC performed a test using the set-up shown in Figure 27a to measure the breakdown strength of a sample of fiber with known flaws. The electrodes were applied between various sets of foil contacts. A breakdown strength of 2.5 kV was measured and a burn mark resulted. The burn mark was found very close to polyimide bubbles (Figure 23).

The Aerospace Corporation used the set-up shown in Figure 27b with an associated burn mark shown in Figure 22. The Aerospace Corporation found abrupt breakdown at 3.9kV in a 50% relative humidity environment, indicating a 6.5 kV/mil dielectric strength. Burn marks were found with a variety of sizes the smallest being 30 μm in diameter. They also measured the resistance of the carbon coating for lengths between 1 and 34 cm to be approximately 15 kOhm/cm, which agrees with Lucent-SFT’s databook value.

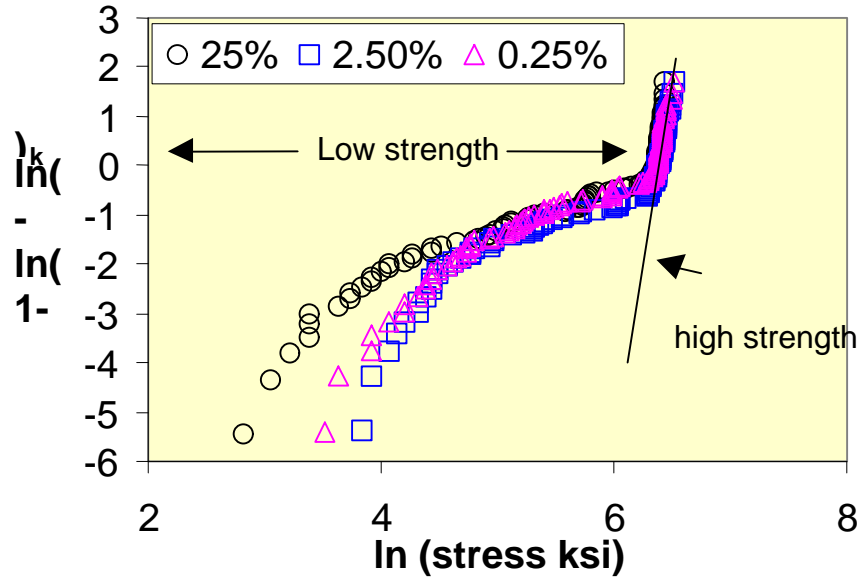
Figure 30 Weibull Plot for Strength of 1996 Vintage Cable from Several Cable Reels

The results of the initial strength tests are shown in the Weibull plots in Figures 30 and 31. Prior analysis showed that the fiber shipped by Lucent-SFT was proof tested to 141 kpsi (@ 3.36 lbs). The cable specification requirement is for a fiber strength of 200 kpsi (@ 4.76 lbs). Lindholm, et. al., report strengths of 500 kpsi (11.90 lbs) and higher for four carbon coated fibers they have manufactured. The plots showed the high strength of the cabled fiber to be around 252 kpsi (6 lbs) and the low strength to go as low as 126 kpsi (3 lbs).

The inspections found that defects were present in large numbers that were either small etch pits at the surface of the cladding or corrosion sites in the same location. The knees in the Weibull plots, an associated slopes, show that there is more than one dominant failure mode. According to the physics of glass, the order of the curves should show the black circles (highest strain rate) located to the right of the other curves, not to the left. Figure 31 shows that the distribution of low strength breaks among the reels was significantly different even for reels with the same date of manufacture. These distributions could not be used to quantify the expected life of the cable using classical methods.

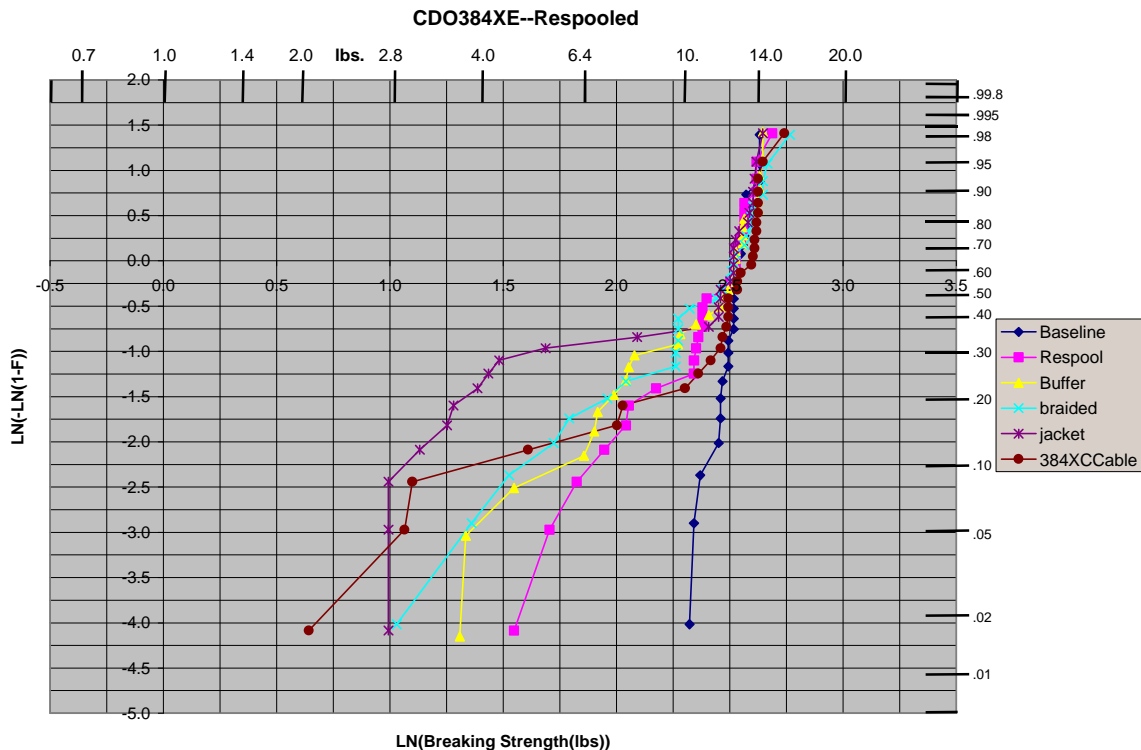
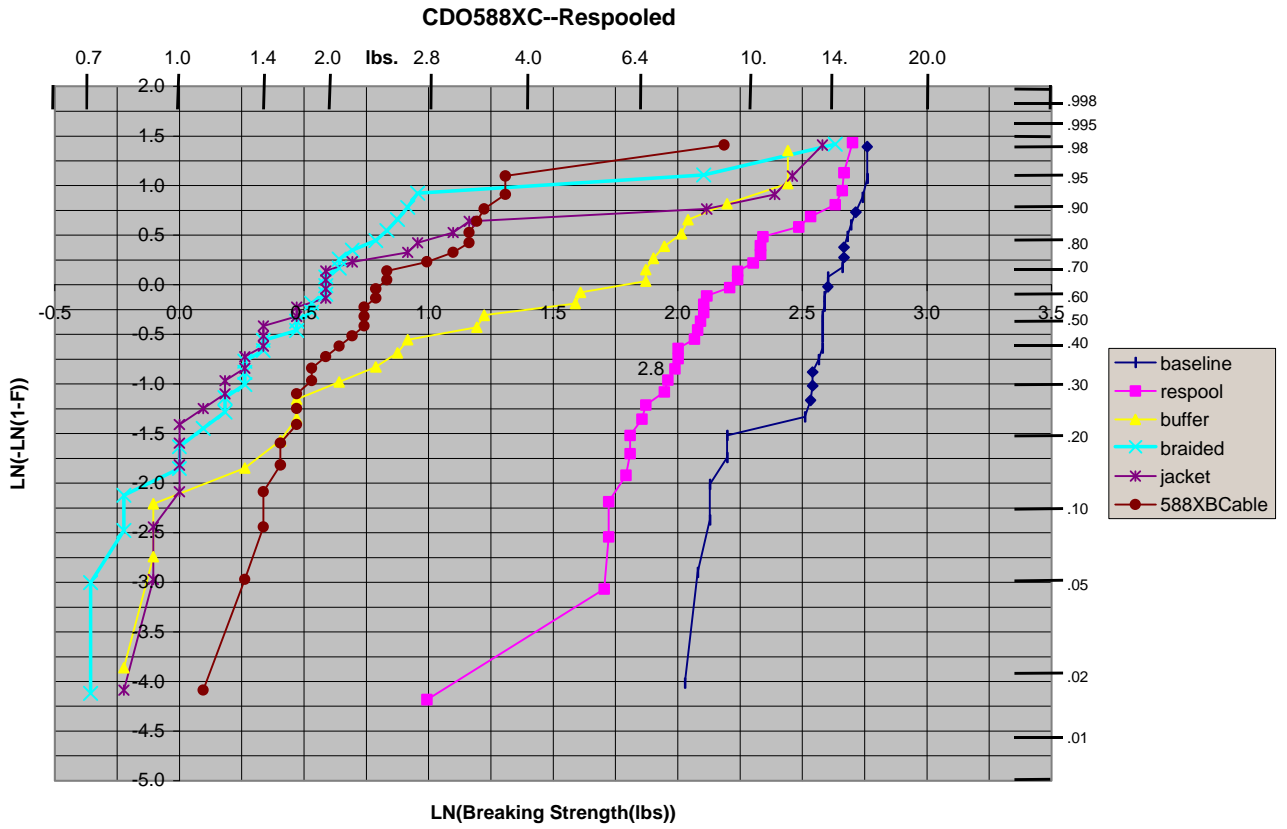
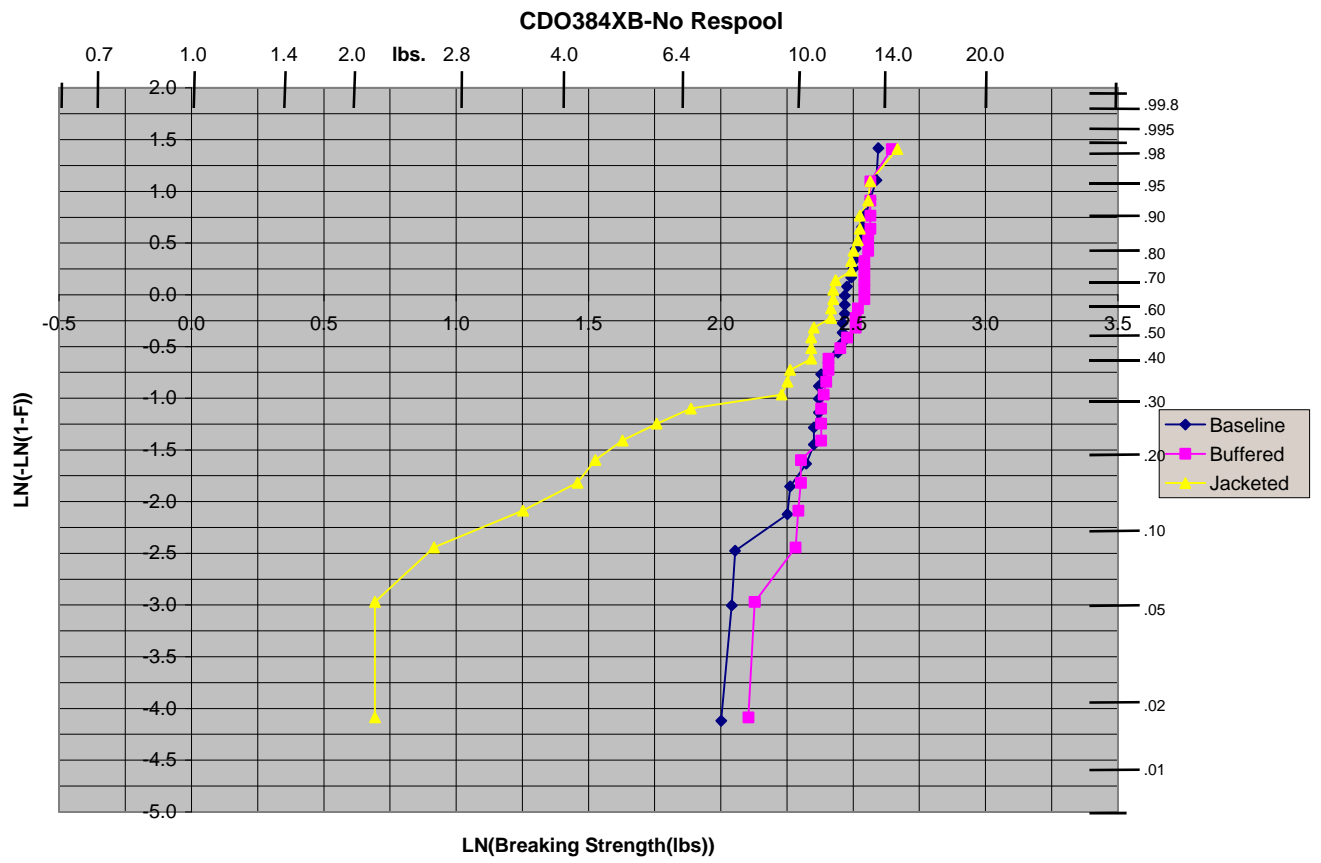
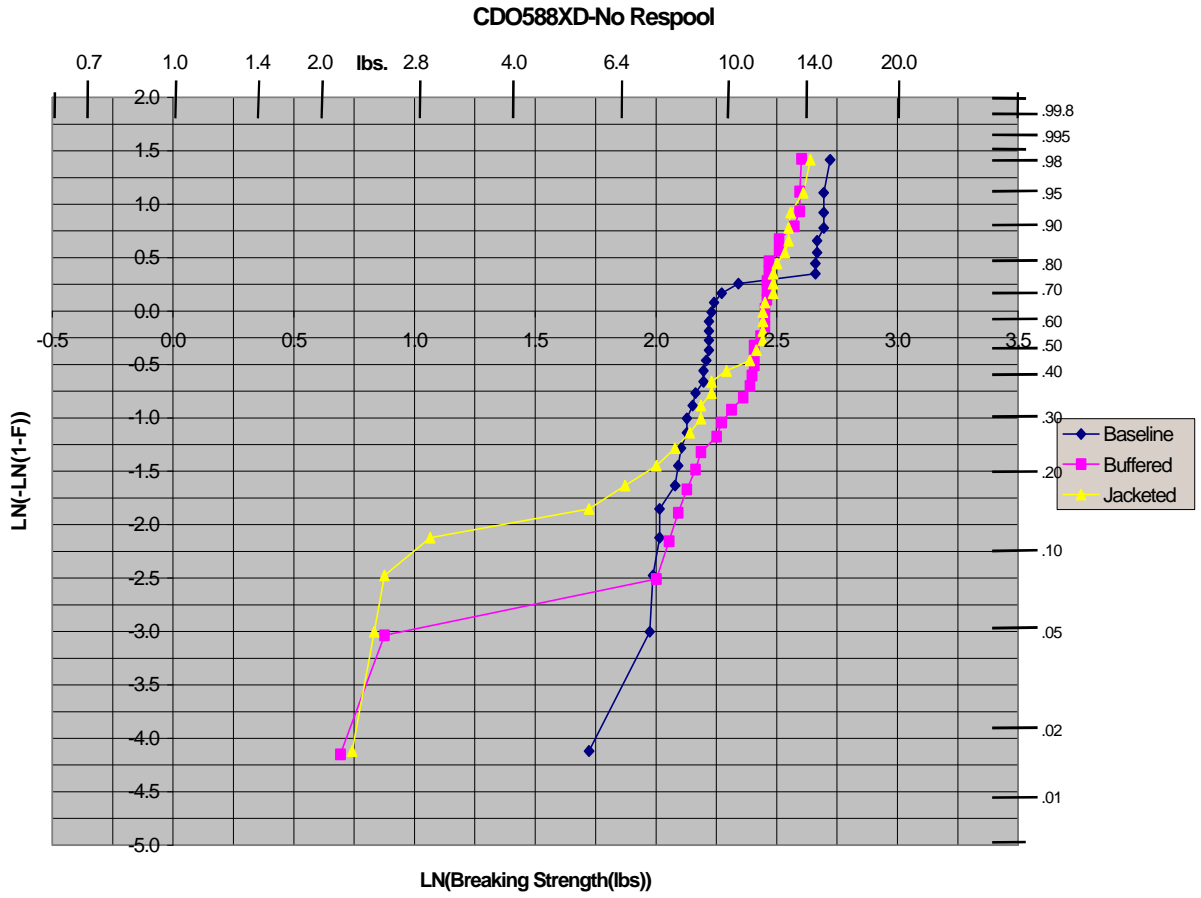
Figure 32 Strengths of DC0384 and DC0588 Fiber During Cabling

The results of the second round of strength testing are shown in Figures 32a through 32d. [ref-22, 23, 24] Figures 33a through 33d show the endfaces of the fibers at the low strength breaks.

Figure 32a through 32d show that the fiber starts the process with high strength and every process step seems to weaken it, including the respooling process. They also show that the 588 fiber lot experienced greater weakening due to the cabling process that the 384 lot did, though they started with similar baseline strength. More bubbles were found in the polyimide coating during DPA on the 588 samples than on the 384 samples leading to continued interest in the correlation between the presence of the bubbles and latent defect sites.

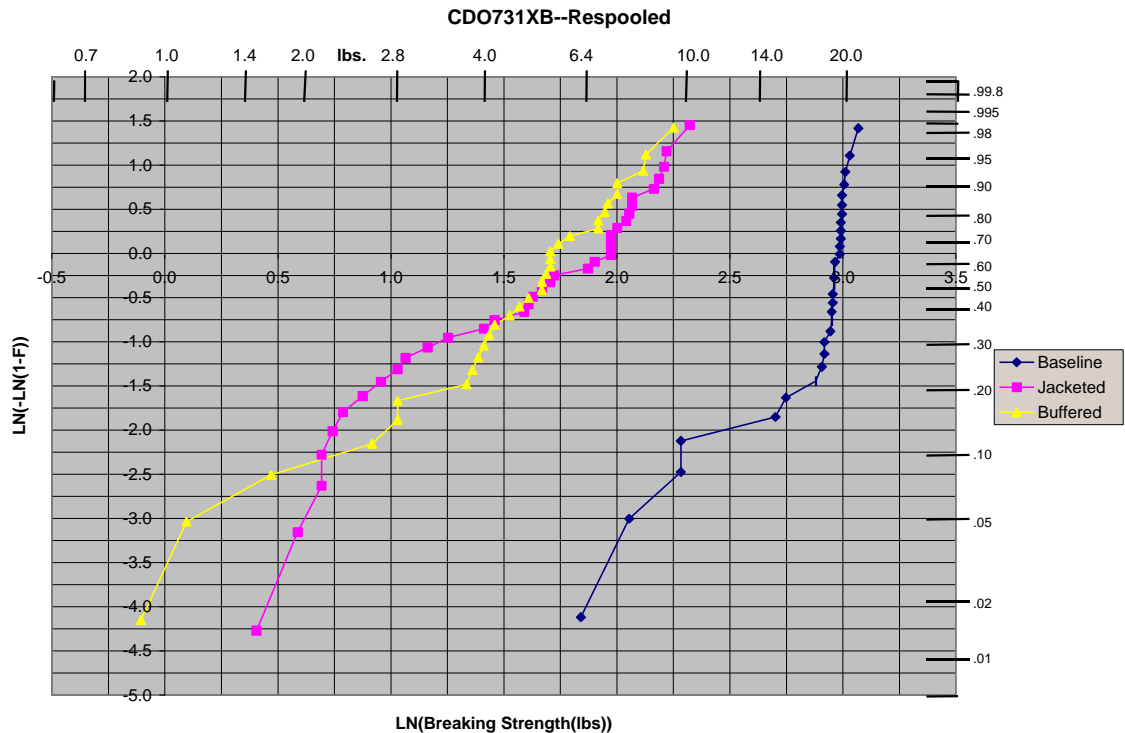
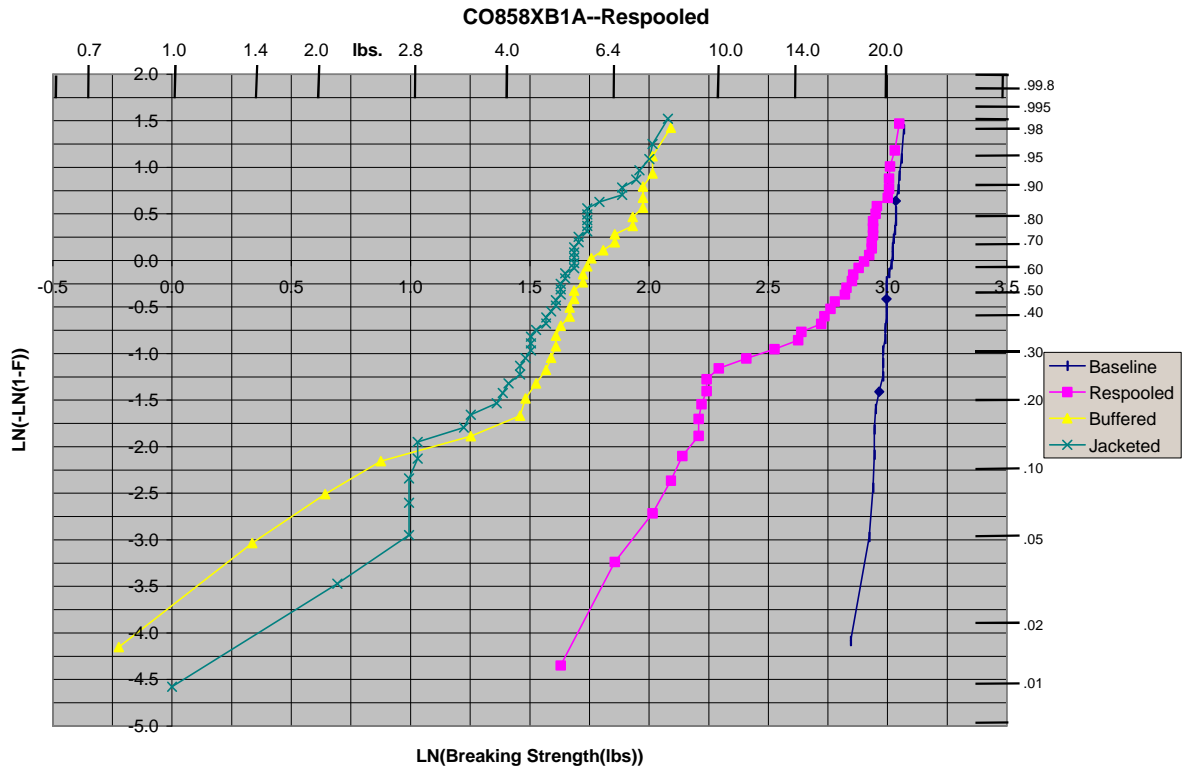
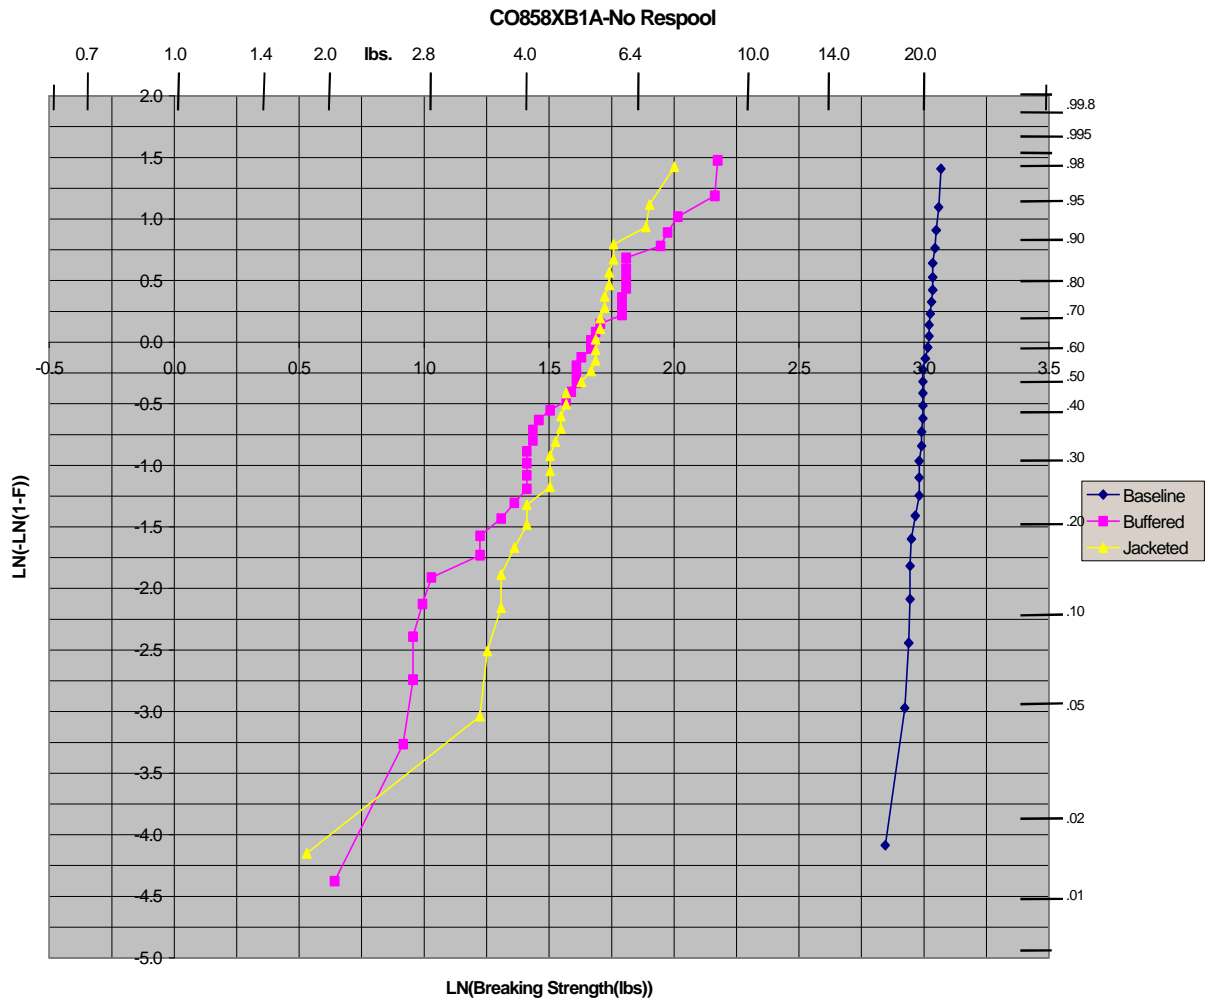
Figures 35 Strength for the Non-carbon Coated Fibers

Figure 35a through 35c show the affect of the various cabling processes on the fiber strength for the non-carbon-coated fibers. The unprocessed fiber has high strength, however as it goes through cabling, its strength is again increasingly reduced. The difference in the behavior between the two non-carbon coated fiber lots is still under study. [ref-26]

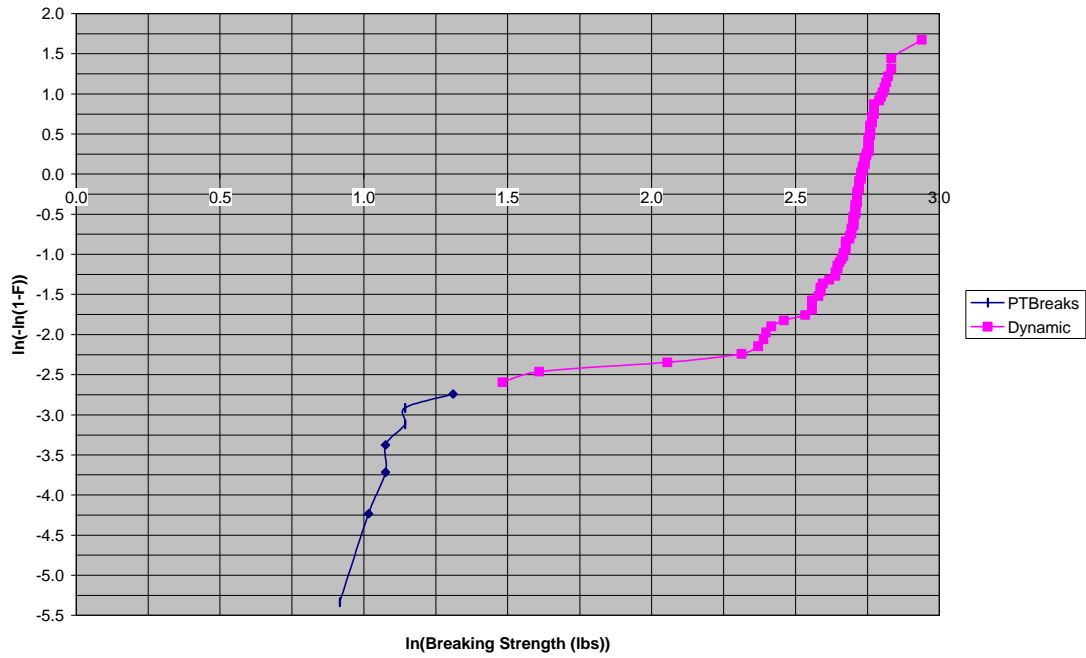
Figure 37 Hypothetical Break Strengths During Screen Compared to Actual Break Strengths on Proof Test Screened Sample

The fracture surfaces of the breaks found in the 04250 sample were analyzed and breaking strengths in lbs were calculated for them. These have been superimposed on the curve of breaking strengths found for the surviving sample, which was strength tested after the mandrel wrap screen. The lower (blue) section of Figure 37 represents the calculated values. The blue portion of the curve in Figure 38 are extrapolated values for the breaks, which occurred during the mandrel wrap screen in the 04245 sample. Figure 39 shows the dynamic strength data alone.
