Report Number NTSB/AAR-86/02

Report Title Air Canada Flight 797, McDonnell Douglas DC-9-32, C-FTLU, Greater Cincinnati International Airport, Covington, Kentucky, June 2, 1983 (Supersedes NTSB/AAR-84/09)

Report Date January 31, 1986

Report Type Aircraft Accident Report June 2, 1983

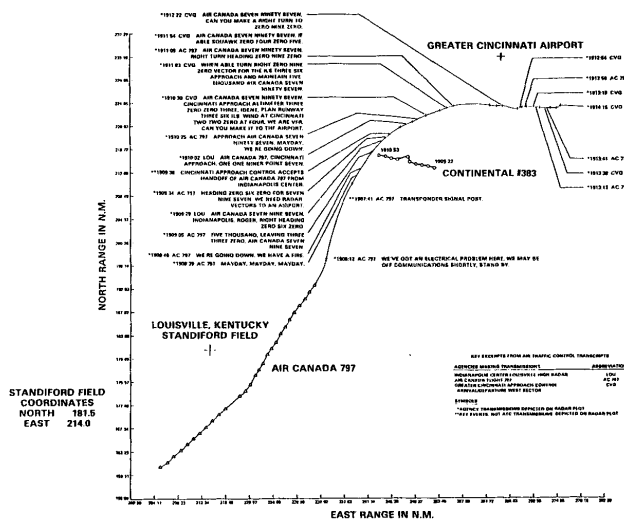
Figure 13.--Ground radar tracks for Flights 797 and 383.

Data Analysis Reduction Tool (DART) radar data information was obtained from the Indianapolis ARTCC. The data included airplane position information and available mode C altitude information for Flight 797 and for Continental Airlines Flight 383, which was transmitting on code 0662. The Safety Board's laboratory reconstructed the ground radar tracks of both Flights 797 and 383. Runways 9R-27L and 18-36 of the Greater Cincinnati Airport were digitized and plotted with the ground tracks. Times of key transmissions and selected key events were included along Flight 797's radar ground track. The last radar fix retrieved from the DART's data occurred at 1914:15, and the last transponder information from Flight 797 was received at 1906:12. ([See figure 13.](#))

Based on the times contained in this model and the manufacturer's performance data, the total time required to descend from 33,000 feet and land on runway 27L was 9 minutes 41 seconds.

The field elevation at Standiford Field, Louisville, Kentucky, is 497 feet. The Safety Board estimated that 10 minutes 11 seconds would have been required to descend from 33,000 feet and land at Standiford Field.
