**2004 Operations, Maintenance,
and Monitoring Report**

Cameron Creole Plugs Project

State Project Number CS-17
Priority Project List 1

May 2007
Cameron Parish

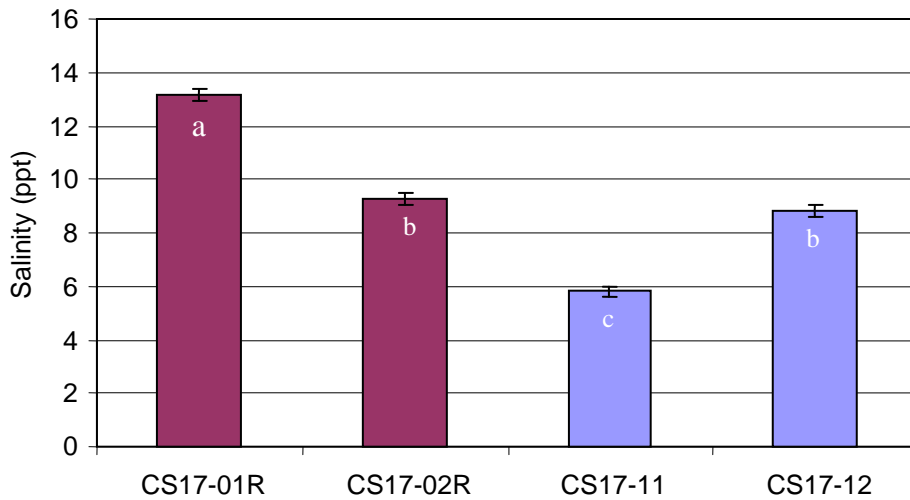
Salinities were higher at CS17-01R than at the other stations for 2003 ($p < 0.0001$) (figure 10). This is most likely because the recorder is located in Calcasieu Lake and is impacted by saltwater entering the lake through the Calcasieu Ship Channel. Salinity has shown the same trend at the four recorders in the CS-17 project since 1997 (figure 11). Of the other 3 stations, CS17-11 in the northern project area, had the lowest salinity and CS17-01R in Calcasieu Lake had the highest salinity. There were no specific project goals for salinity.

Figure 10. Yearly mean salinity of daily means for 2003 at each CS-17 recorder (Mean \pm SE). CS17-01R, the recorder in the lake, was found to be significantly higher than the other three recorders. CS17-02R, the recorder in the borrow canal, was found to be higher than CS17-11 (in the northern project area) but not CS17-12 (in the southern project area). Levels not connected by the same letter are significantly different.

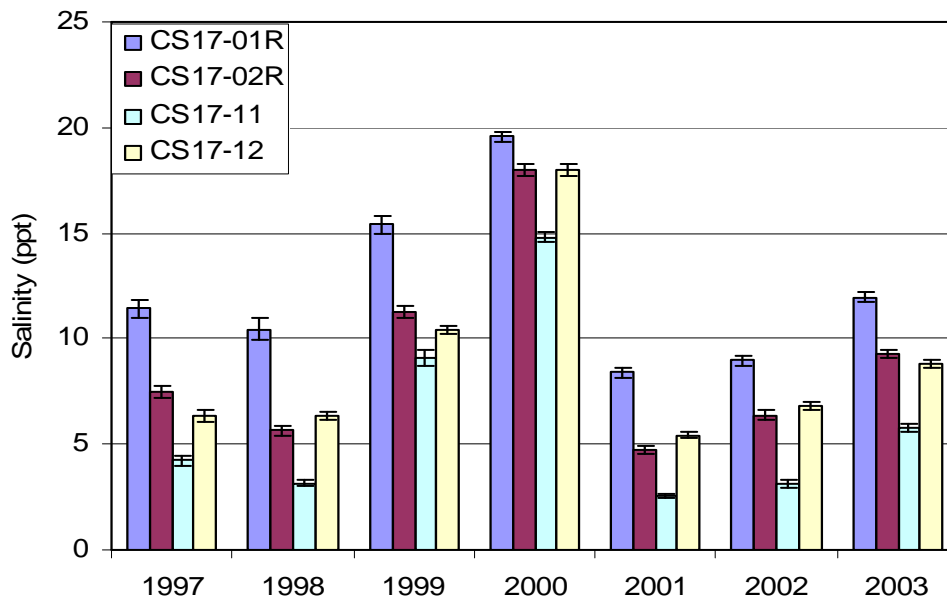
Figure 11. Yearly salinity over the course of the CS-17 project. Salinity has increased and decreased due to rainfall while salinity trends among the four recorders have remained the same since 1997.

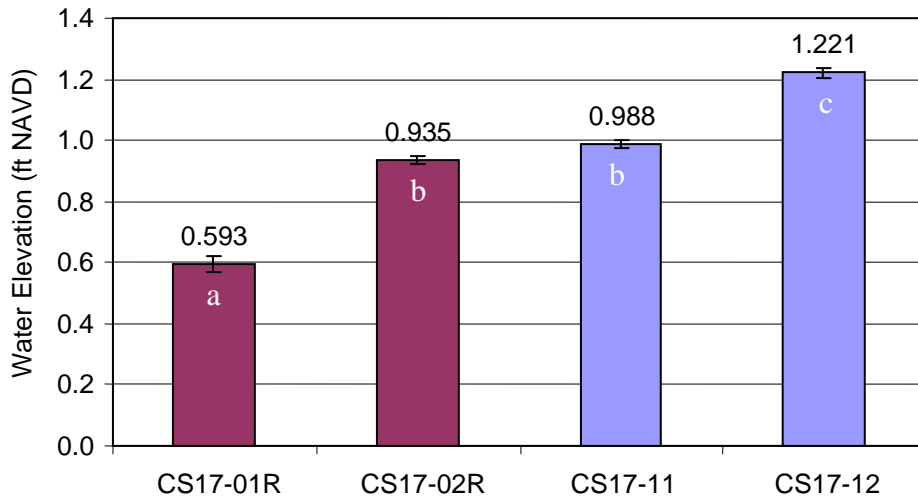
Water levels were lower at station CS17-01R than the other 3 stations in 2003 (figure 12). Water levels were highest at CS17-12 ($p < 0.0001$). Stations CS17-02R and CS17-11 had approximately the same mean water level for the year. Water level and the percent of time the marsh was flooded at station CS17-12 in the southern project area has increased relative to the reference station CS17-02R since 1999 (figures 13 and 14). One goal of the CS-17 project was to decrease the duration of flooding in the southern project area. These data show that water levels have increased in the southern project area.

Figure 12. Yearly mean water level of daily means for 2003 at each CS-17 recorder (Mean \pm SE). Water elevation at CS17-01R, the recorder in the lake, was found to be significantly lower than at the other three recorders. CS17-12, the recorder in the southern project area, was found to be higher than the other recorders. Levels not connected by the same letter are significantly different.
