**LEVEL 1 ACCIDENT INVESTIGATION REPORT**  
**OF AUGUST 17, 2004**  
**FATAL AIRCRAFT ACCIDENT**  
**ON THE**  
**GRAND COULEE-BELL NO. 6**  
**500 kV LINE**

**FINAL REPORT**  
**OCTOBER 1, 2004**

**BPA**  
**Level 1 Aircraft Accident, August 17, 2004 in Mead, WA**  
**FINAL REPORT**

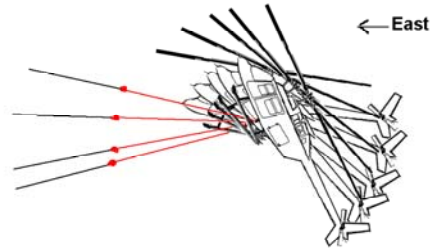
TSE reel snags and starts pulling sock-line in taking up the slack in the lines. The sock-line, lead rope, & long-line act as a lever on the aircraft's vertical CG. The lever action combined with the aircraft's rearward momentum forces the nose up. At this angle the aircraft is losing altitude.

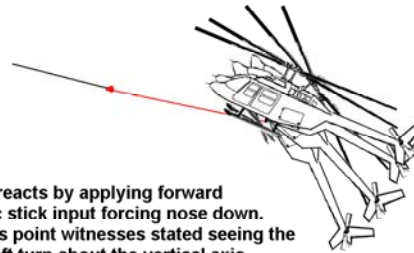
Pilot reacts by applying forward cyclic stick input forcing nose down. At this point witnesses stated seeing the aircraft turn about the vertical axis, aircraft is now pointing west.

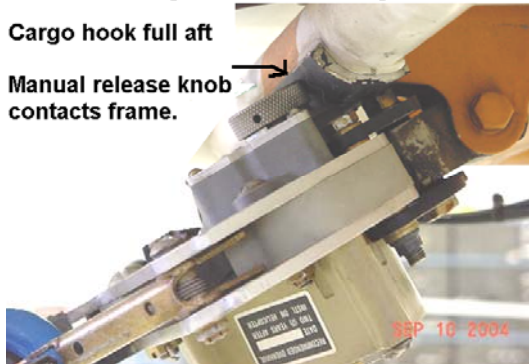
**Cargo hook full aft**

**Manual release knob contacts frame.**

Witnesses reported that the aircraft then nosed down. The AIB determined through examination of the wreckage that the aircraft then turned about the mast centerline to the left. The nose of the aircraft was now heading westerly. At this point, the longline was taut against the belly of the aircraft, trailing directly aft, because the sock line was still attached to the longline as well as to the reel on the puller/tensioner.

Physical evidence indicates that when the aircraft's belly hook is pulled full aft, the manual release knob for the longline will jam against the belly-hook attachment frame rending the pilot's electrical release inoperable (the second option for releasing the load).

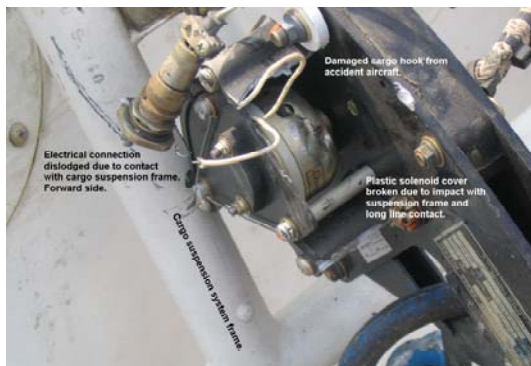
The postaccident investigation and analysis revealed that when the belly cargo hook is pulled full forward, the plastic housing encasing the electrical release connection and solenoid contacts the cargo suspension frame. This contact can--and in the case of the accident helicopter, did--cause damage to the housing where the cannon plug is located. When the belly hook is pulled full aft, the manual release knob contacts the frame. On the accident helicopter, the force was great enough to force the knob off in flight.

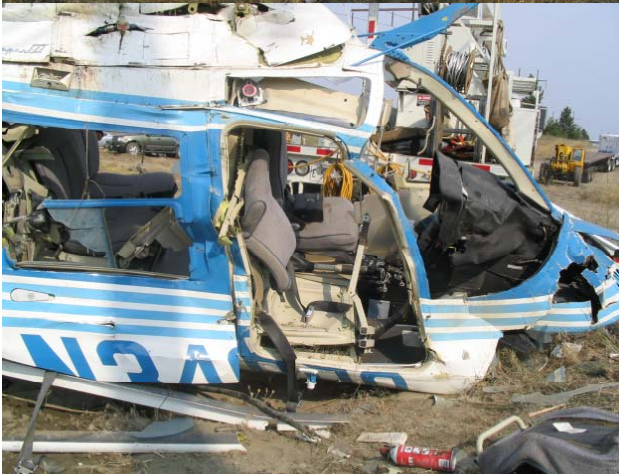
Left Side View. Looking south.

Red M/R blade struck upper cabin at left door post. Rescue workers pulled door off during extraction of pilot.

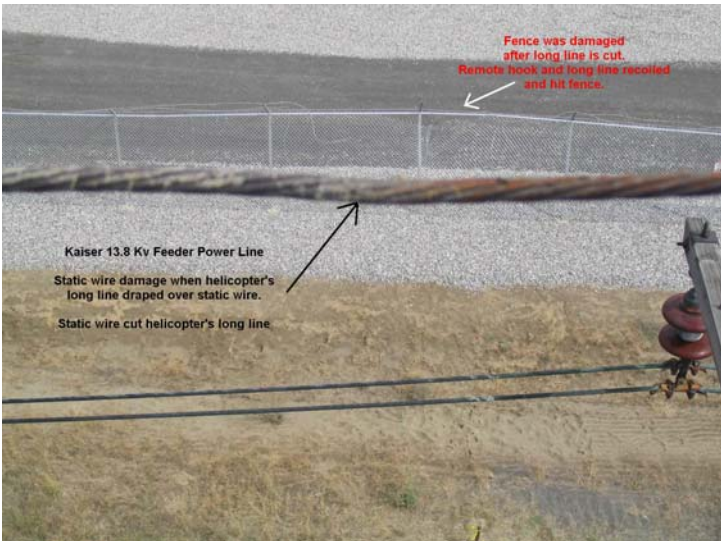
Remote cargo hook, remaining 19 feet of long line, and lead rope recoil into substation perimeter fence, after being cut by 13.8Kv Kaiser static line.

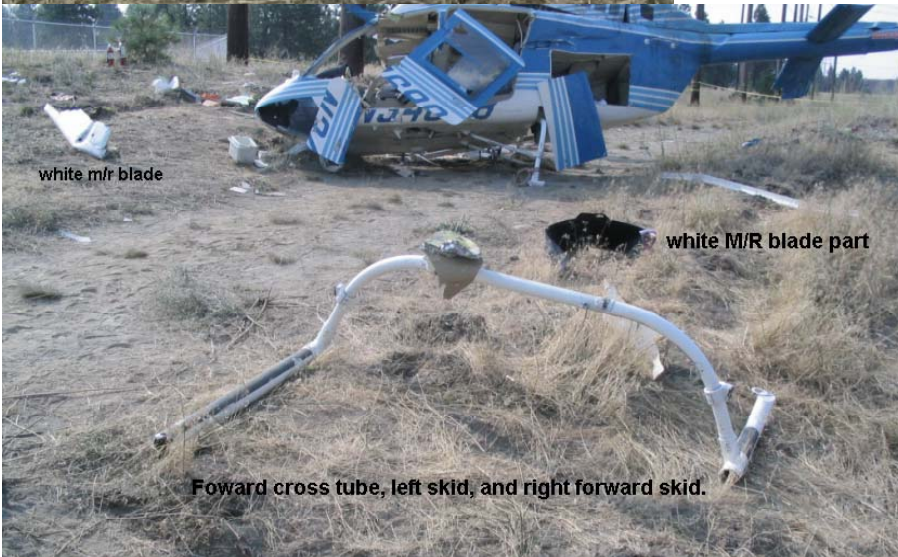
Close up of left front cross tube showing scuffing and where landing gear caught and was torn out of aircraft's underside.

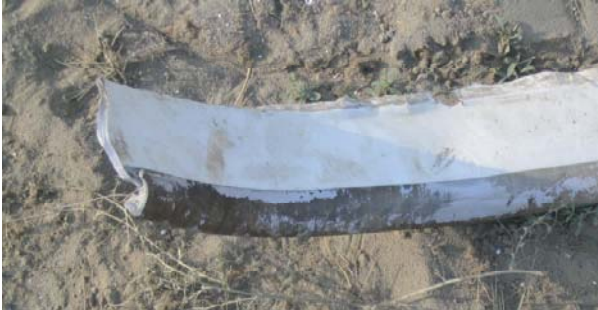
Close up of red M/R blade strike looking due west. M/R was under full power when it struck pole.

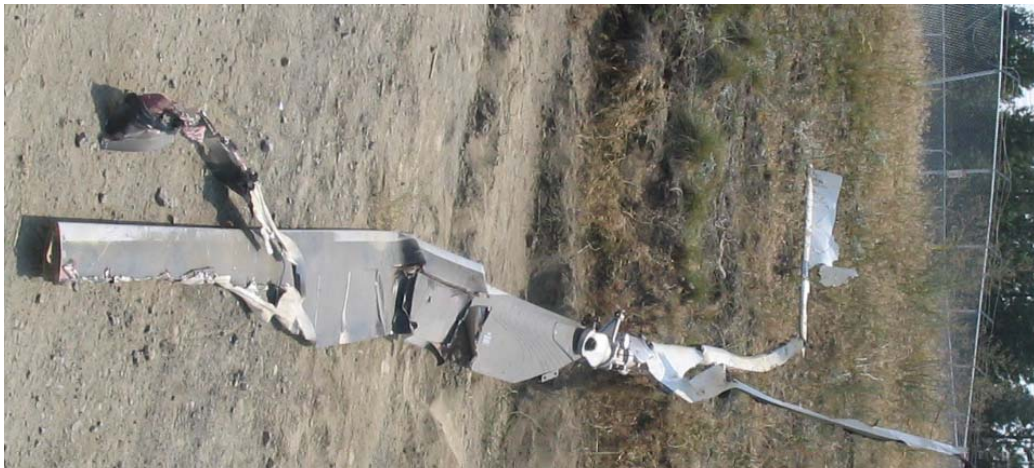
Below all parts of the main rotor system are placed next to each other. White blade is on left. White M/R blade tip was embedded in the dirt just forward of the cabin. (See wreckage map Appendix 4)
