Five Year Review Report Northwest Pipe & Casing Clackamas, Oregon

Northwest Pipe and Casing

ORD 980988307 Clackamas, Oregon

September 2006

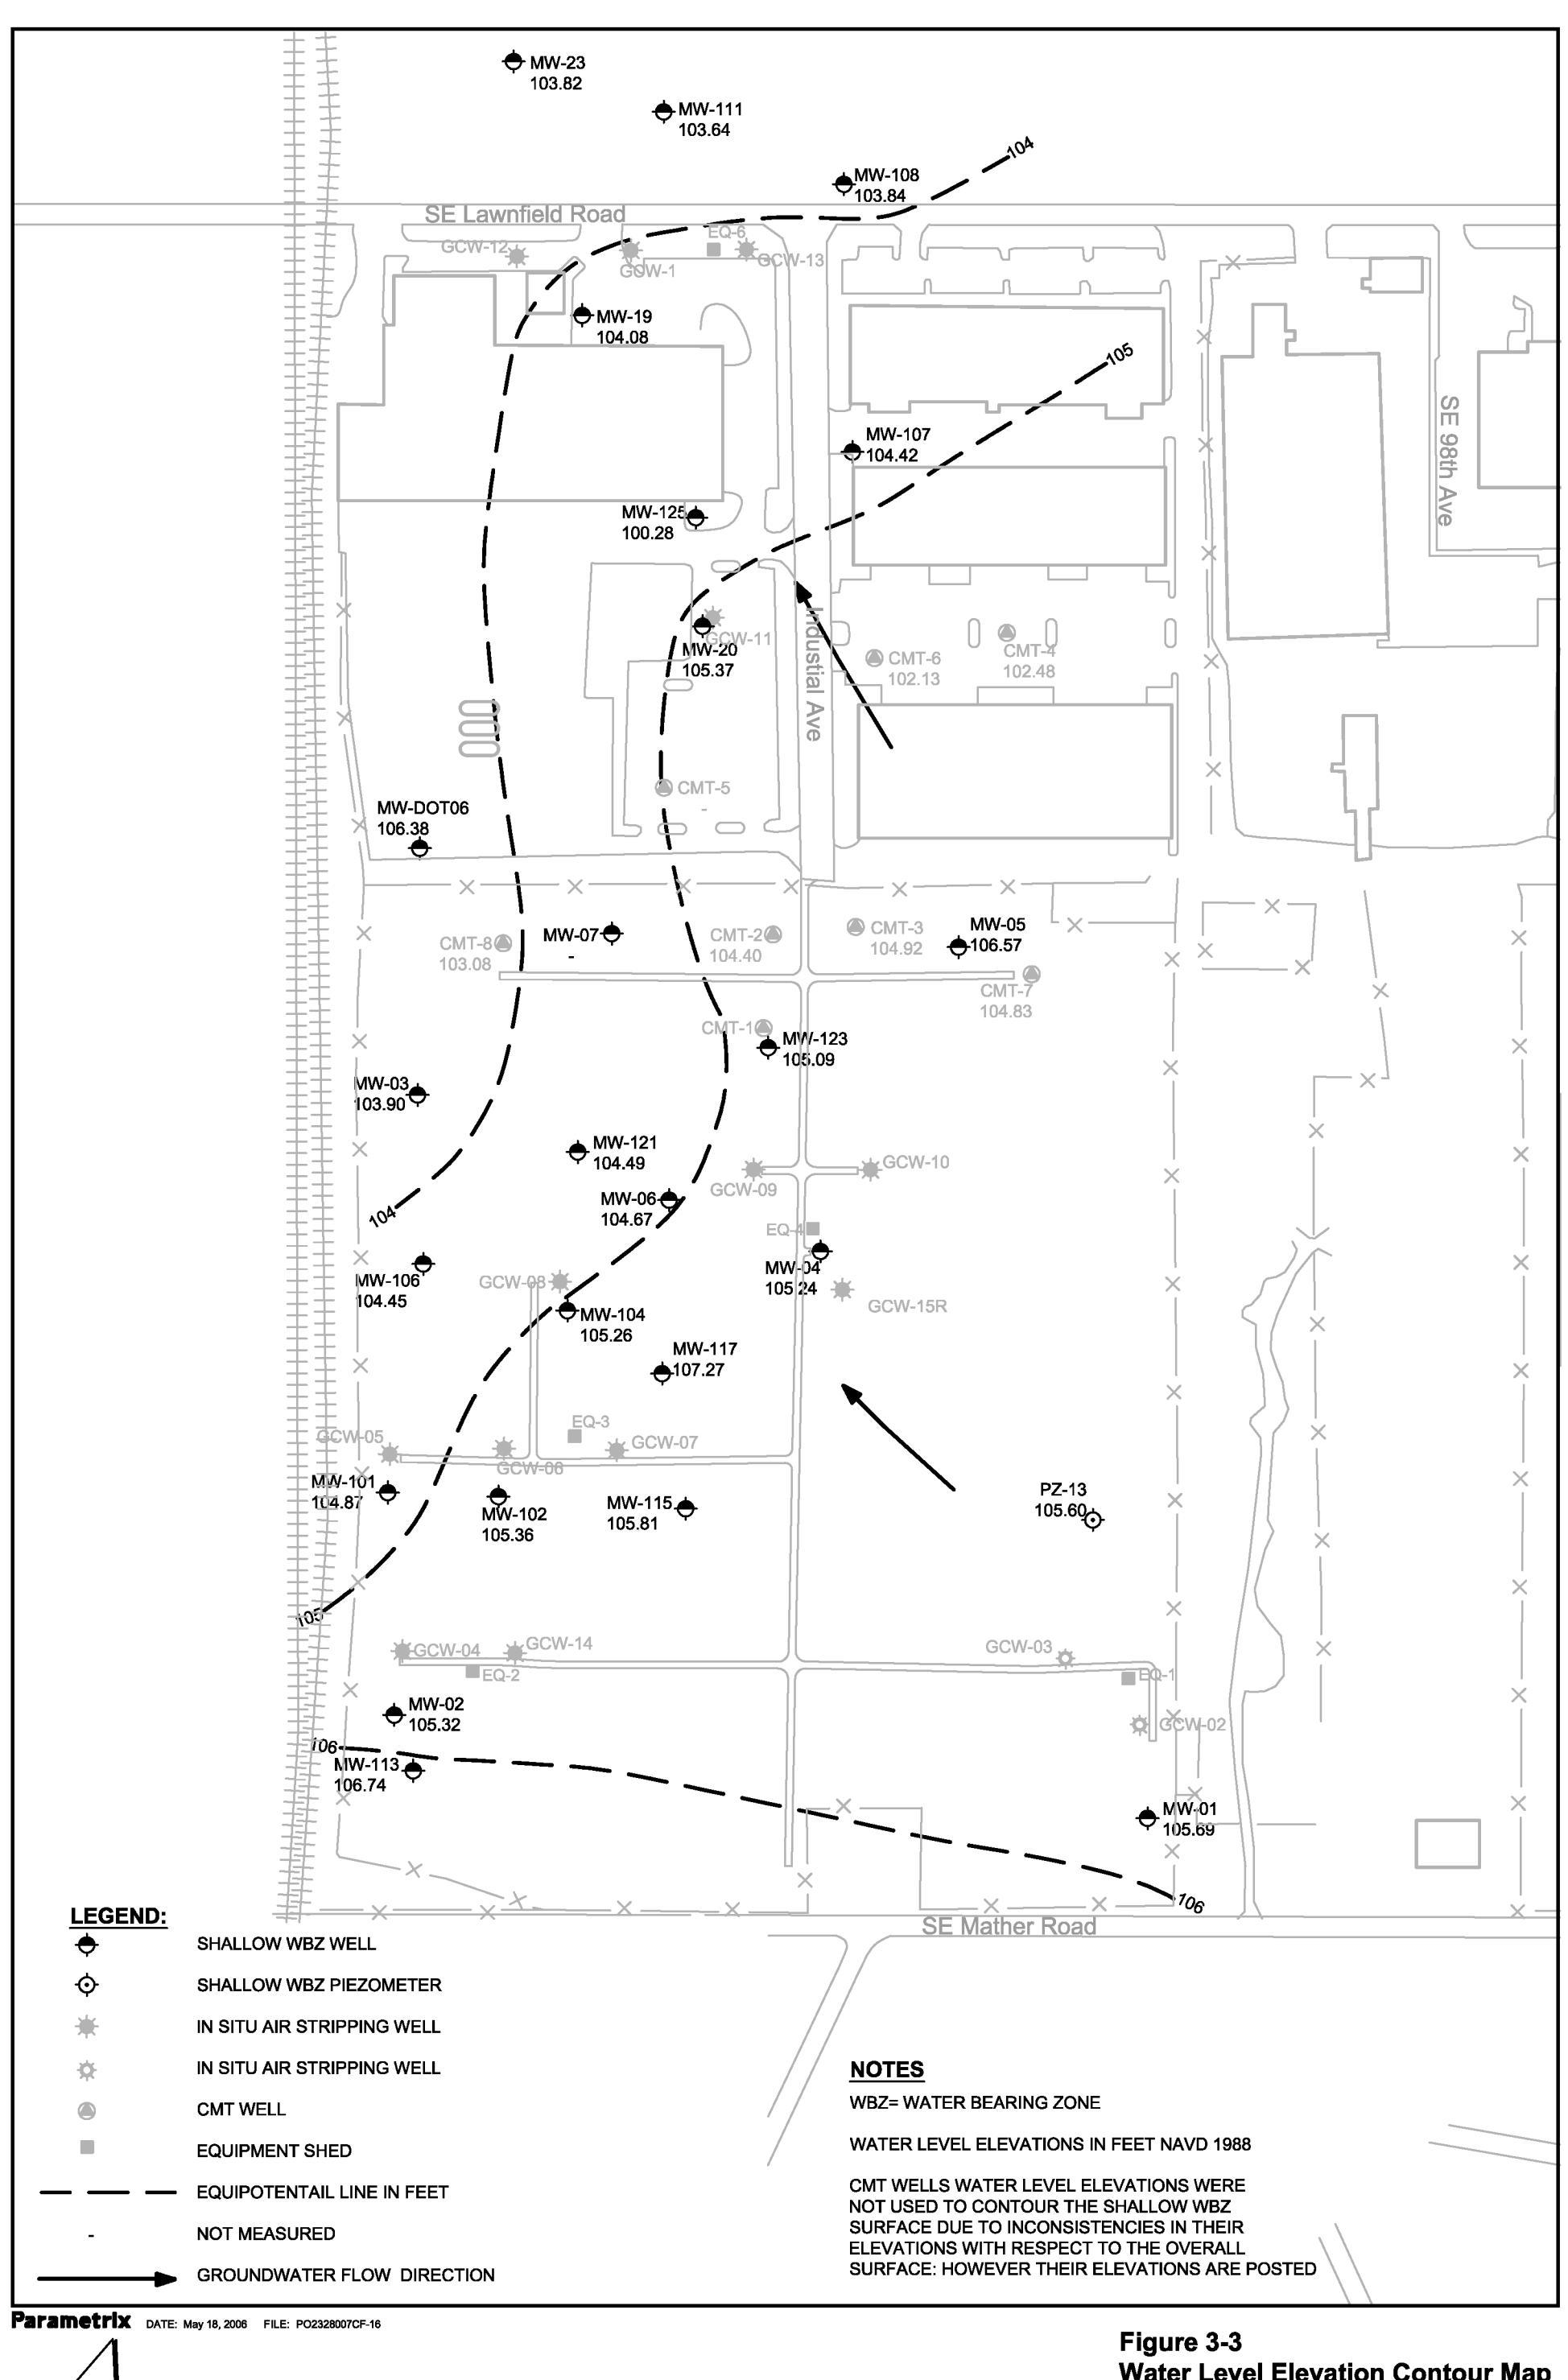
0 200' SCALE IN FEET Figure 3-3 Water Level Elevation Contour Map Shallow Water Bearing Zone November 2005

Groundwater elevations in the Shallow and Intermediate WBZs range from 100 to 106 feet NGVD. Groundwater flow direction in the Shallow and Intermediate WBZs is approximately north to northwest (Figures 3-3 and 3-4, respectively). Natural groundwater hydraulic gradients vary seasonally and range from 1.0E-03 feet per foot (ft/ft) to 1.0E-05 ft/ft.

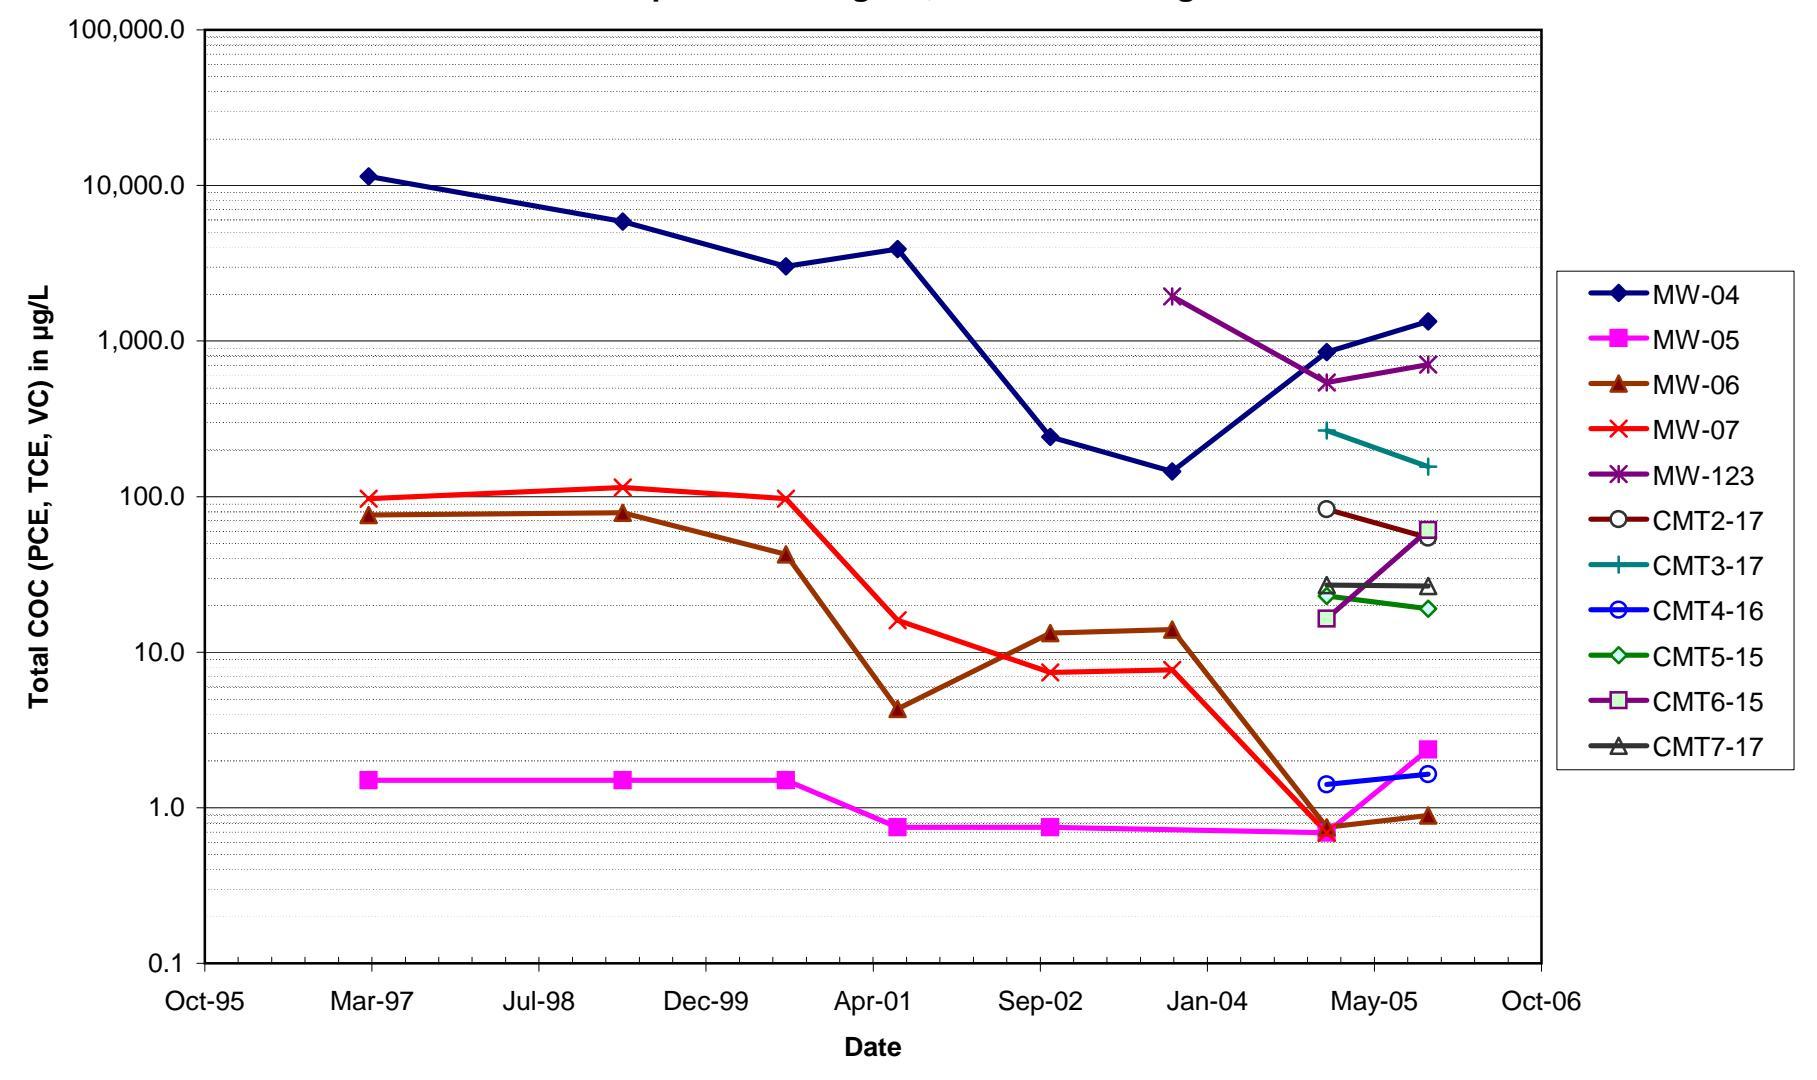
Figure 6-3 Total COCs (PCE, TCE, VC) Concentration Trends in Plume 1 Shallow Water Bearing Zone NW Pipe and Casing Inc, Clackamas Oregon

- Total COCs concentrations in the Plume 1 source area are decreasing over time in monitoring wells constructed in the Shallow WBZ (Figure 6-3); however, PCE and TCE concentrations in the Plume 1 source area persist at concentration greater than 1,000 μg/L and 100 μg/L, respectively.

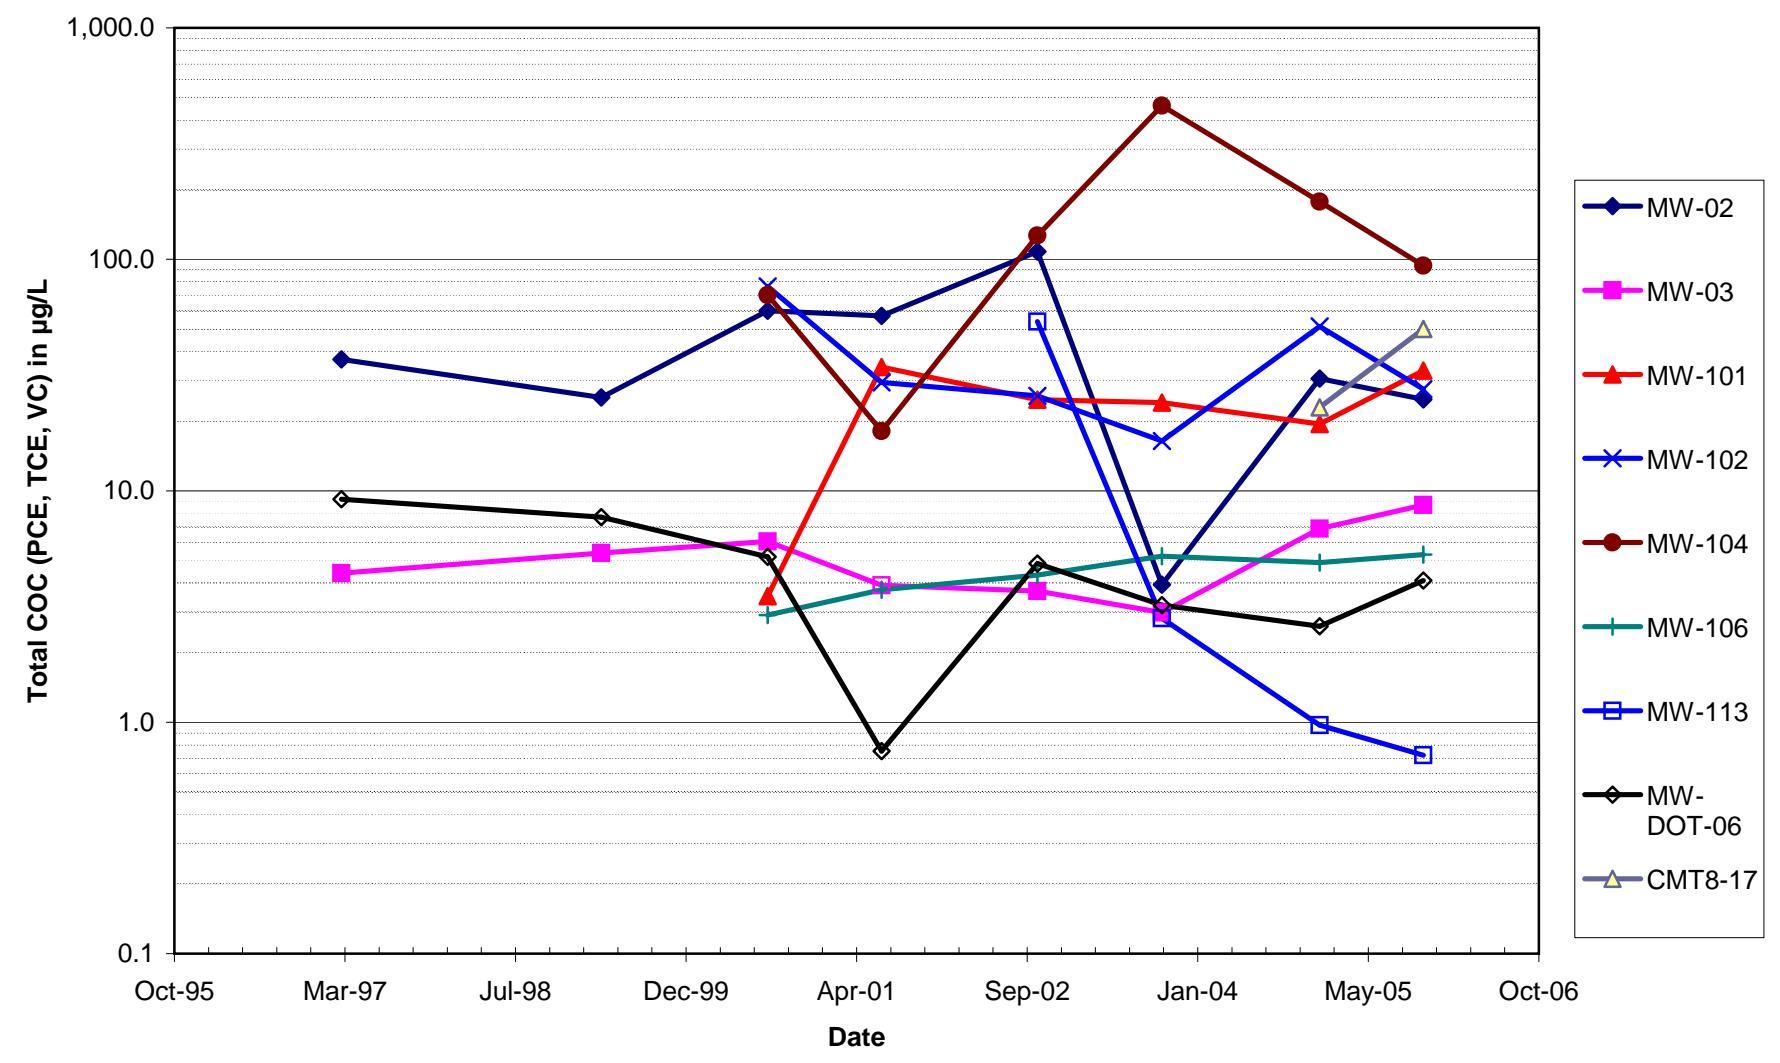
Figure 6-5 Total COCs (PCE, TCE, VC) Concentration Trends in Plume 2 Shallow Water Bearing Zone NW Pipe and Casing Inc, Clackamas Oregon

- Total COC concentrations in the Plume 2 source area are decreasing over time in monitoring wells constructed in the Shallow WBZ; however, concentrations of Total COCs above their respective RGs persist (Figure 6-5).
- Concentrations of Total COCs associated with the Plume 2 source area appear to be migrating hydraulically downgradient in both the Shallow and Intermediate WBZ (Figure 3-5 and Figure 3-6).

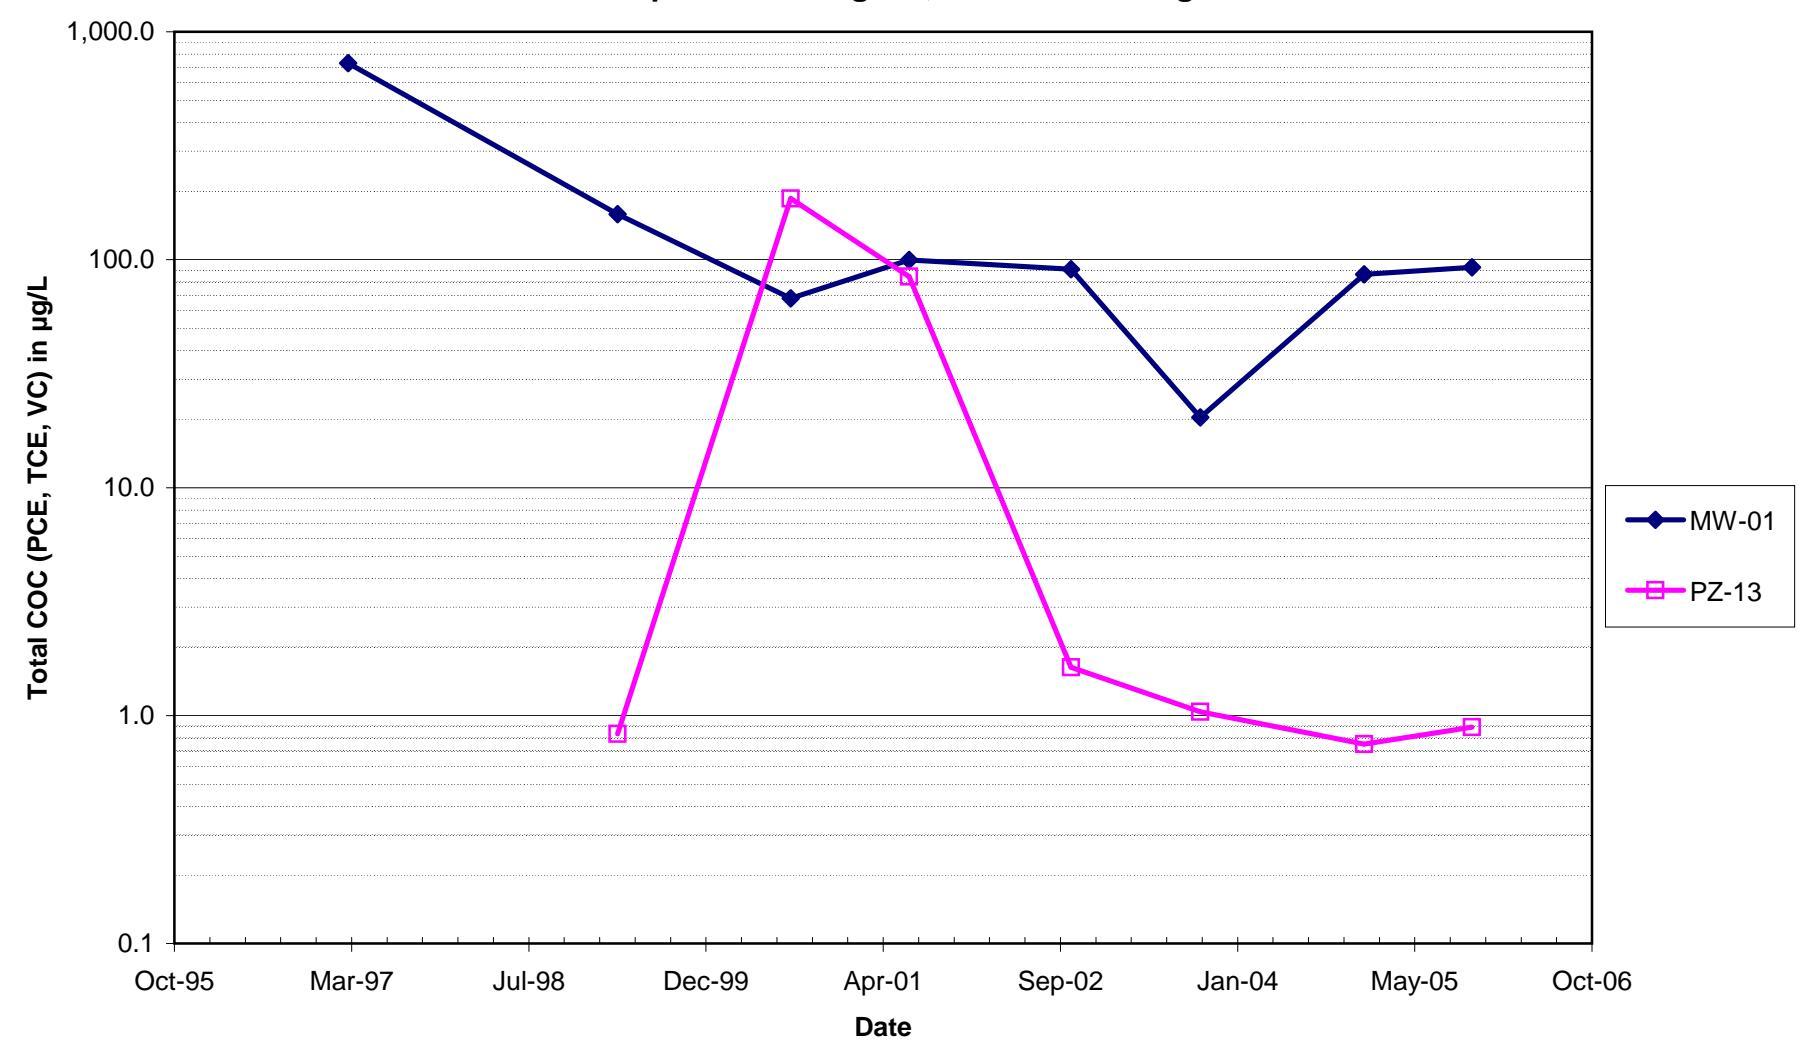
Figure 6-6 Total COCs (PCE, TCE, VC) Concentration Trends in Plume 3 Shallow Water Bearing Zone NW Pipe and Casing Inc, Clackamas Oregon

• Concentrations of Total COCs associated with the Plume 3 source area are decreasing over time in monitoring wells constructed in the Shallow WBZ (Figure 6-6).
