**JOHN F. KENNEDY  
SPACE CENTER**

MAB 3221-69

**(Status Report)**

**Study of Corrosion Protection  
Methods for GSE Applications at  
Kennedy Space Center**

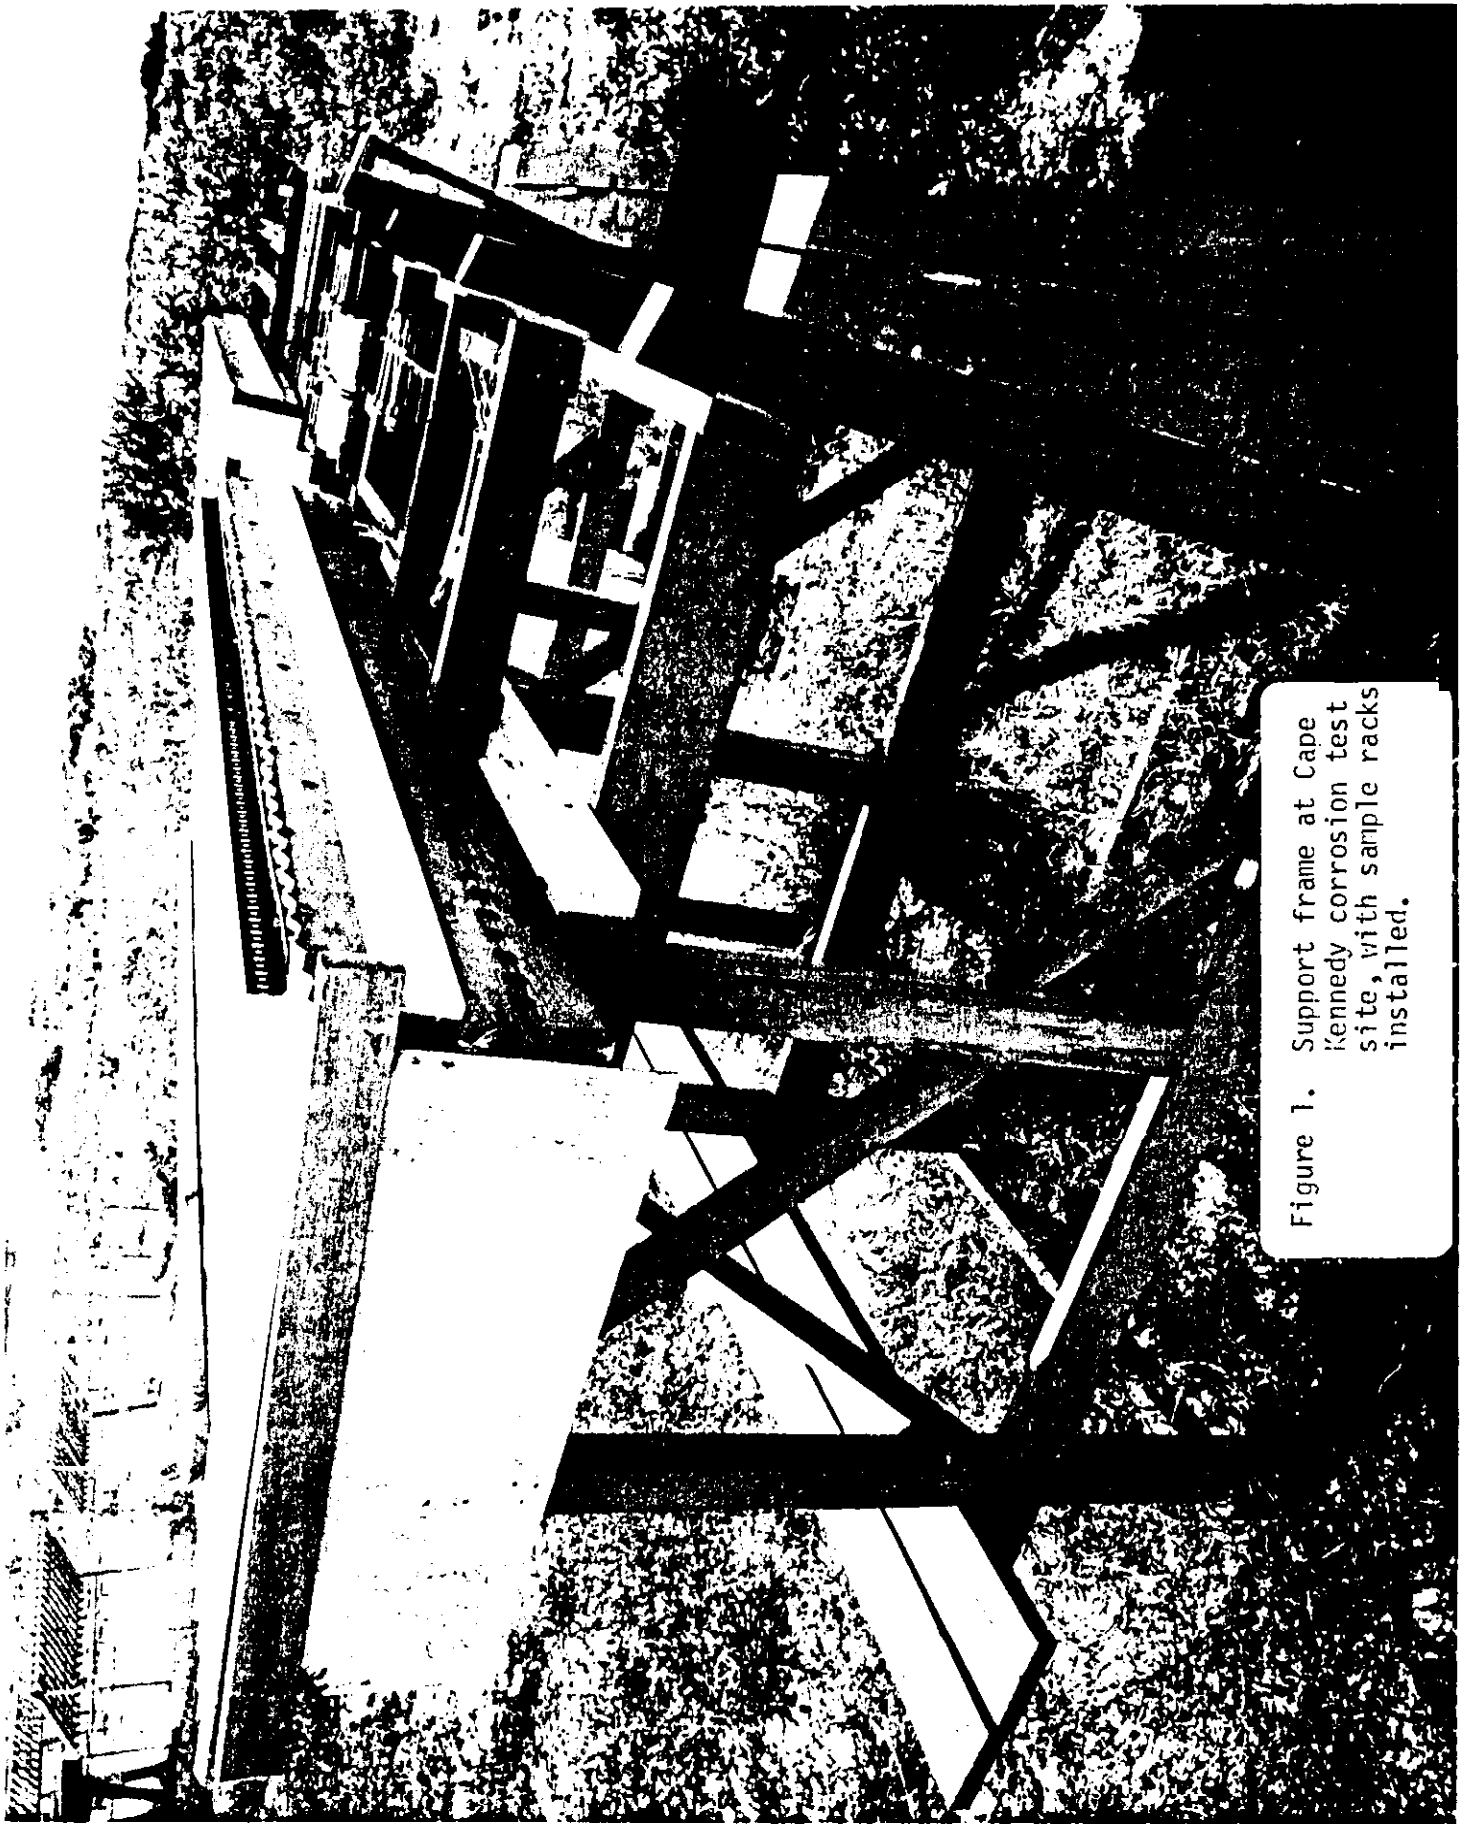
- 2.4 These specimens, as described, constituted the basic materials for evaluation by beach exposure, in terms of the initial concept of the program. The specimens were mounted in wooden support racks, the cables and turnbuckles being suspended horizontally by nylon tie cords. The other samples, with the exception of the carbon steel pipes, were also mounted horizontally, being attached by circular clamping straps to cross members on the racks. The carbon steel capped pipes were mounted vertically, with the 1/2" drilled hole in the lower cap. The sample racks were transported to the CKAFS corrosion test site and installed in a support frame located approximately 375 feet from mean high tide. Most of the samples were placed at the corrosion site on February 18, 19, or 28, 1970. One group, the aluminum tubes coated with inorganic zinc rich paint, was installed on April 1, 1970. One complete set of sample racks was placed in the exposed section of the exposure frame, and the other set was placed in the sheltered section. The support frame with the sample racks installed is shown in Figure 1. In this view, the four racks in the exposed section of the frame can be seen. The other four racks are located under the roofed section.

Figure 1. Support frame at Cape Kennedy corrosion test site, with sample racks installed.
